River Whitewater – Farnborough & DAS

An Advisory Visit by the Wild Trout Trust August 2015

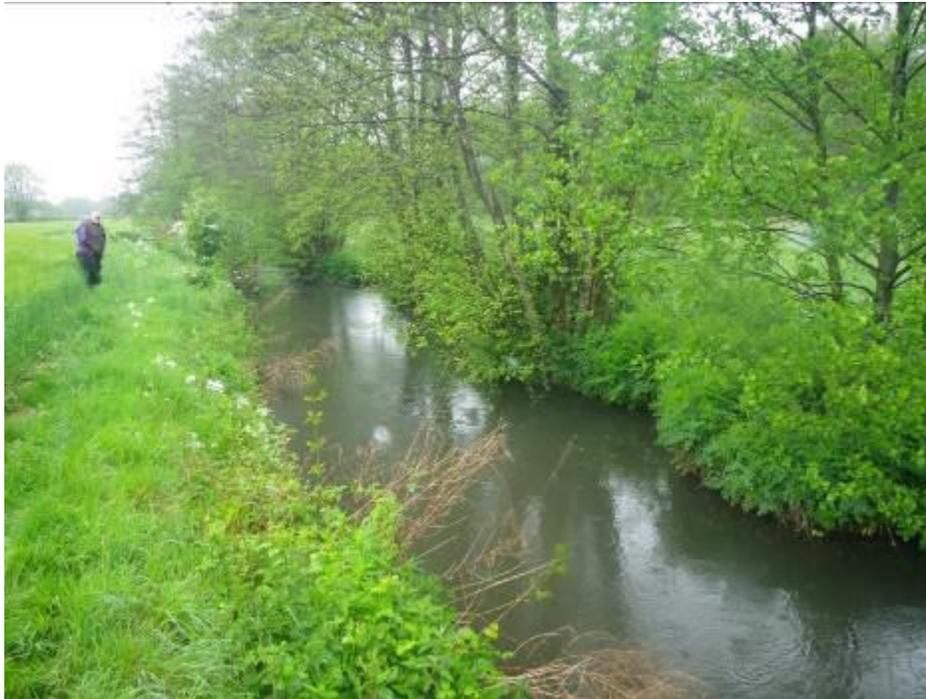
Long sections of the upper half of the fishery are tree lined (photo1), particularly adjacent to the LB. However, shading was not considered to be excessive at the moment, with a healthy balance of dappled light and shade hitting the channel. Many of the alder trees here have been previously coppiced and many are the same height and age. To avoid a big, expensive programme of tree work in the future, occasional clumps should be re-coppiced to promote improved in-channel weed growth and to introduce some diversity into the tree canopy itself.

Photo 1. Stands of mature alder on the top reach adjacent to the LB. Many have been previously coppiced and a return to some rotational coppicing of short blocks will benefit the fishery.

Overall the fishery looks to be in good order. The club have a relaxed approach to riparian maintenance which benefits the ecology of the river. Care must be taken to ensure that all of the alders, which tend to dominate the middle and upper reaches, do not all mature at the same time. Some rotational coppicing is therefore recommended to help maintain a balance in the light regime and promote diversity in the shape and extent of the tree canopy.

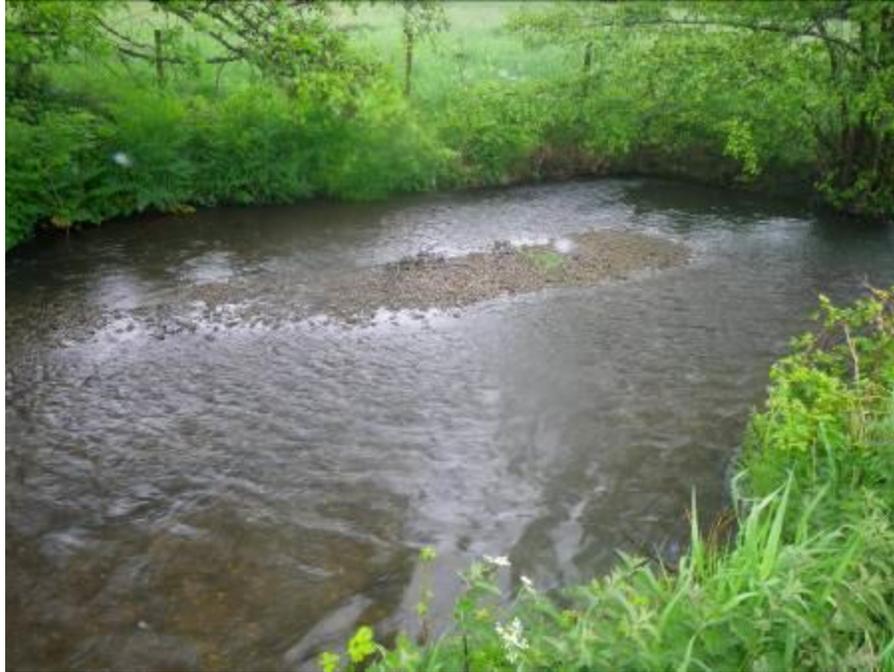
Shallow gravel sites suitable for trout spawning were evident (photo 2), if comparatively limited in extent. Most of the suitable spawning and juvenile habitat sites were located upstream of the Holdshott Farm complex.

Photo 2. Shallow gravel glides and riffles are critically important habitat but are unfortunately limited in extent. Making sure these sites function as spawning and nursery sites is a priority.

The shallow gravel glide and riffle sections on the top reach are of critical importance. Any production of juvenile trout and coarse fish here will filter downstream to populate the entire fishery. It is recommended that some pre-spawning maintenance is carried out on the "up-ramp" of the gravel glides immediately upstream of where the broken riffles begin to form. This work should take place in the first half of October and involves breaking up the hard gravel crust with fencing spikes and either vigorously raking the river bed, or jetting with modified water pumps to loosen the bed material and blow fine sediments from potential spawning sites. Spending one morning cleaning and preparing likely spawning sites could significantly boost wild trout spawning success. Information on all of these techniques, including the installation of tree sweepers, can be found on the WTT website www.wildtrout.org. Specific video guidance on tree sweepers or "kickers" (<http://www.wildtrout.org/content/how-videos#tree+kicker>) and on gravel management (<http://www.wildtrout.org/content/how-videos#gravel>) appear in the "video hub" section of the site.

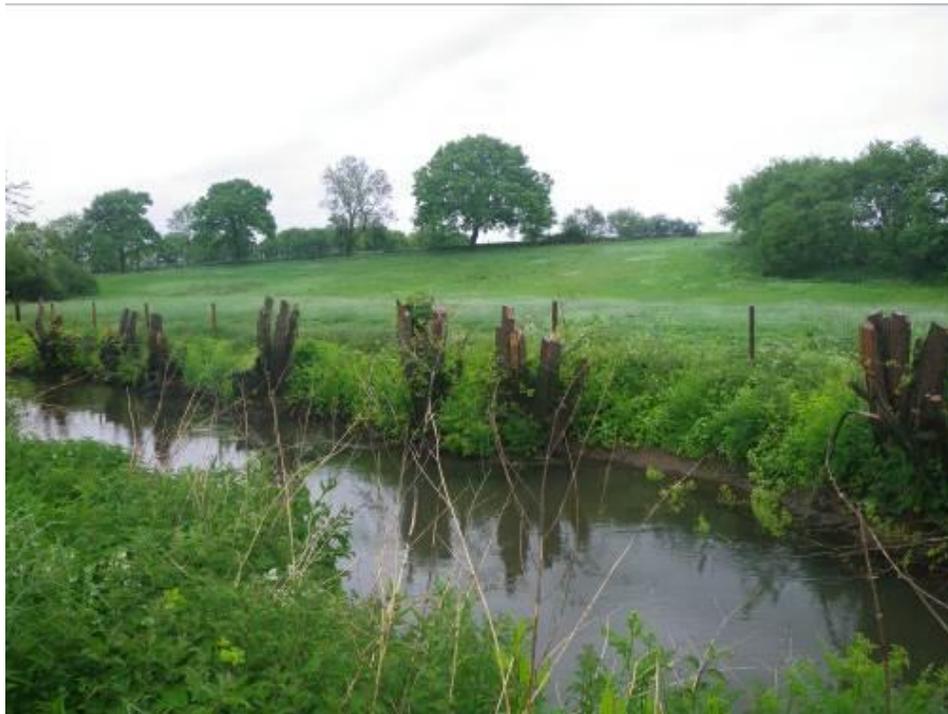
Approximately 300m upstream of Heckfield Bridge there was evidence of recent tree work undertaken by the land owner of the opposite meadow (photo 3). It is understood that this particular land owner does not own sporting rights, however, the work undertaken has not been carried out with river ecology in mind, with most

Alder trunks having been cut approximately 1.5m above water level. These trees have been coppiced before, as evident by the multi stooled nature of the trunks. A much better option would have been to leave a few of these trees to slowly mature and coppice out some sections in-between. For the best results, alders should be coppiced to the ground to promote low cover, rather than high level shading. That said, these trees will recover, even if they will take on a slightly odd appearance in the future.

Photo 3. Line of Alders recently felled by the opposite landowner near the bottom boundary. Retaining two of three mature stools and coppicing others to the ground level to promote low cover would have been a better scenario for the river.

Alder roots are fantastic for providing solid bank protection and also provide cover for fish as well as sometimes being utilised as a spawning habitat by species such as roach and perch. It is recommended to engage with the land owner to discuss objectives for the river and perhaps offer to help with any future tree management.

The tree works undertaken on the lower end of the fishery, although poorly executed are not a disaster. The trees will recover, however; it is recommended that representatives from the F&DAS and Loddon Consultative engage with the new land owner to raise awareness about the importance of sensitive tree management. The F&DAS could consider making an offer to include these trees in their own maintenance schedules in the future.

- **Fully engage with the downstream neighbours over the importance of sensitive tree management**

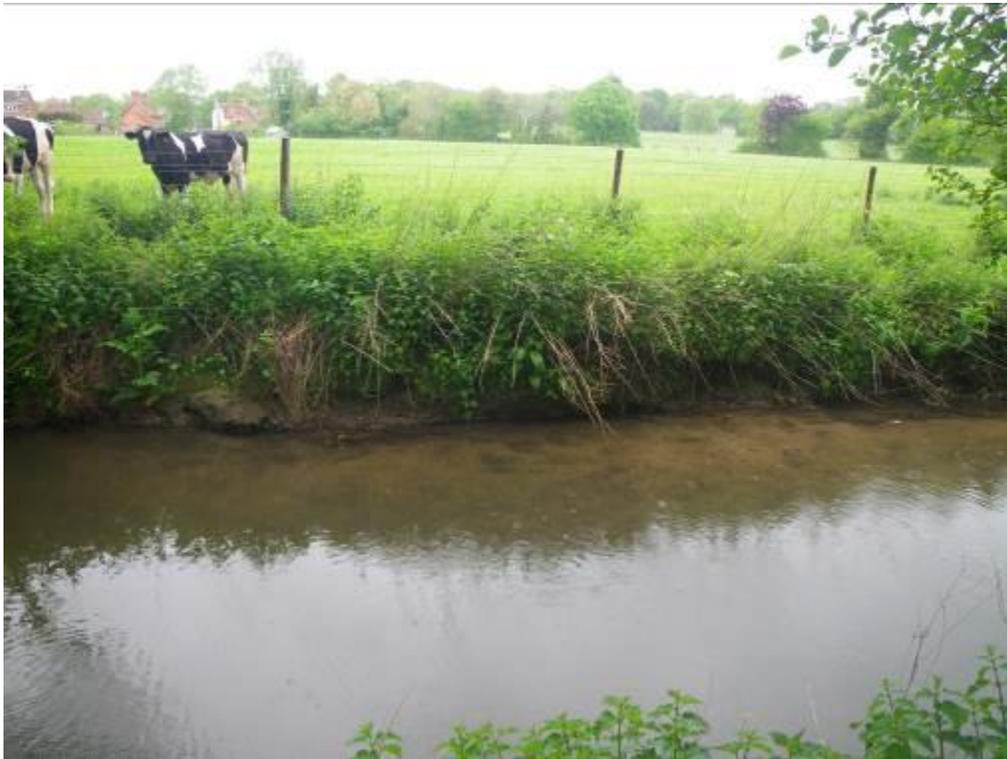
Steady glide habitat dominates long reaches of the fishery. In places there are good examples of low, overhanging cover provided by occasional thorn trees (cover photo) and willows. Bare margins were evident (photo 4) in a few locations and possibly reflects the slightly “flashy” nature of the lower Whitewater compared to the stable nature of true chalkstreams. These sections could easily be improved with the addition of brush wood berms, or tree sweepers (see recommendations).

Photo 4. Bare margins providing no habitat for fish. A brushwood toe to the bank would provide improved winter cover for small fish.

Woody materials won from tree work could be beneficially used to create improved winter cover, especially in the toe of sections of uniform, shallow glide.

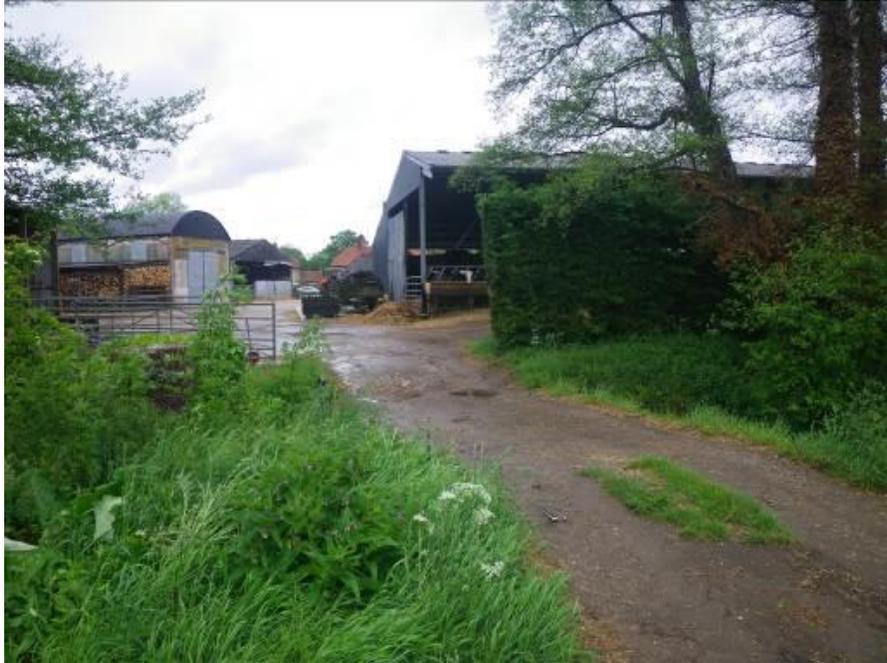
The proximity of Holdshott cattle sheds to the river (photo 5) are a cause for concern, as is the level of bank damage to the first meadow immediately below the farm (photo 6). Issues associated with potential pollution via cattle sheds should be addressed by the EA and it isn't for the Angling Club to tackle their own landlord regarding this issue. Considerable improvements to the quality of the river could be achieved via a fencing project and the provision of cattle drinking bays which can be designed to provide a good habitat for juvenile coarse fish fry and reduce diffuse pollution pressures.

Photo 5. The track from the farm complex and cattle sheds runs over the river bridge looks to be a direct pathway for potential pollution. At the very least the farm should be subject to a pollution prevention visit from the EA and action taken, if needed to alleviate the risks.

- **Engage with the club landlords at Holdshott Farm over options to reduce pollution pressures. This action should sit with the EA and Consultative and not involve the tenants.**

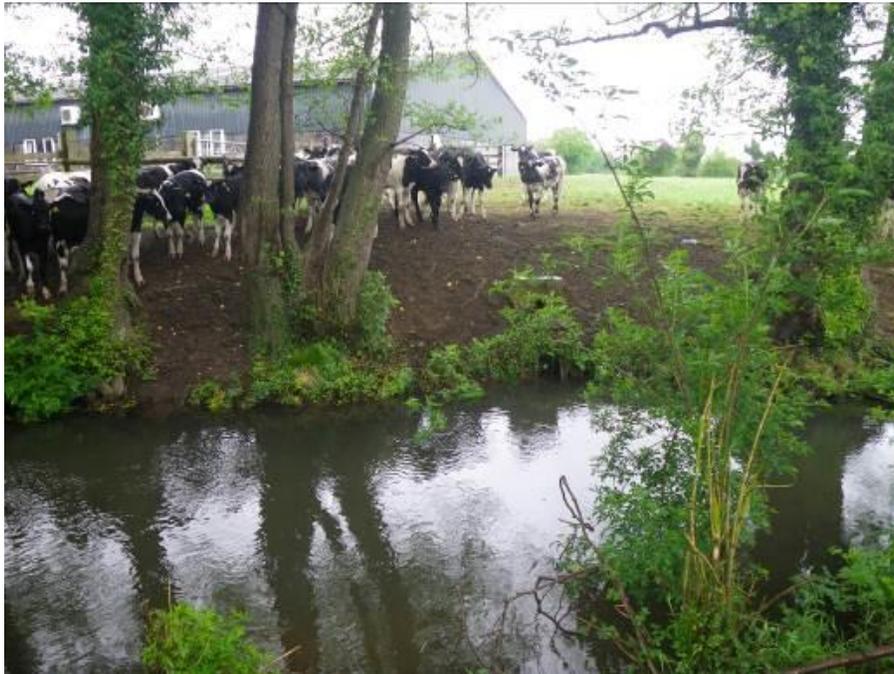
Photo 6. The meadow immediately downstream of Holdshott Farm requires stock fencing to protect the river from excessive siltation and diffuse pollution pressures. Any fencing could also incorporate cattle drinking bays that are ideal habitat for coarse fish fry.
