### **Advisory Visit**

**River Whitewater (Wensum), Norfolk**

**16<sup>th</sup> September, 2009**

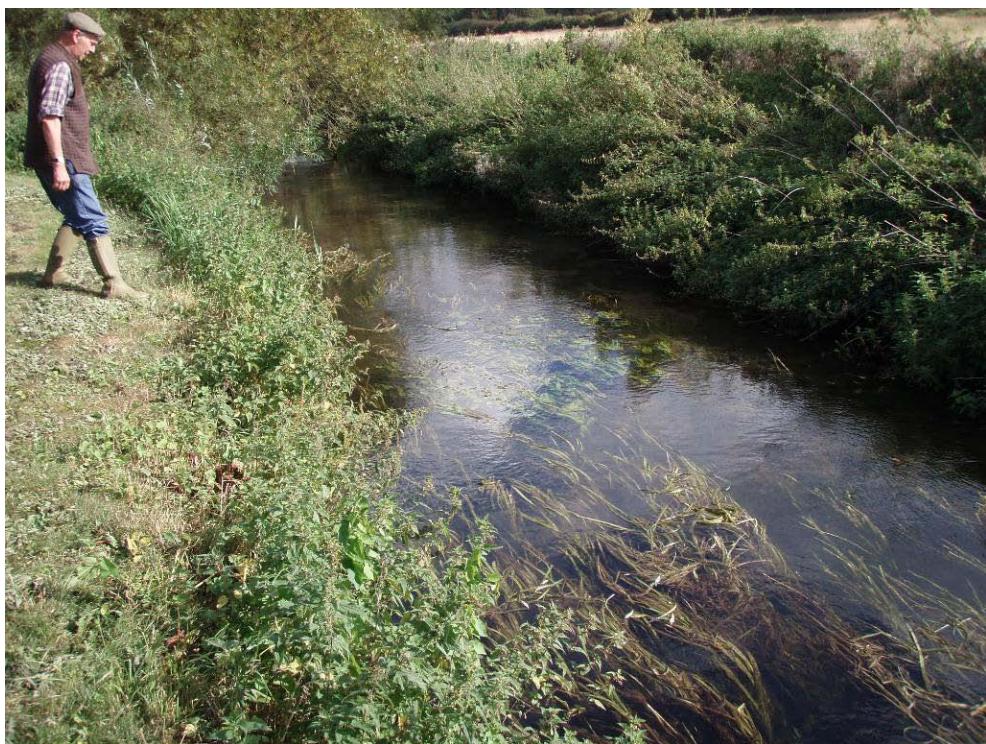
The river is a low gradient channel which has been widened and deepened in the past. The channel is 5 – 6 metres wide, and there are large accumulations of silt on the river bed. Aquatic plant growth was heavy at the time of the visit and the plant community was typical of lowland dredged rivers which have subsequently silted up. Submerged aquatic vegetation is dominated by species adapted to a slow-flowing or stillwater environment, and includes water lilies (*Nuphar* sp.) and submerged bur-reed (*Sparganium erectum*). Emergent aquatic vegetation is also dominated by bur-reed which is present in dense stands within the channel.

**Photo 1** Over-wide channel with silty bed and high banks

- Plan and undertake a programme of river channel rehabilitation on the Whitewater. The basis of such a project would be the creation of a two-stage channel with a narrower low-flow channel within the existing reprofiled channel to retain flood flow capacity.

This could be achieved using the cut-and-fill technique (Figure 1). Measurements taken during the visit (Figure 2) indicate the creation of a berm would need the excavation of a cross-sectional area of approximately  $1.375 \text{ m}^2$  of bank. As a very rough guide, if bank reprofiling were carried out over the entire 850-m length of the fishery, this would require the excavation of around  $1170 \text{ m}^3$  of earth.

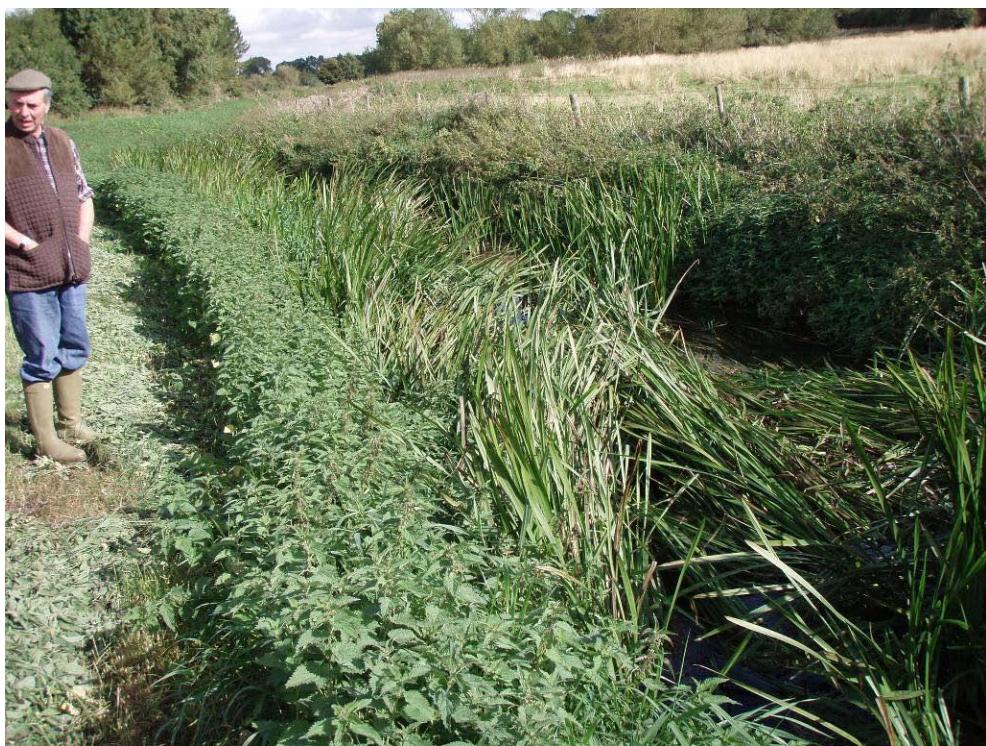
**Photo 2** Bur-reed (*Sparganium erectum*) has colonised large areas of the channel

Mr. Bunning reports increased growth of emergent aquatic vegetation this year compared with previous years. Flows were particularly low at the time of the visit following prolonged dry weather, which may be a contributory factor. It is also worth checking to see if there are any abstractions upstream of this point and whether they may be having an effect.

- Check with the Environment Agency to see if there have been any increases in water abstraction upstream of the fishery which could be contributing to lower flows and increased invasion of the channel by bur-reed.

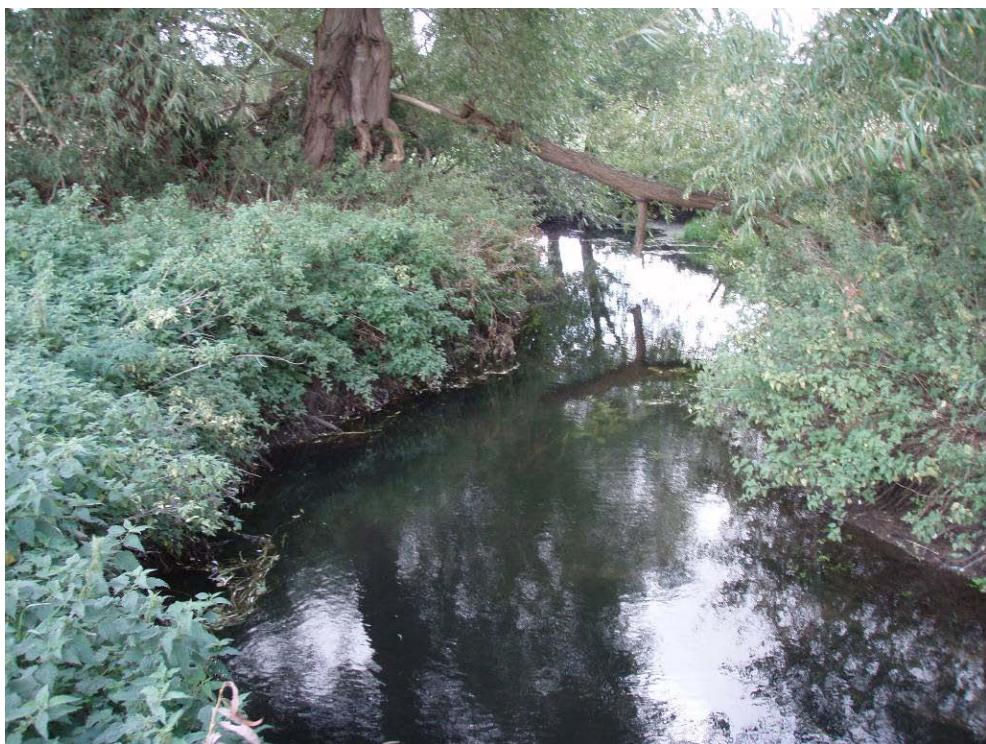
**Photo 3** Aquatic vegetation is more limited in shaded areas

The right bank also has more trees and bushes in certain areas, including crack willow, alder, sallows and towards the downstream end of the reach, oaks. Aquatic weed growth within the channel is less vigorous in areas which are shaded by the trees.

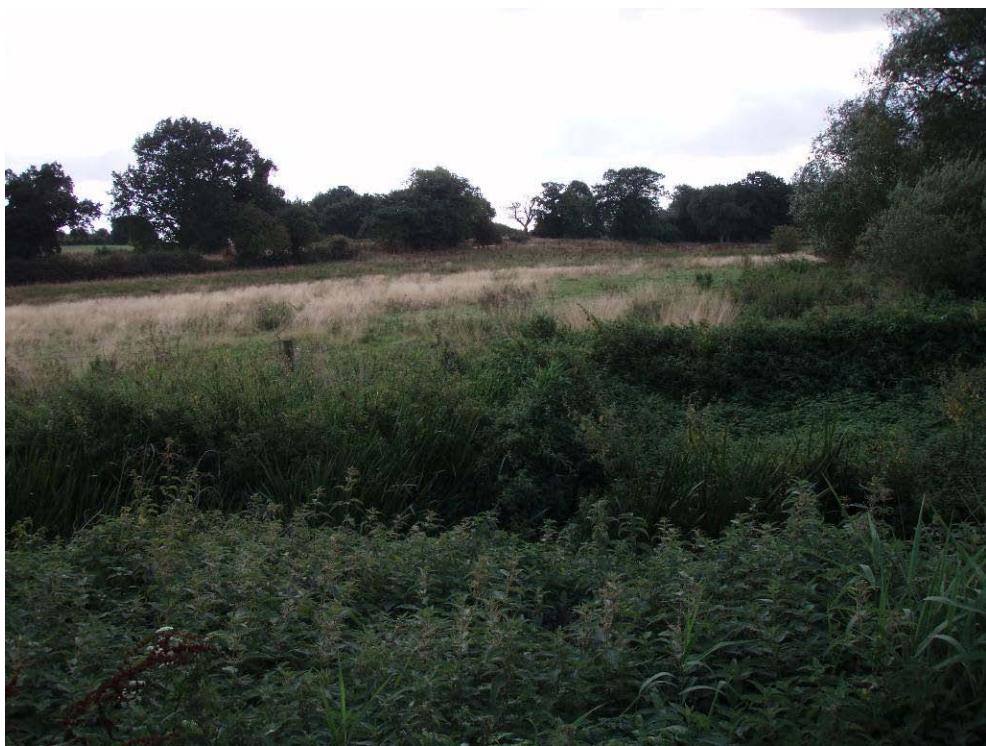
**Photo 4** Land use on the RHB is rough grazing in a wet meadow

The left bank is maintained by the angling club and is mown grass with a nettle-dominated fringe alongside the river. There are few trees and bushes on this side. On the right bank there is a marginal fringe of dense, low vegetation dominated by nettles; beyond this is a fenced, low-lying, wet grazing meadow with rough grass and rushes (*Juncus* sp.) which was being grazed by sheep.

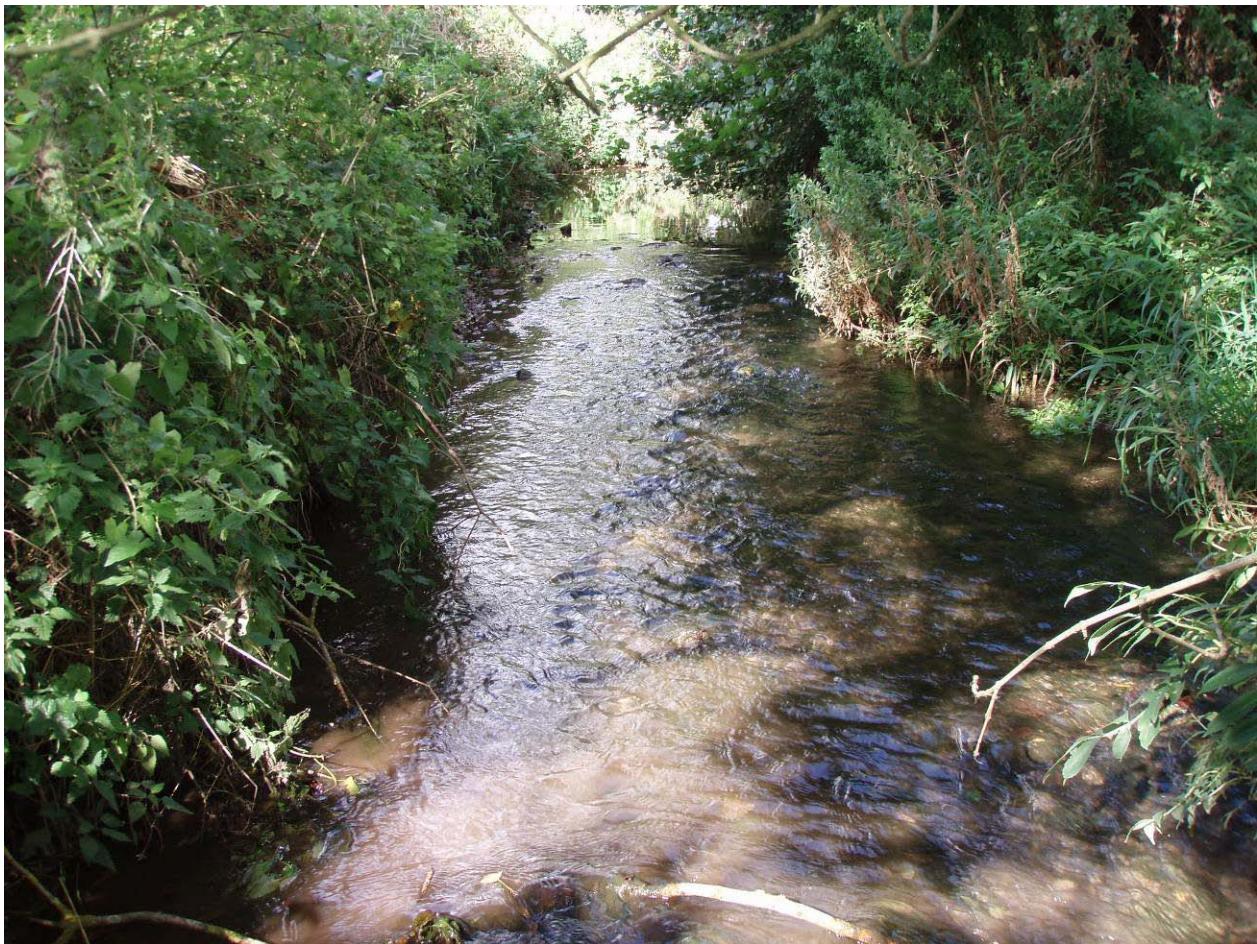
At the downstream limit of the reach a small tributary, the Blackwater, enters on the LHB. This stream has areas of pool and riffle habitat, and some gravel areas which are suitable for trout spawning. A small proportion of the flow is abstracted as a feed to the trout lakes on site through a small diameter (approximately 8") pipe.

It is very likely that these small, spring-fed tributaries are vital spawning areas for trout which will then drop down into the main river. It is very important to ensure that these small tributaries are protected, and that no

damaging works are allowed to take place (such as dredging or 'ditching out'). The streams are very overgrown, but this is no bad thing in that it provides protection from predation (e.g. by herons) for both larger spawning trout and their offspring.

**Photo 5** The Blackwater has some reasonable habitat for trout spawning

- Protect the small tributaries and ensure no works detrimental to their condition are allowed to take place. Do not be too hasty to clear bankside trees, bushes and vegetation as this provides good cover and protection for fish in such small watercourses.

- Walk the tributary streams to ensure fish have free passage for as far upstream as possible. Take this opportunity to clean gravel areas on riffles by forking over to a depth of about 30 cm (12 inches) to displace fine sediments and improve trout egg survival rates. This should be done in autumn (October) prior to trout spawning.

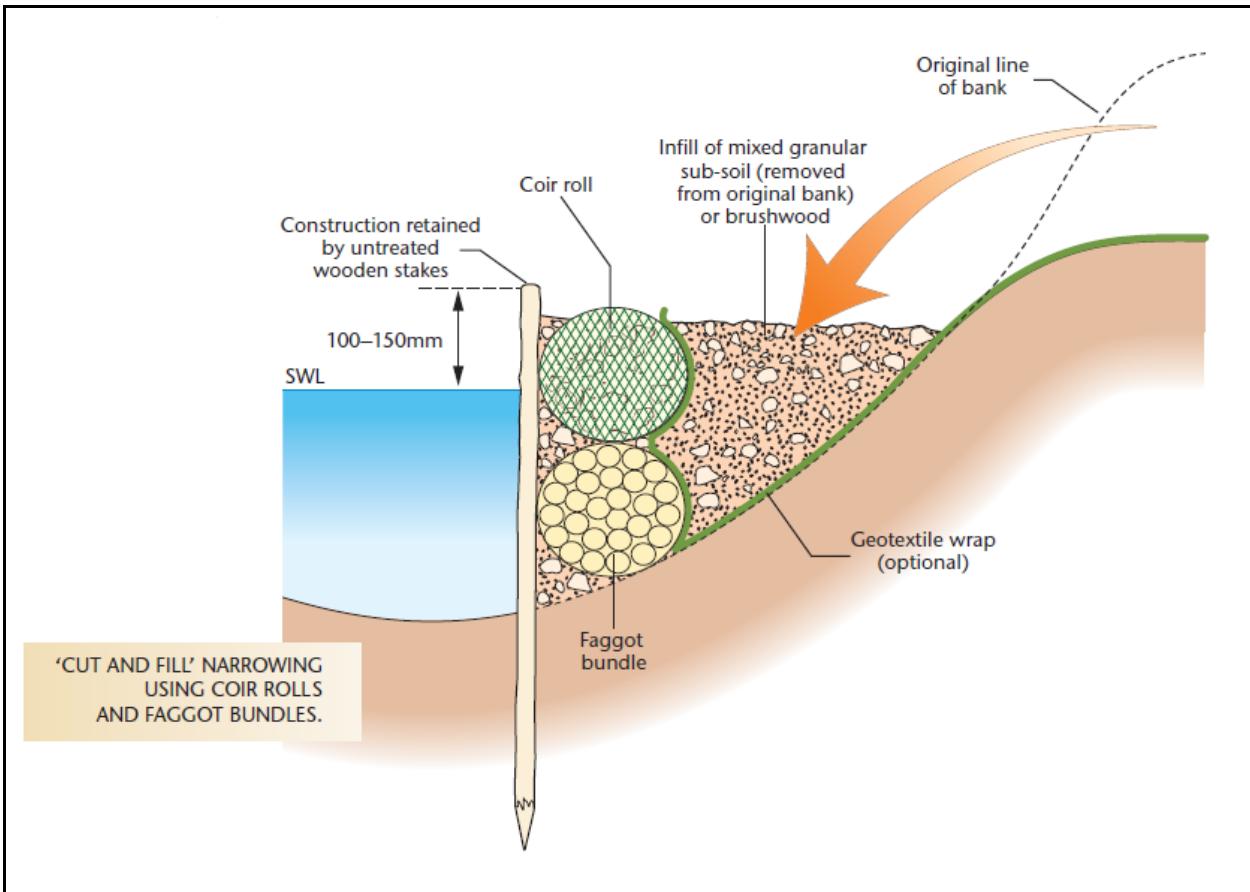
**Figure 1** Cut and fill technique for creating a two-stage channel (from *The Chalkstream Habitat Manual*, Wild Trout Trust).

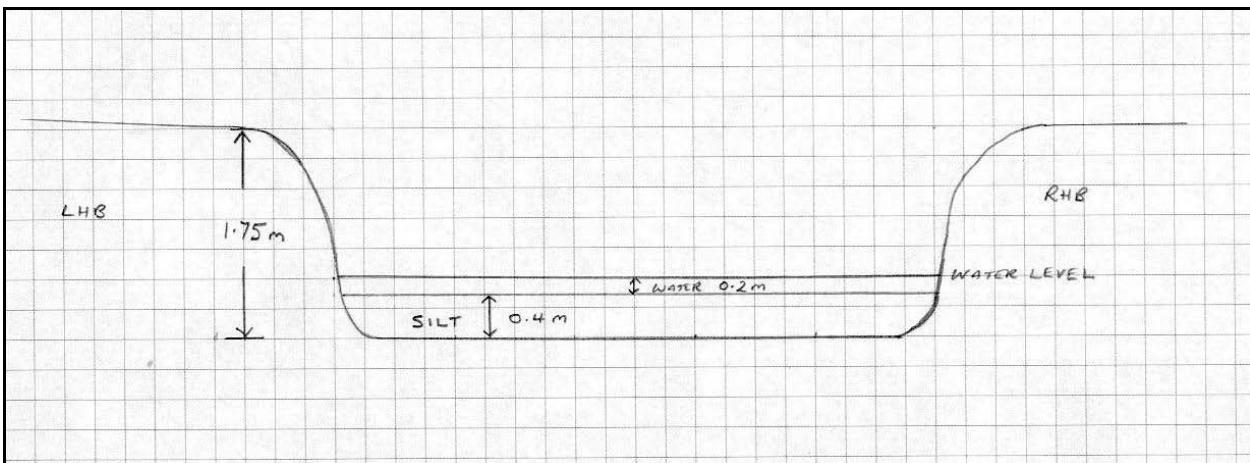
**Figure 2** Typical existing cross-section of the Whitewater

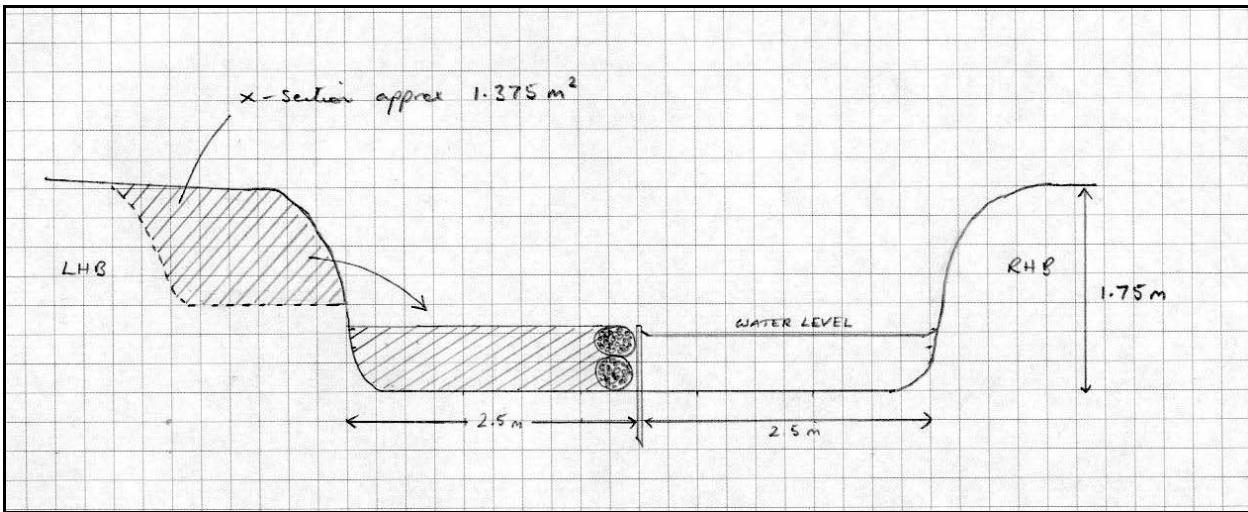
**Figure 3 Potential for cut-and-fill to create a two-stage channel.**
