River Whitewater – Whitewater Syndicate

An advisory visit carried out by the Wild Trout Trust – January 2012

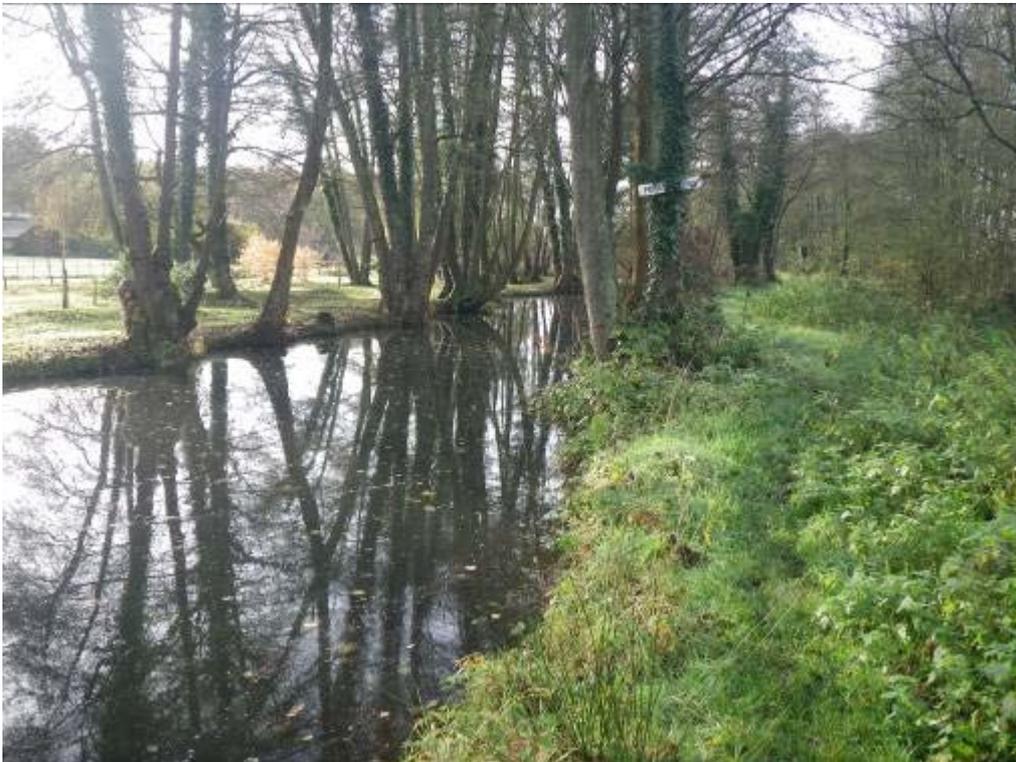
The very bottom section of river upstream of Diple Bridge is heavily impounded by the structure at Diple Mill. This has resulted in a long, slow flowing section of river, passing gently over a mainly soft silt river bed. It is understood that this bottom section is popular with members, which is surprising given that the in-channel habitat for trout is rather poor. The popularity of this beat may reflect the easy access for angling.

Bottom beat just above Diple Mill. Poor habitat for flow loving fish species.

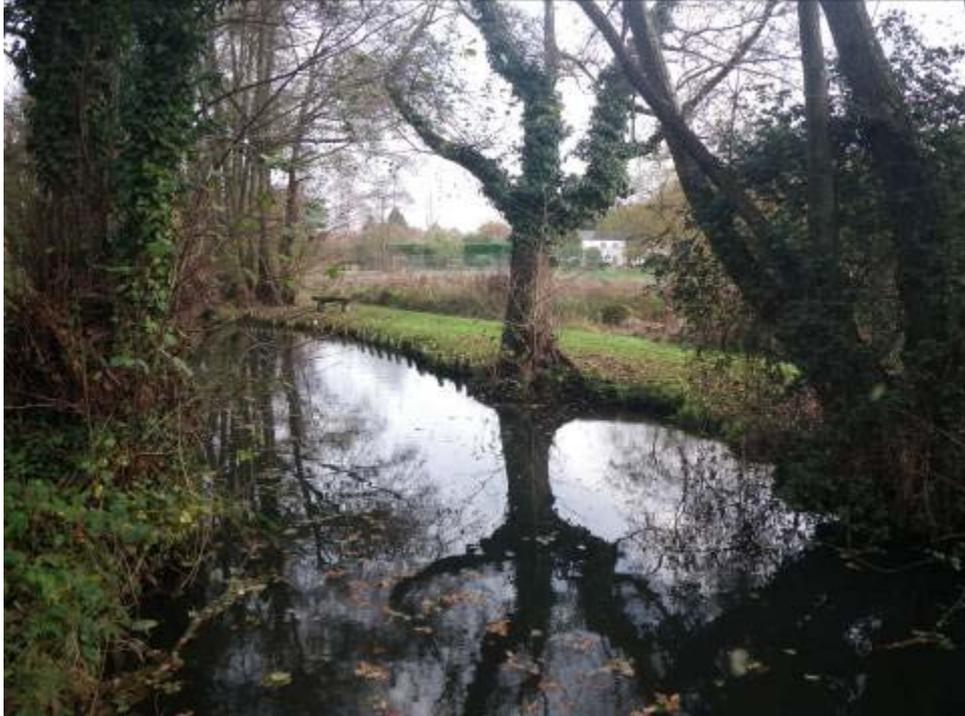
Sections of RB (non fishing bank) between the mature alder trees have been closely mowed and in several sections there was evidence of bank erosion. Some attempts to address bank erosion have been made by driving in vertical wooden poles into pockets of a non degradable geotextile. These defences will provide some short term protection, but the nature of the bank and the significant shading prevents the growth of plants with root systems that would provide long term protection from erosion.

A line of posts and geotextile installed on the RB is unlikely to halt bank erosion.

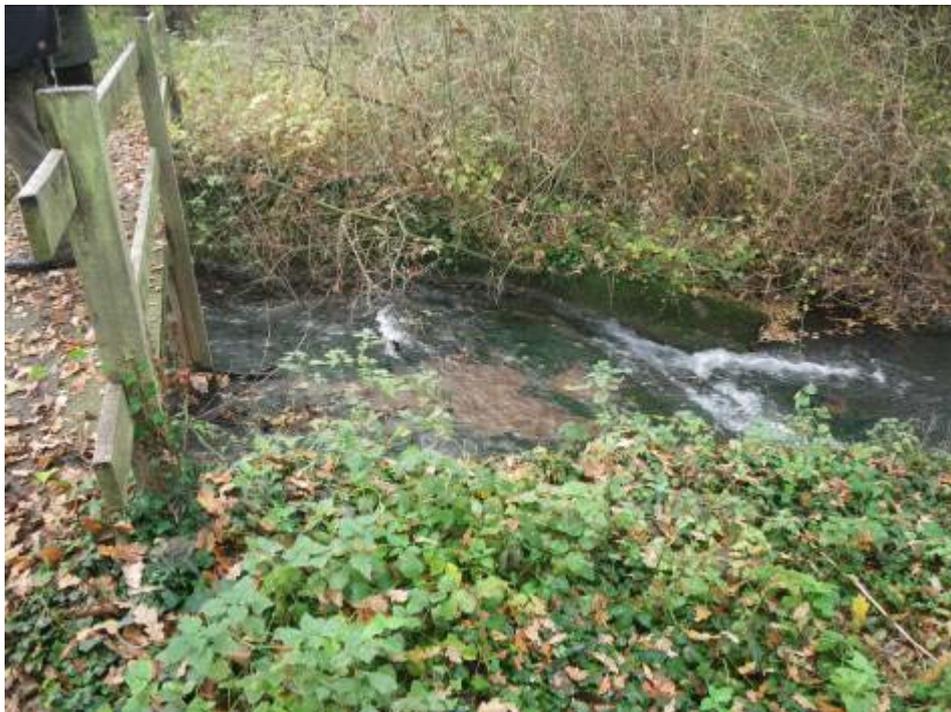
Spillway feeding water down into the small channel running parallel with the LB

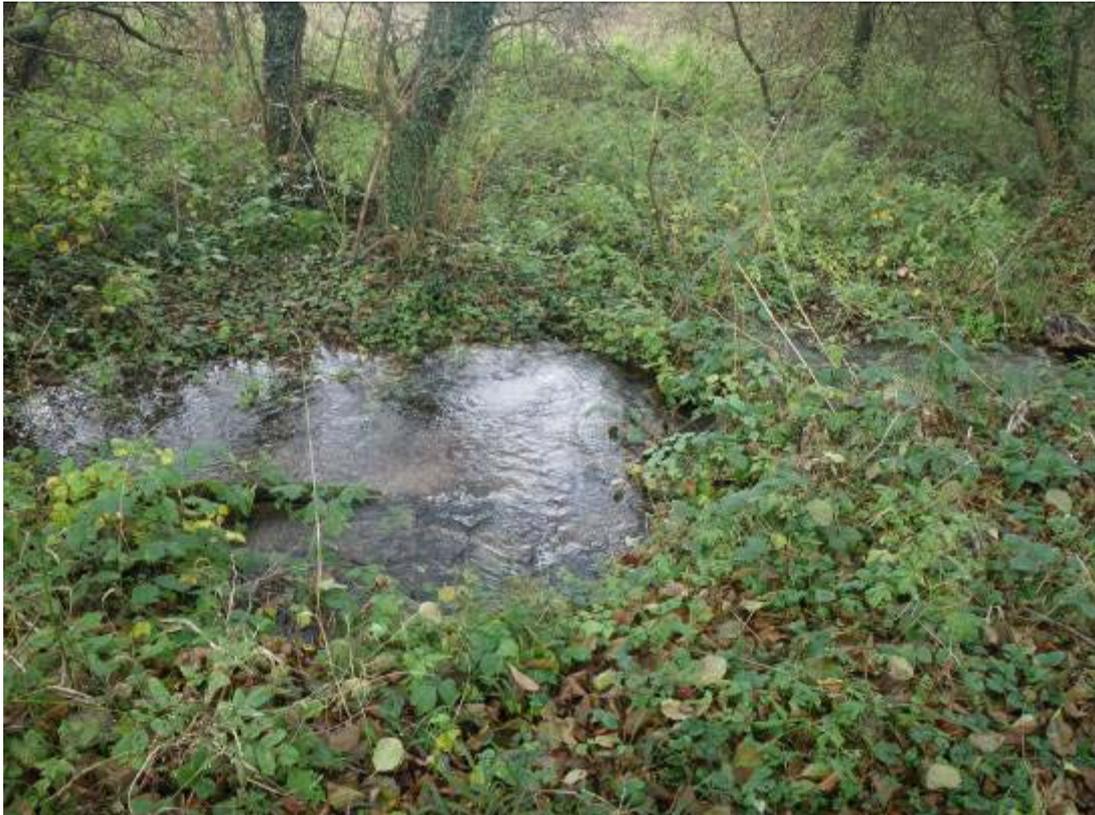
Approximately 250m above the bridge there is evidence of the raised channel leaking into the low level parallel water course running adjacent to the LB. Maintaining artificially high milling embankments is often fraught with difficulty

as water inevitably tries to find the lowest point. It is possible that the comparatively recent arrival of non native signal crayfish (*Pacifastacus lenisculus*) is exacerbating the problem particularly as some banks are quite narrow. Signal crayfish tunnel into banks and make them more susceptible to erosion.

Water percolating through the perched LB into the side channel. This area is extremely vulnerable to a complete breach.

A brief discussion took place regarding the possibility of directing more of the current flow through a new structure into the low level channel that bypasses the Dipley Mill impoundment below. This change would undoubtedly create some excellent quality habitat and would have the additional benefit of opening up access for species wishing to migrate up and down this section of river. It was thought that such a diversion would be extremely unpopular with the riparian owner of the RB, who would lose existing river frontage and also the owners of Dipley Mill, who enjoy milling rights.

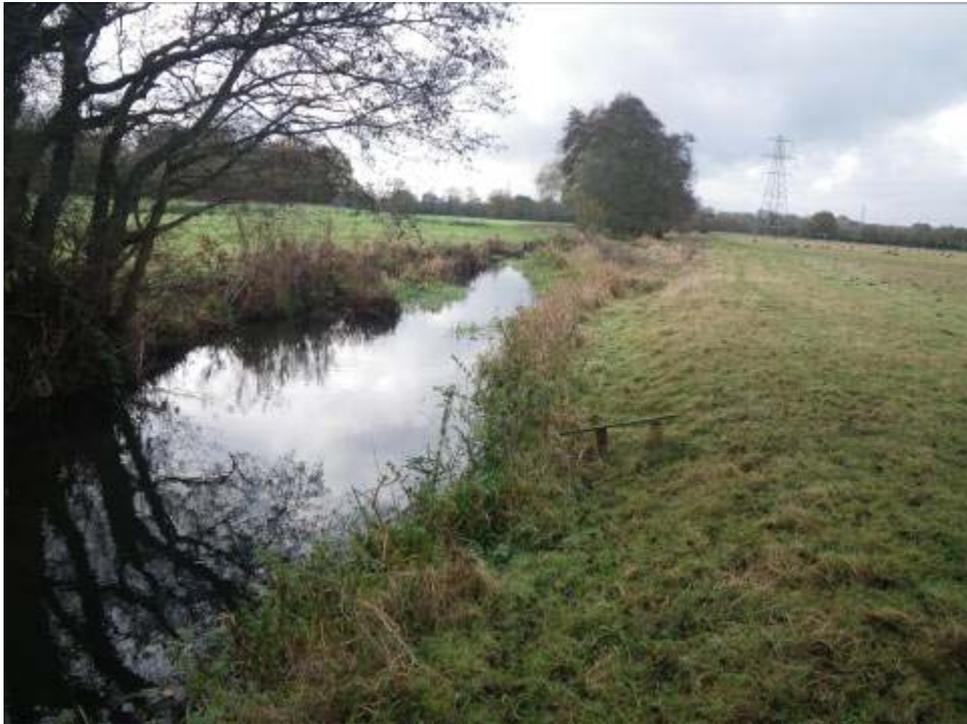
River channel upstream of the lower wooded section.

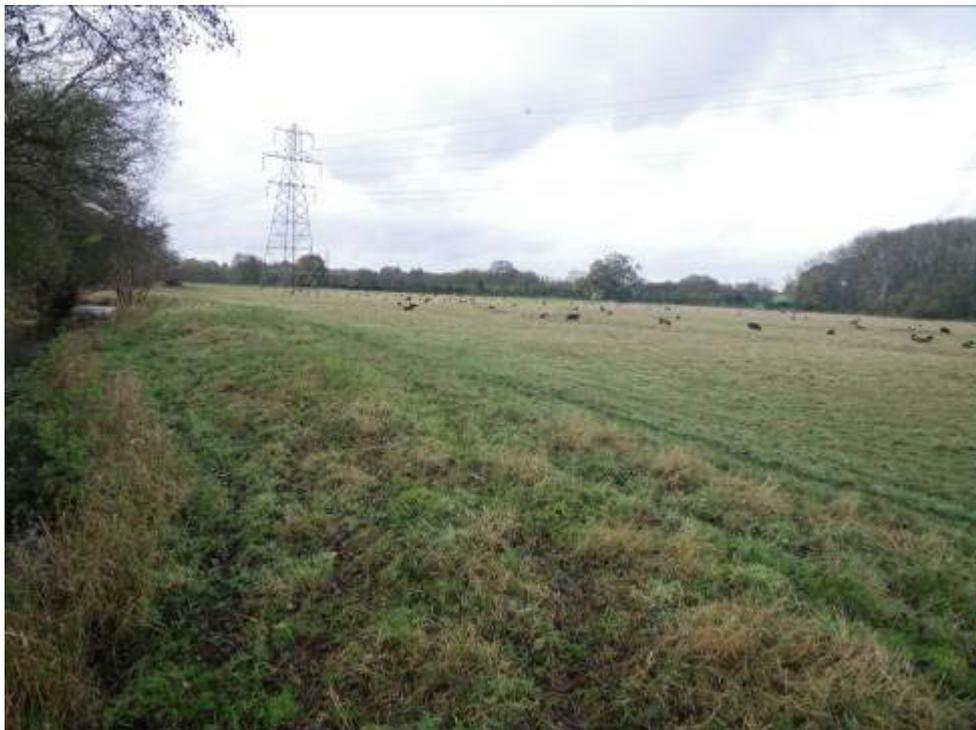
Slightly raised LB to the river and what might be the remains of the original course of the river meandering through the middle of the meadow.

The route of the existing channel appears to be diverted from the lowest part of the flood plain and there is some evidence of a raised LB margin. It is not clear if this slightly raised bank is still associated with the original diversion to create the head for Dimpley Mill, or as a result of extensive dredging work that was carried out on most of the Thames Valley rivers in the post war years. The possibility of rehabilitating a natural meandering channel flowing through the lowest part of the floodplain could be an exciting opportunity but would require agreement from all parties and significant resources.

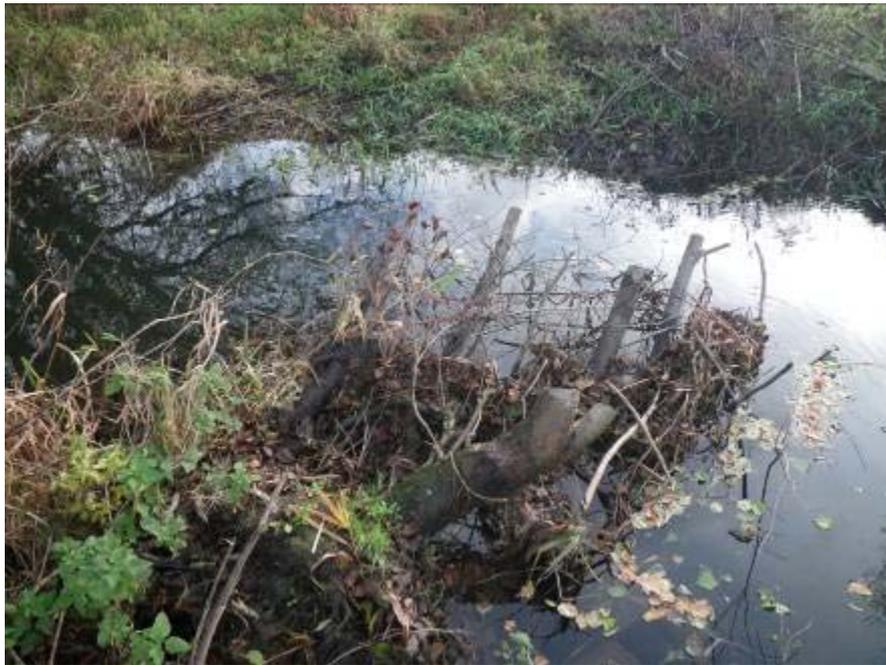
A small fallen tree has folded into the channel pinching the width and promoting local bed scour. A great lie for an adult trout.

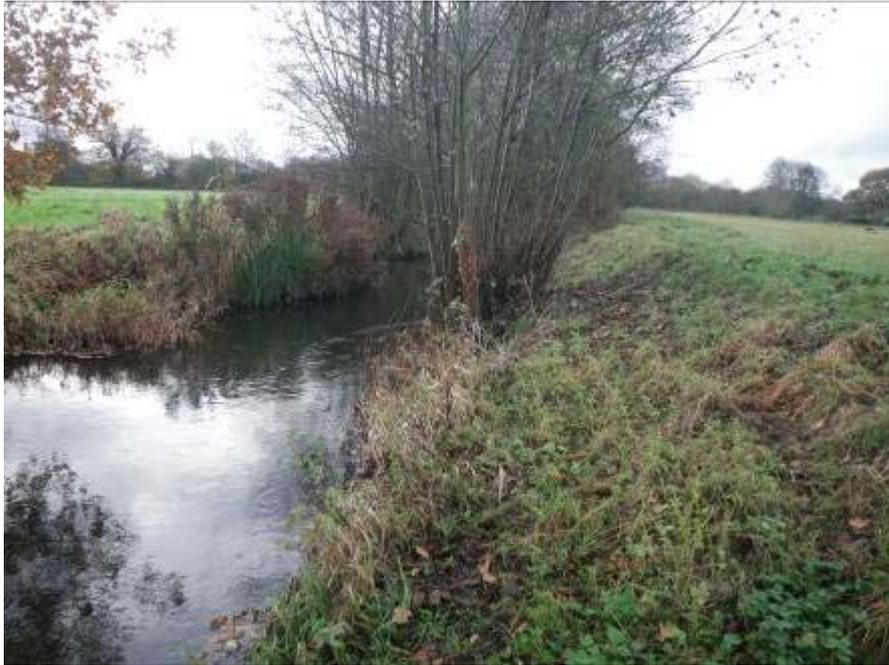
A section of channel which works well. A lightly grazed margin creating a low level berm below a section of naturally pinched channel.

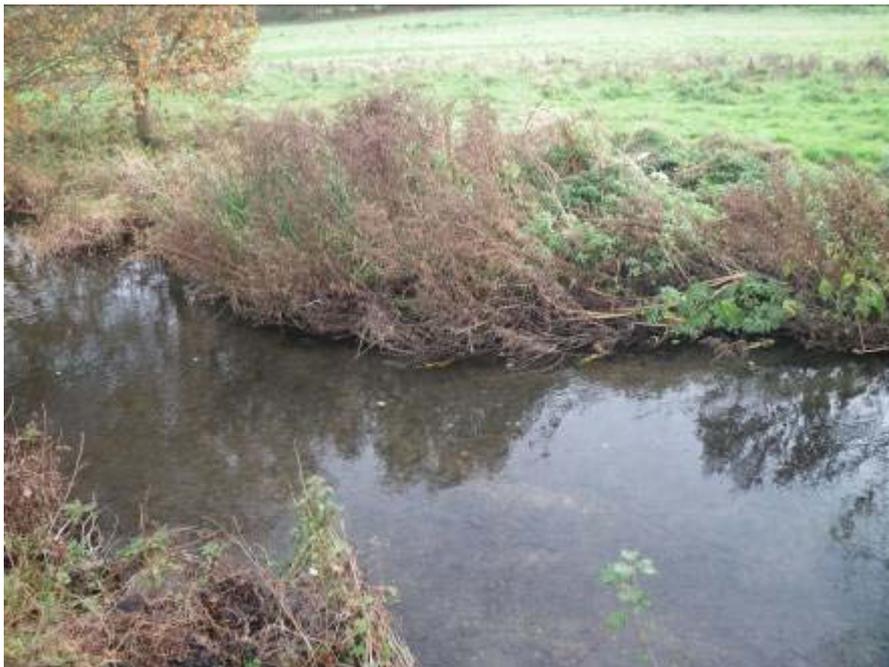
Dead annual herbs gently folding into the channel and providing very good winter cover for juvenile trout. Strimming river banks in the autumn is an activity often carried out on some sections of Hampshire chalkstream but is a practice that is damaging to habitat for small wild trout.

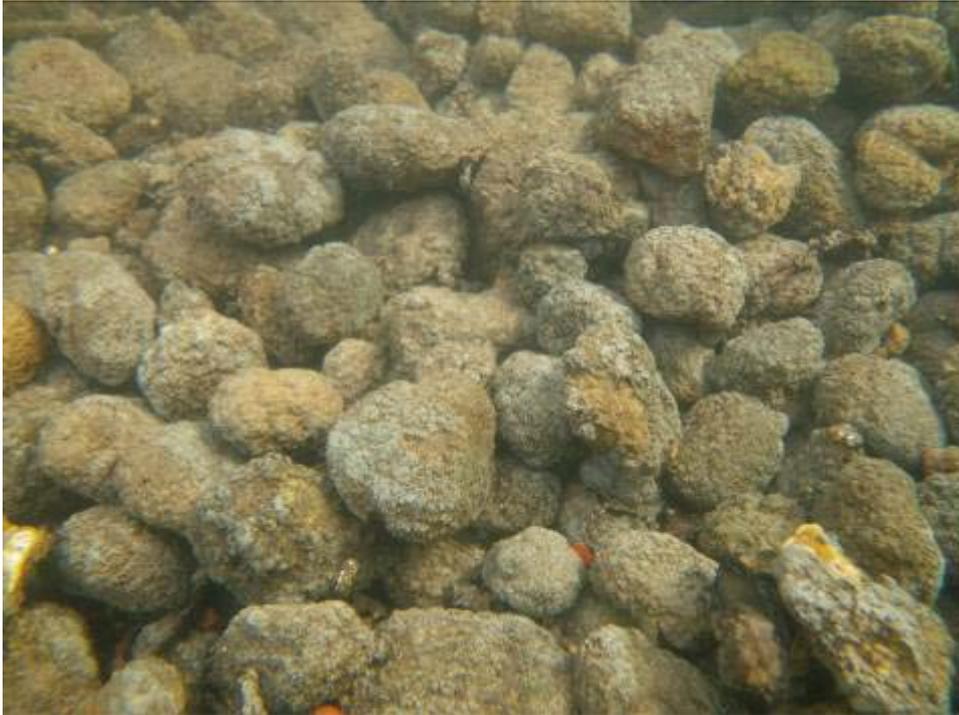
Towards the middle of the beat, some shallow gravel bottomed glides and occasional riffles were found. Unfortunately, the spawning habitat on some sections of the reach is quite poor, with much of what appears to be gravel being made up of nodules of tufa (calcium carbonate deposit). Trout will attempt to spawn in these areas but the bed material is often very compacted and naturally cemented, making the construction of viable redds for trout very difficult. Some

Tufa deposits can give the appearance of good quality gravel beds. If loosened, to break up the crust and blow out the silt then trout can successfully spawn on this bed material.

cleaning of gravels in strategic areas can significantly help to improve the conversion of eggs to fry.

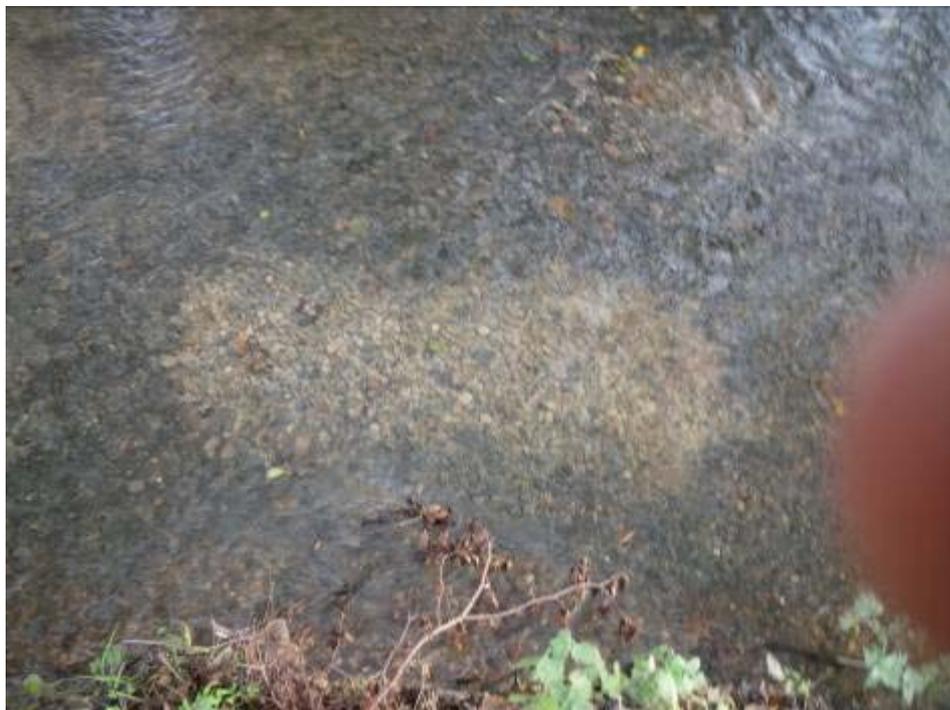
A redd at the head of a gravel riffle where some good quality gravel was found. Providing enhanced cover in the margins of shallow riffles is important to provide cover for juvenile trout once they emerge from the gravels.

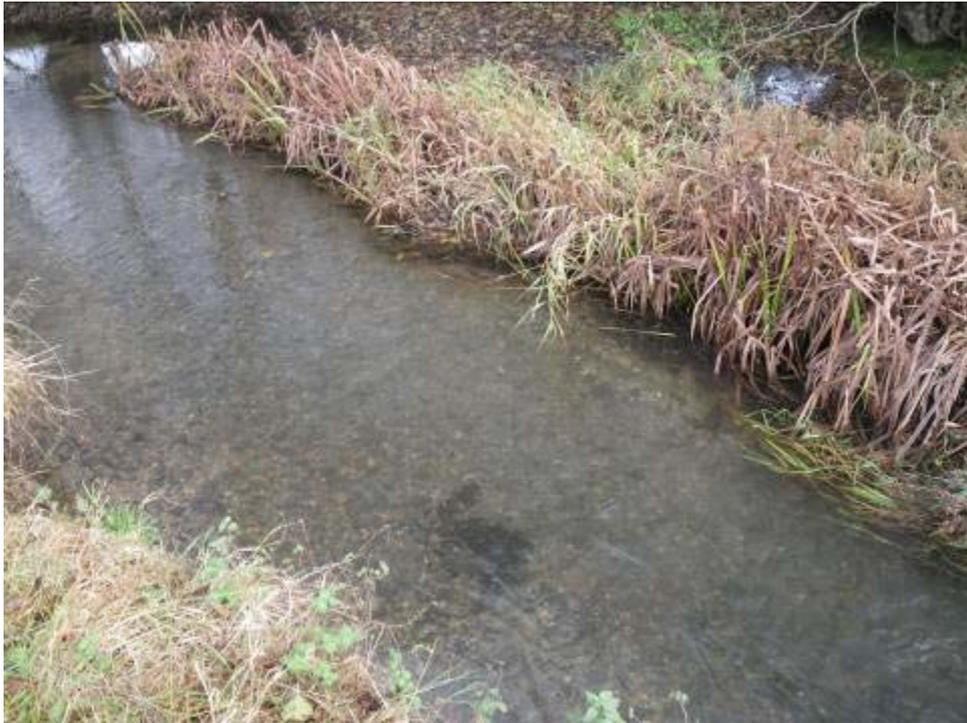
A comparatively rare riffle habitat that should provide ideal habitat for trout fry and parr. Currently only a thin fringe of cover is available on the RB. Carrying capacity could be significantly boosted by laying in woody brushings adjacent to the LB.

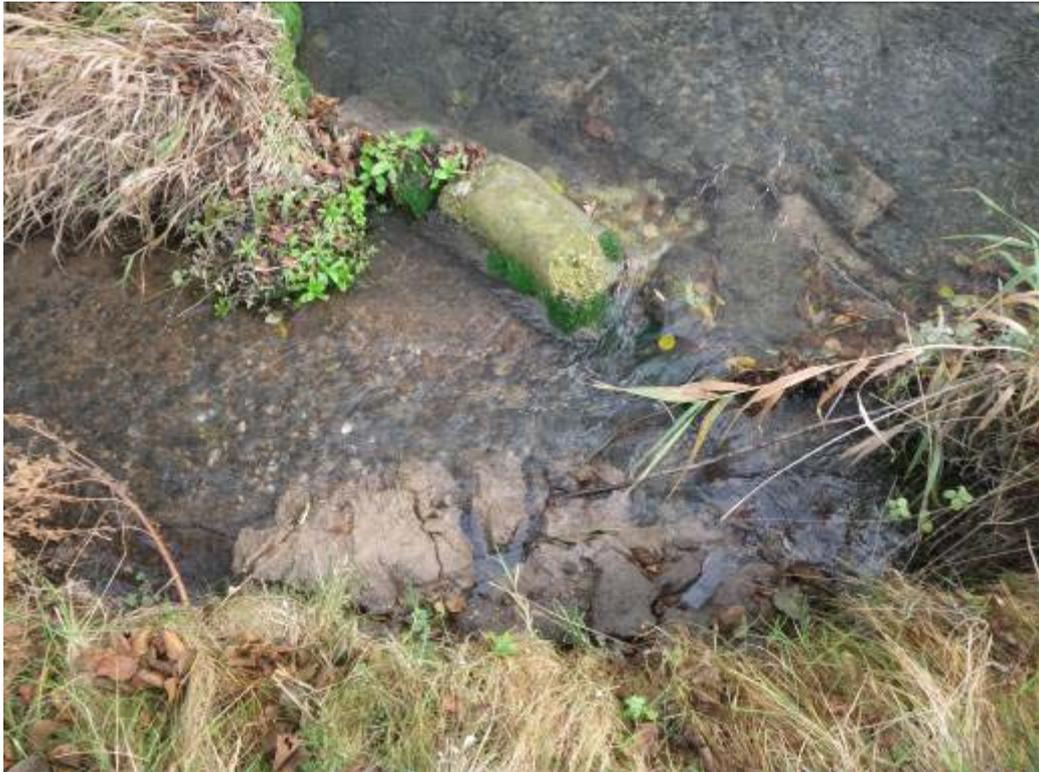
At this point the first in a series of stone and concrete bagwork weirs can be found. The weirs were originally installed to raise water levels and provide some deeper holding water for adult trout. Many of these weirs are failing to provide increased water depth because the river has regraded its bed upstream of the weir and filled the impounded sections with fine deposits. In addition, some structures have been configured in a way that has encouraged lateral bank scour, resulting in an overly wide channel immediately downstream of the structures. Both of these effects are the river's natural (if unwanted) response to the weir.

A notch in a bag work weir causing erosion to the LB.

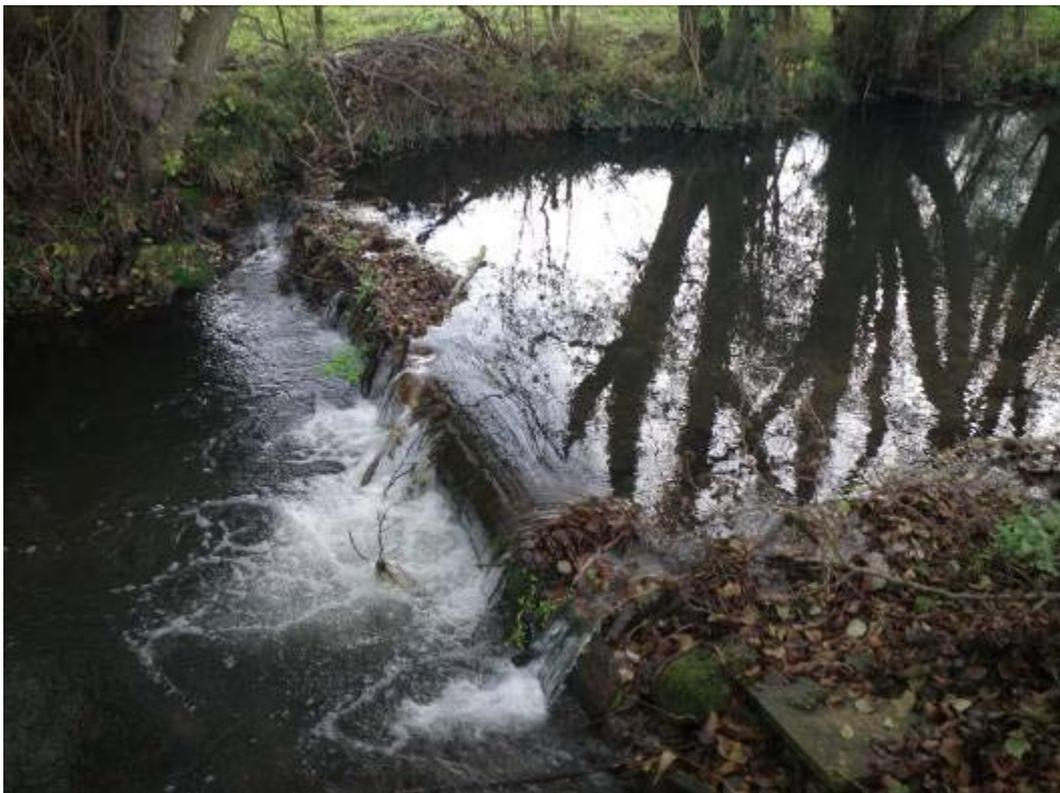
A typical low weir found on the beat. Cutting a notch in the middle will help to pull the water through faster above the structure.

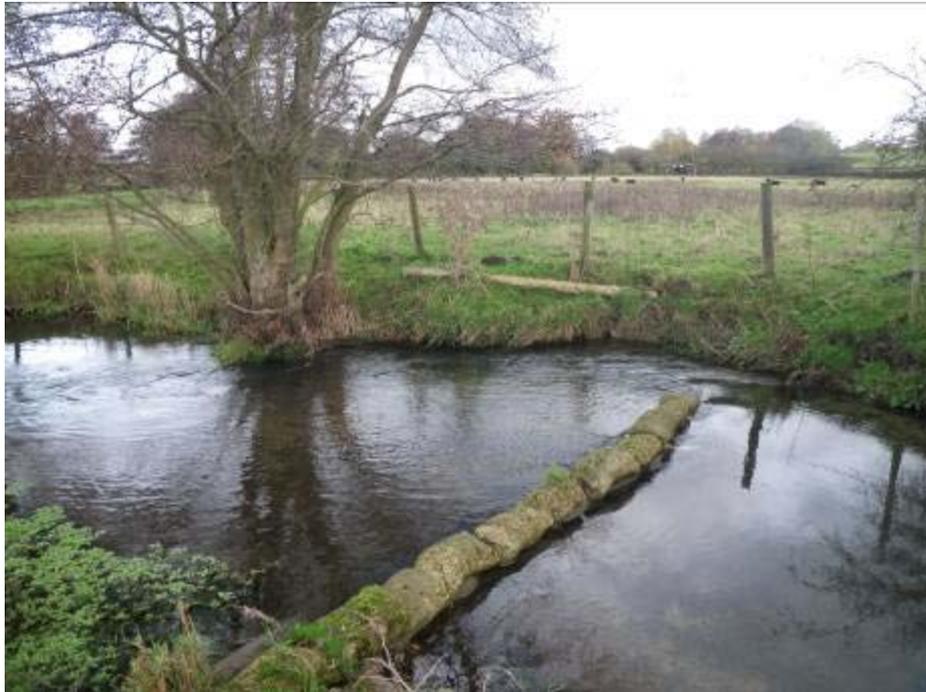
A more valuable and alternative option would be to drop and pin a tree trunk to do exactly the same job.

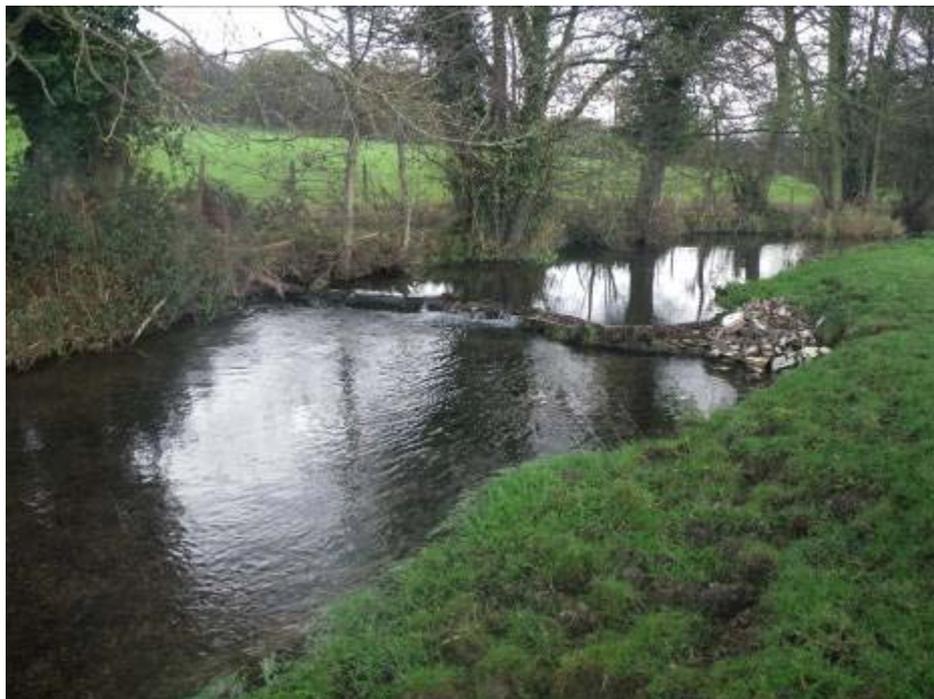
Another weir ripe for notching

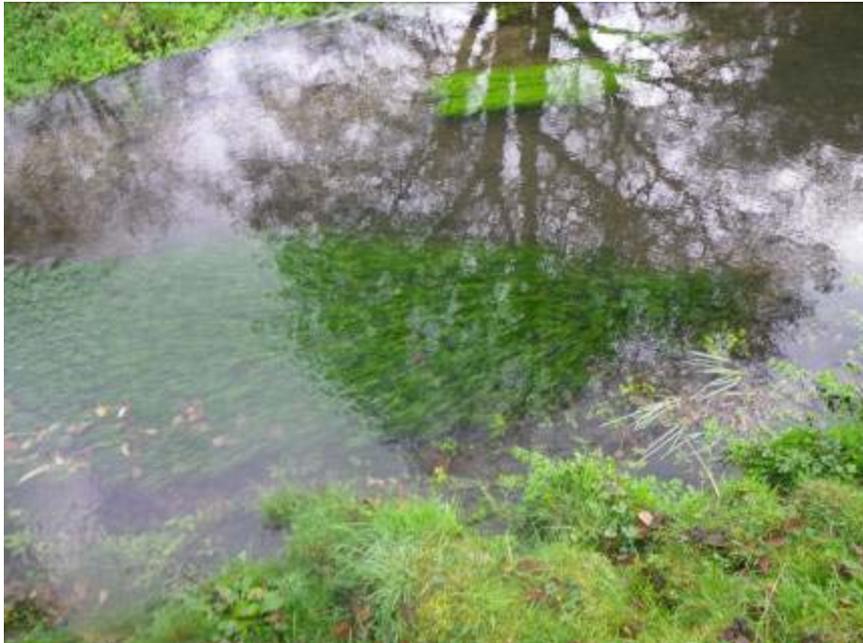
Luxuriant crowfoot growth in the upper reaches of the fishery. A valuable plant for trout and fly life.

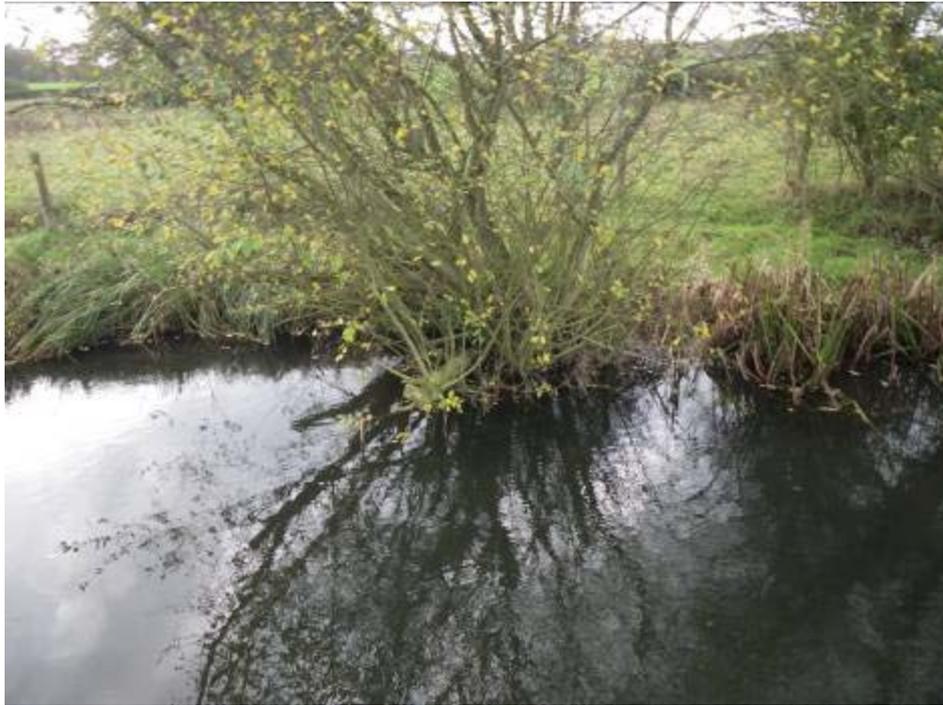
A good trout lie. A willow, sympathetically trimmed to provide some access for a cast.

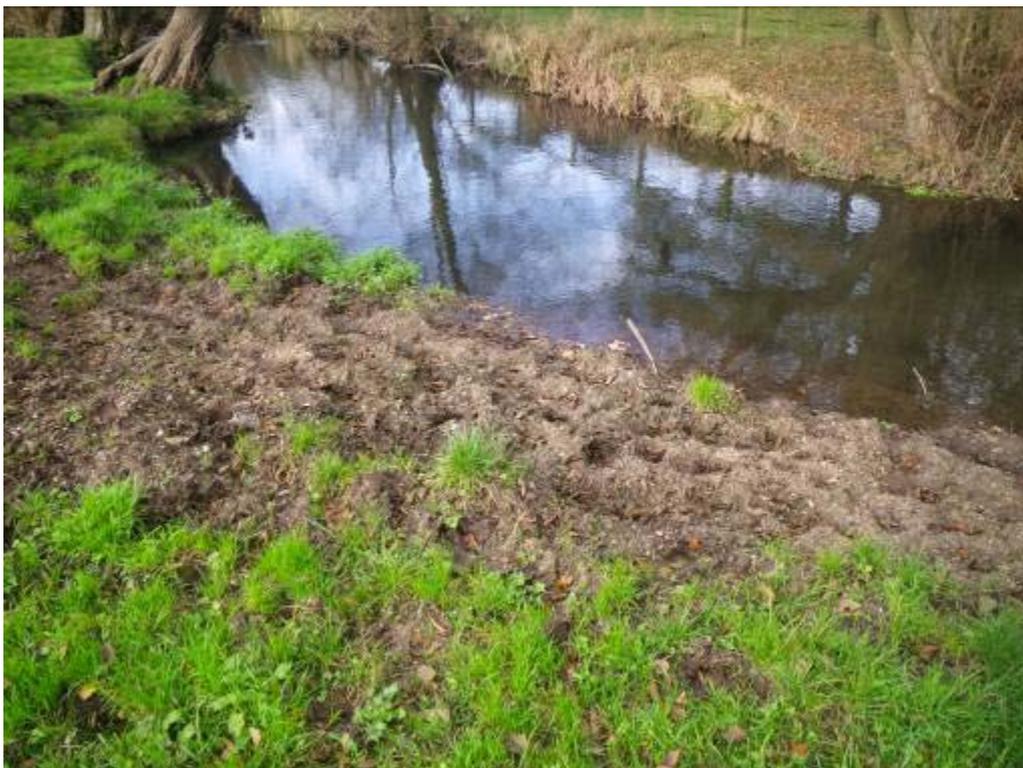
One or two sections of bank were damaged by cattle poaching.

On the whole the river banks were in reasonably good condition , although there was some evidence of cattle damage near to the top of the fishery. A brief conversation took place with the farmer, Mr Tony Foster from Bunkers Hill Farm.

He did not rule out the possibility of stock fencing but would require purpose build cattle drinking bays.

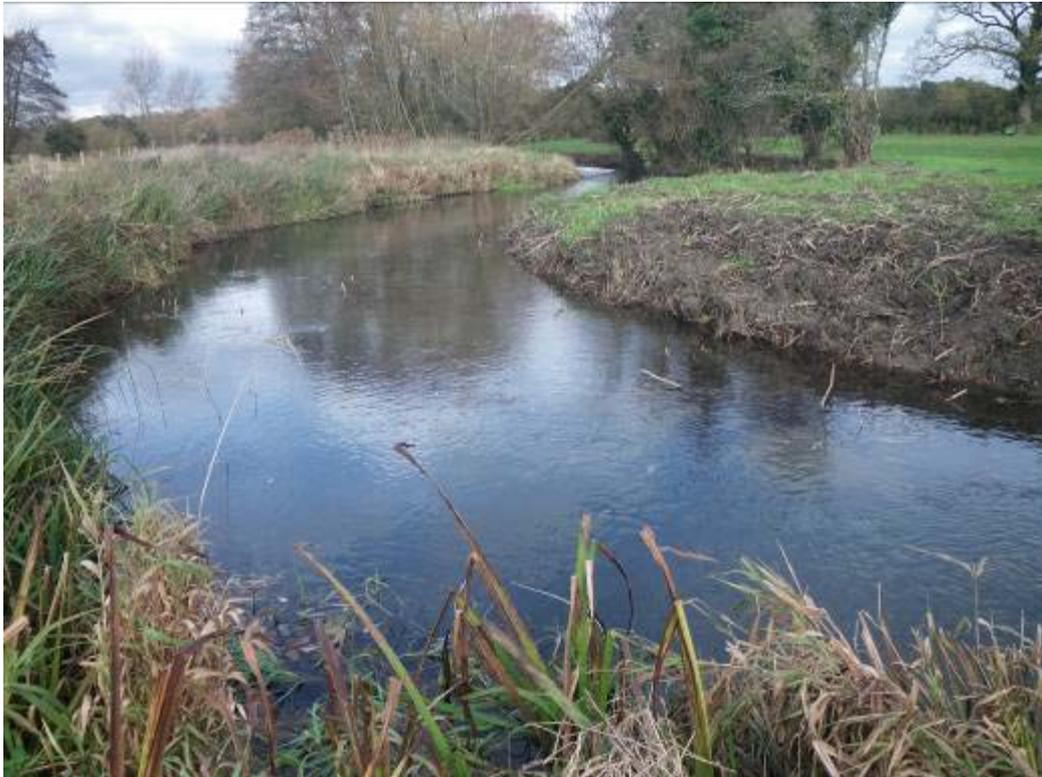
On the RB near to the top boundary of the fishery the landowner has carried out some inappropriate work by scraping the bank with an excavator. It is believed this work was carried out as routine maintenance by the land owner opposite but the work is damaging riparian and in-channel habitat. It is understood that the Environment Agency are aware of the work.

All the plants and bankside cover in a 100m section of RB have been scraped out with a machine leaving an over wide channel devoid of any useful cover

A more sustainable method of controlling the encroachment of emergent plants is to locally clear some short sections and plant small blocks of riverside trees to promote local shading. Willow would be the obvious choice.

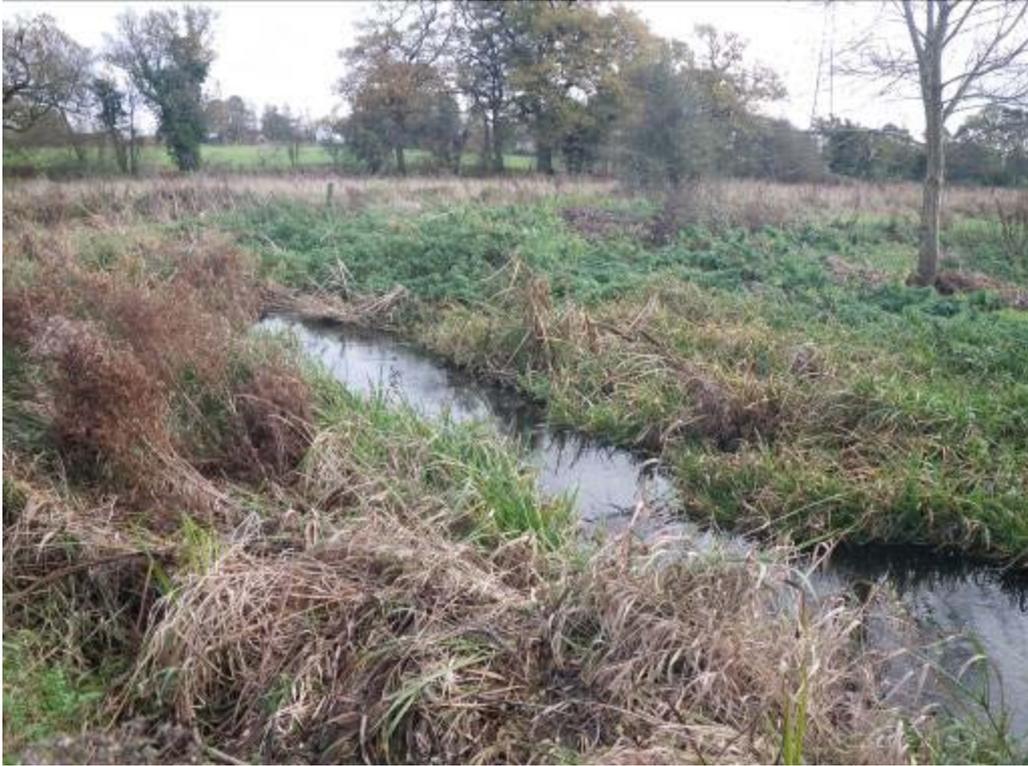
A section of channel where reed encroachment is beginning to close the channel. Sections like this benefit from the odd clump of willow to help shade the channel and limit emergent reed growth.

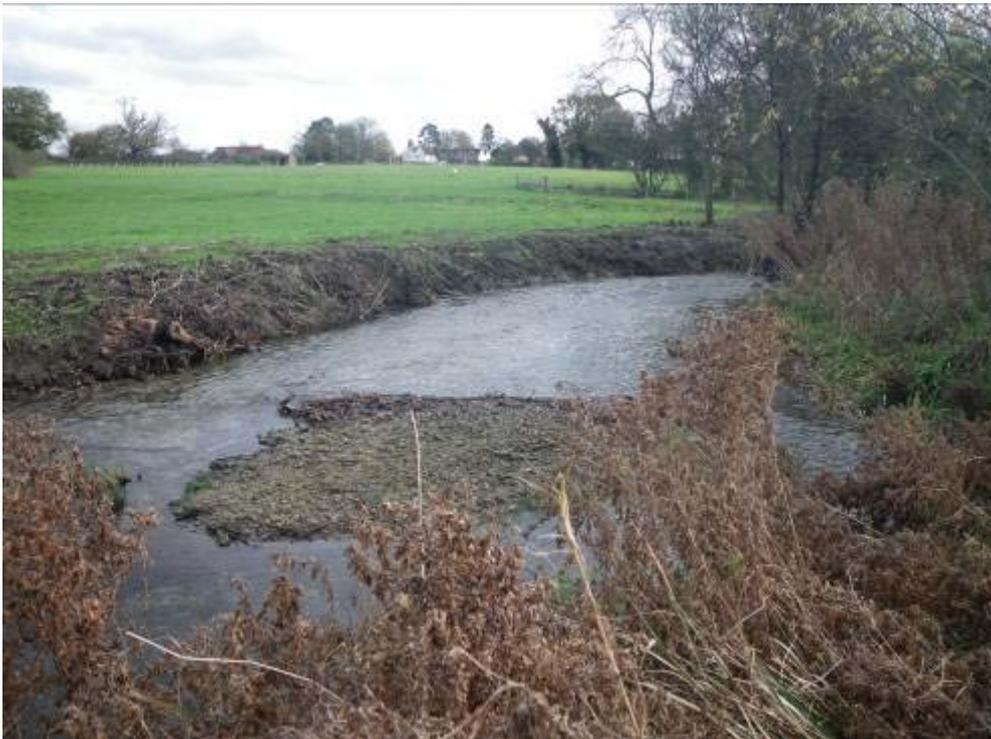
Some potentially good quality spawning and nursery habitat exists on the very top section but the recent work carried out on the RB has seriously damaged the potential for good recruitment during this spawning season.

Potentially a great reach for juveniles but now desperately lacking cover.

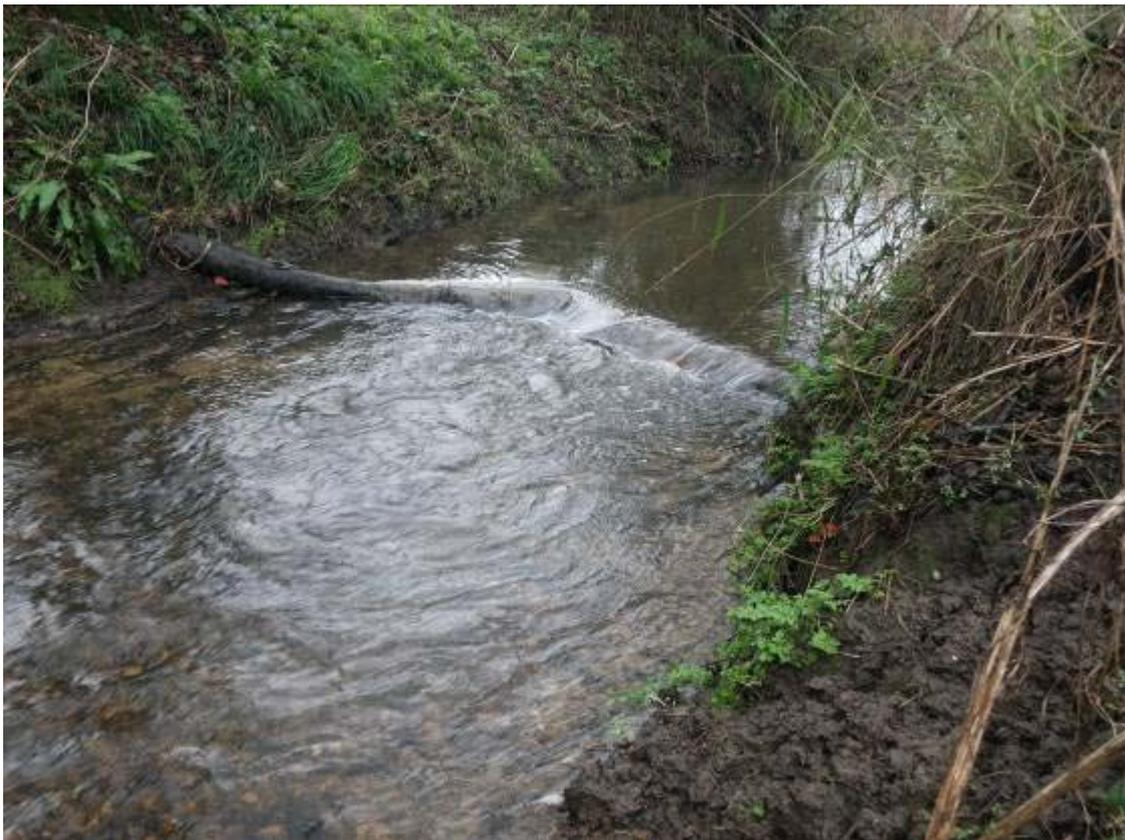
Small paired deflectors with narrow central notch

If large woody debris deflectors are used, the bankside section must be well keyed into the bank and they should be configured to point slightly upstream, to encourage scour to the centre of the channel rather than towards the bank.

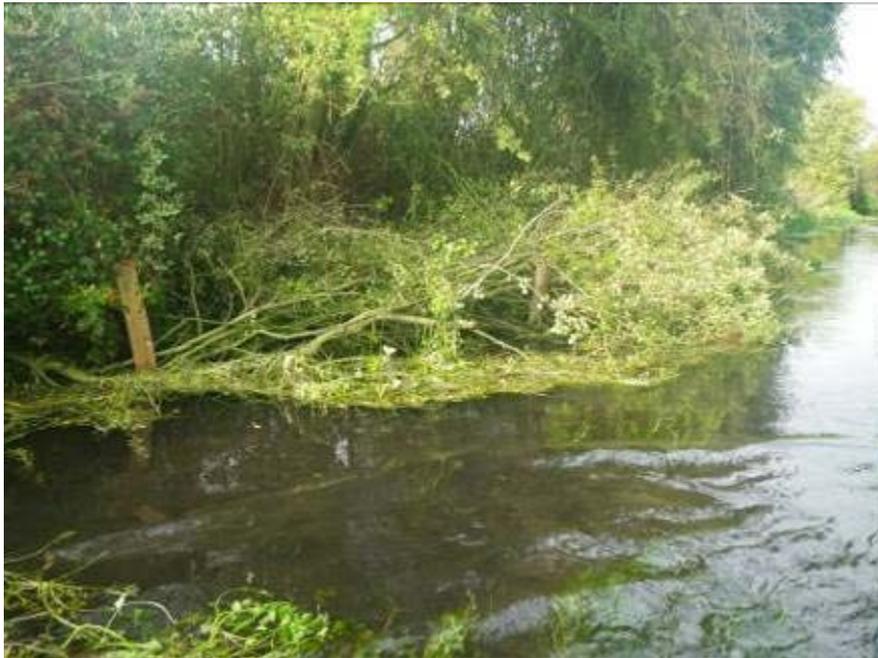
An example of brushings pegged into the margins to provide enhanced cover for juvenile trout on the upper Loddon

As well as using woody debris to promote bed scour, whole trees and brushings can also be usefully used to create in-channel refuge areas. This is particularly important when trying to build the wild component of the stock, where coarse woody debris brushings can either be laid or pegged and wired into shallow runs.

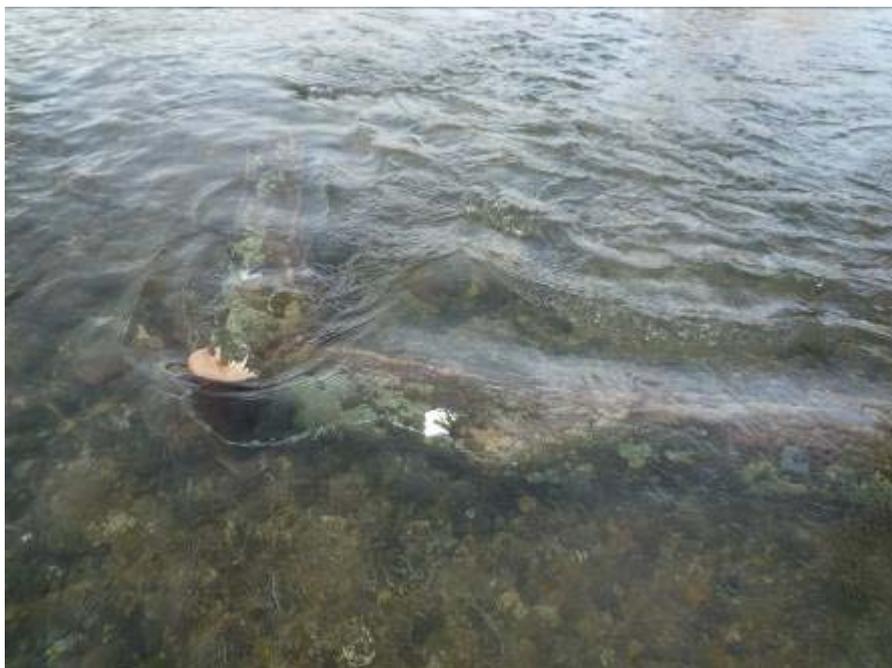
A short upstream facing "V" structure pegged onto a gravel run and designed to improve spawning opportunities. These structures also create small holding pots for spawning adults and holding lies for juvenile trout

Some efforts to improve gravel quality, particularly near the top end of the fishery, would pay dividends. Much of the gravel seen was flat, compacted and heavily infiltrated with sediments. Blocks of LWD pegged onto shallow gravel runs can help to sort and loosen compacted gravels.

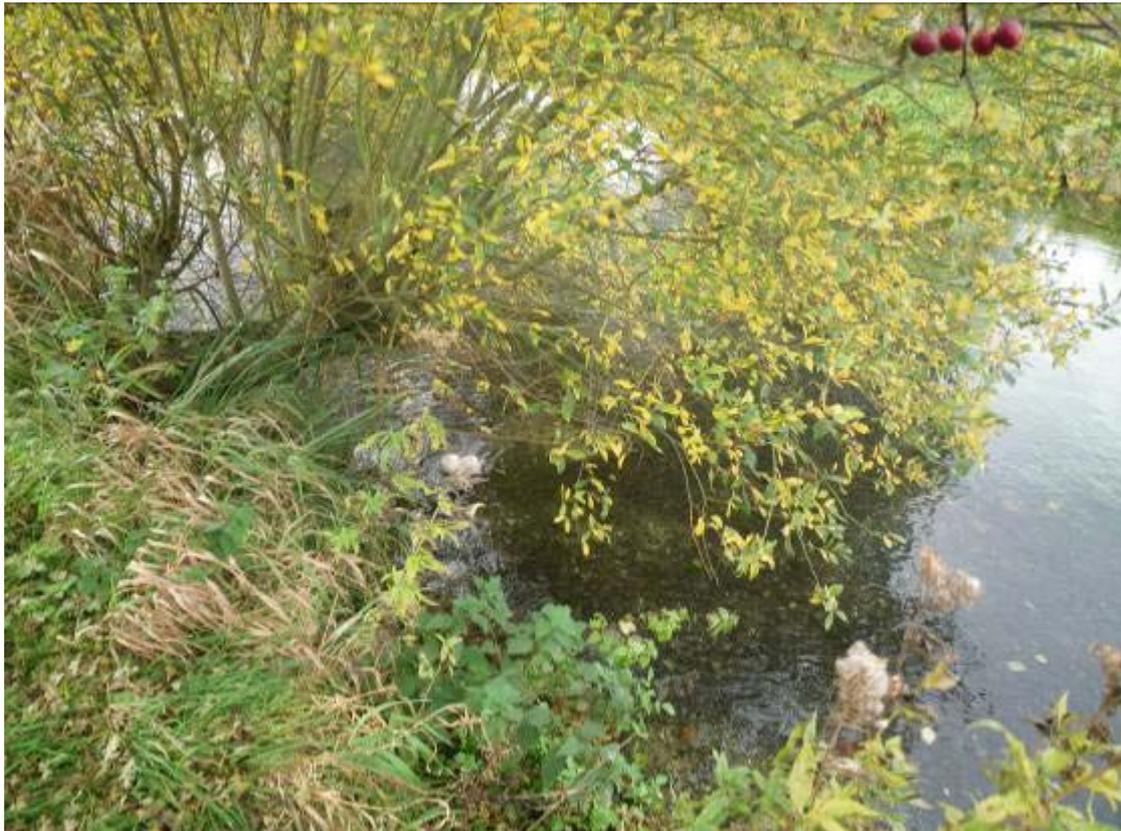
A rare willow overhanging a section of the River Test –a fantastic holding spot for trout. Note the trunk swings out almost parallel with the water level before sprouting upwards. Similar whips or small stakes can be planted to create great lies within a season or two.

There is plenty of scope to improve lies for adult trout throughout the fishery. Most of the current shading on the fishery comes from tall trees which do not provide the low-level, scrubby cover favoured by trout. Some planting of willows jutting out from the toe of the bank to overhang the water would be extremely valuable. When coupled with a large woody debris (LWD) flow deflector to promote some local bed scour, sites can be created to provide superb holding lies. Some low level shading will also help to control excessive reed encroachment and might also help with maintenance, rather than just creating more work.
