Advisory Visit

River Wear

Witton-le-Wear Flyfishers

31/01/2019

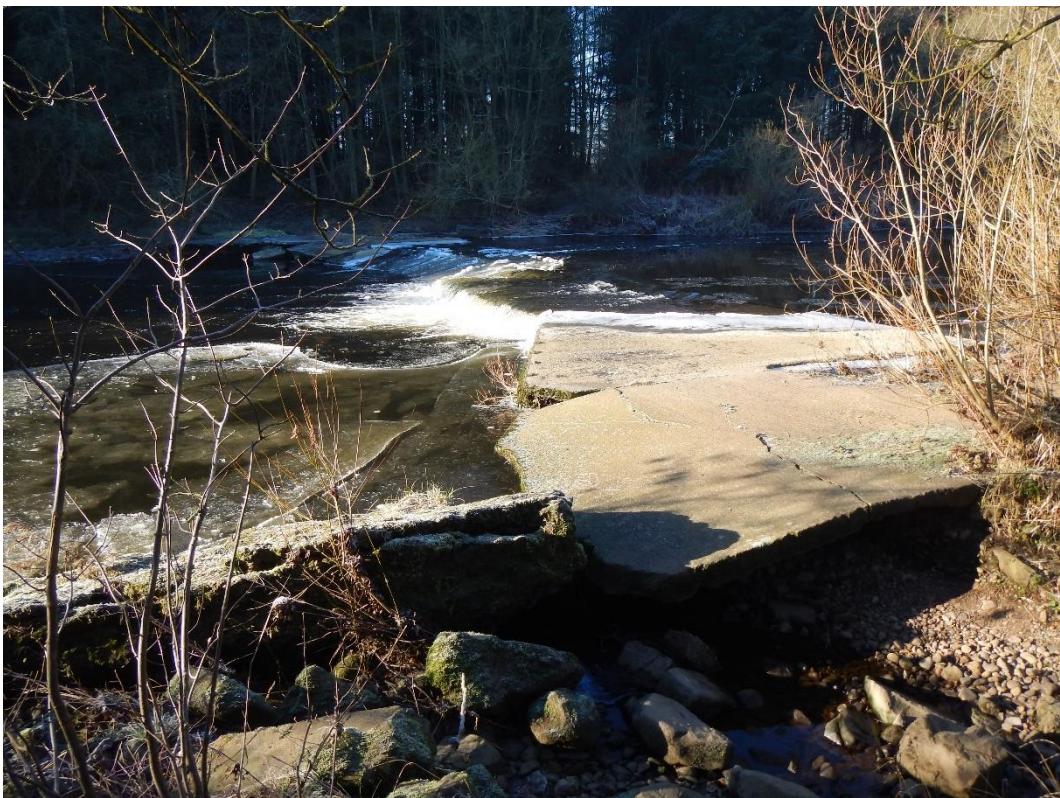
The river was inspected from weirs at the downstream end of the existing Witton-le-Wear Flyfishers' water (Figs 1 & 2: NZ 15917 31051 and NZ 15956 31000, respectively), progressing downstream to the viaduct (NZ 16975 30838). As highlighted in the previous report, these weirs create a major negative impact. Consequently, the adjacent habitat is poorer with fewer individual territories for flow-loving fish and invertebrates. The uniform (similar velocity across the channel), low energy flow upstream of the weirs is unable to effectively transport bed material which is deposited relatively uniformly across the bed, creating progressively shallow, wide and poor-quality pool habitat over time (as the pools fill with bed material).

Figure 1. Stepped concrete weir. The obstacle created will vary depending upon flow, water temperature, direction of fish movement (upstream or downstream), and the size and species of fish, but it clearly unnecessarily restricts fish movement in a range of conditions. The impact of habitat degradation upstream and interruption of bed material transport through the reach is also considerable.

Removing the weirs between the two Litton-le-Wear Flyfishers' beats remains the greatest potential improvement that could be made, to restore habitat quality and access for fish and alleviate a predation hot-spot. There are concerns that removal would degrade the existing fishing prospects around the weirs. This is understandable; however, the natural processes required to re-establish self-maintaining pool and riffle features will begin within the first few high-flow events post removal. Should the channel adjustment take longer than anticipated, a range of enhancement techniques can be employed to accelerate/mitigate the transition. These would involve focussing flows to encourage discrete areas of bed scour and deposition that would naturally maintain depth variability, but they may not be necessary. Simple monitoring and further assessment of the reach (as required) will easily identify whether additional habitat work is needed.

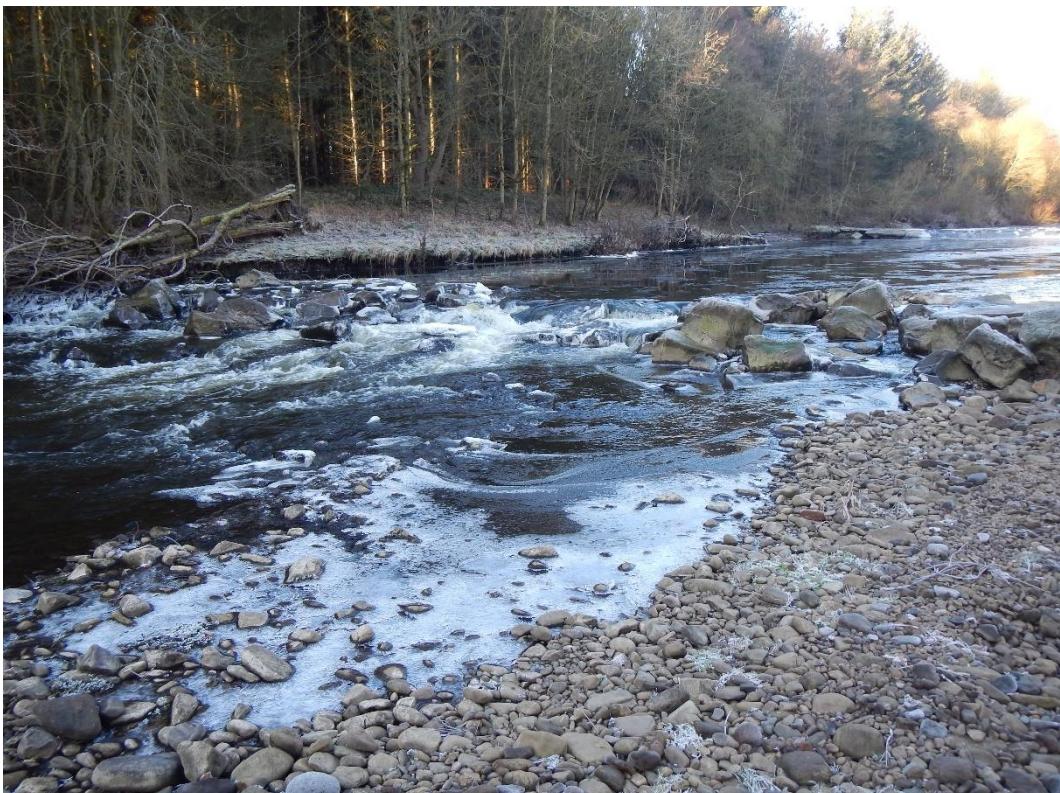
Figure 2. The furthest downstream of the two weirs. This was presumably installed to assist passage over the weir upstream but much of the pool it once created has now filled with bed material. If the concrete weir upstream was removed, this weir could also be removed to reinstate far better habitat quality and connectivity through the reach.

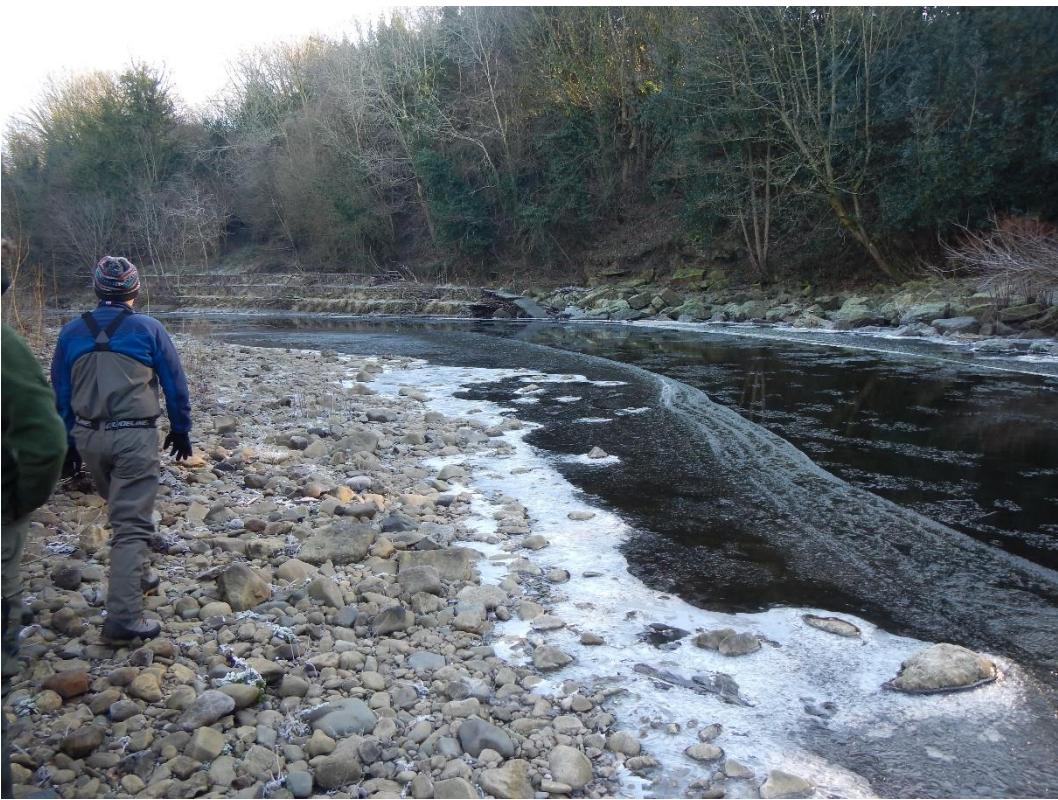
Downstream of the weirs, substantial bank revetment is evident and while this is not ideal, the river's general morphology does improve, exhibiting a more natural pool and riffle sequence (Figs 3 & 4). As the pools are created by scour at high flows, depth is naturally maintained the same way and they do not fill with bed material like impounded river sections. This is an important consideration as the River Wear is a high energy system with the potential to supply large volumes of material from upstream. In the absence of weirs, this material is naturally transported down the river, being temporarily deposited as bars which create riffles downstream of pools (Fig. 5). Riffles help retain pool depth, but without the fish passage or sediment transport issues of weirs, because the material is free to move and adjust as flows dictate. They also improve flow diversity and bed structure, providing vital spawning and juvenile habitat, with the naturally accelerated flows oxygenating the water and improving the angling interest of a reach. While the dimensions of natural pools and riffles alter over time, overall habitat quality and availability remains similar throughout a reach, providing that natural geomorphological processes are not inhibited.

Figure 3. Downstream of the weirs, the depth maintained in natural pools provides excellent habitat for a range of fish sizes/species. Revetment on the RB restricts natural geomorphological processes somewhat and limits the growth of bankside vegetation, but water depth is naturally maintained within the un-impounded channel.

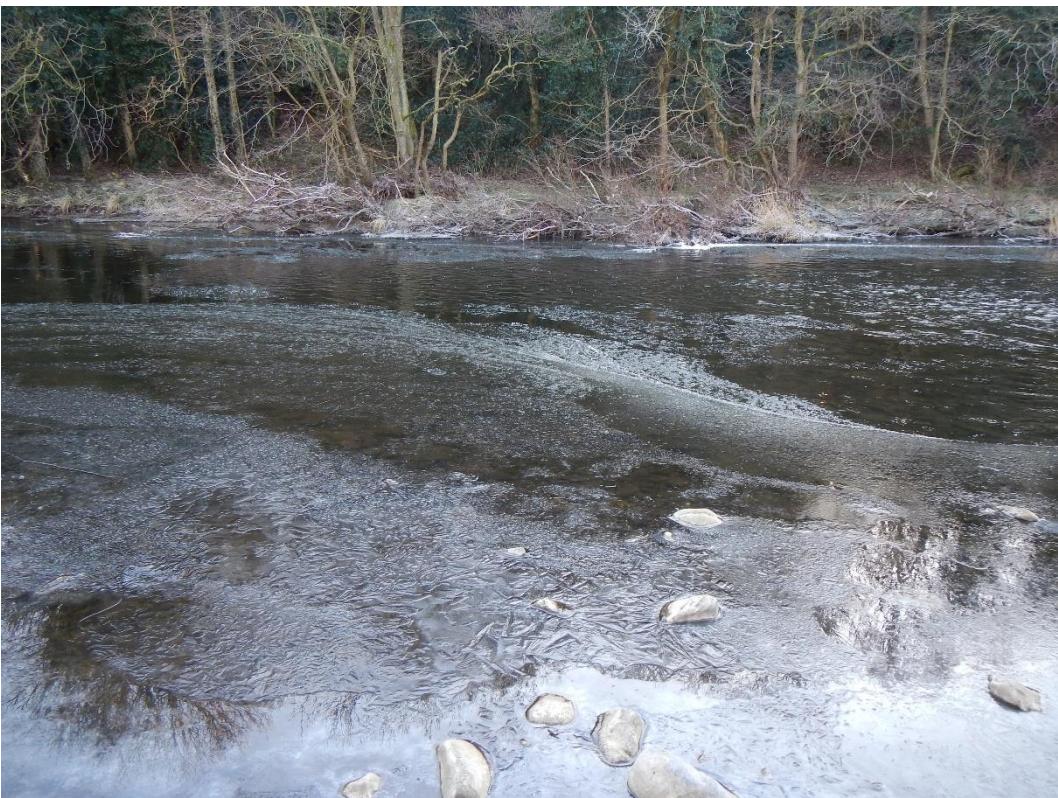
Figure 4. The tail of a riffle (right of shot) that naturally provides vital habitat for juvenile fish and invertebrates, flowing into an area of deeper, adult fish holding water. The trailing willow shrubs on the far, RH bank, further enhance the fish-holding potential of the area.

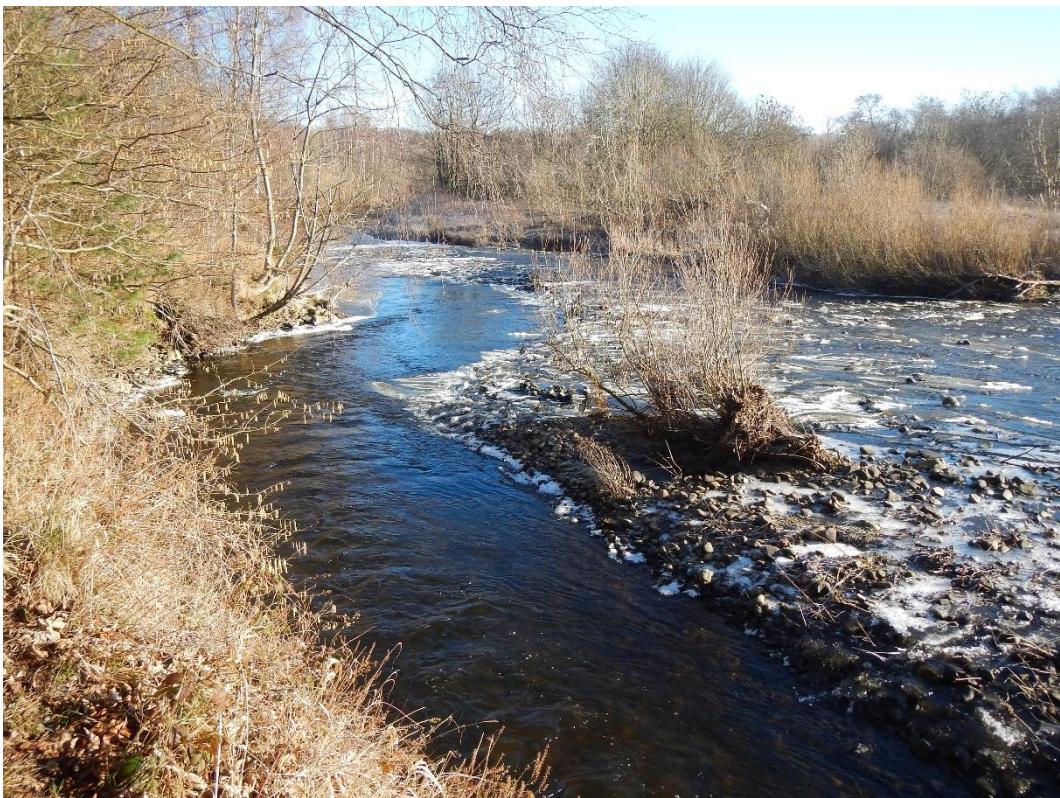
Figure 6. A natural gravel/cobble bar between pools that creates a riffle, providing flow diversity and oxygenation with high-quality juvenile salmonid and invertebrate habitat. The feature also enhances adult fish holding areas upstream and downstream, along with improving the interest of the area for angling interest - all without the significant barrier to fish movement or sediment transport created by weirs.

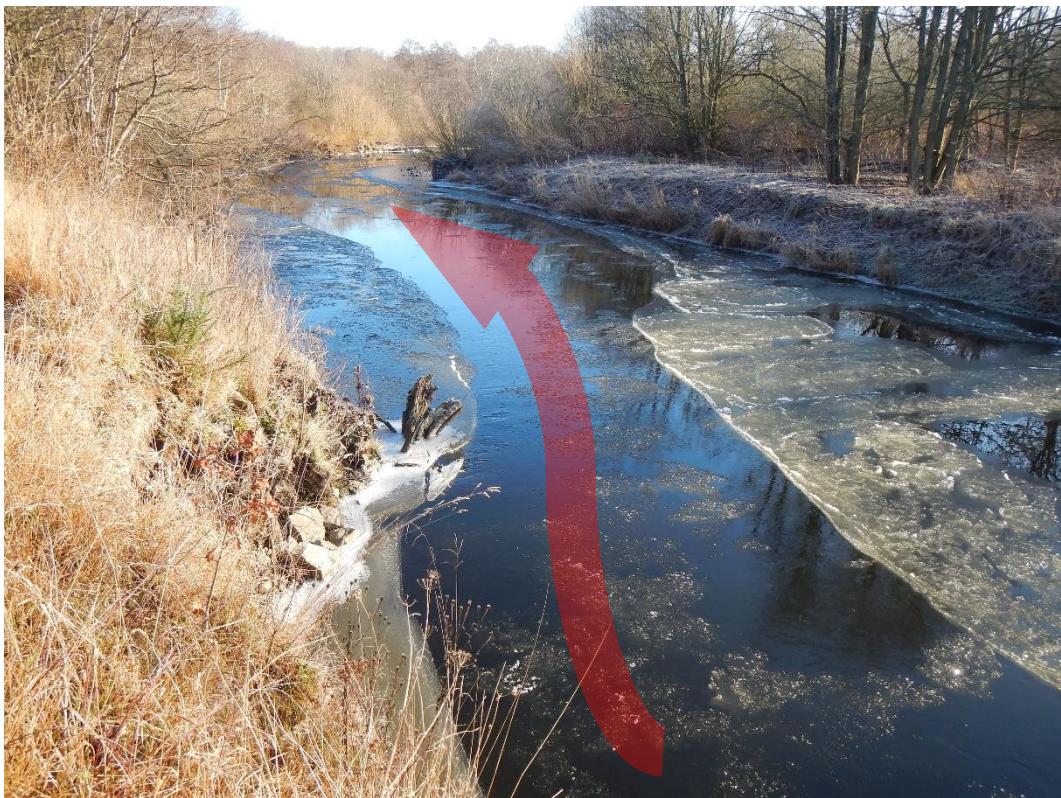
Ice on the water surface during the visit demonstrates the flow enhancement that structure within the channel creates (Fig. 7). Even the small area of bank retained by a willow stump is enough to deflect the predominant flow of the river from the LB across to the RB. Unfortunately, the tree was cut off and the protection to fish and the bank is now diminished, but some benefits remain until the stump completely rots away.

Figure 7. The remains of a willow stump deflects the flow from the LB to the RB, as evident by the frozen, slower flowing areas contrasting with the higher velocity, central channel that is maintained ice-free (red arrow). Unfortunately the tree was cut off, so the other benefits of fish-holding cover and protection are lost. Even the current habitat benefit and bank protection will be lost when the stump rots away. It would have been far better to retain the tree in place (alive) and accepted trickier casting to higher numbers of fish.

As highlighted in the previous advisory report, a general prescription of retaining low-lying/trailing vegetation and increasing its occurrence wherever lacking remains. Further advice and assistance with tree management and installation of in-channel structure throughout Witton-le-Wear Flyfishers' water may be possible if required.

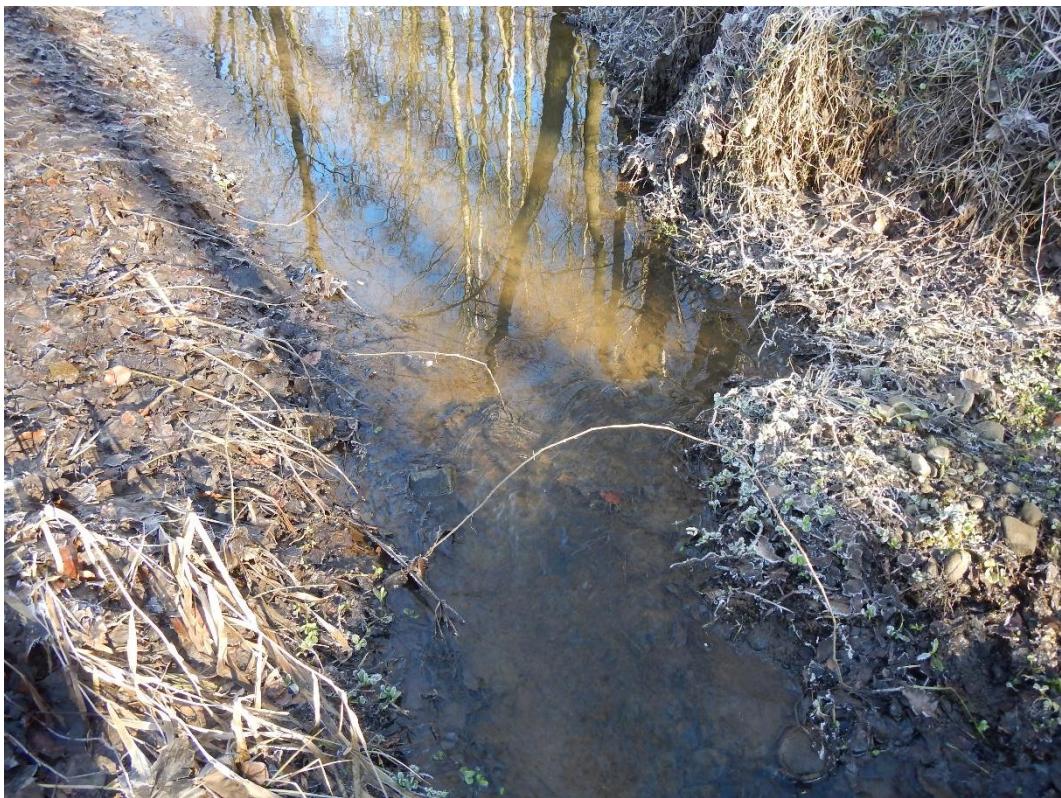
On the LB downstream of the Low Barns Nature Reserve, a series of newly created side-channels have yet to stabilise and further adjustment should be expected (especially with the destabilising effect of Himalayan balsam). It is unclear whether these channels were created entirely by natural erosion or partly through human intervention, but they are already beginning to retain valuable areas of coarse substrate and will ultimately provide good invertebrate and salmonid habitat. However, one channel appears to be supplying a high volume of fine sediment (Fig. 8). Further inspection revealed it to be the outflow of the nature reserve lake which appears to have been partially drained down (Fig. 9).

The draining down of any artificially elevated lake has the potential to liberate large volumes of fine sediment that have accumulated over the years. It is possible that the new channels within the wood downstream of the lake have allowed an increased outflow which may have contributed to the impact, but the presence of a sluice on the outflow means that the impact should be manageable. The timing and undertaking of any lake drain down should be planned and, if necessary, prevented during sensitive periods to avoid unnecessary issues and pollution. The input of fine sediment to a salmonid river in the winter can be particularly damaging and greatly reduces the survival of eggs that are incubating within the river bed.

Figure 8. The particularly silty channel emanating from the Low Barns Nature Reserve. This picture clearly shows finer depositional material smothering the bed. Many of the developing channels within the wood currently have an earth bed, although coarse gravel and cobble is becoming established in many areas which will greatly enhance their ecological potential.

- It may be worth liaising with the Durham Wildlife Trust with regard to the Low Barns Nature Reserve and how management of the site could be undertaken to limit fine sediment input to the River Wear.

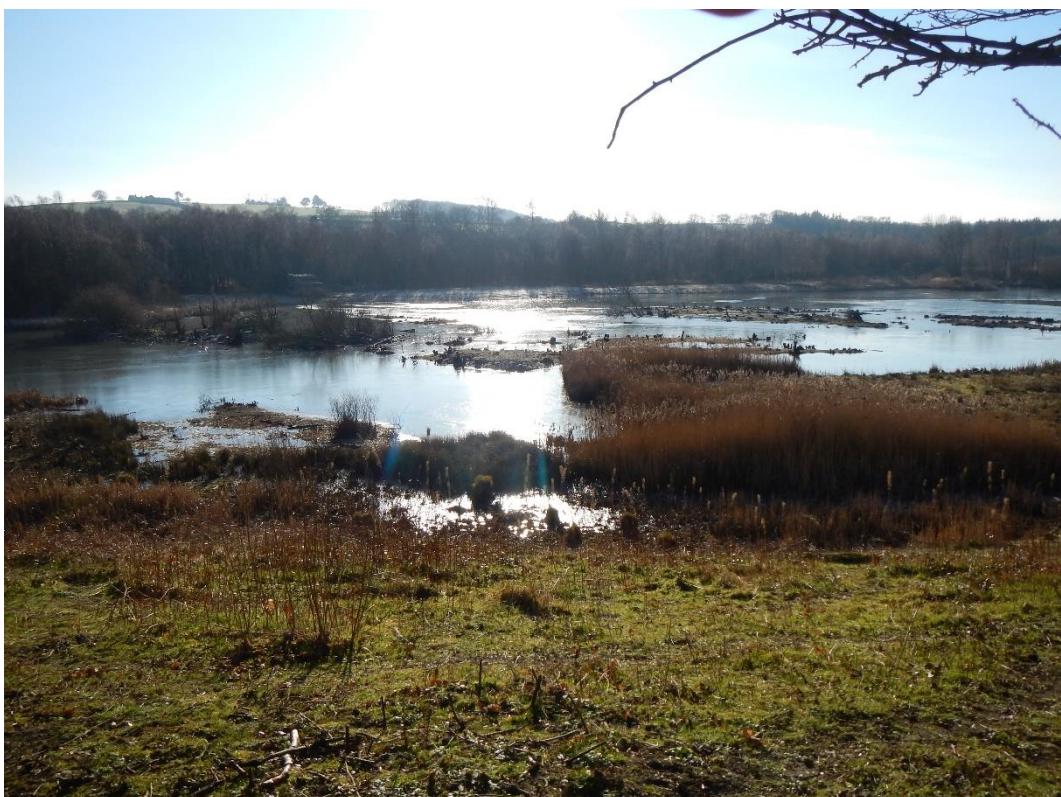
Figure 9. Low Barns Nature Reserve Lake appears to have been partially drained down. This is almost certainly the cause of the increased fine sediment loading observed in the outflow channel/connected side-channels.
