## **River Wylfe – Smallbrook Meadows Nature Reserve**

**An Advisory Visit by the Wild Trout Trust – July 2012**

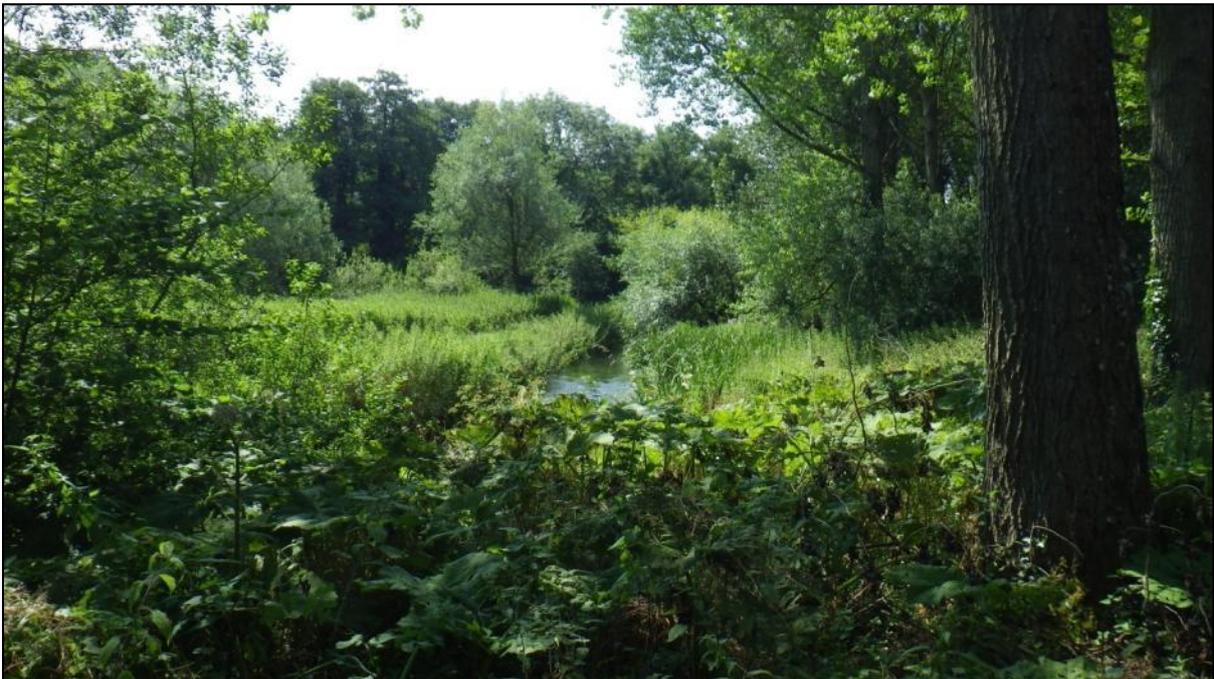
The nature reserve is situated on the left bank of the river, whilst the right bank consists of undisturbed wet woodland belonging to the Sutton Veny Estate. The land on the left bank, where the Wylde enters the nature reserve, comprises an unmanaged and semi-inundated poplar plantation, with a thick understory of stinging nettles. This section of the river is inaccessible to people during summer months, when the dense nettle beds form a substantial deterrent. The banks are in a stable condition, with very little erosion and a diverse marginal floral community. The river here is protected from the impacts of people and dogs accessing the channel, but is also unable to receive the potential benefits of monitoring and management that could be bestowed upon it if it was slightly more accessible (photo 1).

**Photo 1: The inaccessible and unmanaged section of channel where the Wylde enters Smallbrook Meadows Nature Reserve**

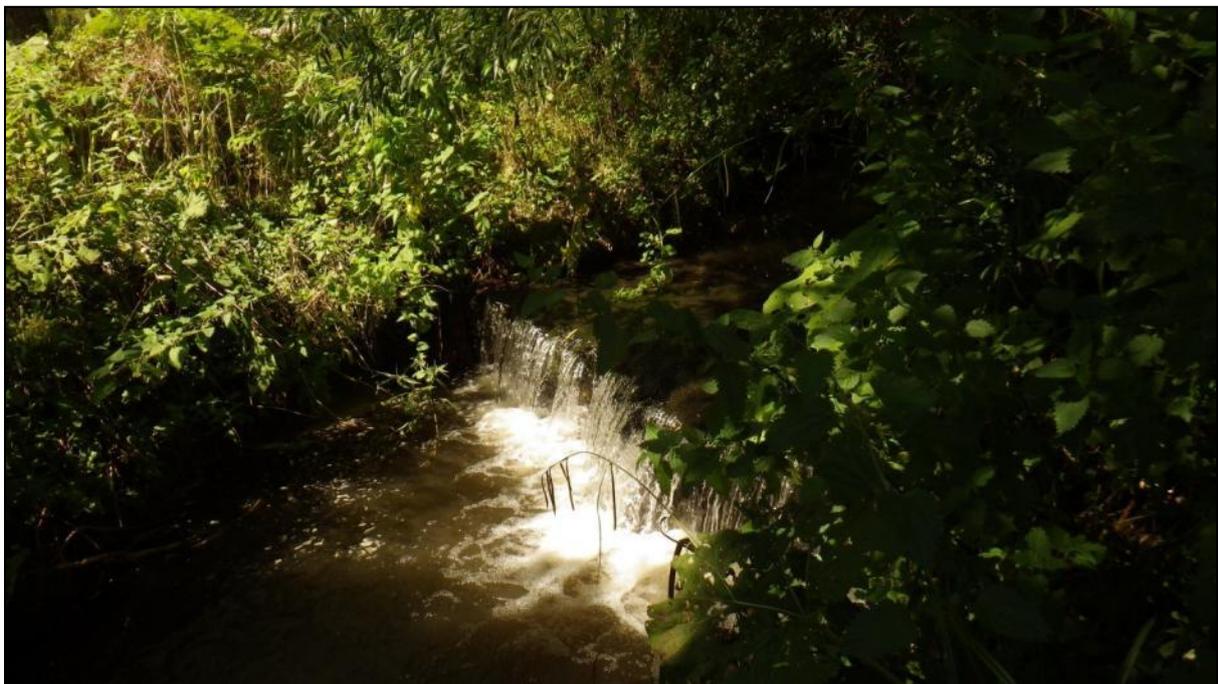
The basic physical characteristics of the Were (a small perennial stream with relatively fast flows), and its location, as a small tributary on the upper Wylde make it a potential spawning stream and nursery for wild, gravel spawning fish. However, a weir near the confluence is likely to be acting as a barrier to fish passage.

**Photo 2 : The small weir on the Were near its confluence with the Wylde**

The weir at NGR ST881441 (photo 2) does not appear to serve any particular purpose. Its removal should be considered the priority option for restoring habitat and fluvial connectivity between the Wylve and the Were and opening up new spawning habitat for native brown trout.

As a secondary option, the weir could be made passable for fish by notching the concrete crest and baffling the water downstream with a small log baffle to reduce the head loss. This option however, will not fully restore connectivity.

- Remove the weir to restore habitat connectivity for fish and invertebrates, and to restore a natural sediment transport regime.
- Repair and protect the heavily eroded bank at the bay and formalise dog access.

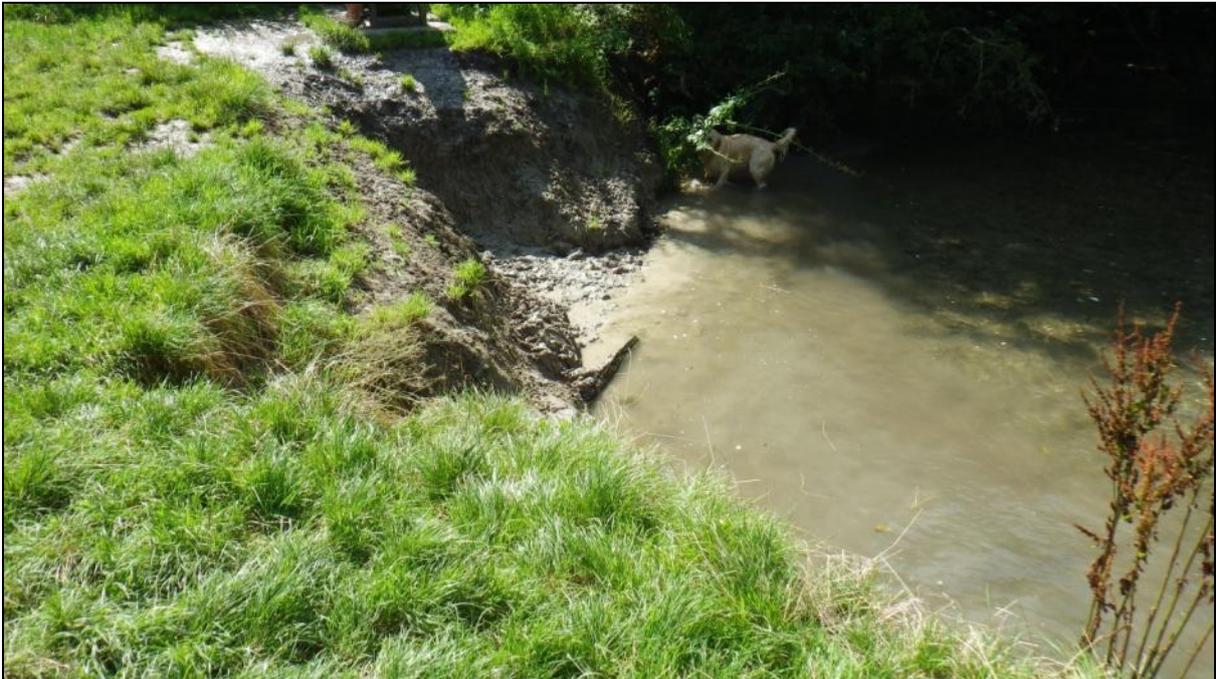
This part of the river (NGR ST881441) is popular with local dog walkers and children and is one of the key attractions of the nature reserve. However, the left bank of the bay is suffering from severe erosion caused by dogs scrambling up and down the bank and a wide shallow bay has formed as the steep bank has

migrated back. The bank here appears to have been eroding for quite some time and has been eroded back to higher ground, leaving a large area of bare soil. This exposed face will continue to erode unless the problem is addressed, and the considerable and sudden drop in height from the upper bank to the shallow bay below could be a health and safety risk to visitors.

**Photo 3: Severe erosion caused by dogs clambering out of the bay. This is a regular occurrence happening several times a day.**

The eroded bank at the bay (NGR ST881441, photo 3) needs to be repaired and protected from further erosion. Owing to the steep gradient and height of the bank above water level, a design to stabilise the slope should also include measures to reduce the health and safety risk associated with the sudden drop.

A simple terrace design constructed using sweet-chestnut stakes and geotextile could be back-filled with site-won soil. This should be designed so that the height of the terrace above the water is significant enough to discourage dogs accessing at this point whilst also reducing the overall height of the bank above water level.

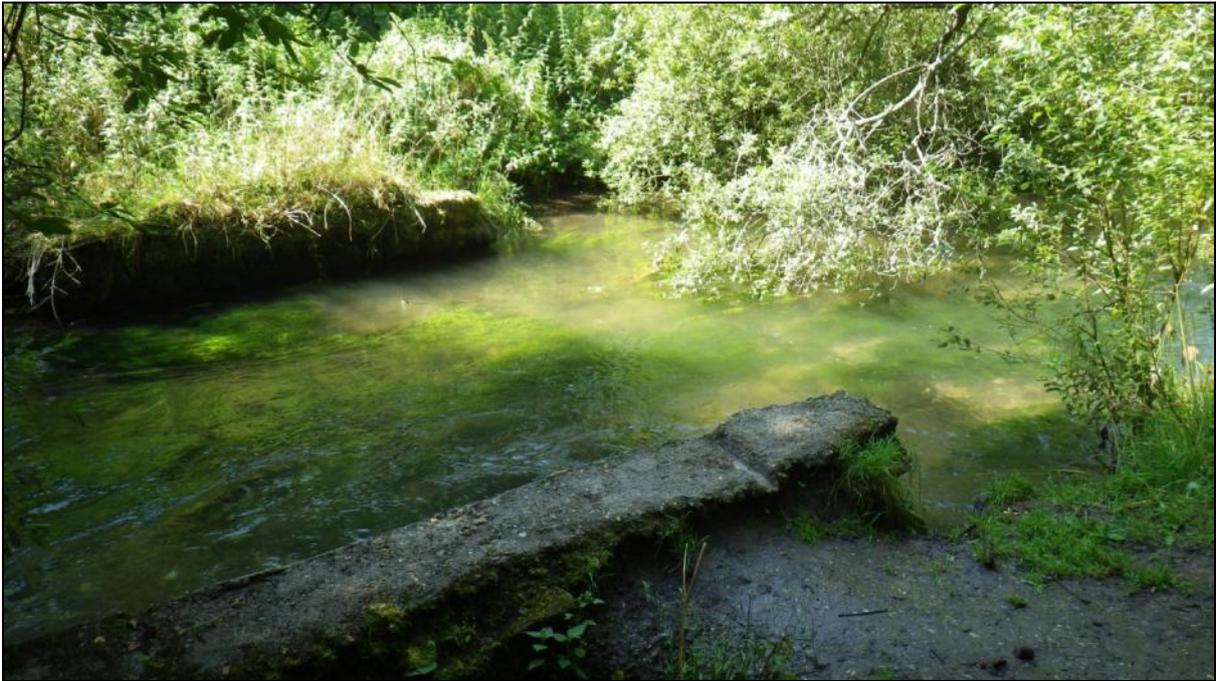
**Photo 4: The remnants of an old structure (possibly old bridge abutments or the remains of a box culvert) pinch the channel – increasing flow velocity and promoting weed growth**

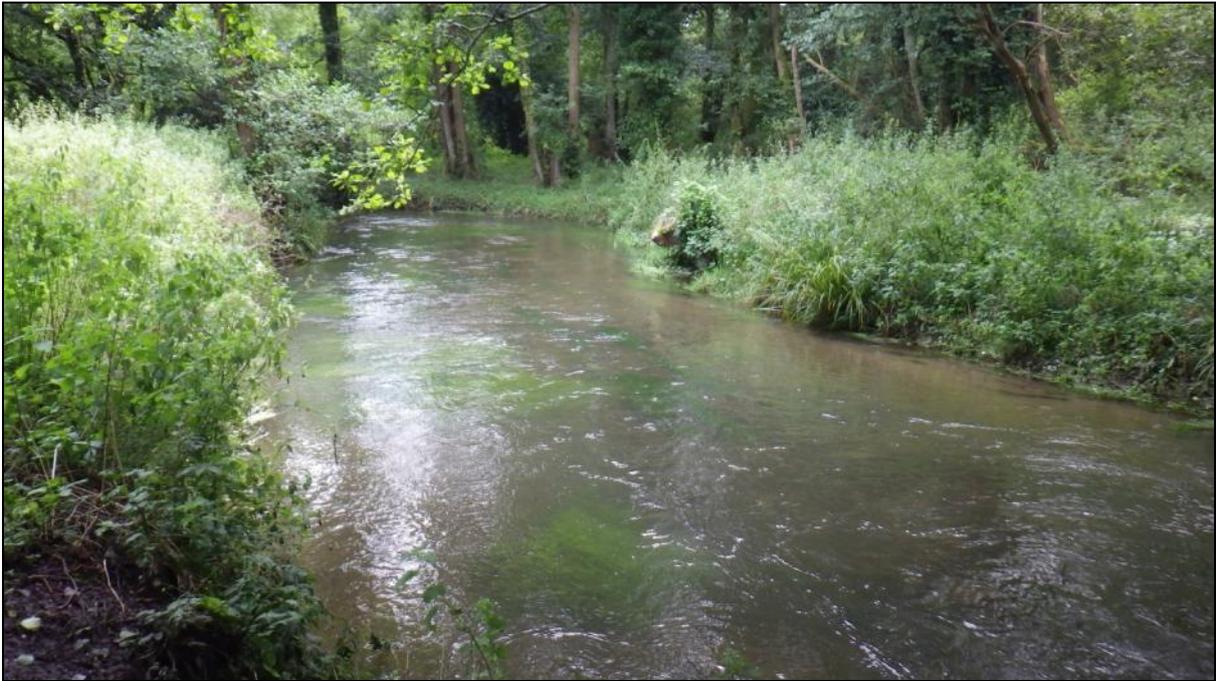
Downstream from the derelict structure, the river is pinched by the root systems of two large alder trees on either bank. This has created a scour pool in the bed and a long riffle as scoured-out gravels have deposited downstream. A sweeping double meander has developed, scattered with clumps of submerged weeds.

**Photo 5: The riffle formed from gravel deposits scoured out from the pool. Water crowfoot and Starwort (*Callitriche spp.*) grow in the fast flows and open sunlight.**

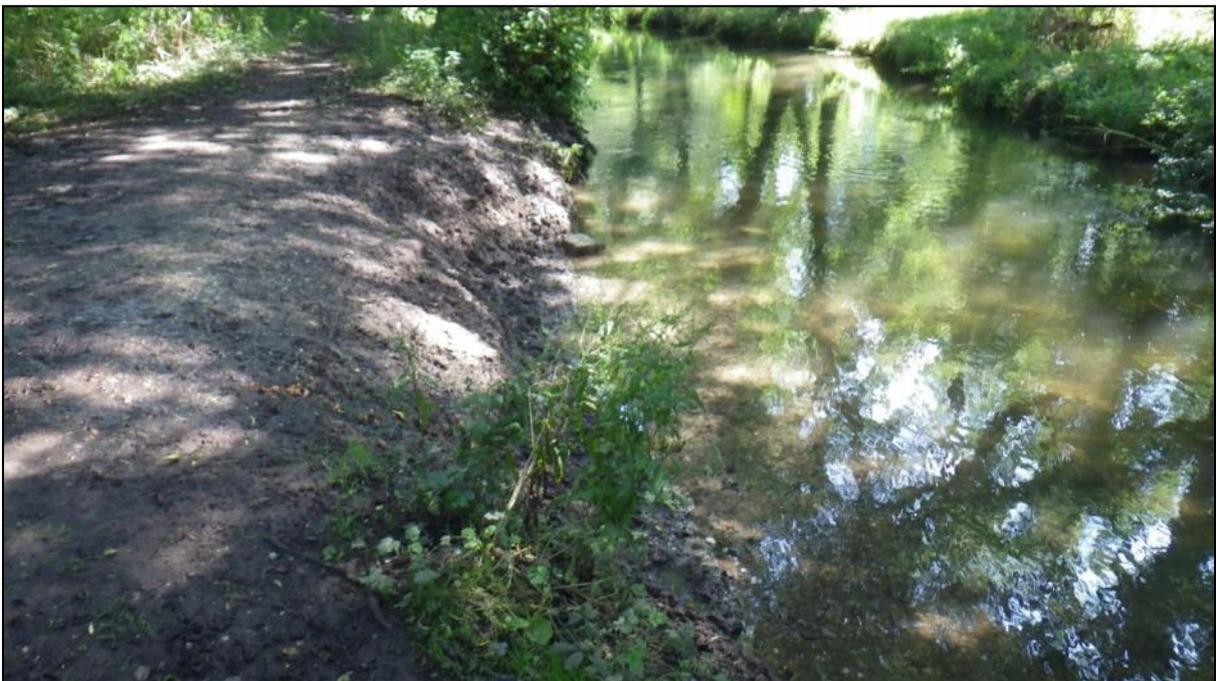
A footpath follows the river on the left bank and another eroded bay has formed from dogs accessing the river (NGR ST883441). This bay is also likely to continue to erode unless it is protected.

**Photo 6: Further erosion from dogs entering and exiting the channel. Heavy shading over the bank has restricted marginal plant growth and left the banks bare and vulnerable**

The second eroded bay (NGR ST883441, just upstream of the straightened section) is also in need of some repair and protection. This area is another popular spot for dog walkers and a suitable repair design would have to protect the bank whilst also allowing for dog access. A nearby alder over-shading the channel could be simply felled across the bay, trimmed, and fixed in place. This would not only form the skeleton of a repair structure but the extra sunlight would encourage growth of marginal and in-channel flora.

- Use the trunk of one felled tree in combination with a geotextile liner and gravel back-fill to repair and protect the smaller eroded bay upstream of the straightened section.

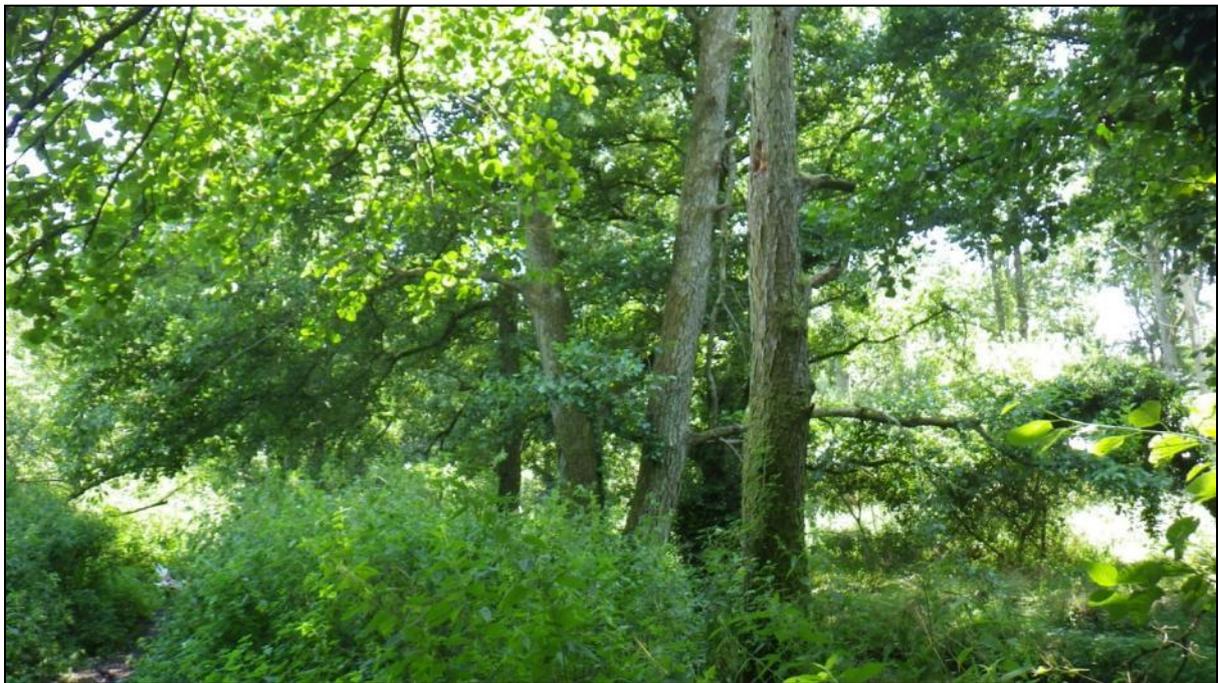
From the bay downstream to the boundary of the reserve, the channel is straightened with a uniform width. The left bank is populated by tall alder trees that shade the channel, limiting the growth of in-channel weeds. The over-shading also prohibits growth of marginal plants and leaves the banks exposed and susceptible to further erosion.

**Photo 7: Dense tree cover provides a solid root structure in the left bank that protects the bank from erosion but also over-shades the channel and inhibits marginal and in-stream plant growth.**

- Undertake selective tree works along the left bank through the straightened section of the river with an aim to open up patches of canopy and allow more sunlight into the channel.

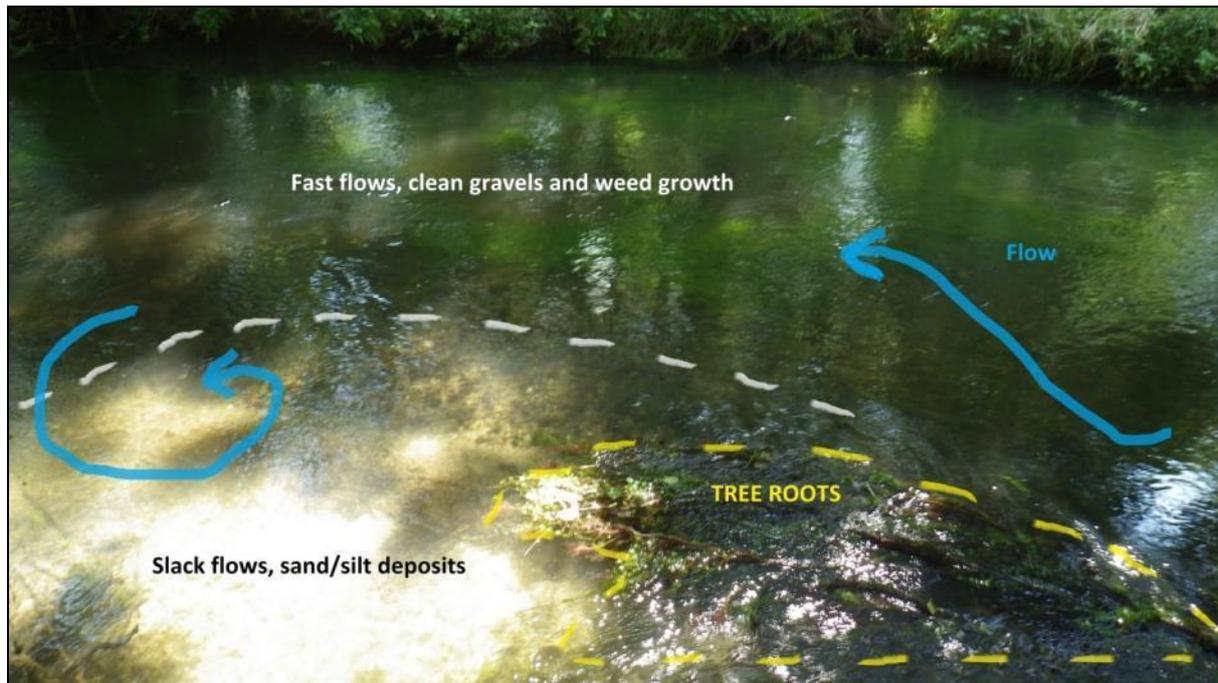
The root systems of these trees grow out into the river and act as flow deflectors introducing flow diversity to the straightened reach. In the flows deflected and accelerated by the roots, gravels have been scoured and naturally sorted so as to become suitable for gravel spawning fish. In the slack backwaters behind the roots, sandy deposits have built up. Where tree roots do not protrude into the channel the straightened reach is lacking in flow variation and habitat diversity, and the bed is largely shrouded in a uniform blanket of sandy sediment.

**Photo 8: Tree roots branching out into the channel deflect flows and increase heterogeneity in geomorphology and habitat diversity**

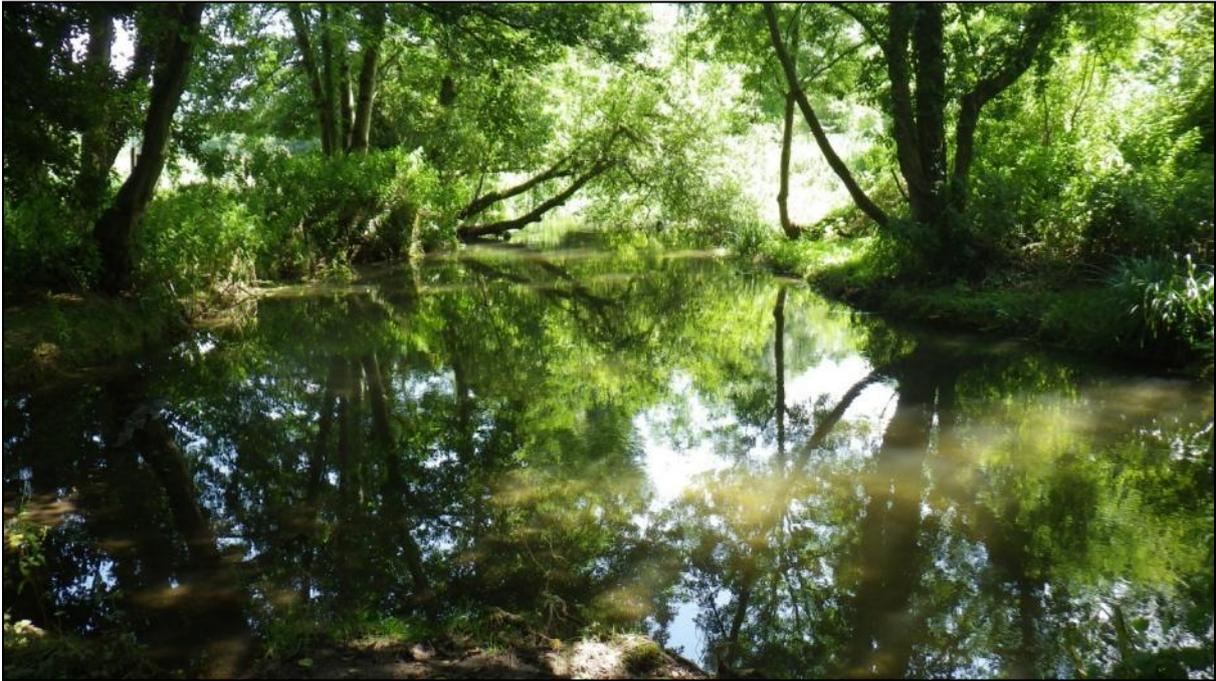
At the downstream extent of the straightened reach the channel widens as it is joined by a semi-inundated ditch that may have once been the original channel. The river bed is choked with sediment that has dropped out of suspension as the river slows through the widened channel. The river here is also very heavily shaded.

**Photo 9: The over-wide and over-shaded section of river near the downstream boundary of the reserve. The mirror smooth surface of the water highlights the lack of flow diversity (and therefore habitat diversity) present.**

Near the downstream boundary of the reserve, the wide and silted section of the channel could benefit from a simple in-channel CWD structure to divide the channel into two defined faster-flowing and slack backwater zones.

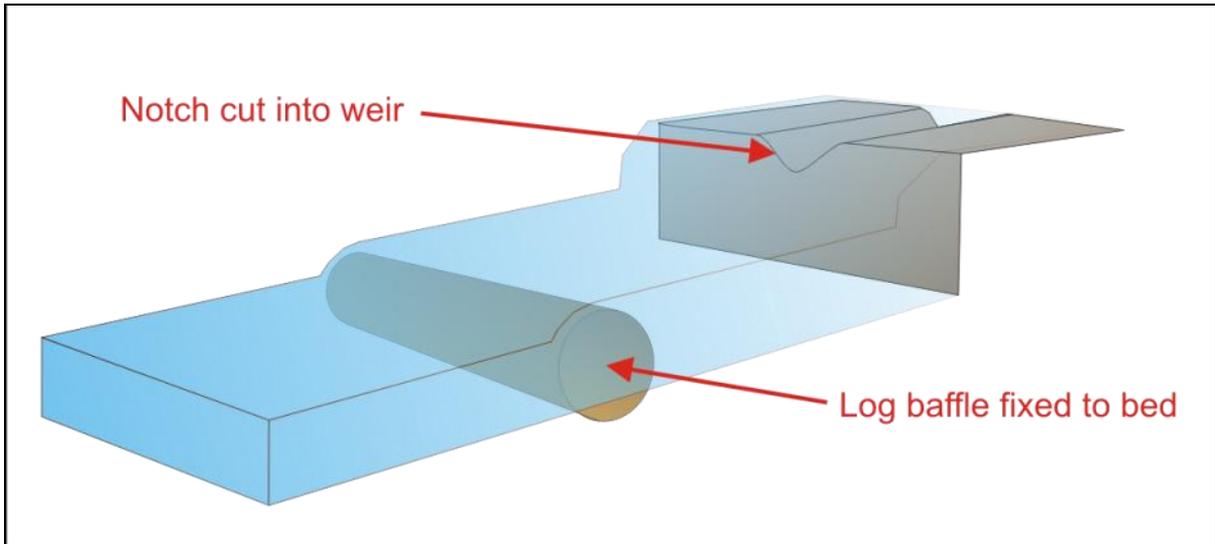
**An example of a simple easement to allow fish to pass over the weir and access the Were brook (secondary option).**

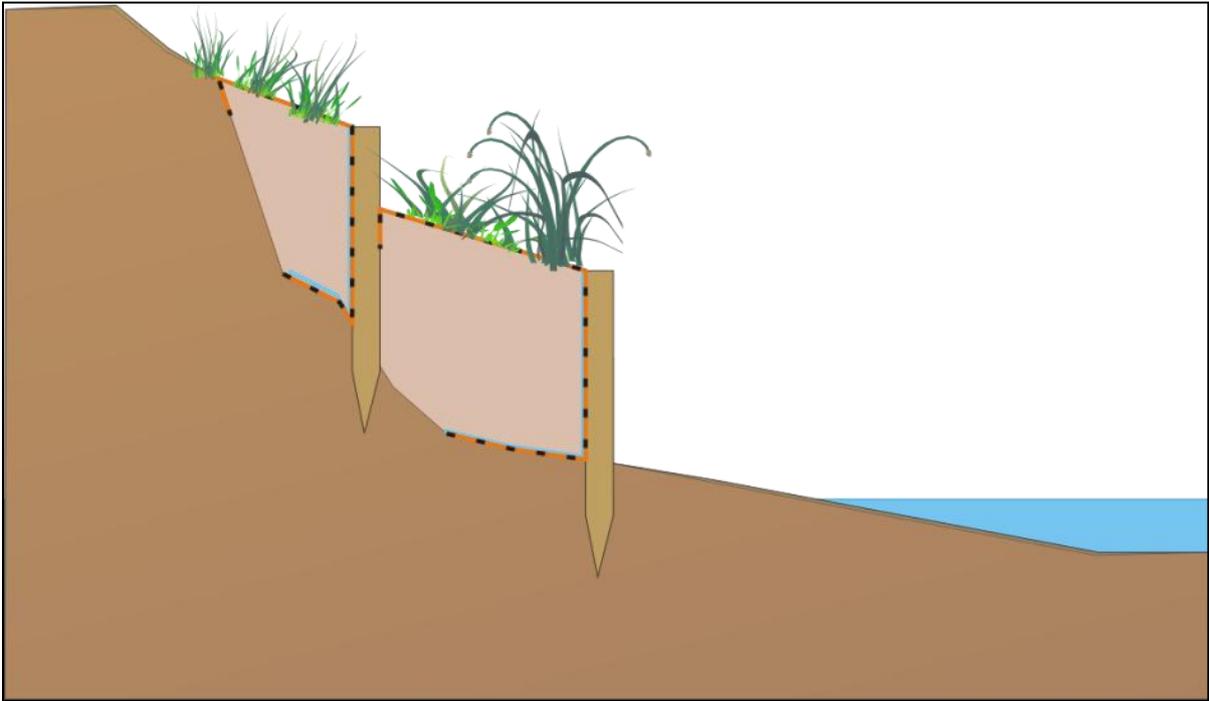
**An example post and geotextile terrace design back-filled with soil and planted with marginal species of local provenance.**

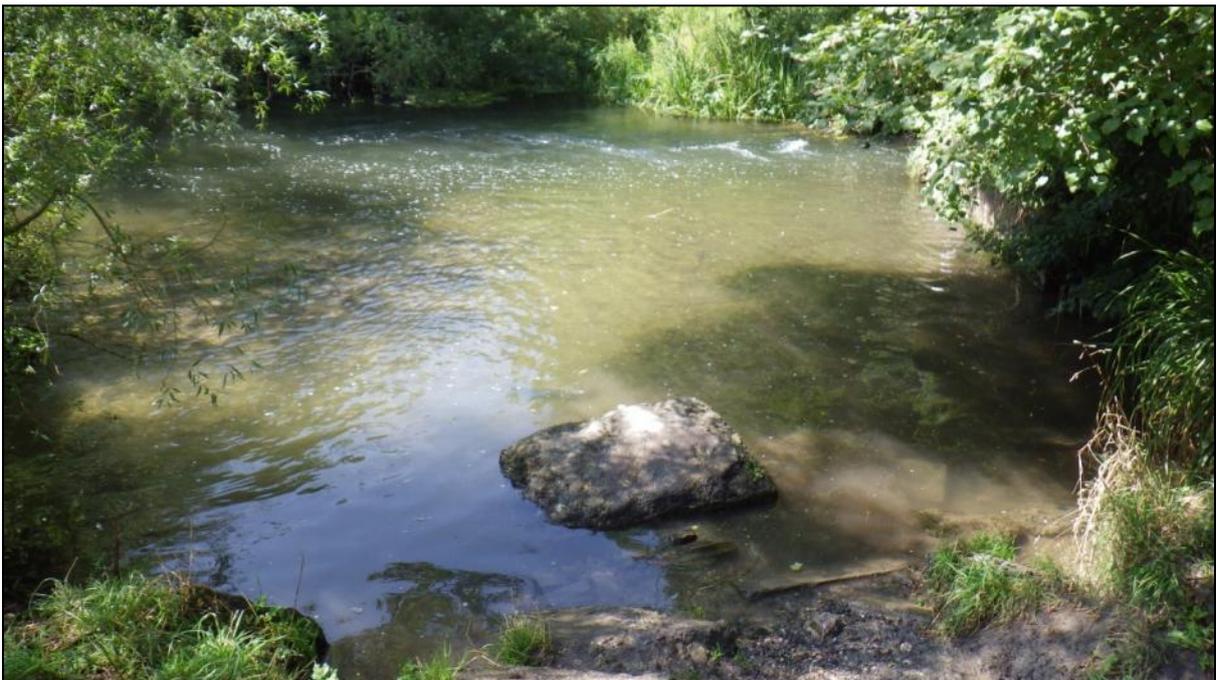
The bay would still be accessible to dogs via an adjacent section of bank that is already reinforced by rubble and the remains of a concrete structure. Here the bank has a shallow gradient and is much less vulnerable to erosion.

**Photo 10: An alternative area for dog access protected from erosion by rubble and a shallow gradient.**

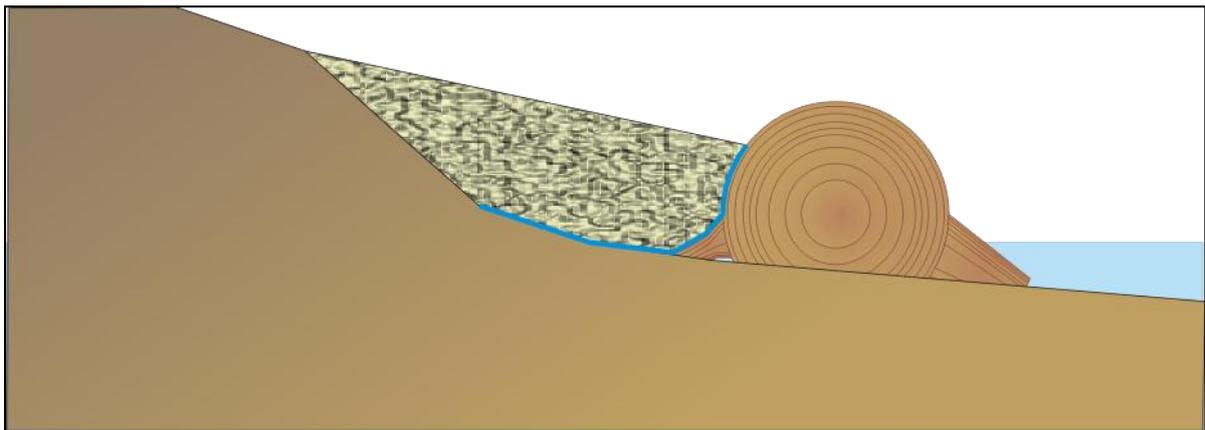
**An example log and geotextile bank protection back-filled with gravel**

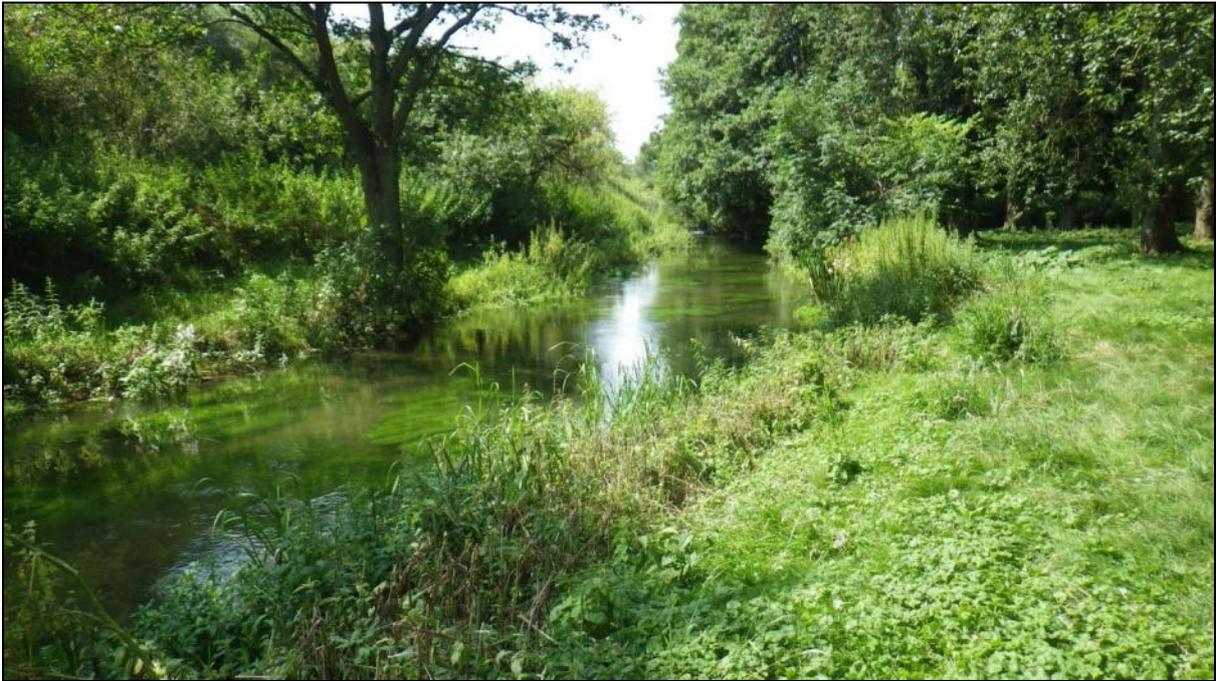
Upstream of the nature reserve a section of the Wylfe is exposed to much more sunlight. The river bed and marginal zone are densely populated with a variety of native plants. This section of river is also teeming with wild trout.

**Photo 11**The Wylie upstream of Smallbrook Meadows. An abundance of sunlight entering the channel has allowed aquatic and marginal plants to flourish.

The stark contrast between the river just upstream of the reserve and the overly shaded and straightened reach within the reserve illustrates the potential the river has for aquatic and marginal plants when direct sunlight is allowed into the channel. In fact, the river through the reserve has arguably more potential than the reach upstream as tree roots and the remains of old infrastructure have helped to diversify flow patterns, providing a more varied physical habitat with patches of fast flow perfect for water crowfoot.

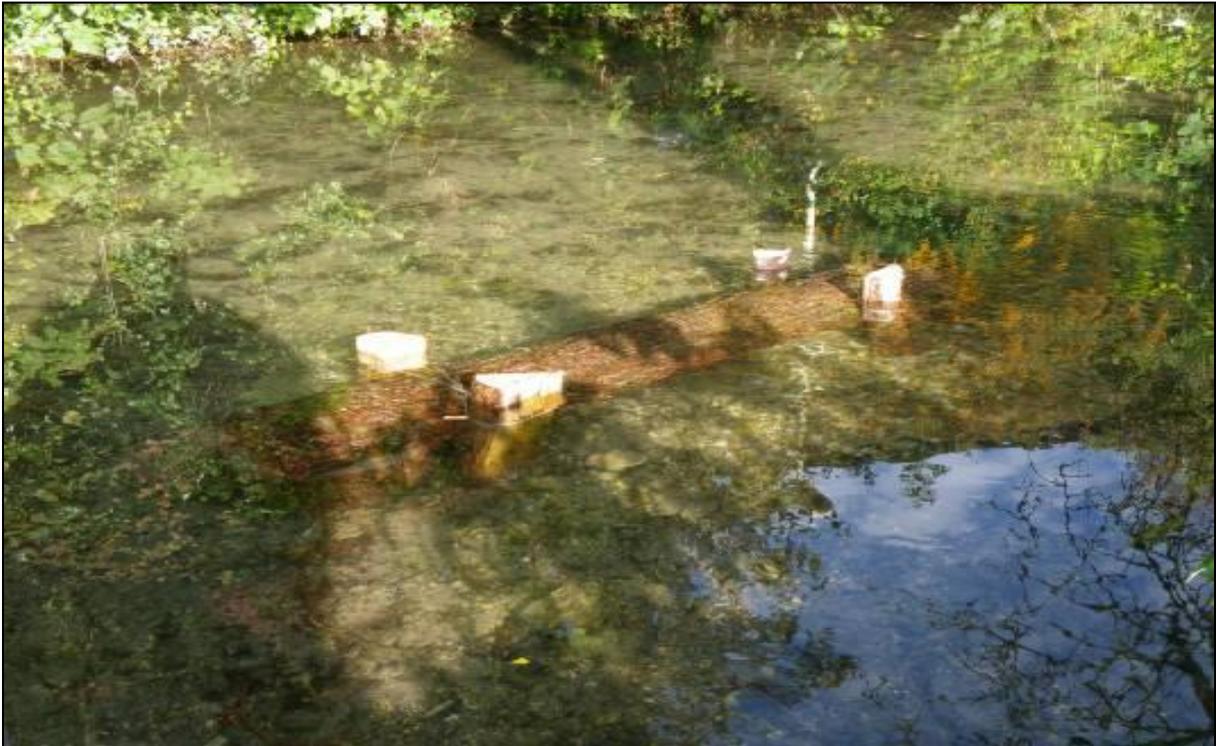
**An example log deflector fixed to the bed with chestnut posts and fencing wire**

Thinning out the trees on the left bank will also provide materials for further in-channel habitat enhancements. Large woody debris (LWD) deflectors constructed from larger boughs and logs can be installed in the channel to further diversify flow patterns, create localised scour to maintain healthy spawning gravels and locally increase flow velocity that will encourage the growth of flow-loving plant species.

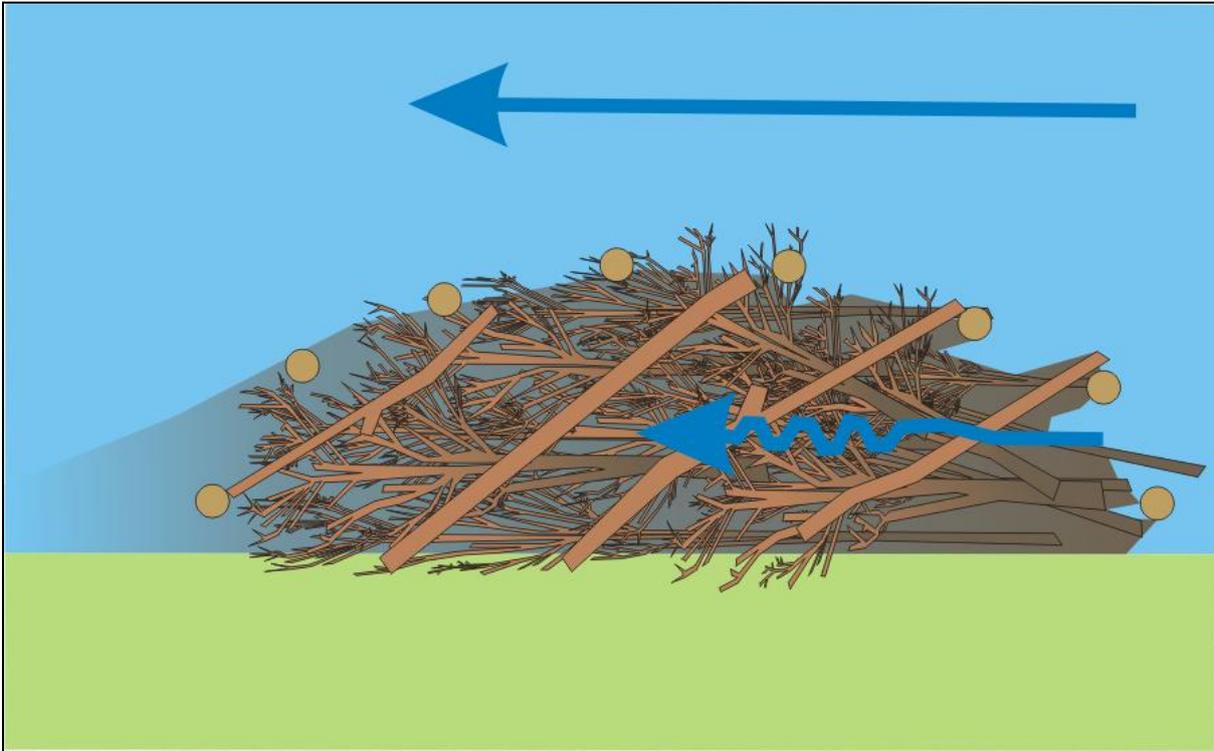
**A 'brushwood mattress' slowing flow velocity causing sediment to drop out of solution and accrete within the structure (blue arrows indicate flow).**

Brash from tree works could also be used to create coarse woody debris (CWD) mattresses that will act as sediment traps and provide great habitat for marginal species such as yellow flag iris (*Iris pseudochorus*), sedges (*Carex sp.*), reed canary grass, (*Phalaris arundinacea*), purple loosestrife (*Lythrum salicaria*) and meadowsweet (*Filipendula almeria*). All of these species and more are already growing naturally within the reserve and could be simply translocated to the riverbank to help establish a dense marginal habitat.

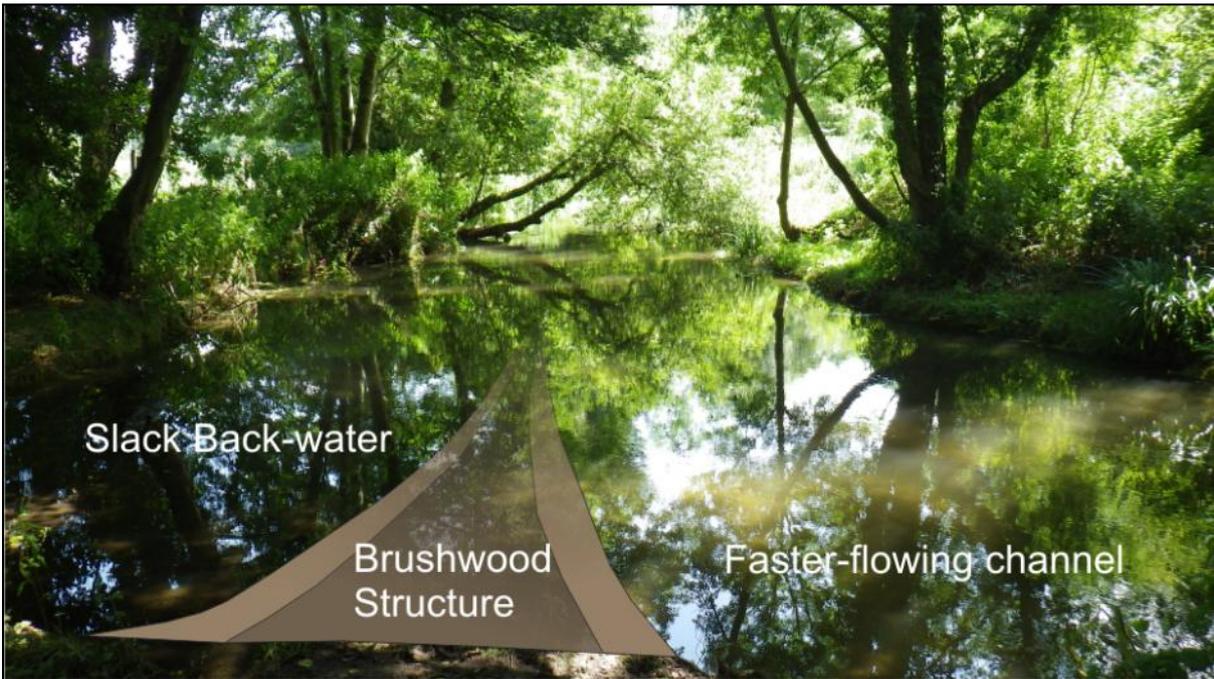
**Suggested location for a brushwood structure separating the flowing channel from a slack backwater.**

This would not only clean the gravel bed through the faster flowing section of river (important for wild trout), but would also provide a large backwater habitat for coarse fish species, amphibians and emergent plants.
