**Advisory Visit**  
**River Wyre, Wyresdale Anglers**  
**23/03/2016**

## **Key Findings**

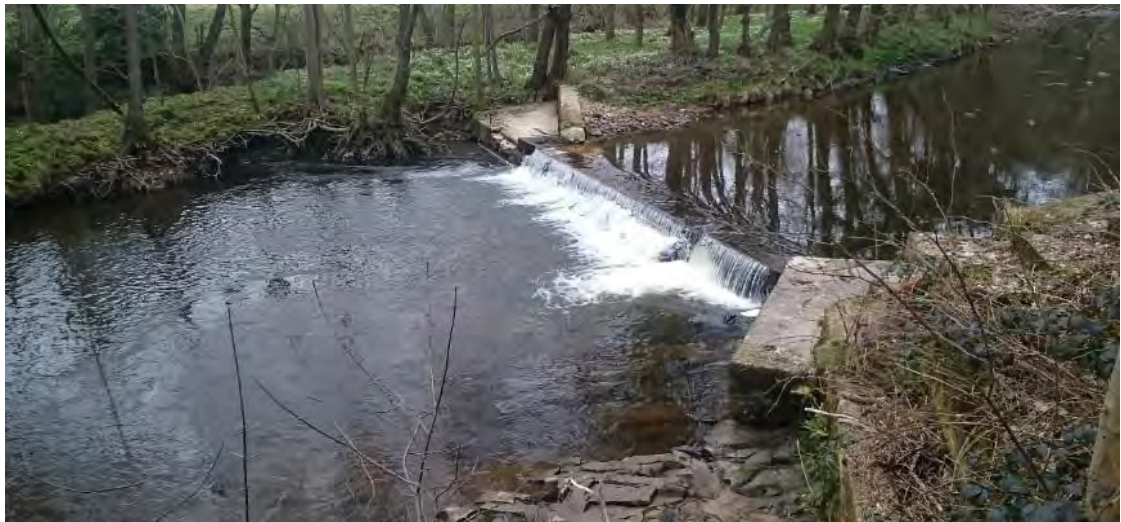
The pool immediately d/s of the weir is deep, containing many large boulders, and is bordered on the LB by a substantial ramp of sorted gravel indicating that there is ample supply of this vital spawning substrate to the river (Fig 3). A notch in the weir focuses the current under low-flow conditions but this does not alleviate its impounding effect sufficiently to avoid the issues mentioned above.

**Fig 1. The defunct weir at Dolphinholme Farm is an obstruction to fish passage, causing impoundment and associated hydrogeomorphological issues u/s. The notch appears to be blocked by a single boulder and could be exploited.**

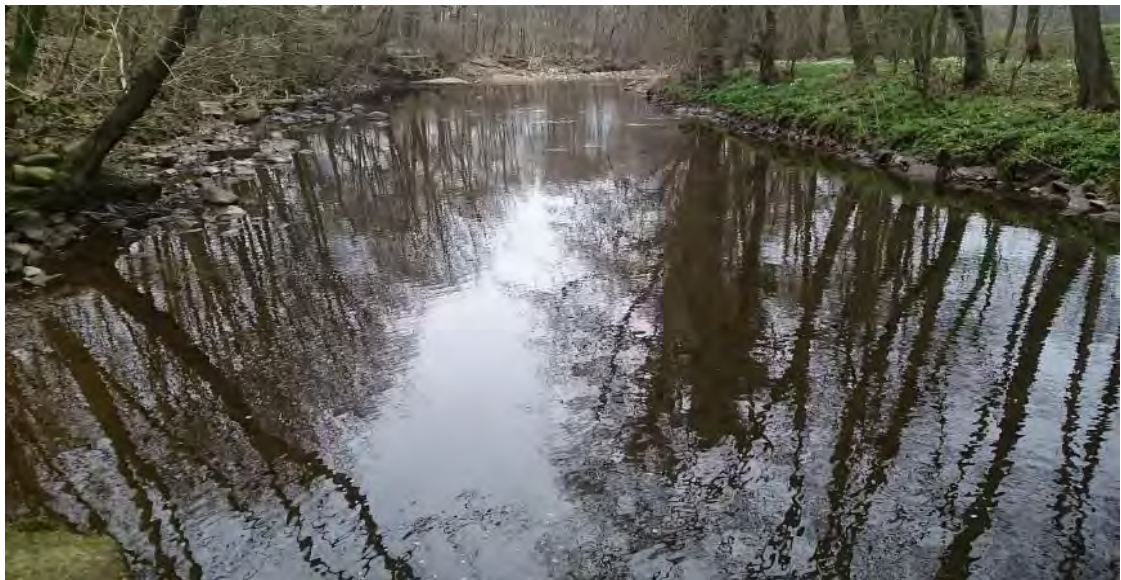
**Fig 2. Looking d/s to the weir in Fig 1 demonstrating the extent of impoundment and lack of low cover from riparian vegetation. Several trees on the RB could be used as tree-kickers.**

There was a distinct lack of low cover from riparian vegetation overhanging the water, despite the native mature trees present on both banks; some of these, especially on the RB, could be felled and used as 'tree-kickers' (to emulate natural tree fall and its associated benefits seen later in Fig 5). Tree-kickers are felled trees, introduced wholly or partially to the channel but cabled to their living stump and hence unlikely to move d/s – see Recommendations.

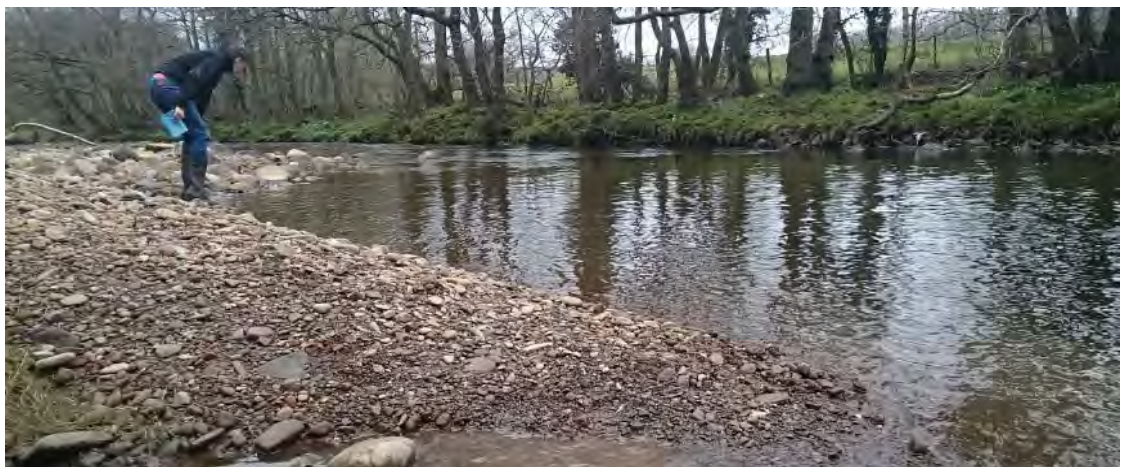
**Fig 3. Ramp of sorted gravel adjacent to the weir pool demonstrating ample supply of suitable sized spawning habitat from further u/s.**

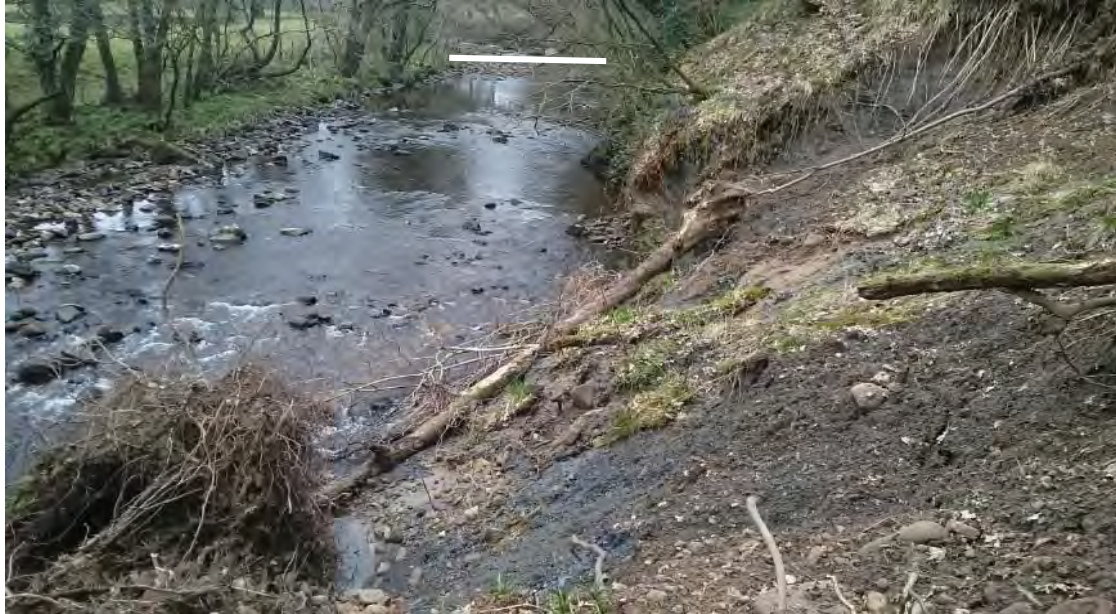
The u/s extent of the historical impounding effect of the weir was judged to be where the channel returned to a more natural sequence of pool-riffle-glide (white line in Fig 4). At the low flow experienced during the visit, the river was meandering naturally within the cobble and boulder bed. A substantial land-slip had occurred over the winter that deposited several large trees into the channel, providing valuable cover and in-channel structure (Figs 4 & 5).

**Fig 4. Substantial land slip on LB supplying large woody material into the channel. The uppermost extent of the impounding effect of the weir can be seen at the white line. NB flow was equivalent to low summer level during visit.**

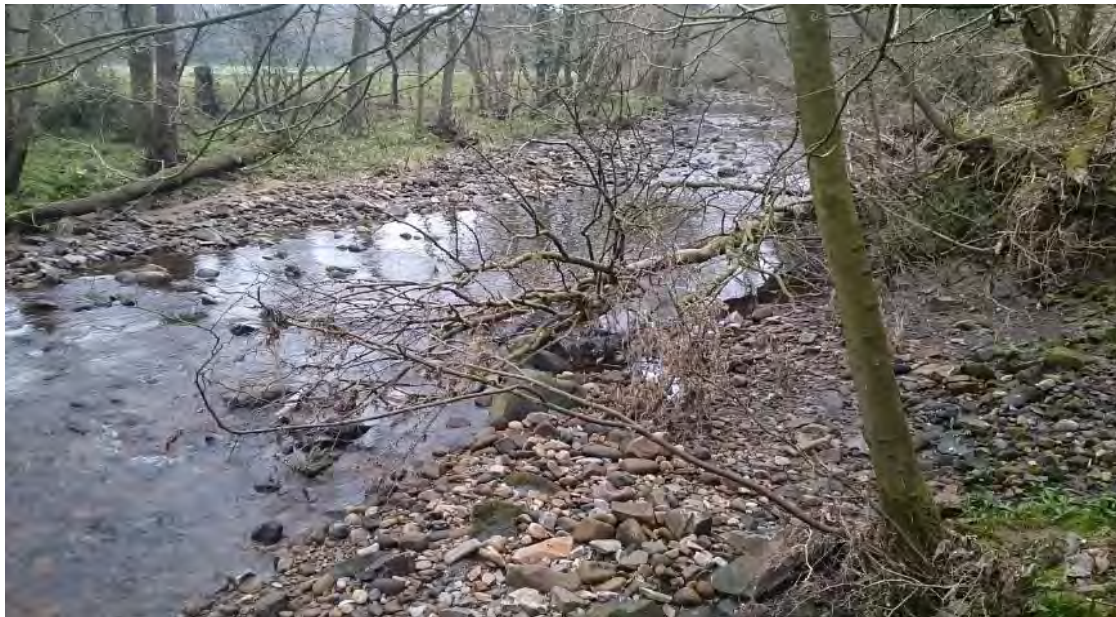
**Fig 5. The crown of the tree deposited from the landslip (root mass visible bottom left of shot; Fig V). A ramp of sorted gravels has been retained and deposited in its lee, caused by undershot scour acting against the trunk and branches (which also provide valuable low cover). That scour has also deepened a lie for fish next to the trunk.**

These should be retained in position as they introduce valuable habitat variability via scour underneath (local deepening; good adult holding habitat), deposition and sorting of gravels d/s (which might be used for spawning under higher flows), diversion of flow across the pool d/s (creating a focussed feeding line), and low cover / refugia amongst the crown branches in which fish can evade predators.

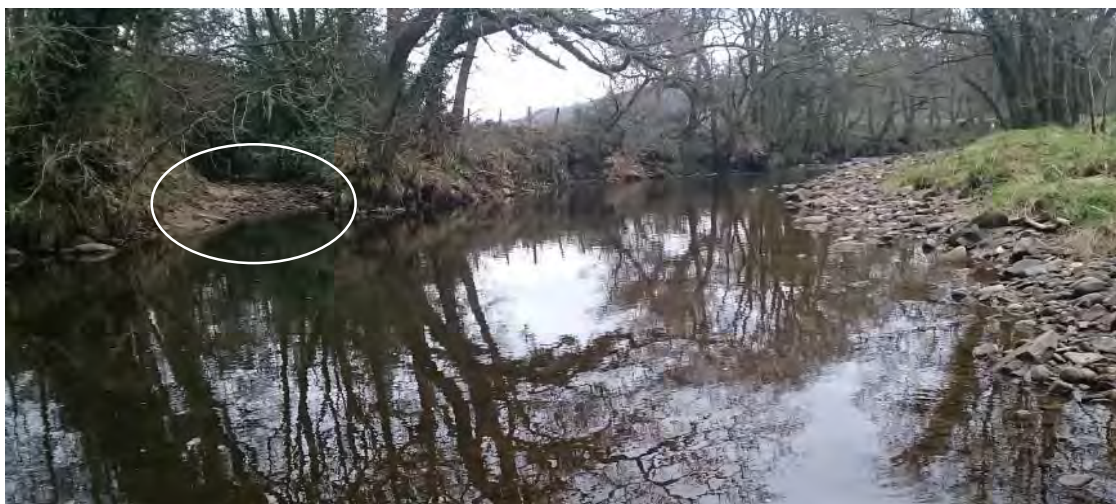
This was the lowest point of inspection on this stretch, at the confluence with Damas Gill (on the RB; Fig 6). According to Glenn, Damas Gill is an important spawning tributary. Certainly, the quantity and quality of the gravels deposited in the mouth of the Gill hinted at this role. Damas Gill enters the main channel in a deep pool and hence provides safer and easier access for spawning fish wishing to ascend. Maintaining access and quality of tributaries such as this will be essential to promote sustainable populations of wild trout.

**Fig 6. A deeper pool caused by natural erosion on the outside of the bend. Damas Gill enters on the RB. Note the considerable accumulation of gravel just u/s of the confluence (in the Gill; white ellipse).**

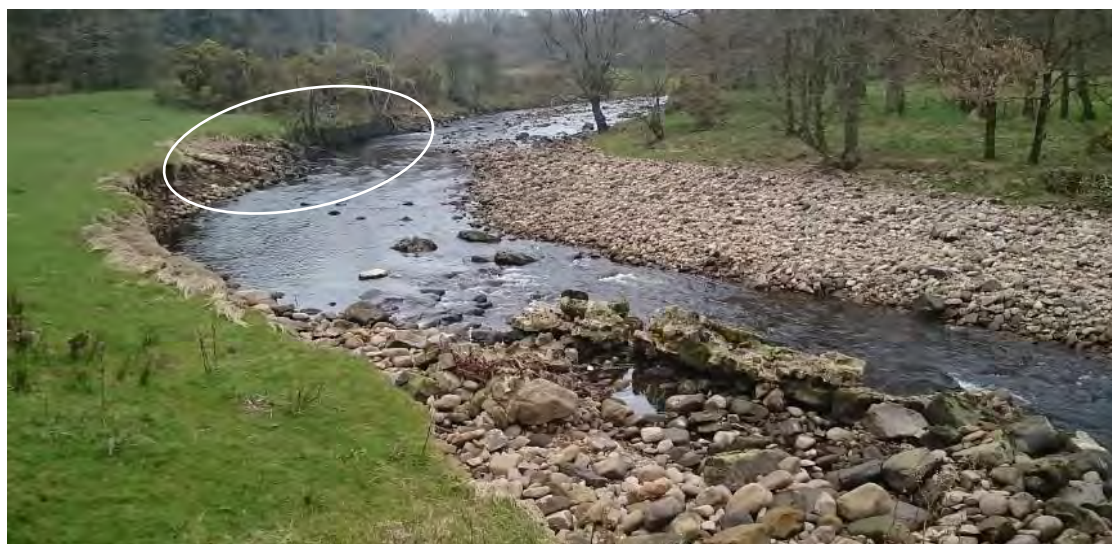
**Fig 7. The uppermost section visited at Corless Mill where the mill leat infrastructure has been eroded into the river. Gabions are present u/s (white ellipse) but are only exacerbating erosion immediately d/s where there is insufficient root structure in the soils due to livestock access to the very bank top (see Fig 8).**

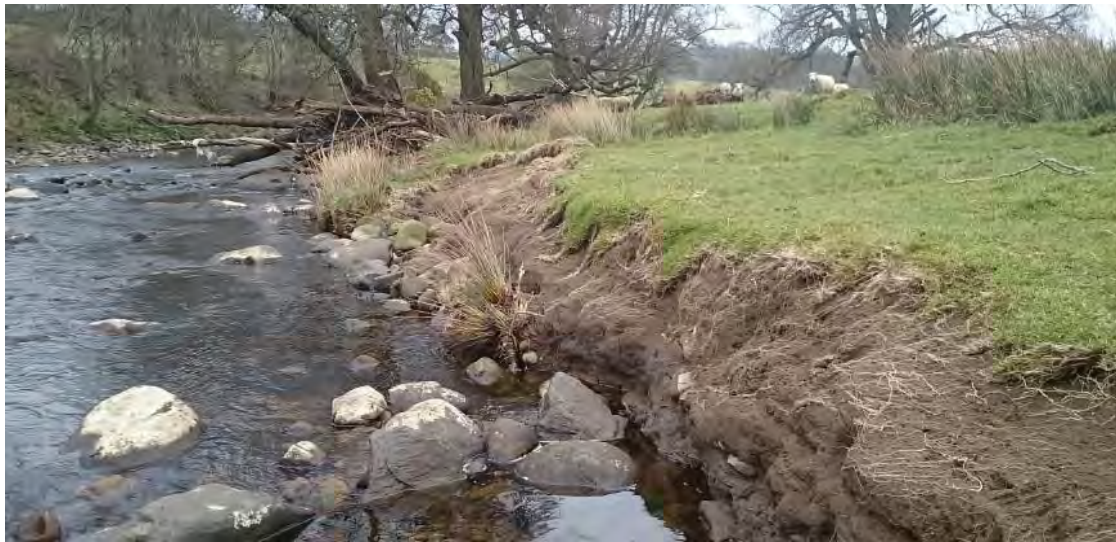
Both banks are open to sheep grazing, and with unfettered access, they have reduced the riparian vegetation to a short sward of grass with no regeneration of trees. Grasses that are continually cropped invest more energy in replacing their shoots and little into their roots; as a consequence, there is little depth and diversity in the root structure. Un-grazed banks allow a diverse array of herbaceous vegetation to develop which provide a complex matrix and structural stability to the bankside soils, thereby providing further resistance to erosion (see Fig 8). Hence the extensive erosion seen at Corless Mill is resultant from several contributing factors.

**Fig 8. The RB immediately d/s of the mill leat intake showing flaying of the short sward grasses during recent spates. Lack of vegetation diversity and associated root structure due to grazing (here sheep) makes the soils especially susceptible to erosion.**

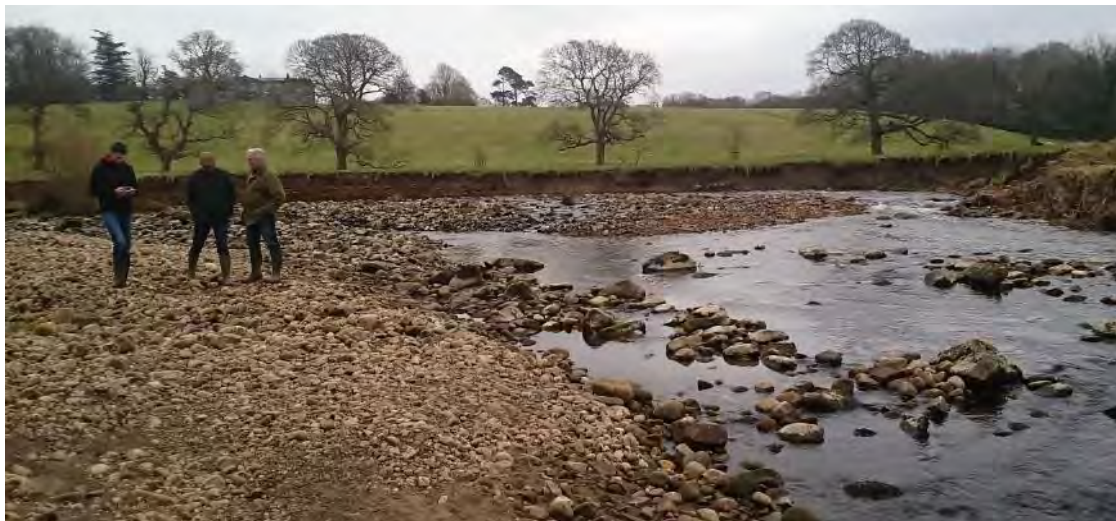
Protecting the RB and forcing the river to bend left (away from the mill; Fig 7) has placed undue erosional stress on the LB (Fig 9), which has succumbed to block failure immediately d/s of some remaining willows (that are protected from grazing). The flow is now diverted back to the RB at an unnaturally acute angle which is leading to increased erosional pressure on the RB (Fig 10). The lack of structure in the soil because of livestock grazing means these soils are easier to erode.

**Fig 9. Extensive erosion of the LB by block failure has left ~100m of vertical bank and a distinct ~90° right turn (toward the camera) as the river now hits more resilient substrate.**

The recent shift of the entire river channel at least 20m into the LB (Fig 9) has left extensive gravels and cobbles exposed in the former channel. This coarse substrate has created a braided-channel with shallow pocket water. Juvenile fish will certainly use this habitat, but the reduced proportion of refuge-habitat makes it less likely to support adult trout. There is a distinct lack of riparian cover which is essential not only for the trout instream, but also for emergent aquatic insects to complete their lifecycle. In addition to aquatic invertebrates eaten by trout, many terrestrial insects fall onto the water from bank-side vegetation and become trout prey.

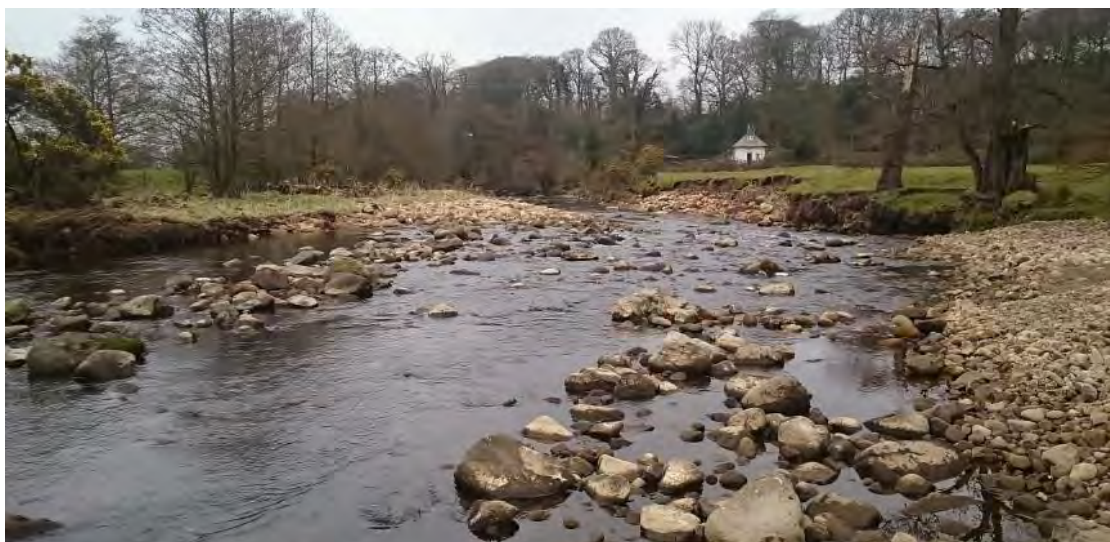
**Fig 10. The sharper redirection of water (from Fig 9) across the original channel path is now exacerbating erosion on the RB d/s and undermining the roots of the mature trees.**

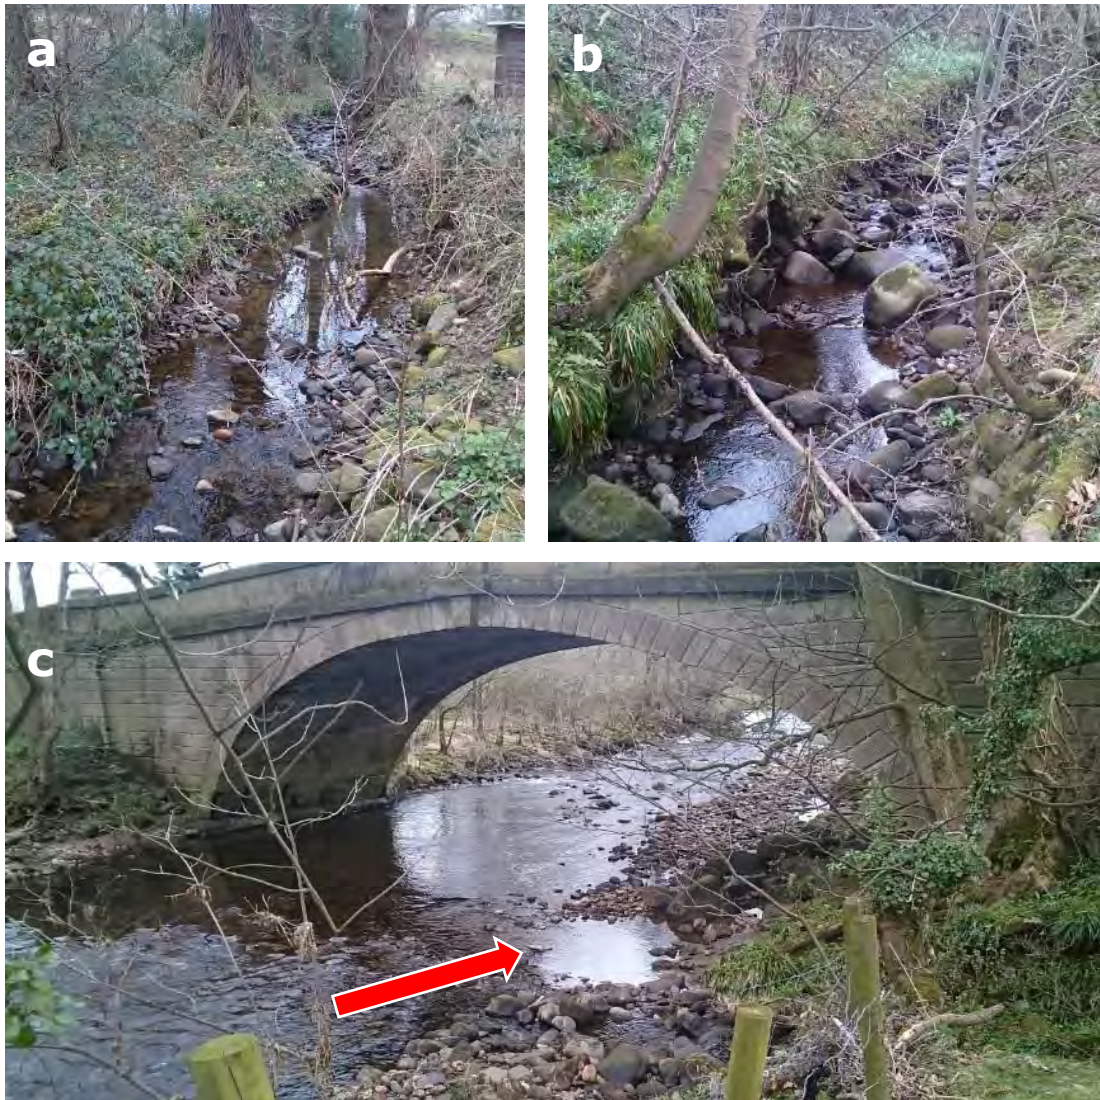
The next stretch was accessed from the **Club's** lake fishing car park at SD5188152162, adjacent to a small tributary, Street Brook. Anecdotally, sea trout have been observed cutting redds in the Brook, and since this is completely under the control of Wyresdale Anglers for several hundred metres, it could be the focus of some relatively inexpensive habitat management to improve the potential spawning and juvenile habitat (Fig 11a-c).

Currently, there is relatively little instream structure within the Brook to retain gravels, so this must be improved. Glenn Welsby recalled that attempts to introduce gravels were only partially successful because they were not retained under high flows.

**Fig 11. The potential spawning tributary, Street Brook: a) looking u/s at the fishing hut; b) looking u/s from near the confluence; and c) the confluence with the Wyre, marked with a red arrow. NB there is a substantial weir ~40m u/s of the road bridge on the main stem Wyre, just evident under the arch.**

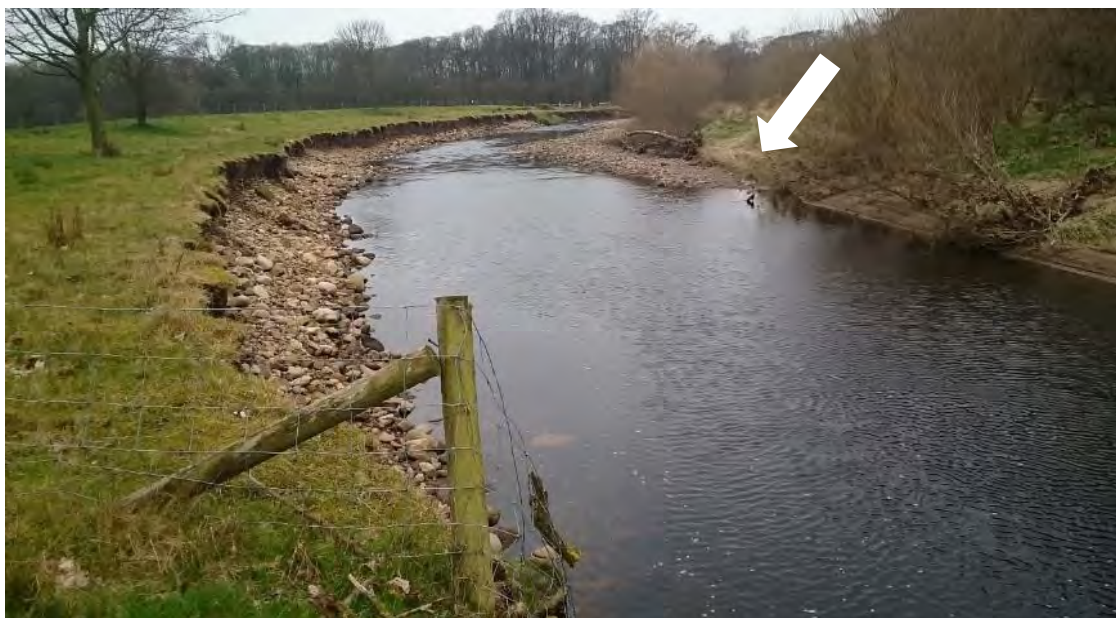
The channel is straightened for ~100m below the road bridge with evidence of block walling on the LB; here, the river passes between old gravel pits excavated during the construction of the M6. As a consequence of historical engineering (block walling), the LB is higher than the RB which retains a more natural gradient. Recent spates have eroded heavily into the LB, again by block failure, and scoured the turf to leave it severely undercut in places (Fig 12). This section has been fenced off recently by Wyre RT but has yet to regenerate a natural diversity of riparian vegetation; as a consequence, with only grass roots *in situ* there has been scant root complexity in place to resist the spate erosion – see Recommendations.

**Fig 12. Erosion of the LB on the sweeping bend next to the Wyresdale Anglers fishing lakes. A paleo-channel can be seen on the RB (white arrow). Heavy coppicing of the willows from the RB could provide materials (stakes & whips) for LB rehabilitation. See Fig 13**

As the erosion is threatening the integrity of the narrow bank separating the river and the fishing lakes, clearly the Club is concerned. Former channels on the RB (a man-made spawning channel and a paleo channel) could be exploited here if the flow in the main channel can be encouraged to leave the LB and focus more towards the RB (Figs 13 & 14). Mature trees on the LB could be used as tree-kickers to divert the flow, while heavy coppicing of the willows on the RB would a) remove their resistance to spate flow which is probably exacerbating the erosion on the LB, and b) provide stakes and whips which could be used to bolster protection of the LB – see Recommendations.

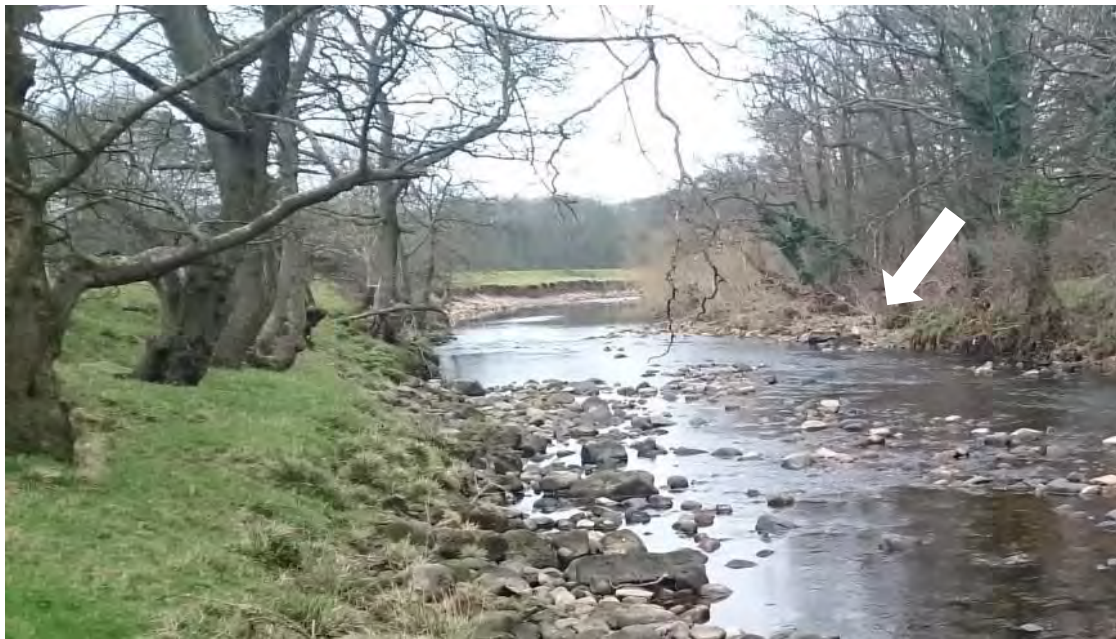
**Fig 13. U/s from Fig 12: a former spawning channel created on the RB is now blocked but could be reinstated. In addition, some of the mature trees on the LB could be used as kickers to divert flow toward the RB, and thereby away from the eroding LB.**

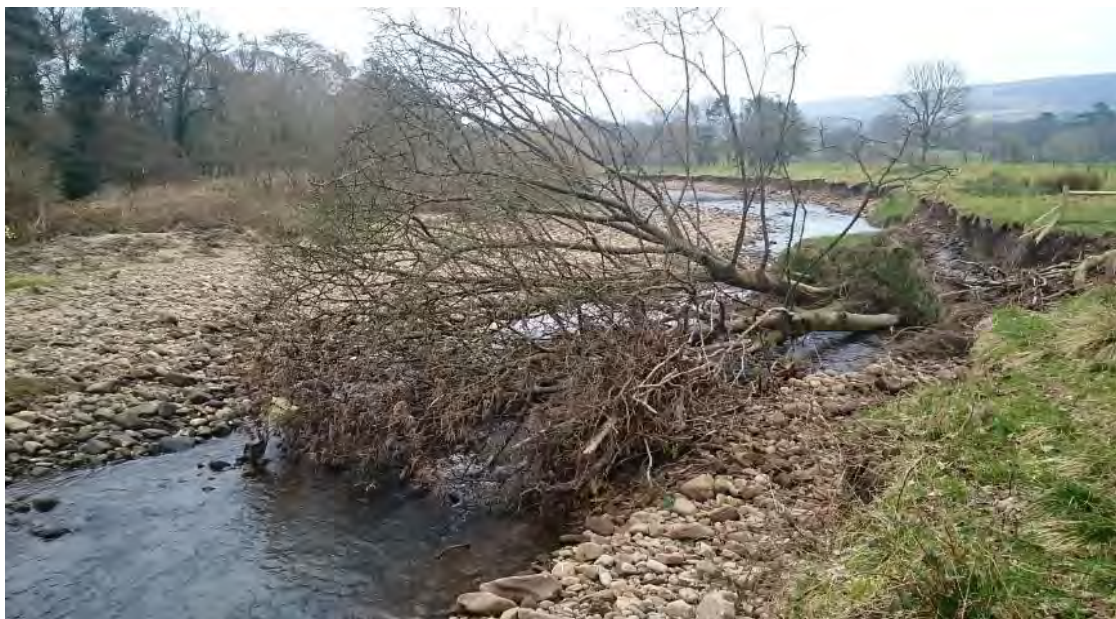
**Fig 14. Looking u/s to the eroded LB of Fig 12. Scale of large woody material introduced into the channel and the gravel retention in the foreground resulting from the natural 'tree-kicker' effect. This should be retained wherever possible but should be secured tight to the bank. Note the width of river compared to width of exposed gravel bank.**

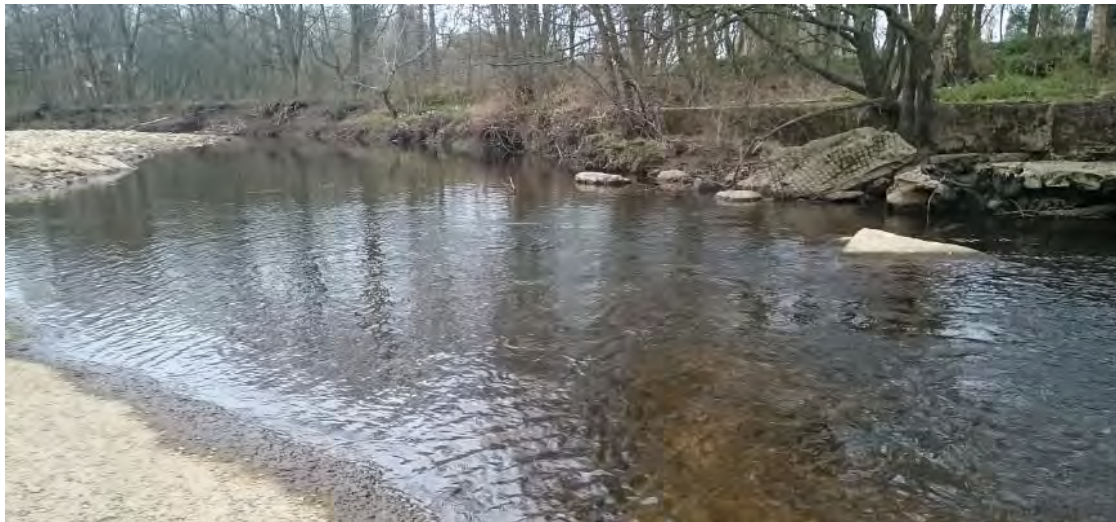
Below the fishing lakes, the river is protected on both banks by mature woodland for several hundred metres but has still been engineered to turn left via an angled weir. The concrete structure of the weir is now severely degraded and while the block work introduces some varied pockets of deep water and sorted gravel bars, the original purpose of the weir to divert flow from the RB is now being circumvented (Fig 15). As a consequence, the RB is being severely eroded because the full force of spate flow is now directed

**Fig 15. Looking d/s from the dilapidated weir (concrete bottom left & top right of shot). Without the diversion of the weir, the river is now cutting a more natural curve into the RB.**

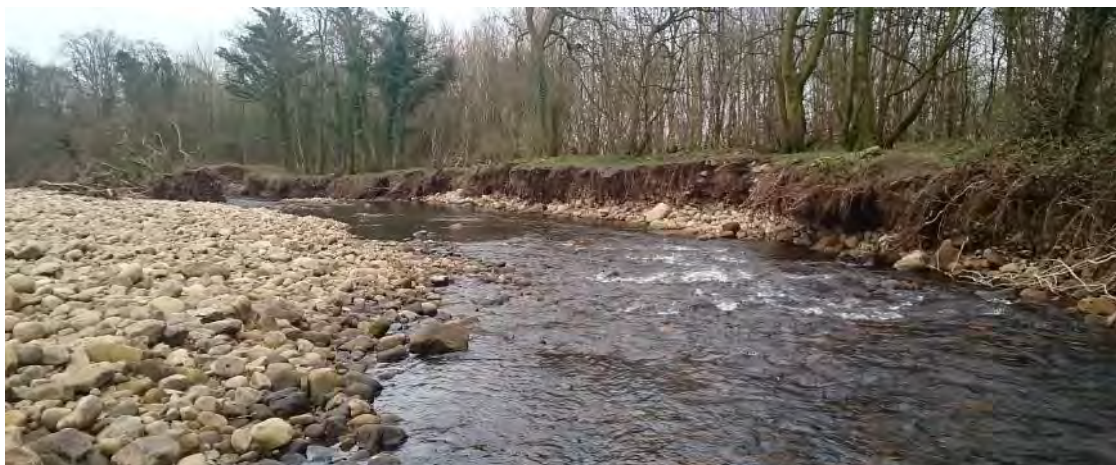
**Fig 16. D/s from the dilapidated weir, the RB is subject to considerable erosion despite mature trees in the riparian zone because the full energy of the spate flow is directed there now the weir has gone.**

at it (Fig 16). This is despite the diversity of mature trees and understory plants in the riparian strip providing a complex root matrix. The river is simply trying to revert to a more natural path, formerly constrained by the weir, and it can be best visualised in Figure 17, using a map.

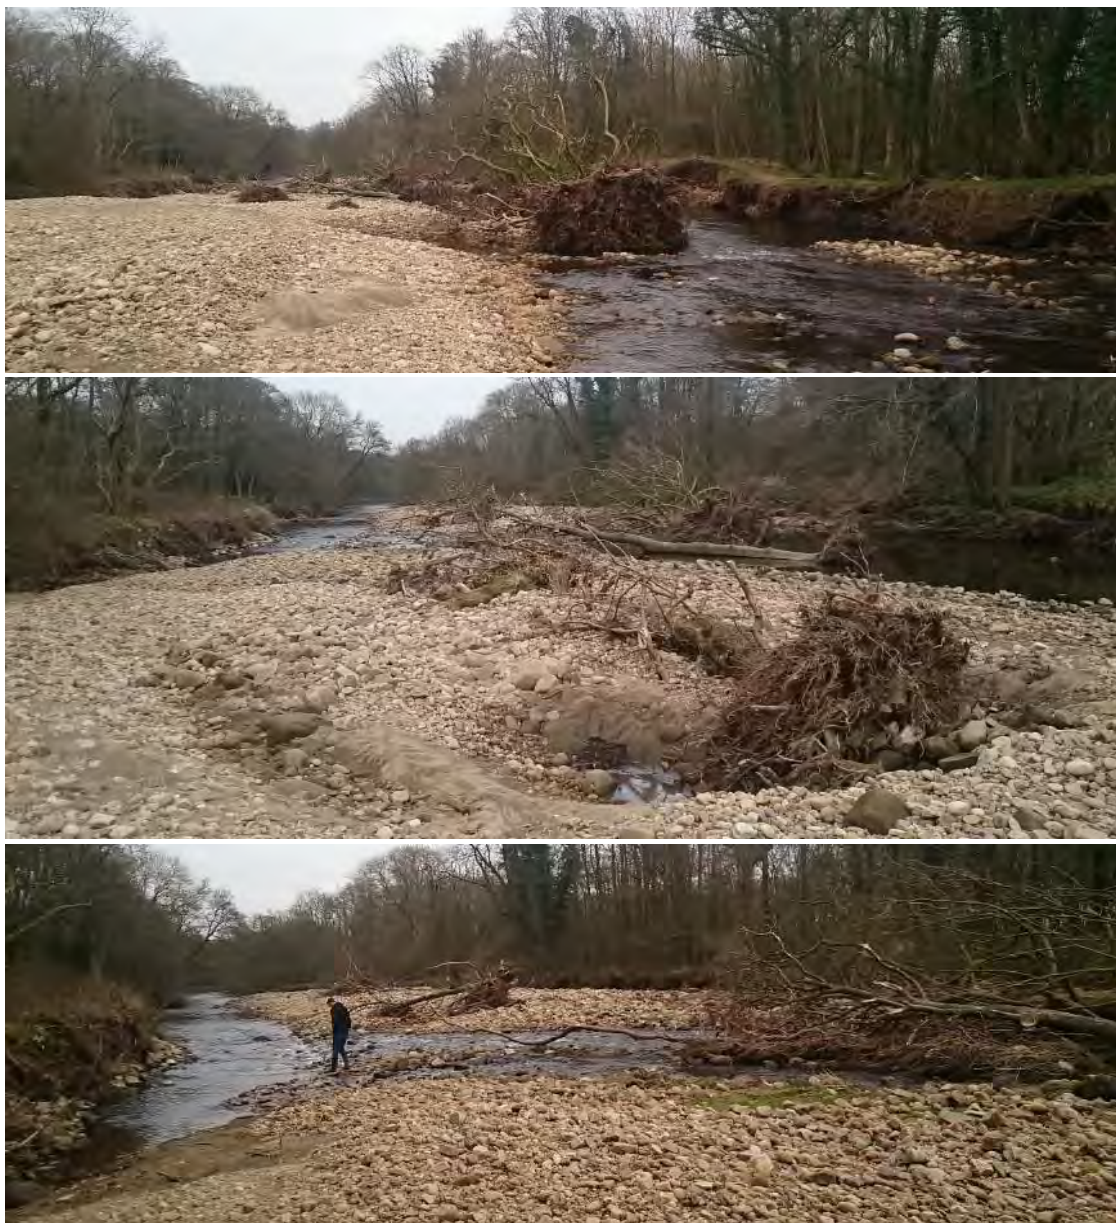
There are many mature trees deposited on the main gravel bar, effectively sitting mid-channel. It might be possible, with some trimming of the root masses, to winch some to the sides where they should be secured in position (pinned or cabled to existing trees) to help protect the bank and provide valuable instream cover (Fig 18). Some are already partially buried indicating substantial deposition on the gravel bar, and these are probably best left. The benefits of woody material to create diversity of depth and flow can be clearly seen in the patterns of scour and deposition around the trunk now high and dry (Fig 18 mid panel).

**Fig 18.** Three panels: Looking d/s, mature trees deposited across the former channel and the river now cuts from RB to LB over hundreds of tonnes of deposited cobbles and gravels which may look dramatic but provides valuable in-channel diversity and important terrestrial and aquatic invertebrate habitats.

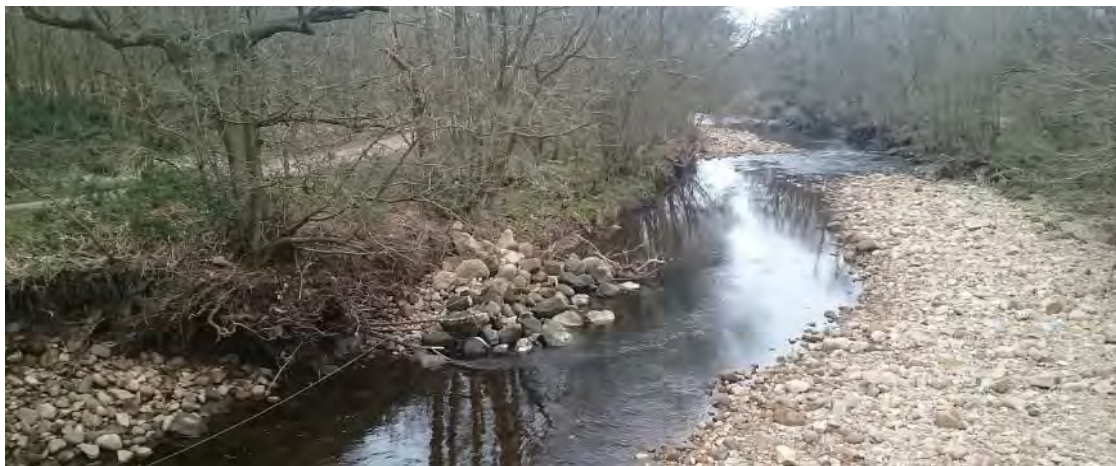
**Fig 19. The river now meandering back and forth across its spate channel. There is evidence of historic boulder revetment throughout these stretches.**

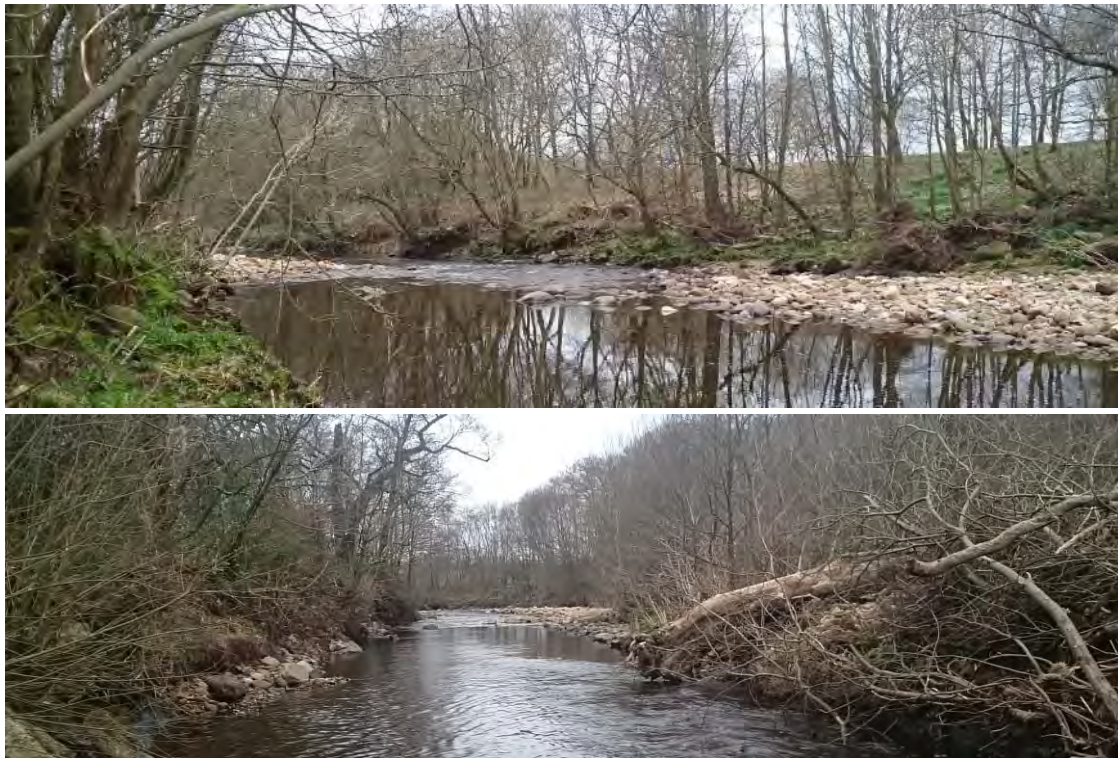
From a track bridge at Wyreside Lakes Fishery to the M6 bridge, a section of ~700m was assessed. The fringe of riparian trees on both banks at the top of this section was narrow but in good condition, ie mature and a mix of native species with some understory present. The river is cutting back and forth across its spate channel in relatively natural meanders (Fig 19). However, it was clear that many of the low branches had been cut back presumably to improve access for casting; this should be curtailed in favour of laying some of the more pliant species (willow and to a certain extent, alder) to provide sporadic patches of low cover to hold fish (Fig 20).

**Fig 20. Although both banks now have a decent semi-natural riparian strip, close inspection revealed much evidence of historic pruning of low branches creating the arching effect seen in both panels above, and a consequent absence of low or important trailing cover, particularly along the LB.**

In addition to stimulating important low level canopy regrowth, laying or coppicing a small proportion of the riparian trees will allow some dappled light to reach the water surface and potentially boost instream production slightly, and to diversify the canopy structure to the benefit of aquatic and terrestrial insects. Both of these will ultimately benefit wild trout populations through provision of better resources.

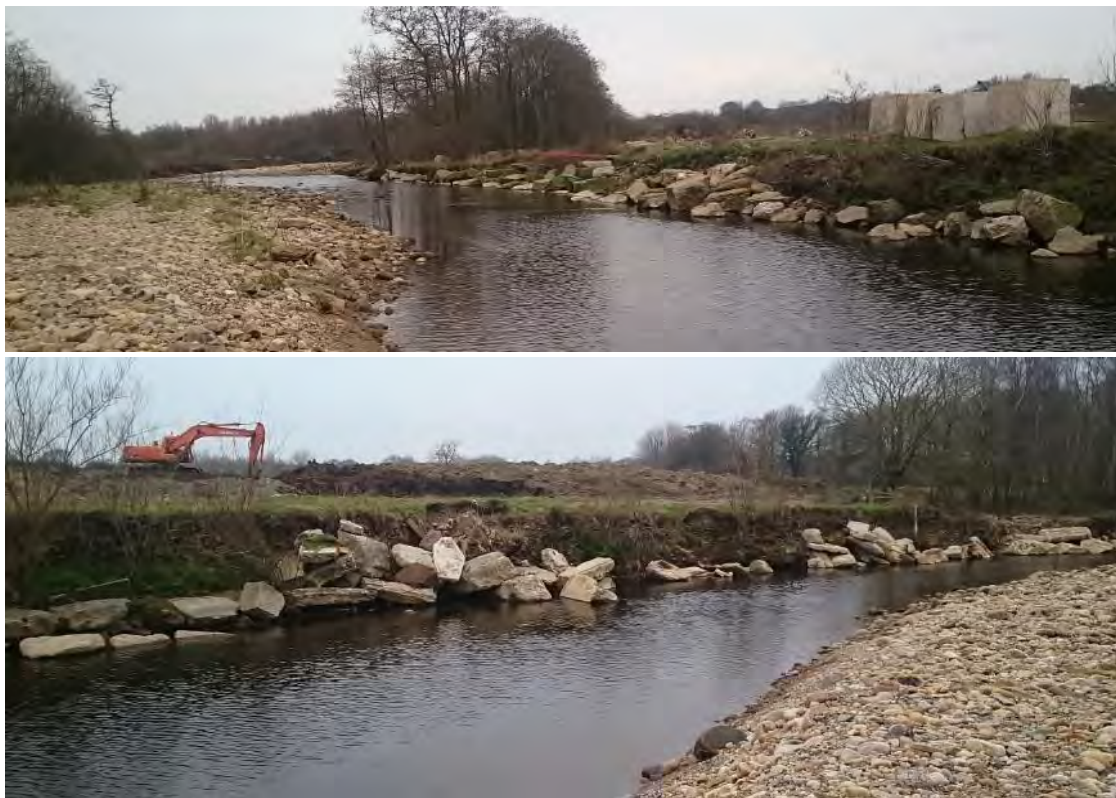
**Fig 21. Introduction of boulder and concrete blocks to prevent erosion of the RB. See reference to video on page 9.**

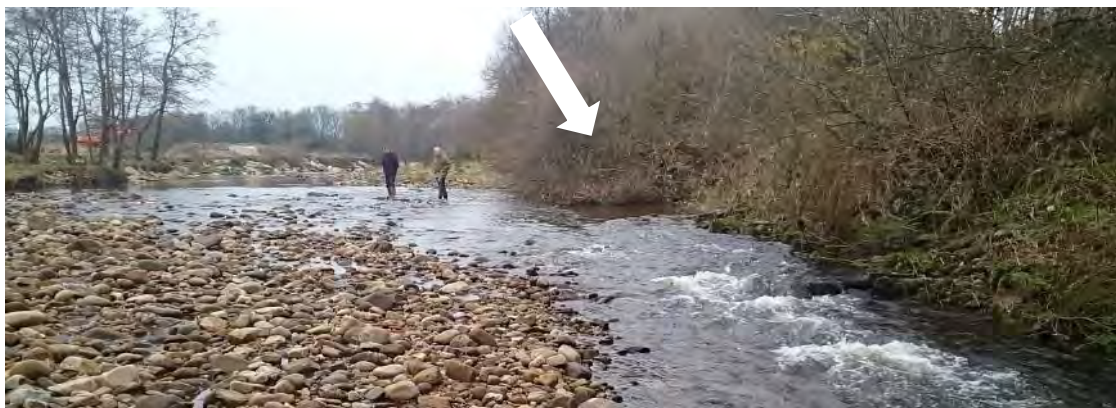
**As outlined above, the river at 'normal' flows is meandering within a spate channel which comprises mostly boulders, cobbles and gravels deposited in bars, and consequently it is even more important to retain and manage riparian vegetation where it actually overhangs the river to maximise cover and feeding opportunities for trout. It was a pity that one of the very few mature willows actually providing low cover and trailing branches was cut rather than laid (Fig 22).**

**Fig 22. Beneficial overhanging willow (at arrow) cut rather than laid – this rare habitat feature is now lost and will take many years to replace.**

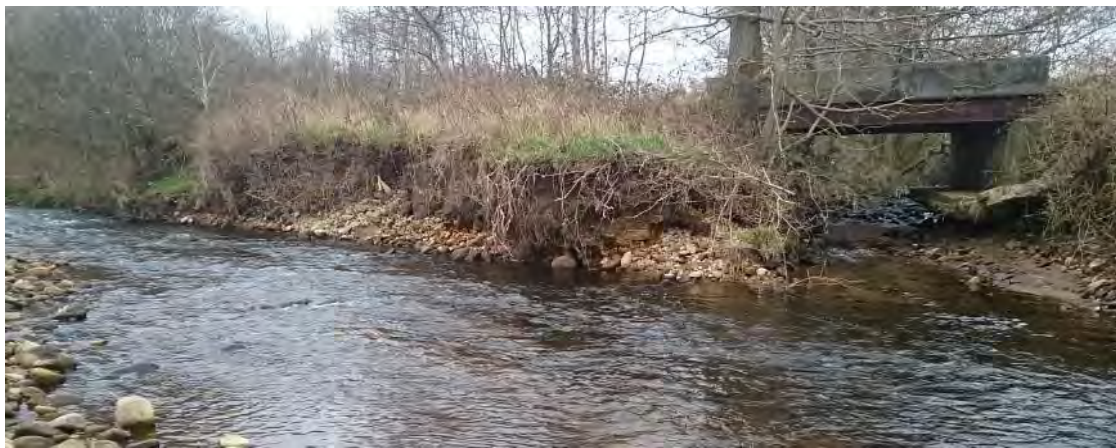
Another potentially important spawning tributary enters the main channel from the LB ~120m u/s from the M6 bridge. Foxhouses Brook, like Damas Gill, enters the Wyre on the outside of a bend and hence there is deeper water at the confluence making it easier for fish to access (Fig 23). Planting up the LB u/s and d/s of the confluence with willow whips will not only protect the banks but also provide cover for fish approaching the confluence. While not directly under the control of Wyresdale Anglers, it would be beneficial to engage with the landowners along Foxhouses Brook so that habitat quality can be maintained along its lower reaches.

**Fig 23. Confluence of Foxhouses Brook with the mainstem Wyre, on the outside of a bend means that there is deep water from which fish can potentially access the spawning tributary.**

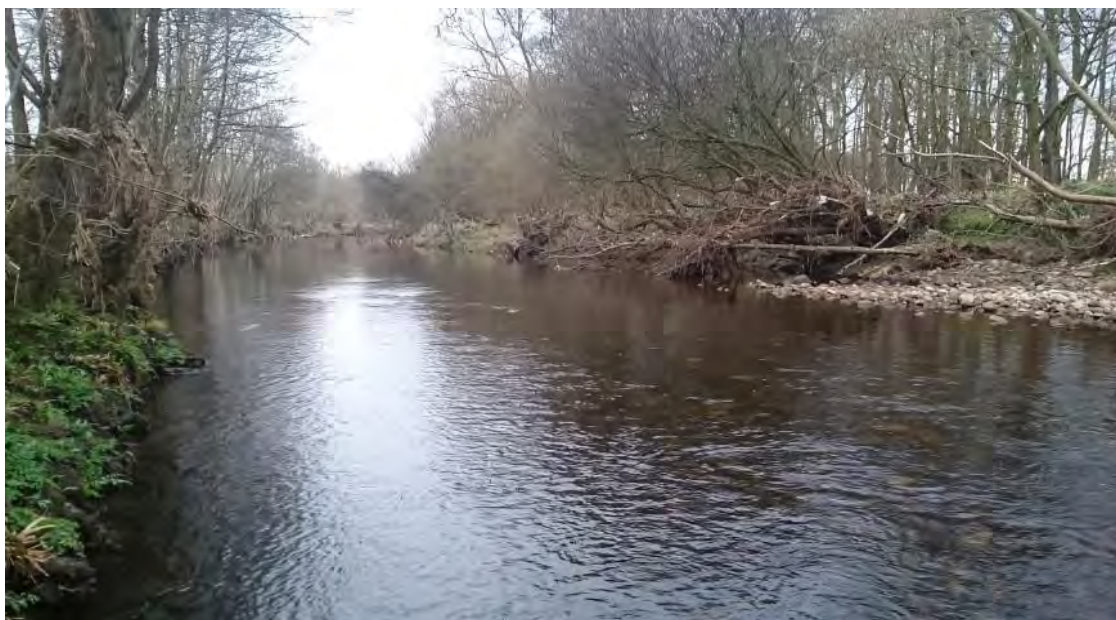
The river was next inspected d/s of the M6 at beats 5 & 6, with a couple of point inspections over a ~750m stretch. The first was along an avenue of trees which would benefit from not being pruned of low branches, and with some laid as tree-kickers into the channel (Fig 24). The RB is more natural in this respect but the flow is focussed toward the LB and consequently the benefit of the low cover is lost partially over shallow water which will not hold adult fish; fry and parr will still benefit.

**Fig 24. Long series of glides where the trees on the LB have clearly been managed to remove low branches. The stretch would benefit from one or two of these trees being felled and secured tight against the bank to diversify flow and increase refugia.**

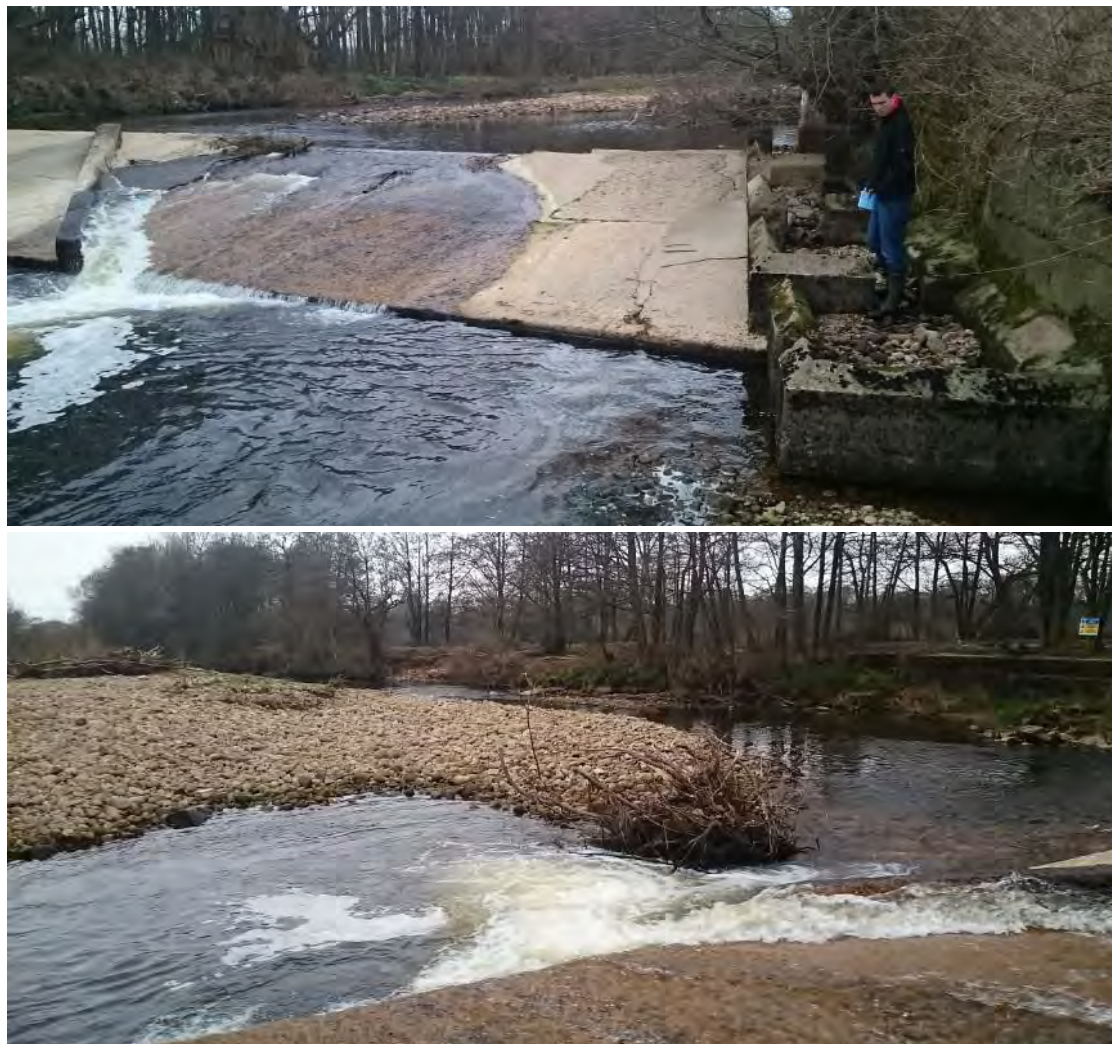
Below the series of glides is a major weir which has a single baulk angled across its face, and a fish pass constructed at the LB. The latter is now obsolete; the weir crest has been breached, and the

bauk serves to divert flow to the LB and affect the deposition of substrate downstream (Fig 25). This is now a complete obstruction to fish passage under normal flows and probably still impassable to the majority of fish under higher flows. Removal would also reinstate a more natural sediment transport regime through the section.

**Fig 25. The weir next to Clevelymere: upper panel looking u/s at the damaged crest, baulk, and dry fish pass; lower panel d/s at the vast deposit of substrate.**
