**Advisory Visit**  
**River Wyre, Wyresdale Anglers**  
**23/03/2016**

## **Key Findings**

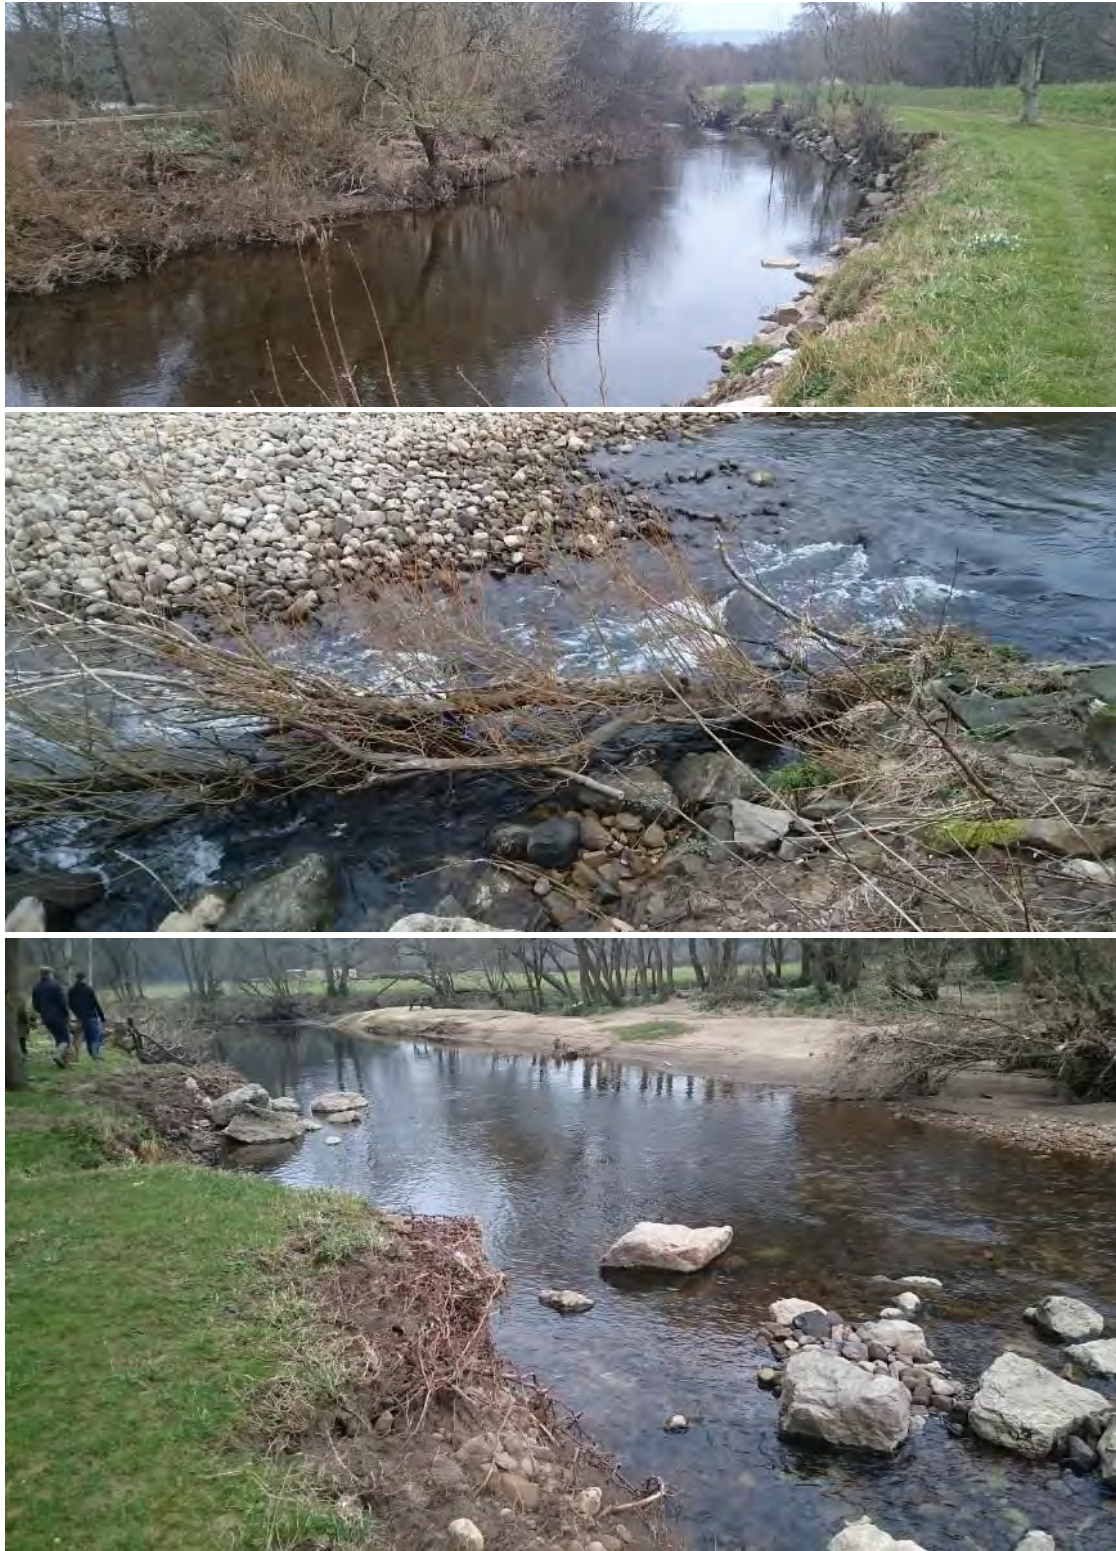
the very edge of the bank also increases the disturbance that fish will experience. Introduction of boulder piles is now causing scalloping erosion in the LB, so these should be redistributed to provide adult trout lies elsewhere. The LB has been rock armoured, presumably to protect the track alongside; see Figure 26 panels.

**Fig 26. Examples of habitat management: upper panel looking u/s at mowed LB compared to relatively natural RB, note also the rock armouring of the LB; mid panel – fantastic laying of willow; lower panel looking d/s at scalloping of LB caused by boulder placements, and note erosion of mowed bank top.**

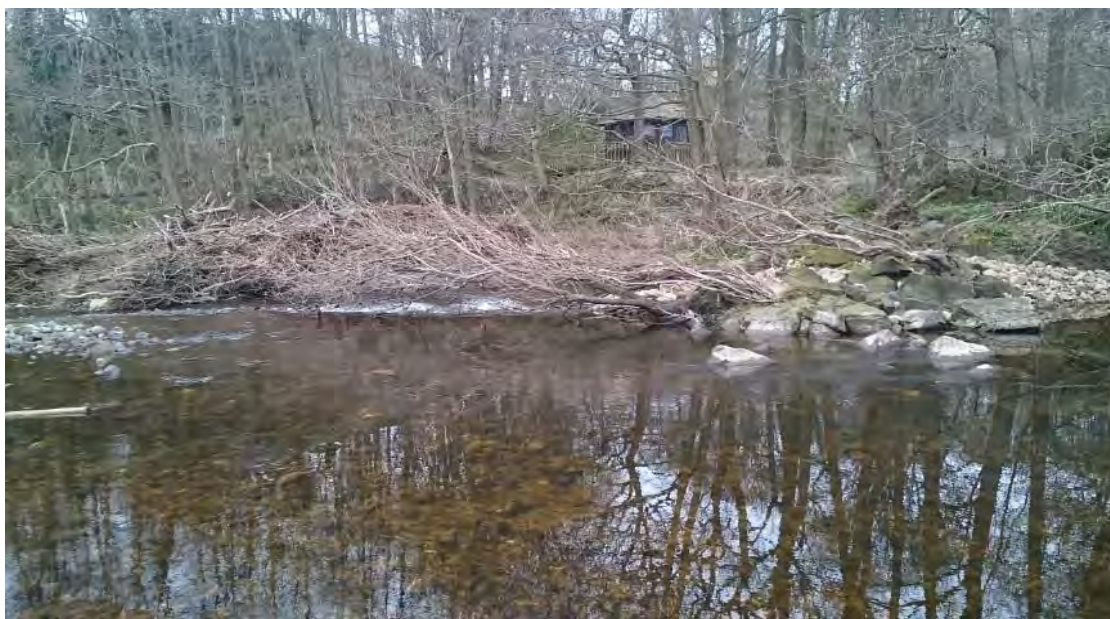
**Fig 27. Natural river form resumes as the river hits a natural barrier (hill) on the RB, and low lying scrub and debris provide fantastic cover and feeding opportunities for trout.**

One of the most natural and diverse areas of habitat was encapsulated in Figure 27 where the river was unconstrained by armoured and the vegetation was also fairly natural and unmanaged (unkempt). While perhaps slightly more challenging for anglers, this pool and riffle had considerably greater holding capacity than many other sections seen. While it was noted that riparian owner on the RB may have less than desirable designs for the riverbank immediately u/s, it is this sort of mosaic of habitat that will most benefit wild populations and could easily be aspired to elsewhere through sensitive management. A patchy, light-touch approach to hinging and tree-kicker use can provide a win:win situation: useful cover and structure for the fish, a diverse canopy that benefits the river corridor biodiversity, and creates enticing gaps into which a cast can be made!

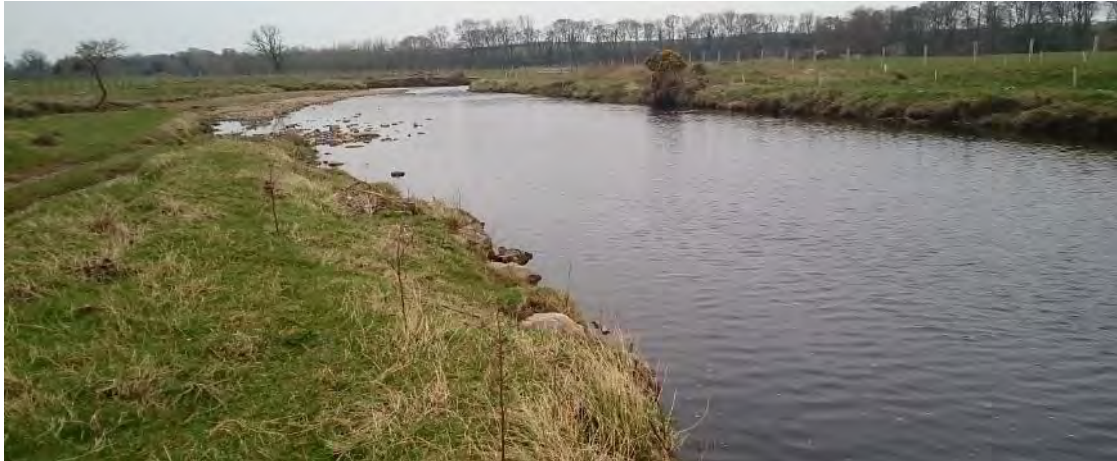
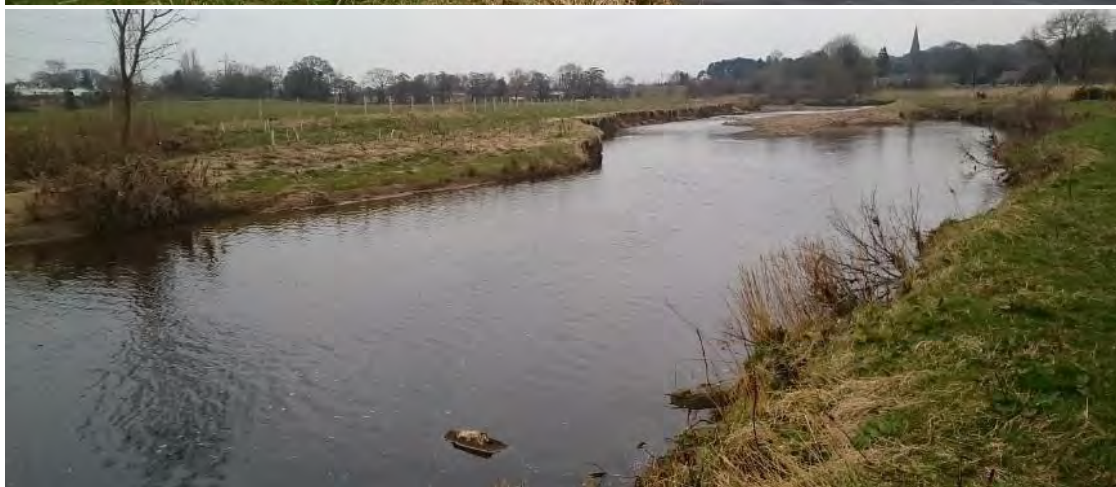
**Fig 28. Barren banks with little overhanging riparian vegetation and hence little holding habitat, especially as the channel is overly wide and uniform in depth and substrate here.**

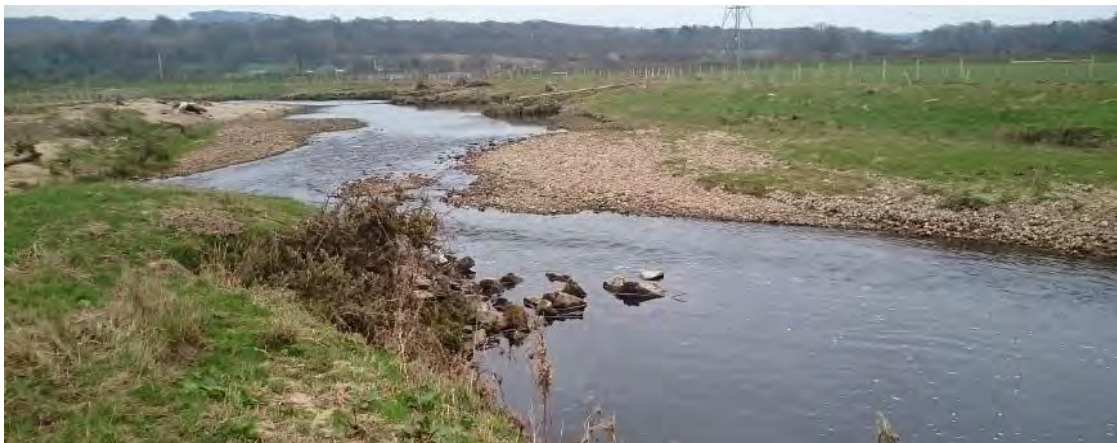
**Fig 29. Looking u/s at channel variability instigated by artificial groynes to divert flow. Note tree planting on LB but lack of cover at the water edge.**

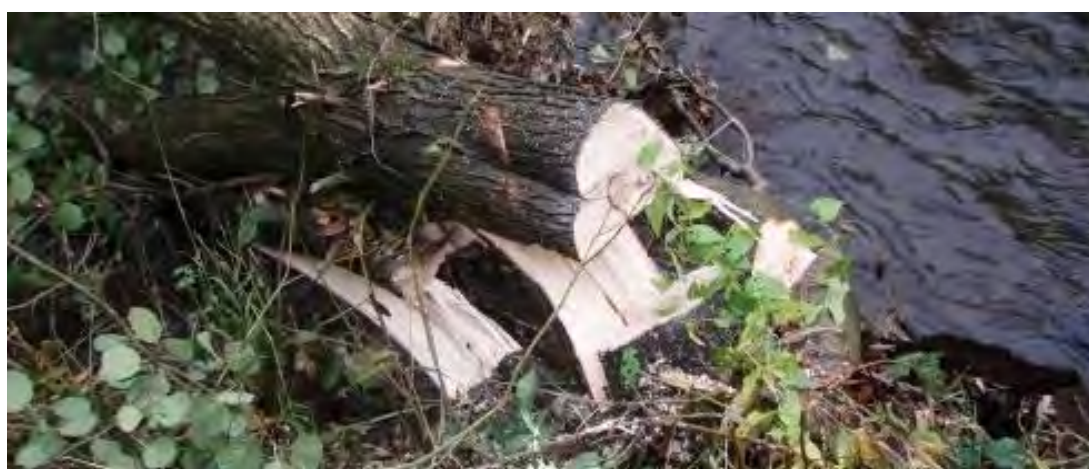
**Fig 23. An example of hinged willow.**

Where trees are already established along the bank, habitat improvements can be achieved by laying trunks, or selected branches down into the watercourse to increase low cover and in-channel structure. This has occurred naturally at various points but living wood and woody debris appears **to have been removed or 'tidied'**. The laying method is usually limited to pliant species e.g. willow, elm, hazel, hawthorn and small alder, but some others can be laid carefully. The process involves cutting part way through the stem/trunk, a little at a time (like laying a hedge), until it can be forced over (Fig 31). The depth of the cut should be limited to only that which is required to bend the limb over, to retain maximum strength in the hinge. Note, the aim would be to lay the trunks parallel to the bank and maintain a healthy hinge, i.e. the trunks are living and well attached, so as not to increase perceived flood risk.
