Itchen - Yavington

An advisory visit carried out by the Wild Trout Trust – May 2013

1. Introduction

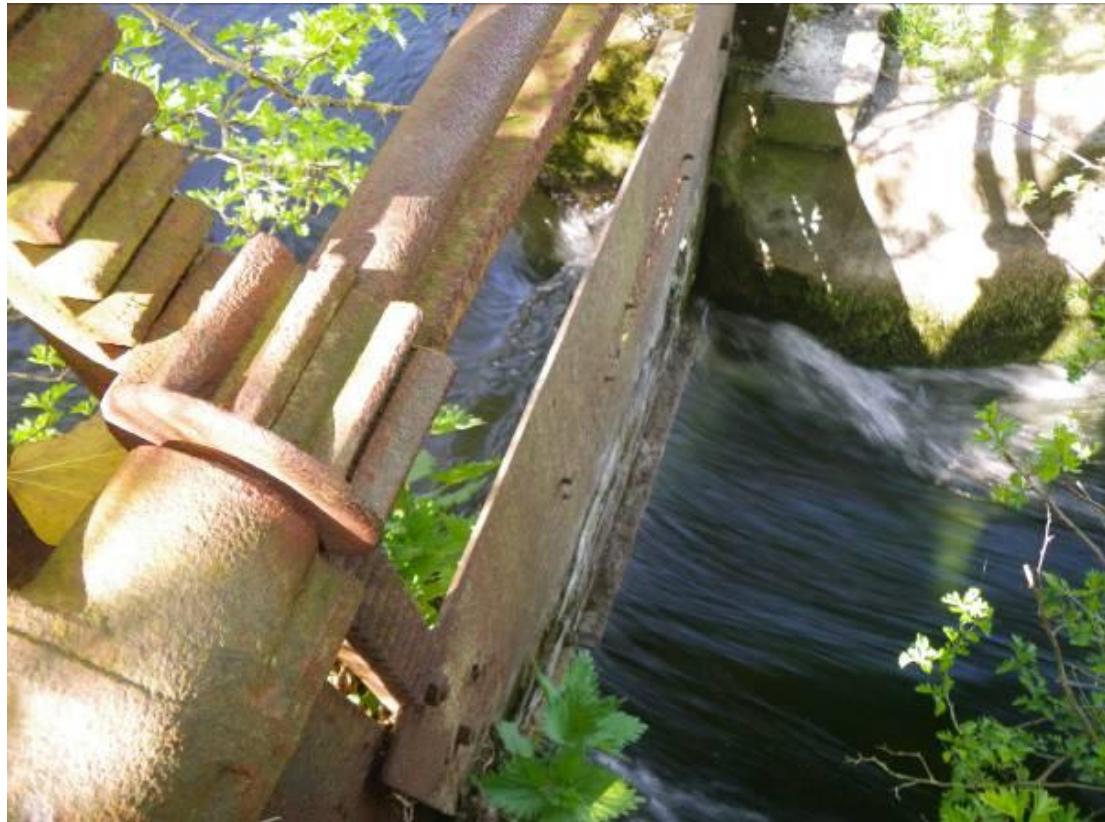
At present all of the structures are non-operable. As such, the split of flows between the main channel and the Elm Stream has been stable for several years. Flows and associated habitat have, consequently, responded to the annual and seasonal patterns in rainfall and river discharge, rather than the action of an individual river keeper or land owner.

Photo 1. Single undershot hatch at the head of the Elm Stream. A barrier to fish migration.

Currently the main hatches would not appear to represent a major impediment to the upstream migration of large salmonids. The structure may, however, limit small trout migration, as well as posing a significant barrier to eel migration. The side hatch on the Elm Carrier is even more problematic, due to the high velocities of water passing under the gate. Improving fish migration both up and downstream through these structures could provide significant benefit for both fisheries as well as the upper Itchen as a whole.

If removing any of these hatch gates were to be contemplated then a corresponding removal of the gate which regulates flow into the Elm Carrier would also be required. It is believed that there are licensed abstractions taking water directly from the Elm Carrier further down, which brings certain rights for an undiminished supply of water via this route for the licence holders.

An early discussion with the upstream interests is therefore recommended so that some joint objectives can be identified and hopefully some beneficial action taken. A possible option to discuss could be asking the EA to measure the current flow split with a view to completely removing the hatch gate at the head of the Elm Stream and then fine tuning the gates on the main channel until the current flow split ratio is met. This action could substantially improve wild trout recruitment in the section immediately upstream of the Yavington beat, potentially providing increased numbers of wild trout for both the main fishery below and the Elm Stream. A consultation with Natural England and the EA is essential.

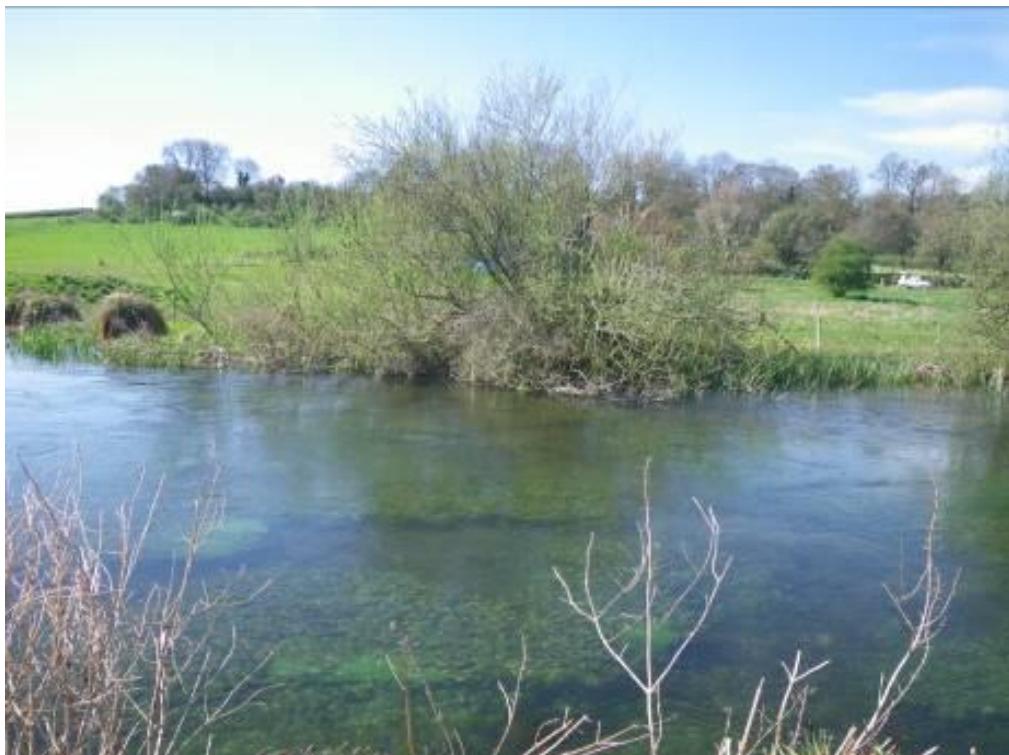
The main channel supports some excellent quality habitat for trout. The channel is not impounded and has a varied planform and bed topography, providing habitat opportunities for all trout life stages. The maintenance regime appears to be sympathetic to the environment and there were good examples (photo 2) of marginal sallows (*Salix caprea*) being allowed to trail into the river, providing valuable cover for fish from predators. A healthy wide fringe has been left over the winter to also provide cover in the crucially important shallow marginal zones.

[Photo 2. A good example of a well managed section of channel at Yavington](#)

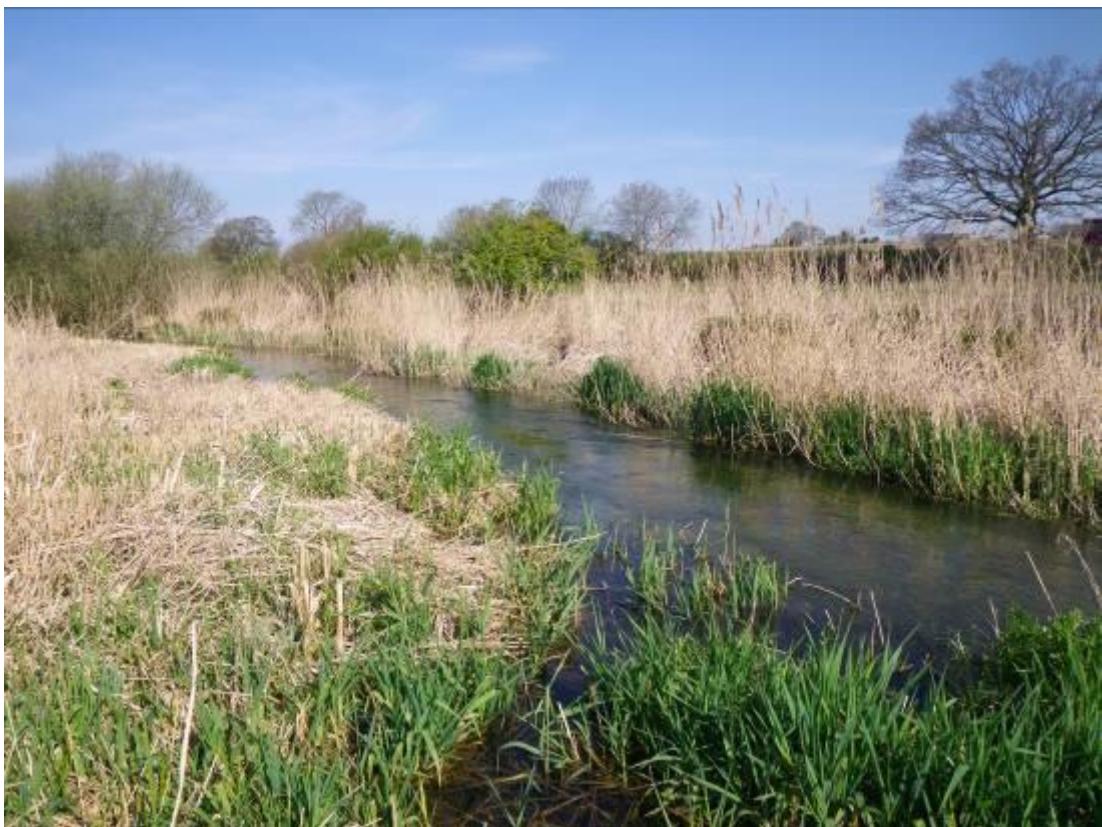
Chalk stream carrier channels such as the Elm Carrier will change shape in response to prevailing flow conditions. Although some emergent reeds and grasses will grow in the middle of the channel, they are better adapted to the slower flowing channel margins. When flow velocities increase they are usually out-competed by flow loving plants such as water crowfoot, water milfoil (*Myriophyllum* sp.) and water parsnip (*Berula* sp.). When flow drops away below the long-term average for a year, or possibly two, then the emergent reed fringe will encroach out into the channel. The amount of flow entering the Elm Carrier will therefore have a big impact on how wide the wetted channel will be.

Photo 4. Typical section of the Elm Stream where reeds will encroach into the channel if the flows drop away.

One option for restricting reed encroachment is to introduce more shading from bankside trees particularly over deeper sections. Planting the occasional low scrubby tree such as the previously mentioned sallow, or hawthorn (*Crataegus oxyacantha*), will provide wonderful winter cover for fish and help to restrict the encroachment of reeds.

Further control of reed encroachment on the Elm Stream could be achieved via the introduction of some marginal shade. Planting the occasional clump of thorn

or sallow will create diversity in the bank-side habitat and introduce valuable summer shade and winter cover.
