Advisory Visit - 26 February 2003

A report on behalf of Wild Trout Trust

River Chess

Micklefield Estate, Near Sarratt, Rickmansworth, Herts.

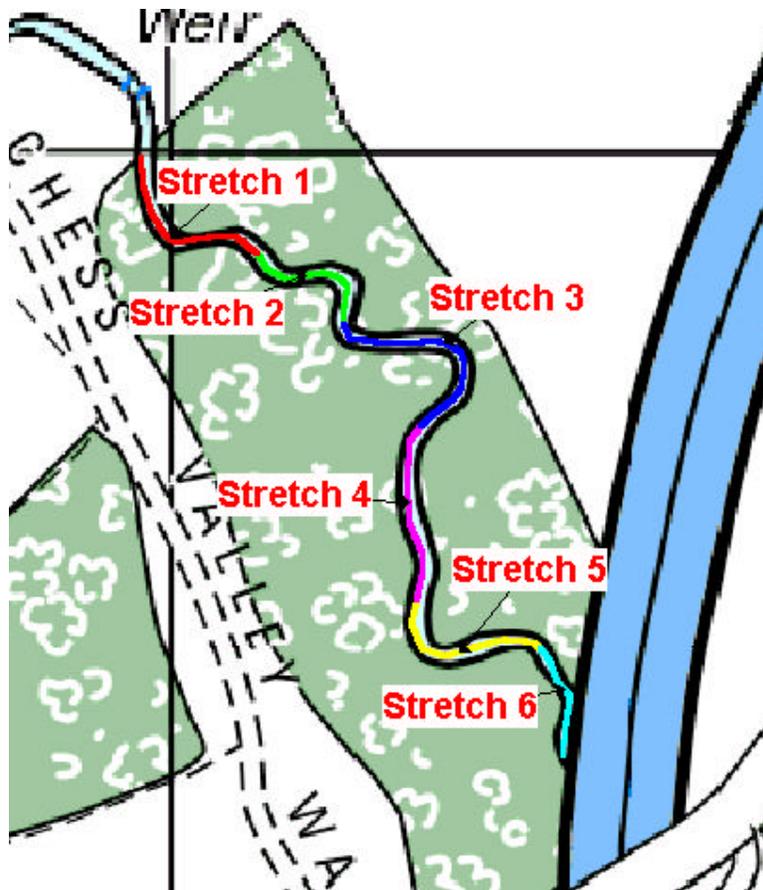
At the top 30m of the river there is a strong flowing riffle, with hard gravels and patchy weed. If permission could be sought to coppice any one of the larger alders, then this would be beneficial.

The top photograph shows the riffle at the head of this stretch.
