WILD TROUT TRUST

Loch Ard tributaries

Aberfoyle Angling Protection Association

15/05/2023

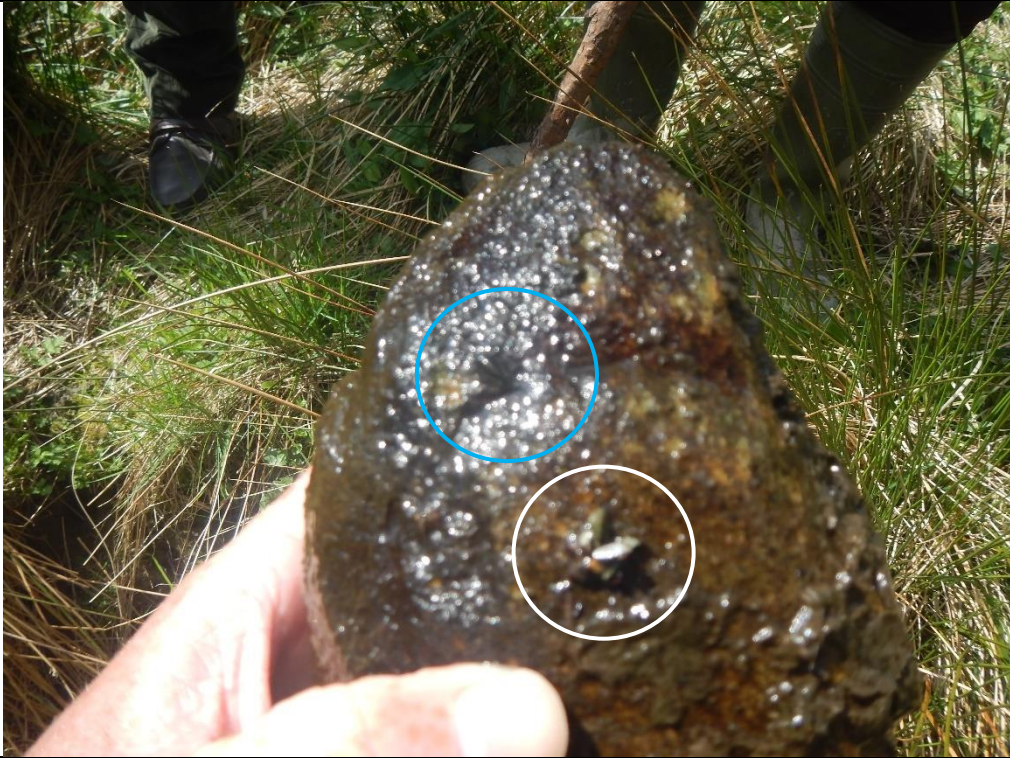
Figure 11. Slightly out of focus shot of cased caddisfly larvae (white circle) and a flat-bodied mayfly (blue circle).

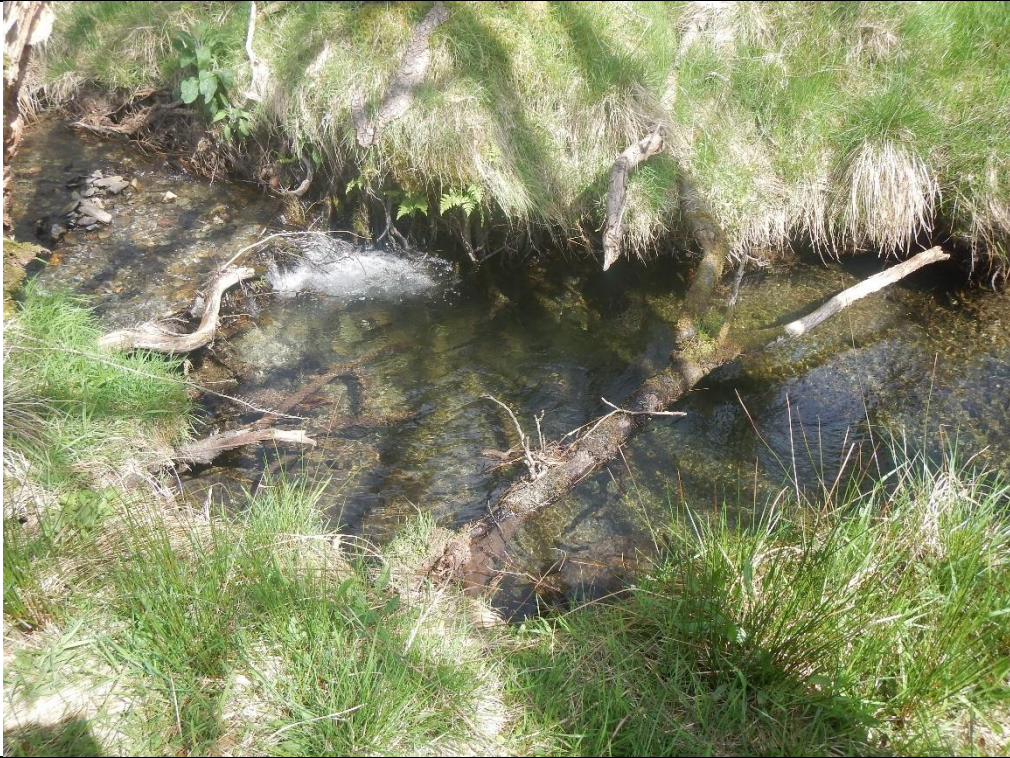
In wider areas, downstream of bends or natural features in the channel (woody material or tree roots) and as the channel gradient gradually reduced, gravel retention increased, improving the spawning potential of the burn (*Figure 12*). Natural woody material accumulations help to shape the channel, kick-starting geomorphological processes and drive bed scour to create pool features with valuable fish-holding structure (*Figure 13*). The structure that woody material provides within a watercourse is often overlooked but it can greatly reduce the ability of predators to exploit fish populations, in addition to diversifying in-channel habitat.

Figure 13. A rare example of natural woody material on the burn, creating a nice deeper scour pool and retaining gravel.

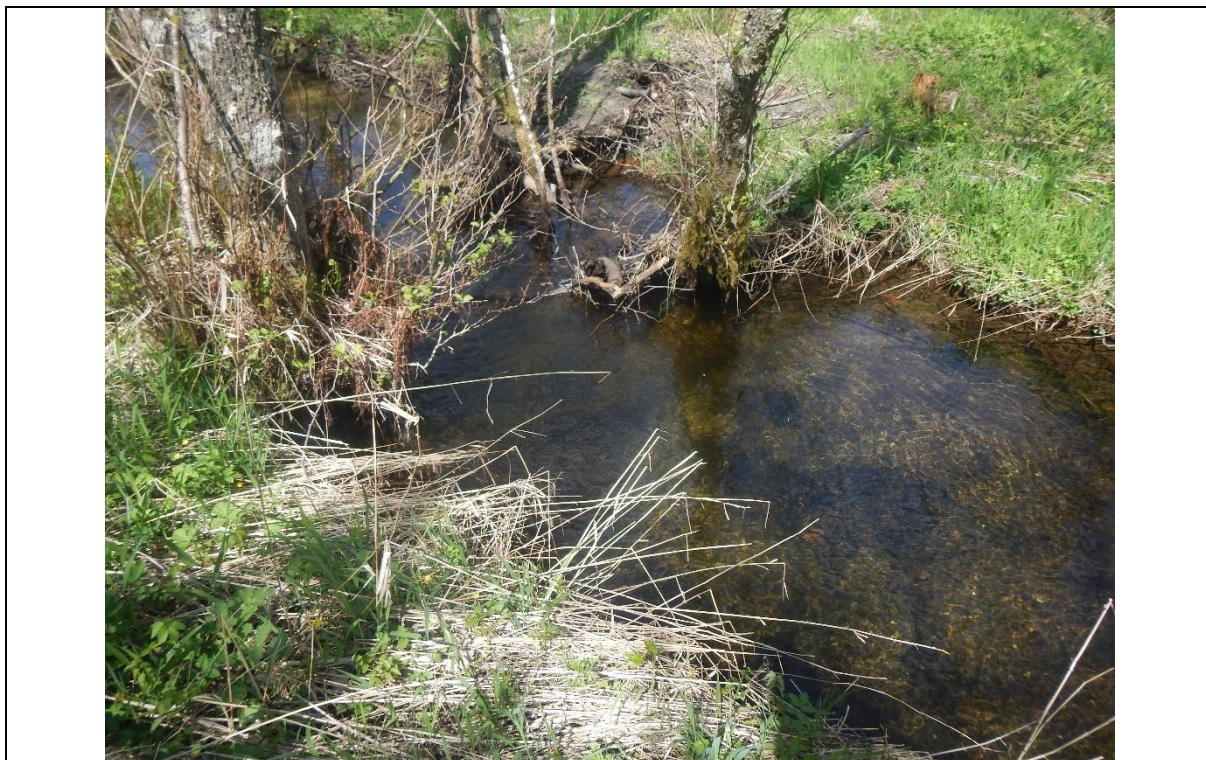
Figure 18. A pinch point between two trees focussing flow into the centre of the channel and driving bed scour to maintain a pool - with several fish observed to be in residence.

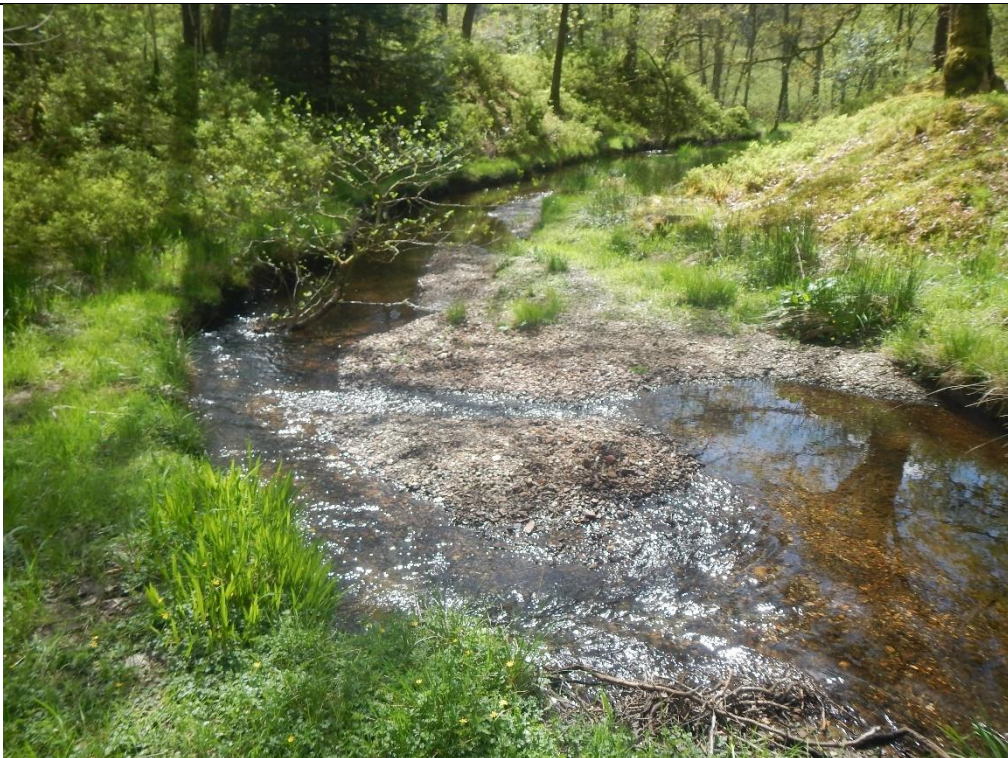
The lower gradient, more sinuous nature of the channel downstream of the road already provided improved habitat, with deeper pools and discrete gravel bars creating good invertebrate and salmonid spawning habitat (*Figure 20*). The availability of woody material and overhanging/trailing structure increased with progression downstream, but could still be beneficially increased in several places (*Figure 21* & *Figure 22*).

Figure 20. Within the naturally wider, more sinuous and lower gradient channel d/s of the road, valuable pools and riffles created a range of high-quality habitat. Note the finer gravel that was retained, offering spawning potential for a range of trout sizes.

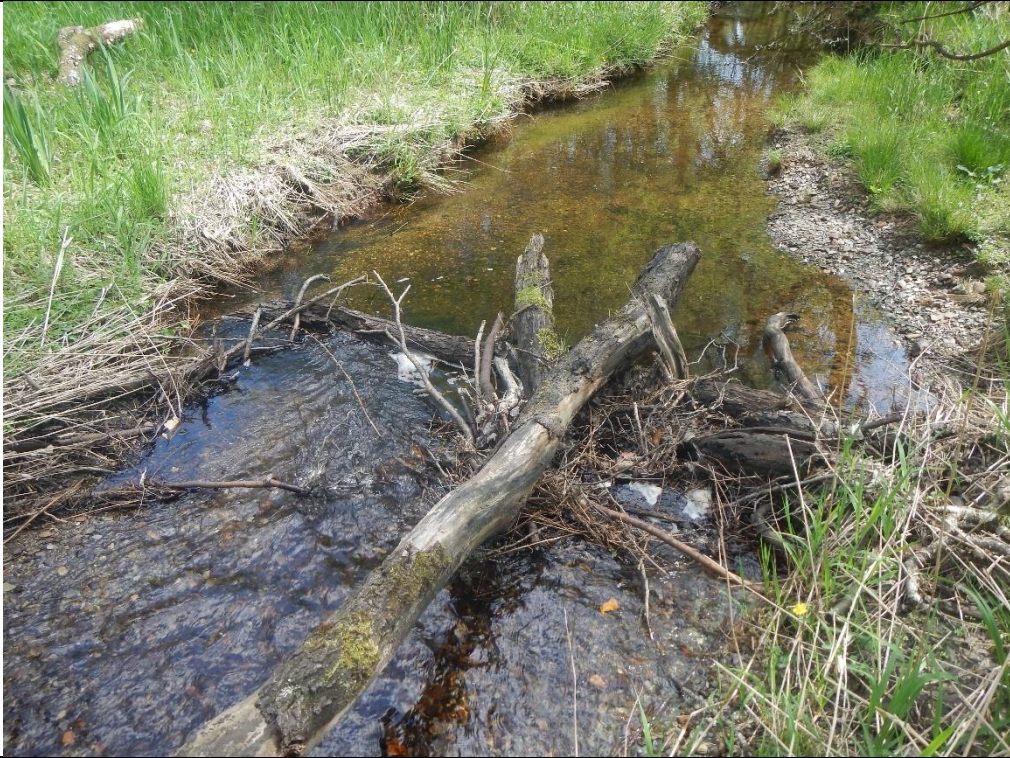
In the very lower reaches, the abundance of woody material is ideal, with great cover structure, scoured pools and dappled shade for fish (*Figure 23*), as the burn meanders among bankside willow trees (*Figure 24*). Access upstream out of the loch was unimpeded and should naturally maintain itself with the naturally floodplain-connected, un-incised channel.

Figure 23. Natural woody material accumulation driving bed scour and pool creation. This could be replicated with habitat structures.

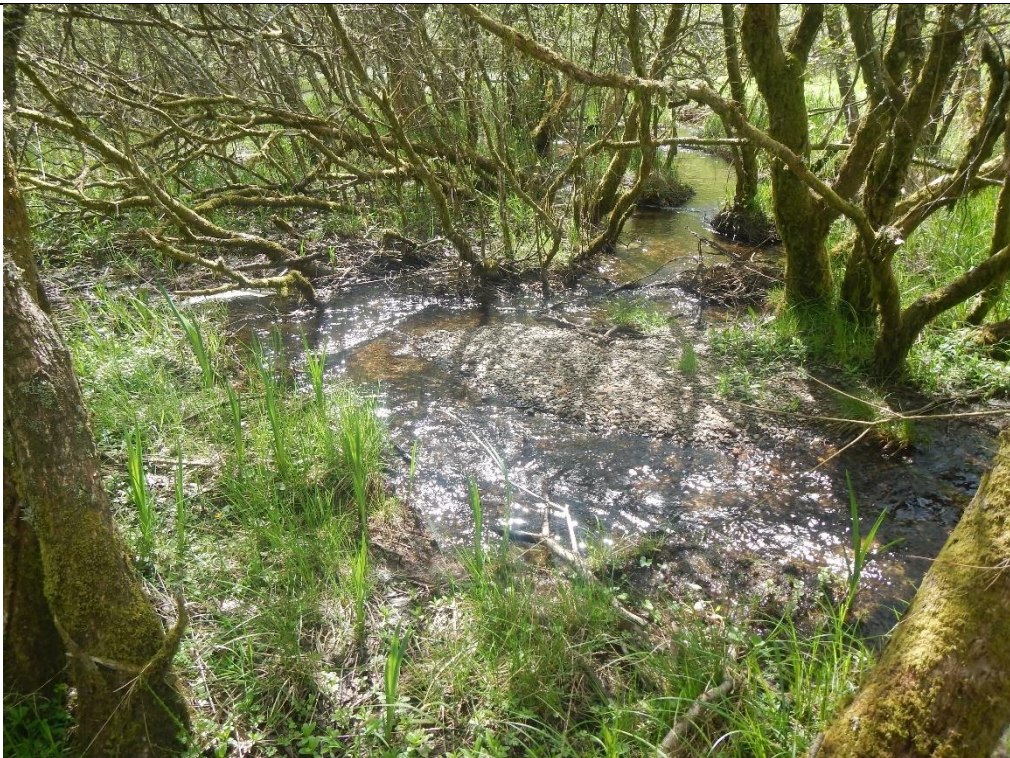
Figure 24. A healthy balance of light and shade over a naturally meandering channel, between bankside willows.

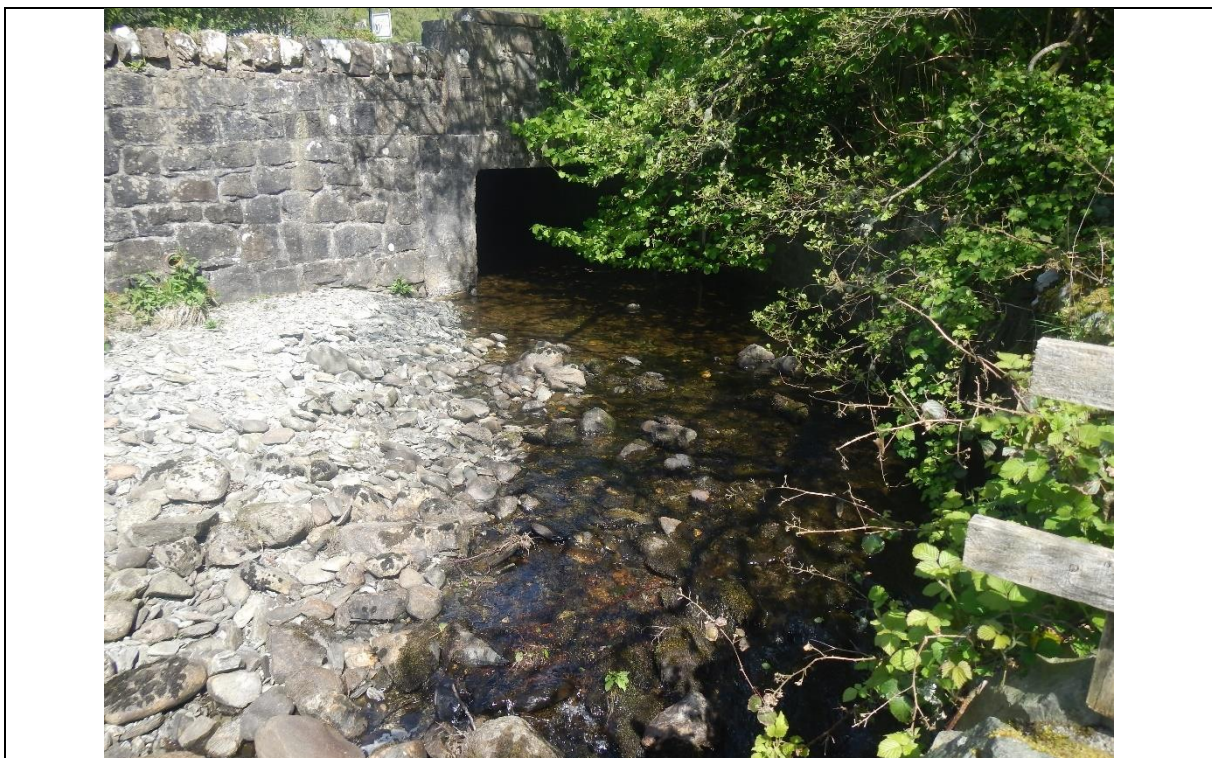
Figure 25. What appeared to be free passage beneath the road bridge.

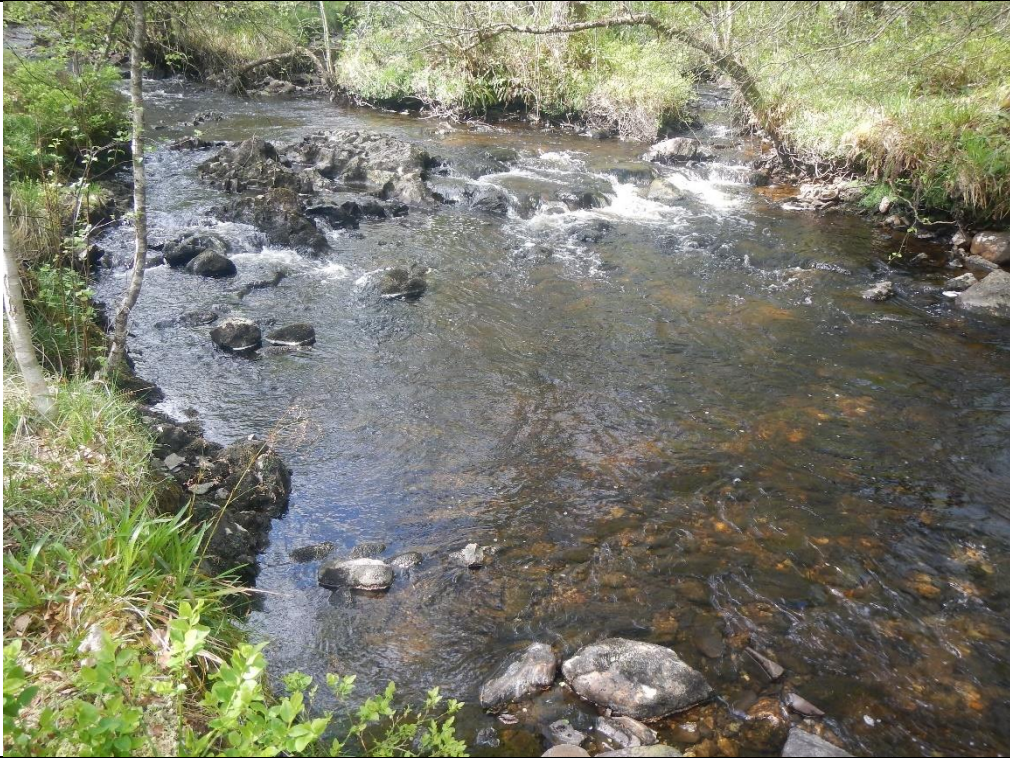
Figure 29. Naturally coarse bed and diverse flow created good juvenile salmonid habitat.

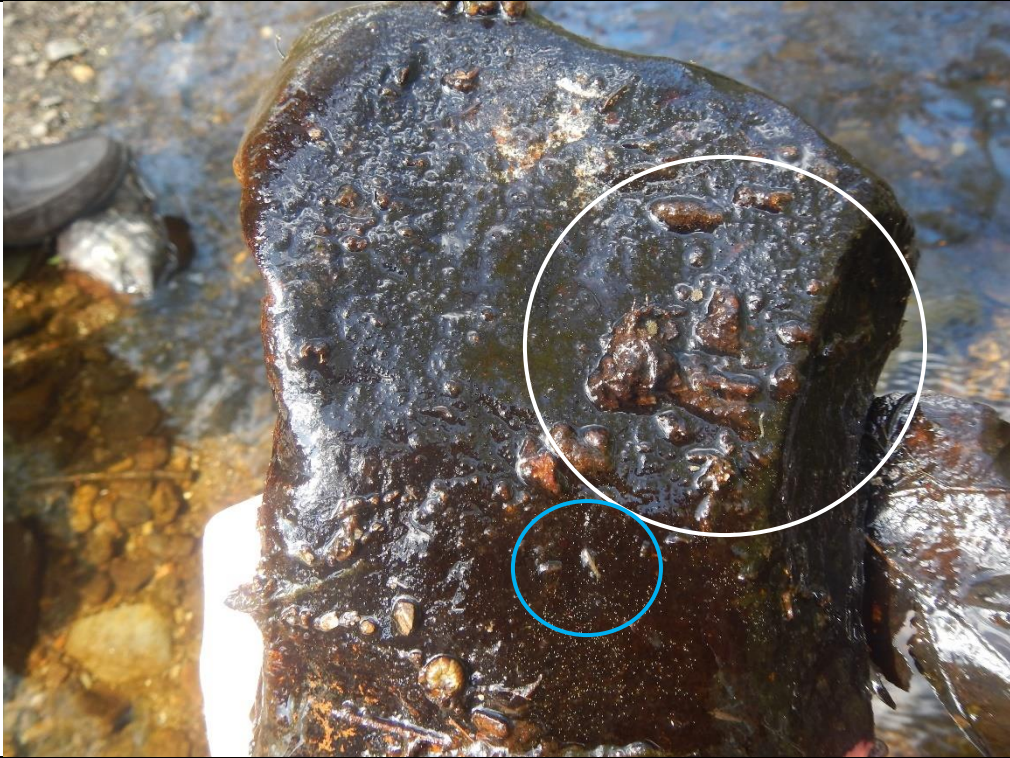
Stone turning revealed a similar diversity of invertebrates as on the other tributaries, with most that would be expected, including mayflies, stoneflies and caddisflies (*Figure 31*). While such inspection is only basic, it does provide an indication that the water quality is adequate to support those species, and considering their relative abundance, it is likely that this is the case over the medium-long term. It is difficult to guess what it was like further upstream, but the cover, light and shade regime is pretty much ideal in the section inspected (*Figure 32*).

Figure 31. Various cased caddisfly larvae (white circle) and a stonefly nymph (blue circle).

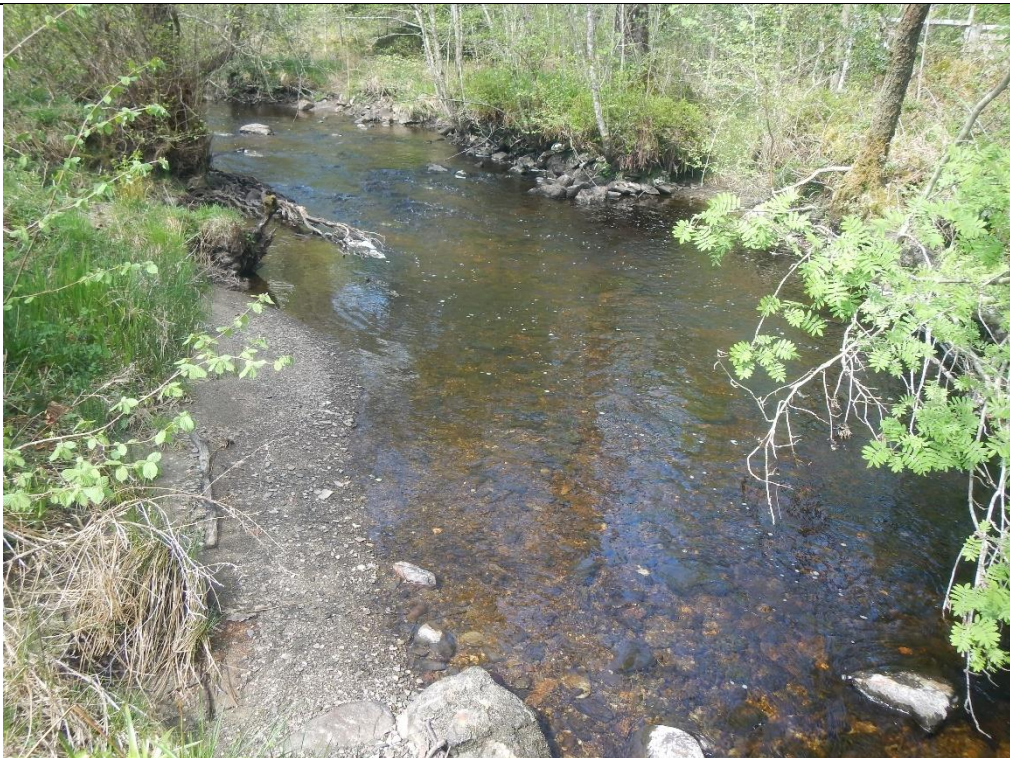
Figure 32. Trailing tree roots, low overhanging cover, diverse flow and a good balance of light and shade from the main tree canopies. Great quality juvenile salmonid habitat.
