Advisory Visit  
Little Ouse River, Thetford  
June 2018

Undertaken by Rob Mungovan

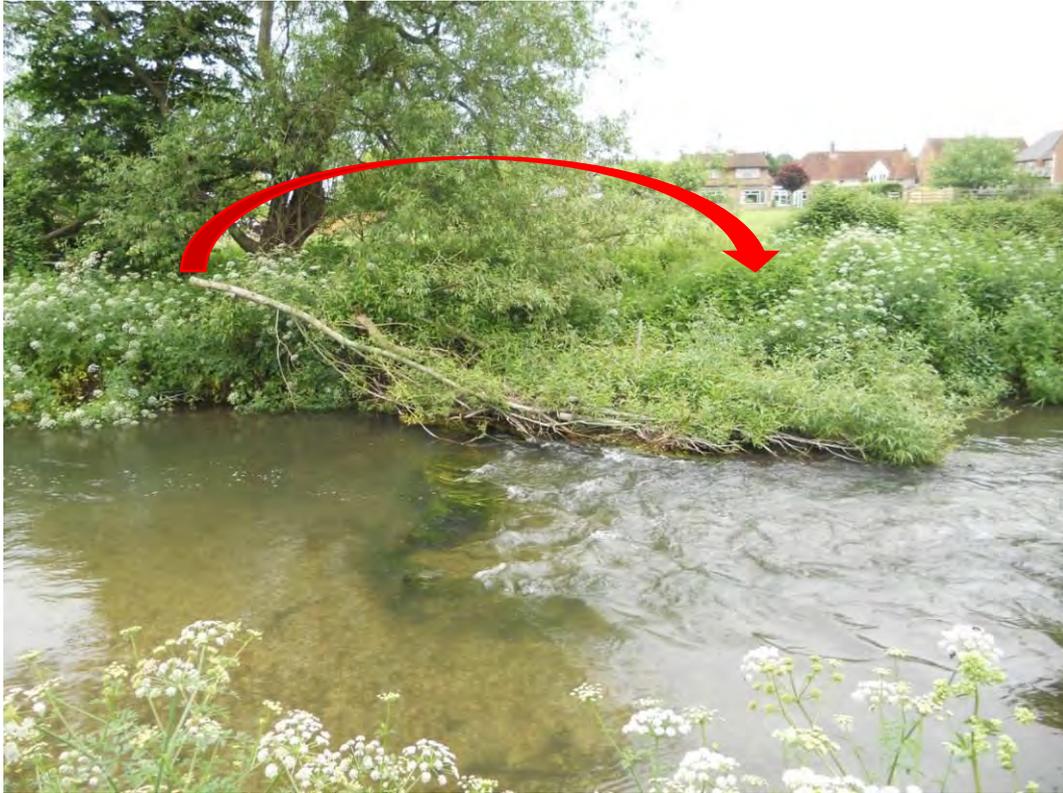
Pic 4 – An example of tree hinging, a simple and effective technique for increasing cover in a river.

The removal and killing of trees has left the bank prone to erosion. Fallen trees within a river can be managed to retain their habitat value by winching them to a secure bankside position and securing them with stakes and/or cable rope. Where riparian trees require thinning and their habitat potential as fallen LWM would otherwise be removed, a technique known as tree-hinging can be used. Tree-hinging is similar to hedge laying in that it retains a living hinge that secures the cut stem to the tree stump. The hinge continues to allow the tree to live so structural strength is retained. For additional security, the tree can be secured using cable rope. Laying the tree canopy down to water level (or below) provides excellent over-head cover, flow deflection and a spawning substrate for coarse fish species. These two approaches would be suitable for many of the trees within Thetford town where trees may otherwise be removed on safety grounds (pic 15).

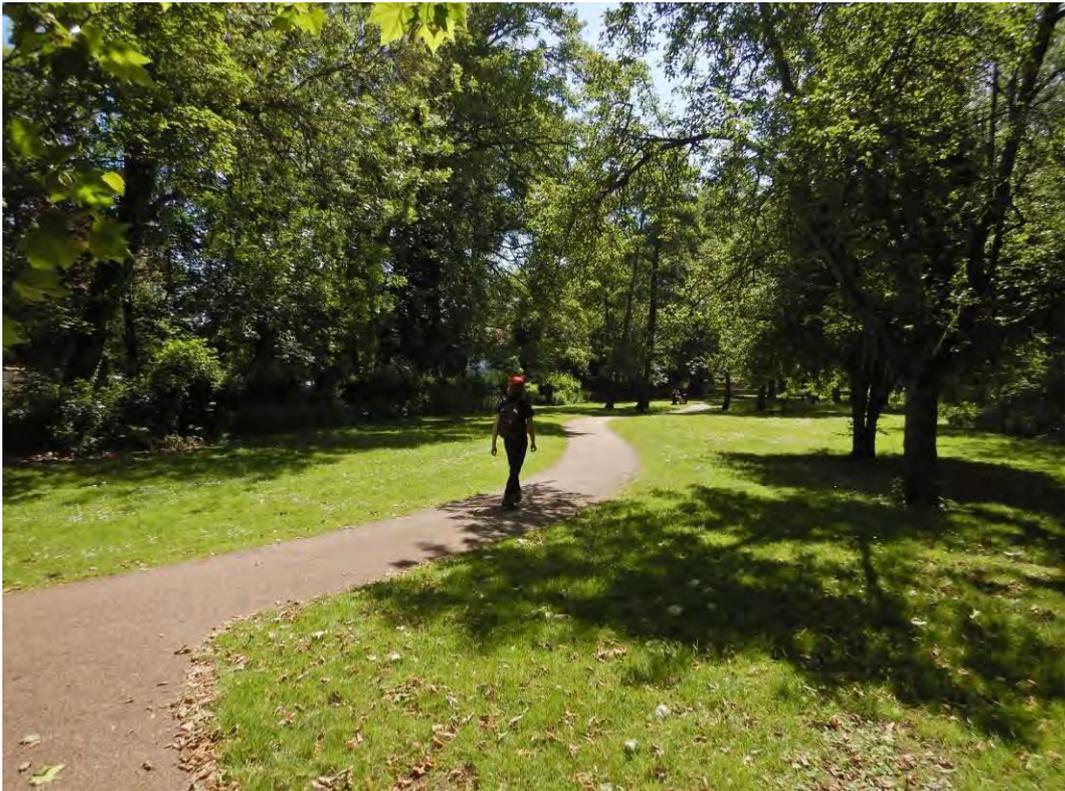
Pic 7 – A typical view of one of Thetford’s urban parks, the Island.

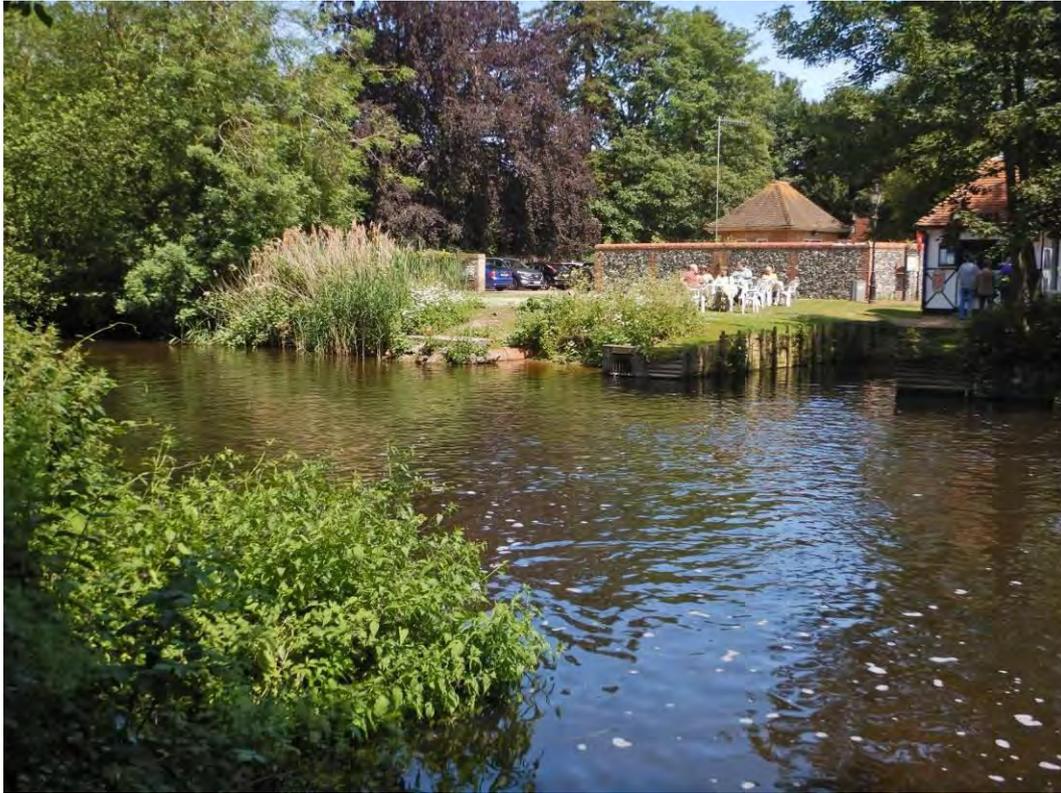
Downstream of the Coffee Mill the river forms an important amenity feature through the town. There is a riverside café which was well attended on the day of the visit. In front of the café there is a dense stand of tall common reed (pic 10) that could provide nesting opportunities for birds such as sedge warblers. In contrast to the reed fringe there is a hard wooden revetment forming a boat dock with accordingly poor marginal habitat, but the inlet of the dock provides a backwater habitat and was being used by fish fry as a refuge from the main river flow. The stand of bittersweet in the foreground has grown over a retained stump and demonstrates how retained LWM can act as support for plants which in turn provide excellent cover at water level.

Pic 10 – The river bank in front of the café provides an interesting set of contrasting habitats.

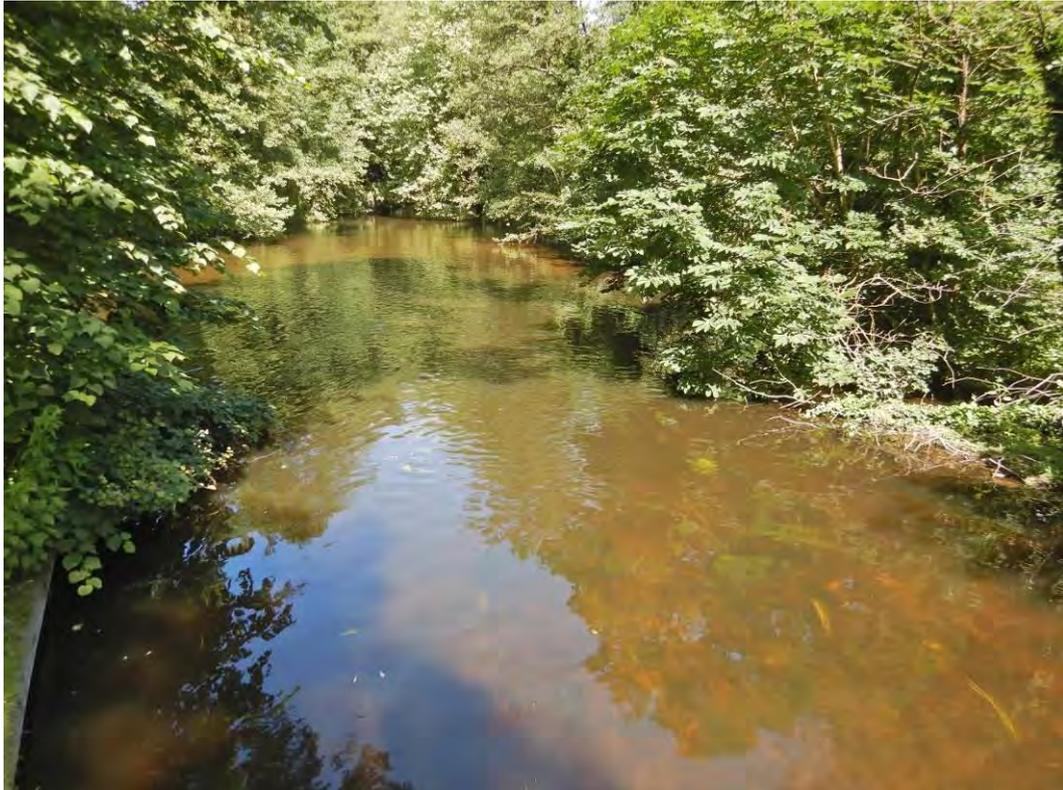
Pic 12 - The view looking downstream from the 1<sup>st</sup> bridge after the Coffee Mill. A shoal (10+) of large dace were seen. Note the relatively clean bed and its clean stony substrate which will harbour many invertebrates.

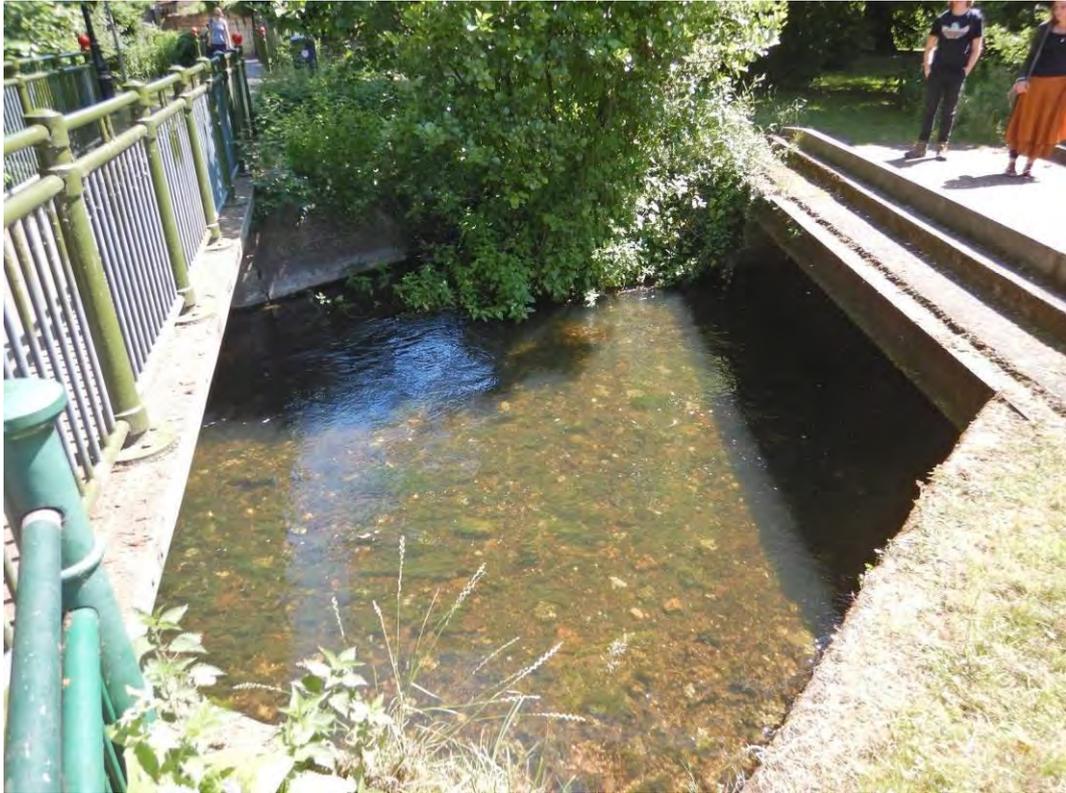
Pic 13 – The view looking off the 2<sup>nd</sup> bridge after the Coffee Mill. Note the shallow depth and stony bed, potentially good trout parr habitat. The trailing vegetation provides marginal cover in addition to that provided by the bridges. The habitat could be further enhanced.

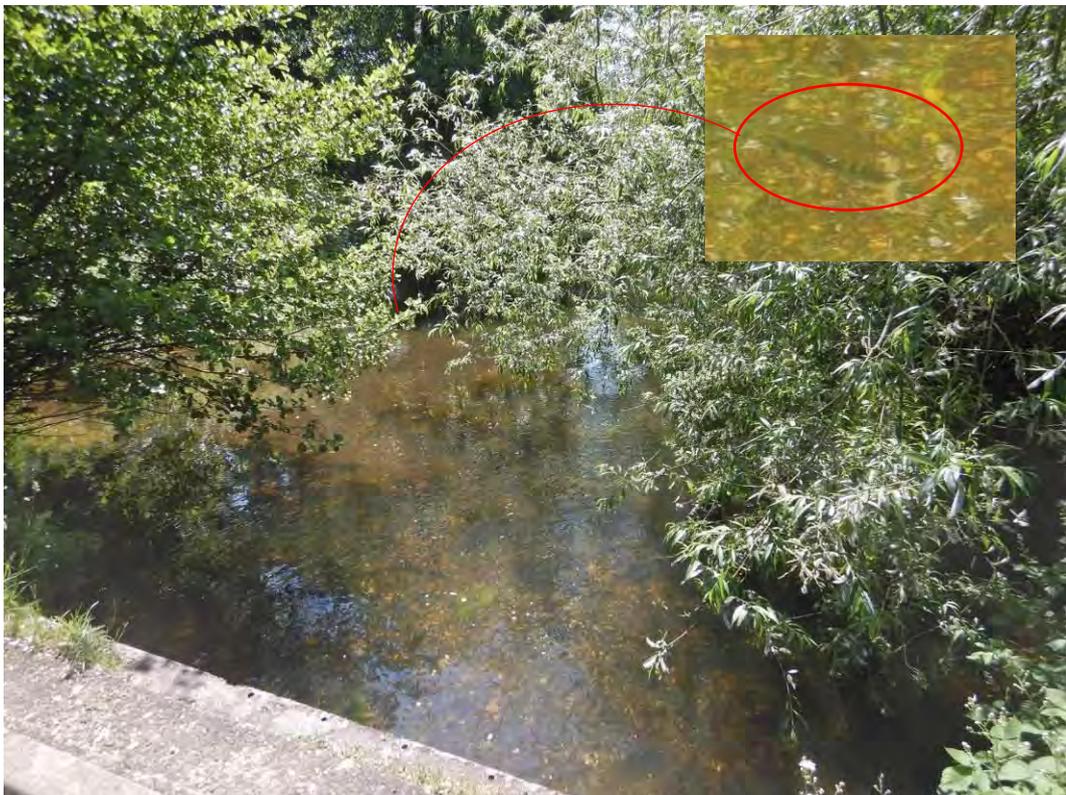
Pic 14 - Good cover for fish and birds is provided by extensive willow branches trailing to the water. A brown trout was observed at this location (inset).

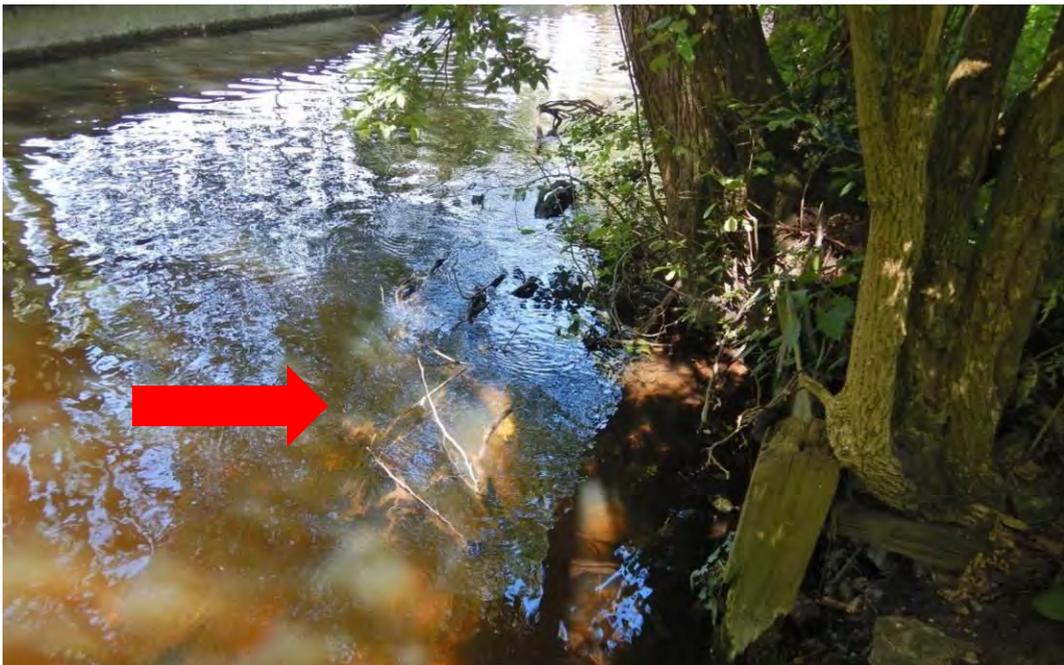
The tree-lined reaches provide further habitat through underwater root systems, particularly from the alder trees. Underwater roots provide excellent cover for both adult and juvenile fish, as well as an extensive surface area for invertebrates to colonise. Tree roots should always be retained.

Pic 17 - Alder tree roots (red arrow) provide excellent underwater habitat in stark contrast to the hard revetment opposite.

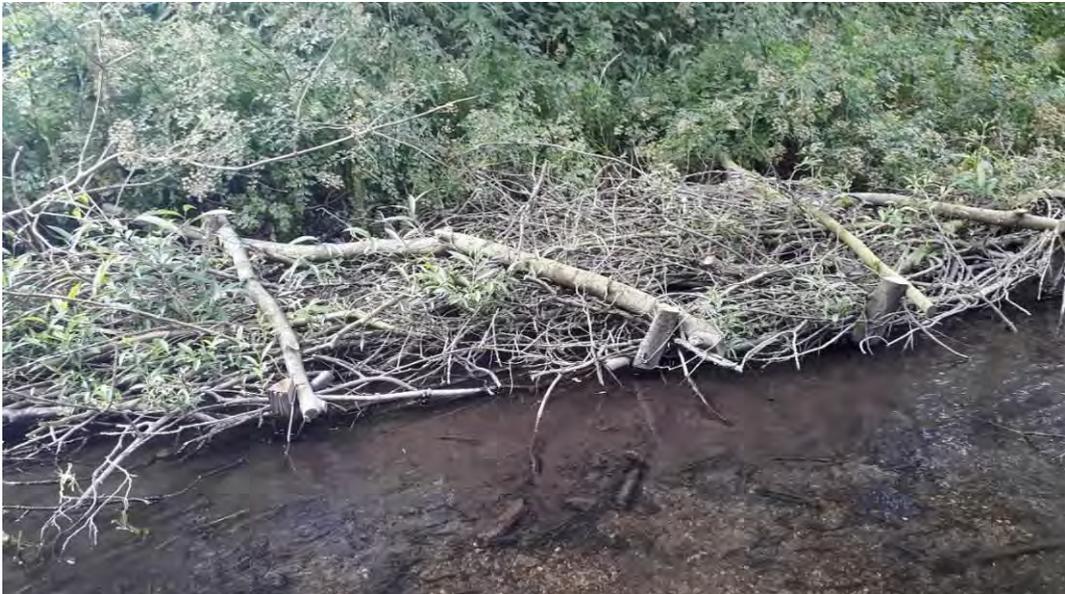
Pic 18 – An example of a low level brushwood mattresses created on the River Misbourne following tree thinning work. Brushwood mattresses can be used to protect banks from erosion, to create in-channel sinuosity and to entrain silt and sand.

Extensive fine sediment is being deposited in the slack water around the confluence of the two side-channels. The use of LWM in the form of brushwood mattresses could help to speed up this deposition and help to consolidate it. Stable silt bars then provide an opportunity for colonisation by vegetation and provide further marginal habitat for invertebrates.

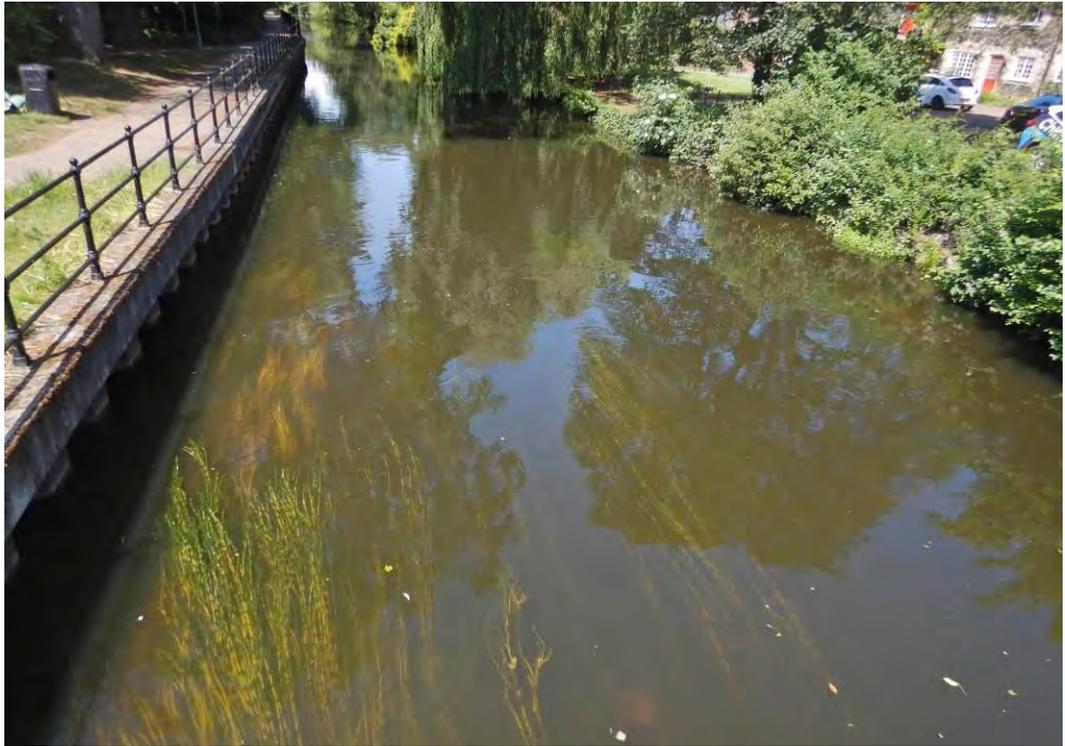
Pic 21 – Approx. 25m downstream of pic 20 the RB of the river is lined with trailing vegetation at water level which provides some off-set to the stark environment of concrete and sheet steel piling provided to the LB.

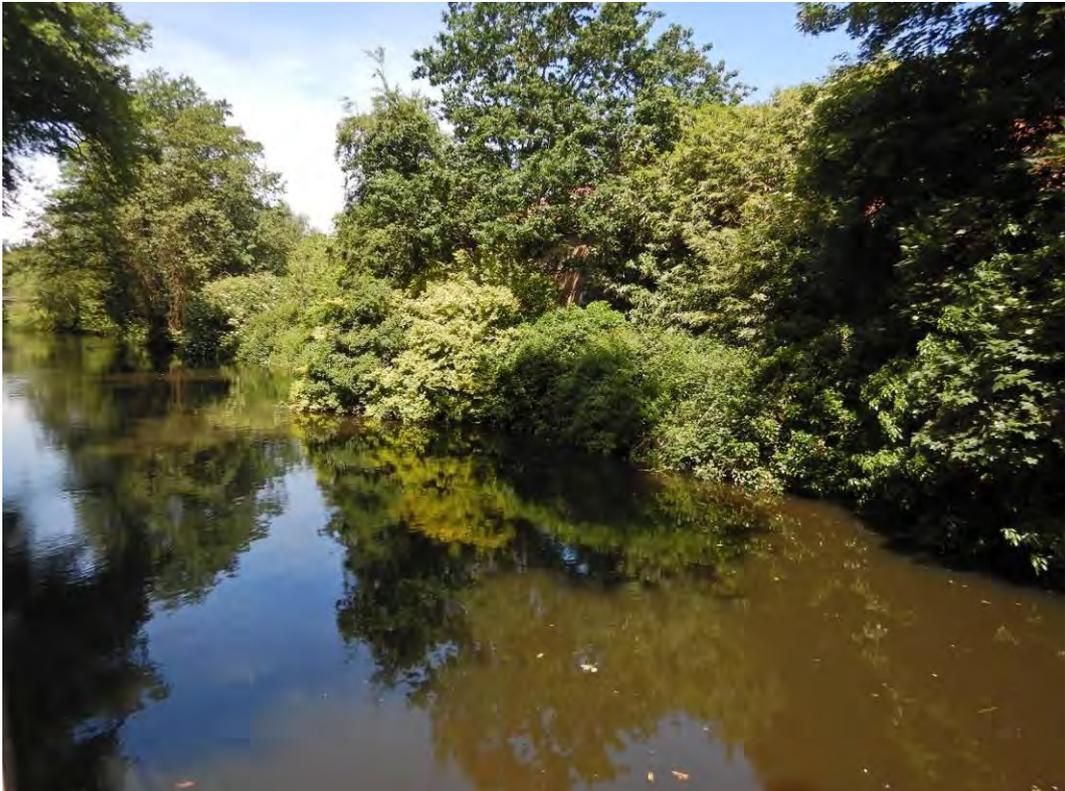
Pic 22 – Riverside trees have been allowed to trail down to water level providing important cover. Trailing vegetation should be retained as far as possible where it does not conflict with navigation.

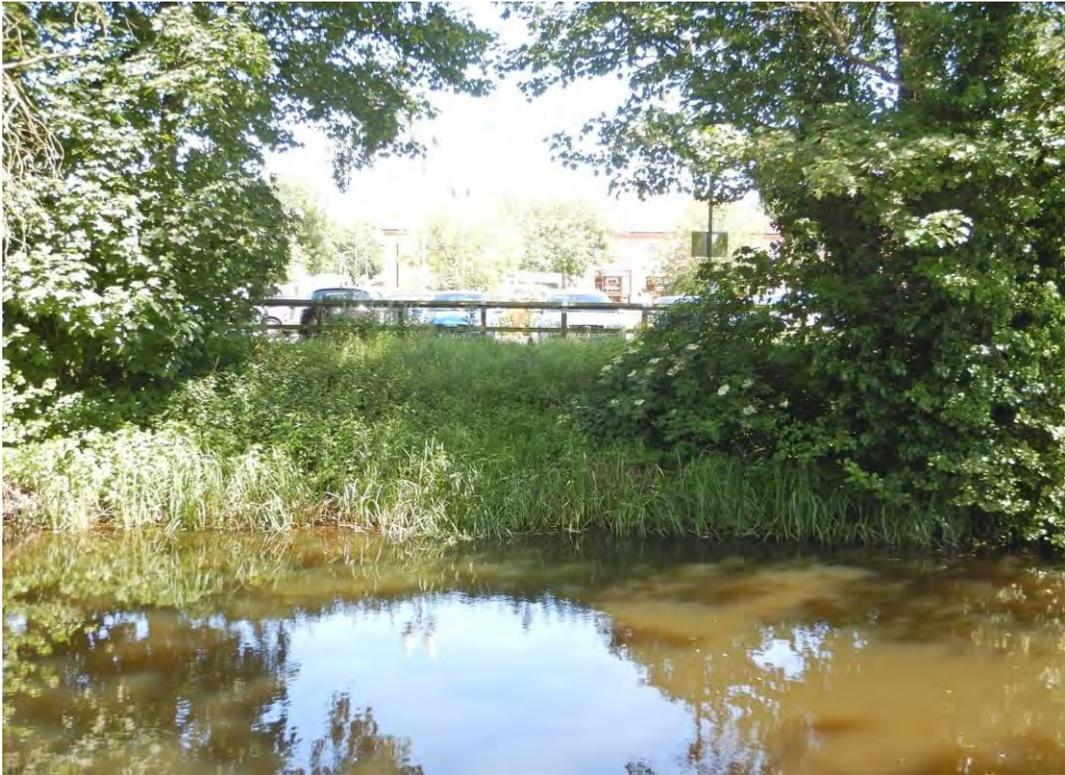
Pic 23 – Where the sunlight reaches the banks marginal vegetation has become established. In this case, lesser pond sedge is providing a contrasting habitat to that of trailing branches.

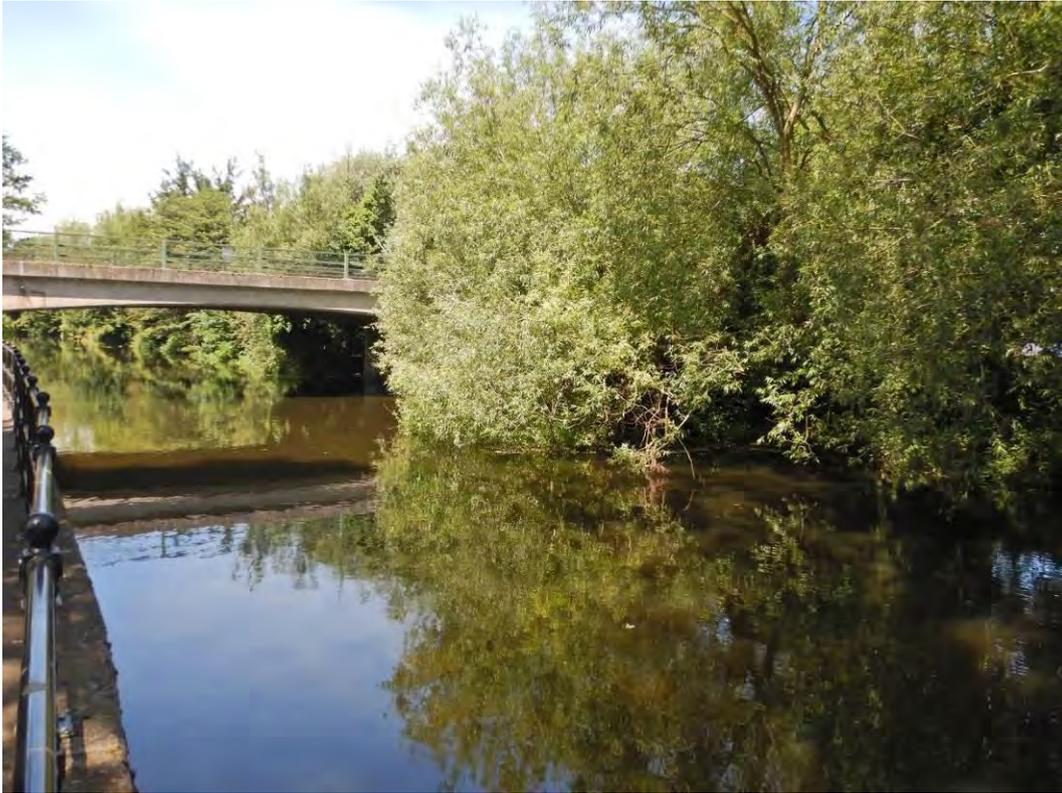
Pic 24 – The view to the London Road bridge showing extensive trailing branches providing good cover for both fish and birds.

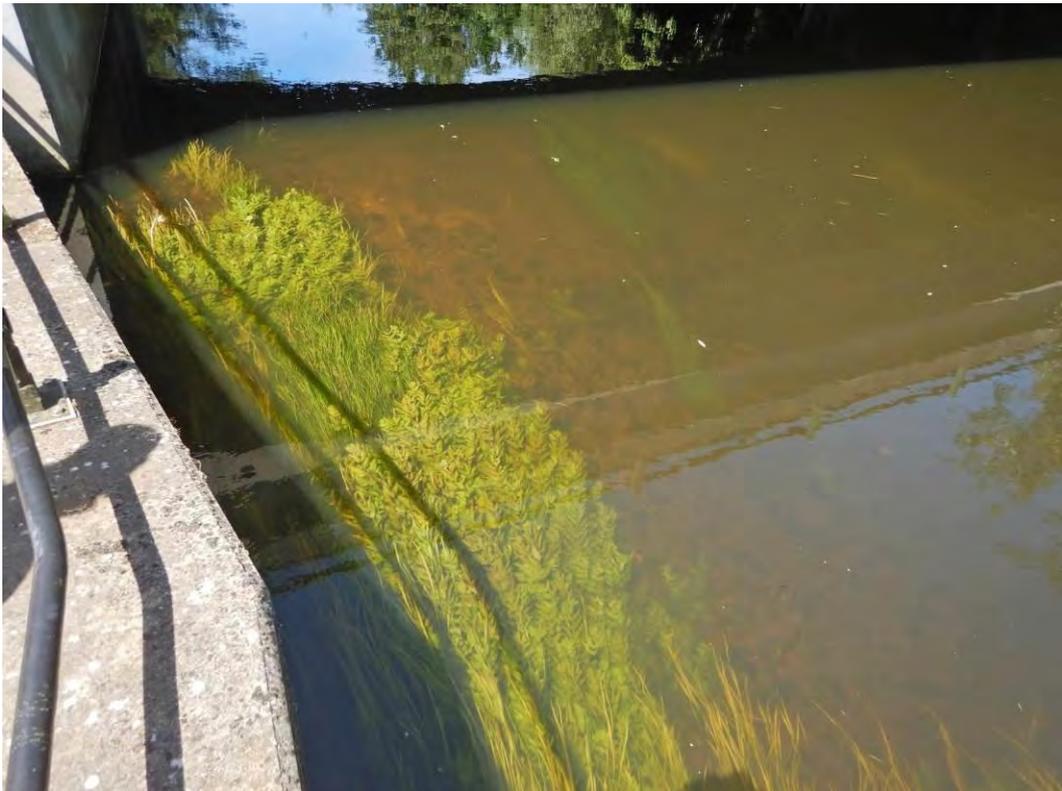
Pic 25 – There is an attractive diversity of aquatic plants including unbranched bur reed, lesser water parsnip, and water crowfoot.

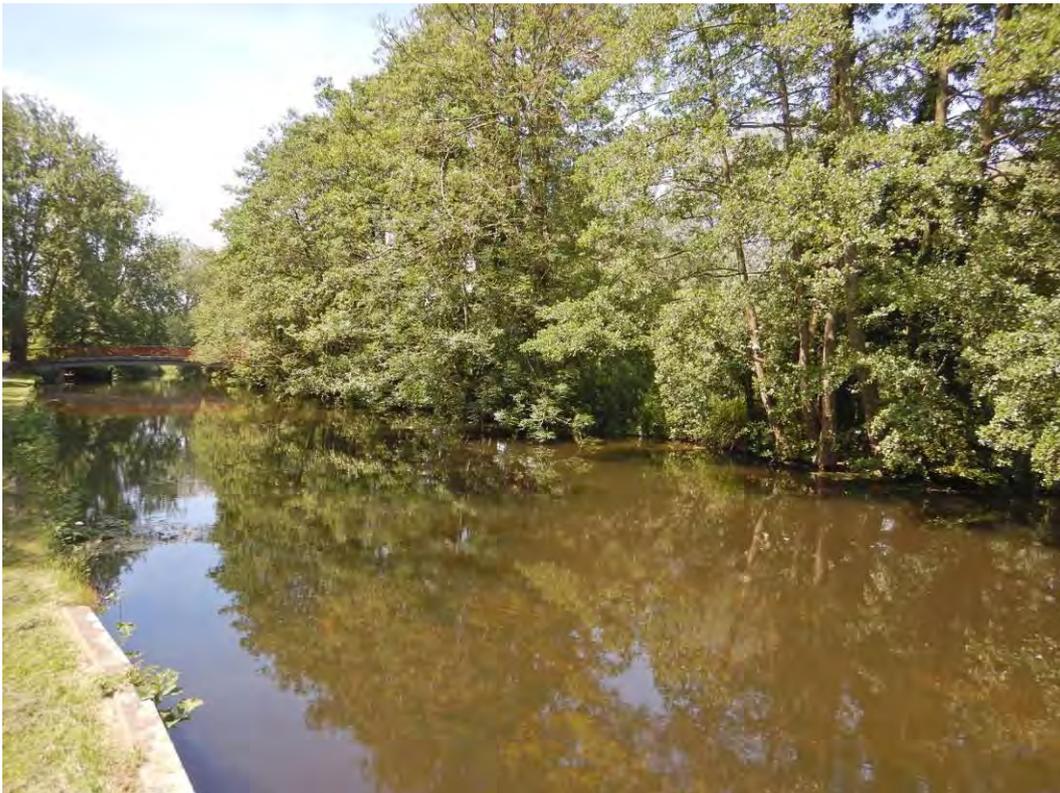
Pic 27 - The RB is extensively tree-lined, providing an important habitat in contrast to the hard revetment of the footpath.

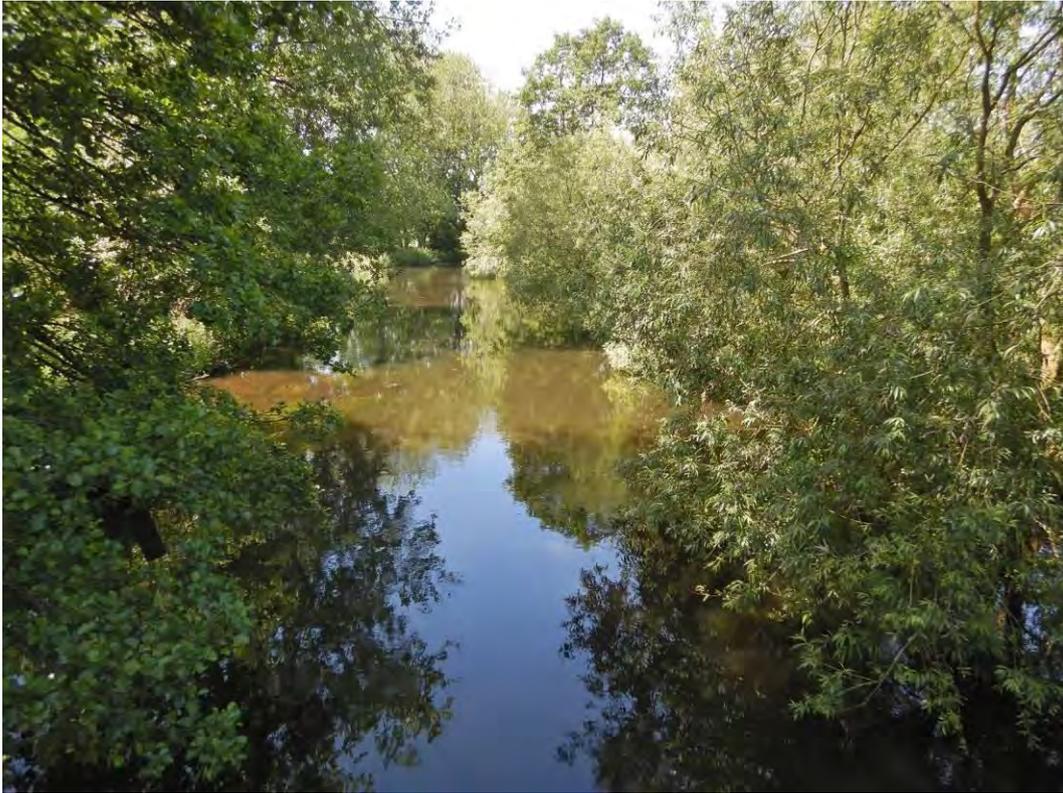
From the London Road bridge the river is heavily tree-lined on both banks. This is likely to be a favoured area by many adult species of fish due to the food input of falling invertebrates from the trees, extensive cover and water depth. Retention of this tree-lined reach should be an objective for local river conservation.

Pic 28 – Downstream of the London Road bridge the river is densely lined with trees which provide excellent cover for adult brown trout.

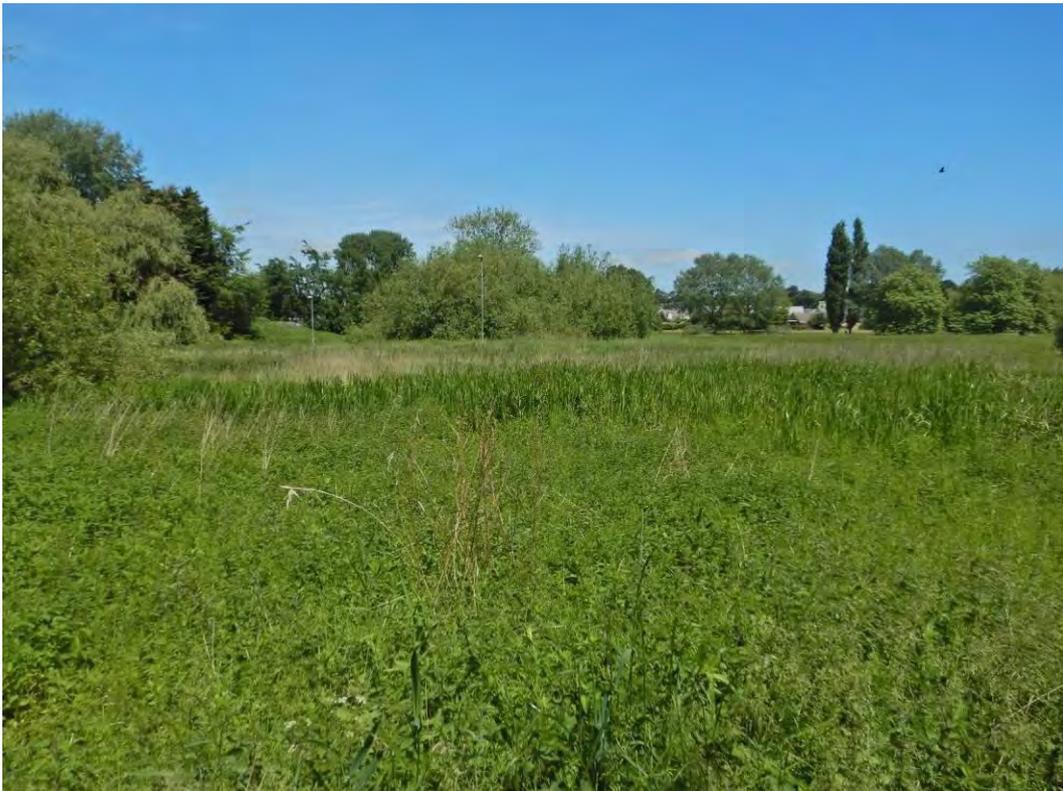
Pic 29 – Wetland habitats were observed on the floodplain near to the Thetford Priory.

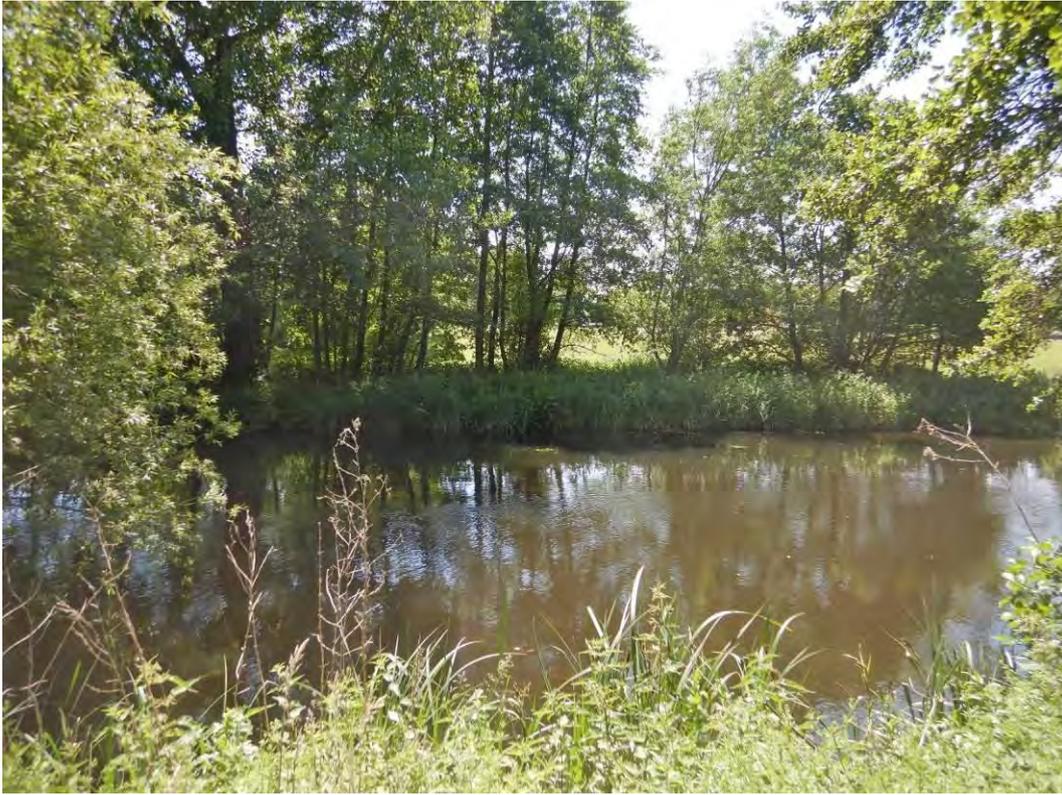
Pic 30 - A sedge bed has developed on the LB suggesting the deposition of fine sediments allowing subsequent colonisation.

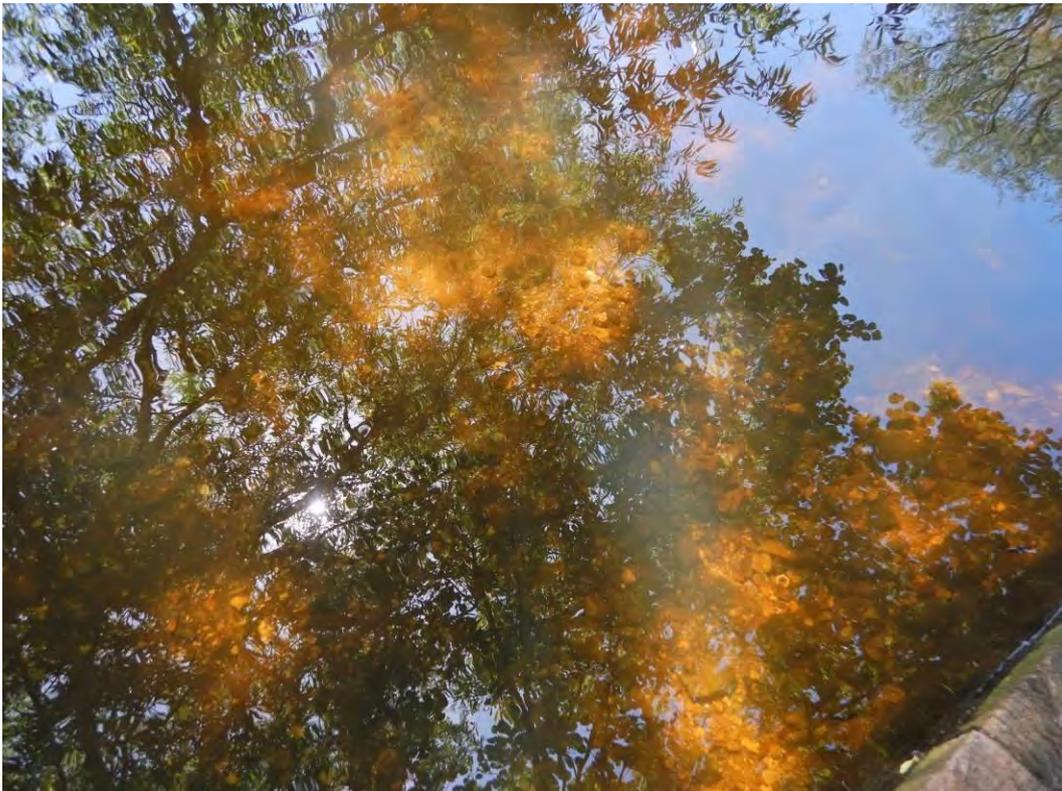
Pic 31 – The majority of the bed throughout the reach visited consisted of clean gravel.

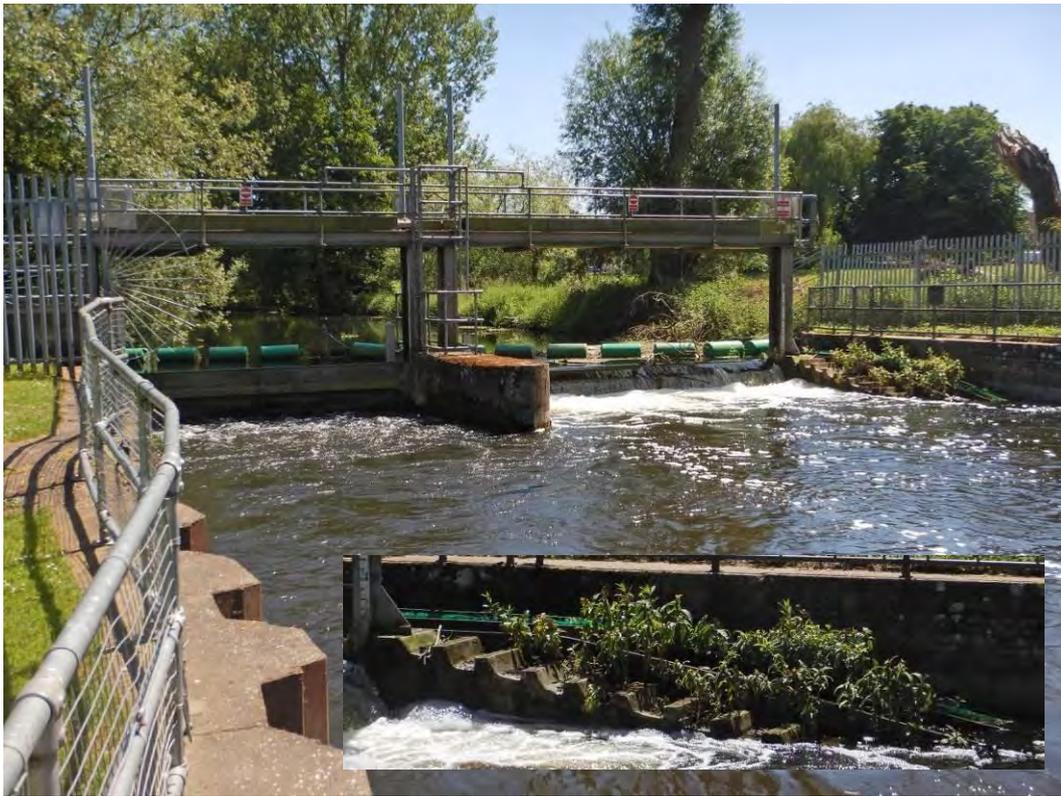
Pic 33 - The downstream view of the staunch showing the eel pass (inset).

It is presumed that the Thetford no.1 staunch's purpose is to retain an upstream water level to aid navigation. If navigation was not required it might be possible to remove this structure, reducing upstream flood risk and allowing the river to develop a more natural form.

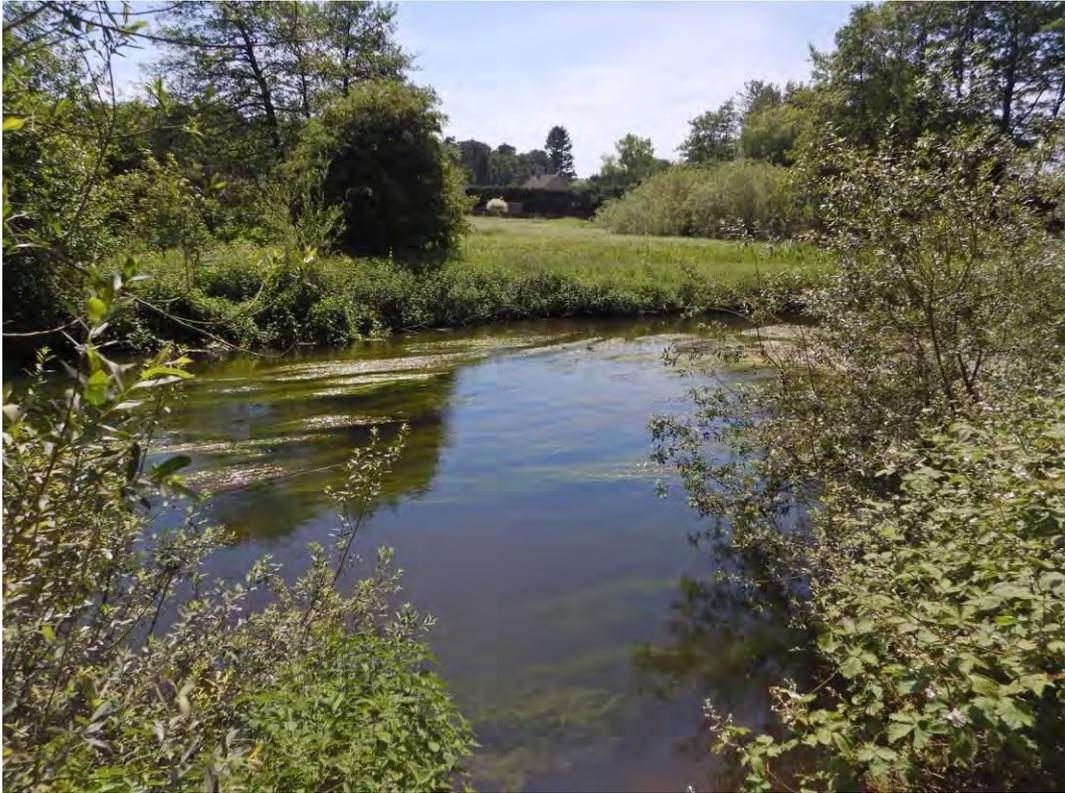
Where the riverbed shallows, the flow rate increases resulting in attractive stands of water crowfoot (pics 35 and 38). Water crowfoot is important for retaining a head of water, increasing in-channel cover, providing shade, and spawning substrate for many coarse fish species. The plant is typical of clean swift-flowing rivers. Extensive reed bed habitats were seen on the RB floodplain where woodland is not established.

Pic 35 – Dense stands of water crowfoot further enhance the river’s biodiversity value.

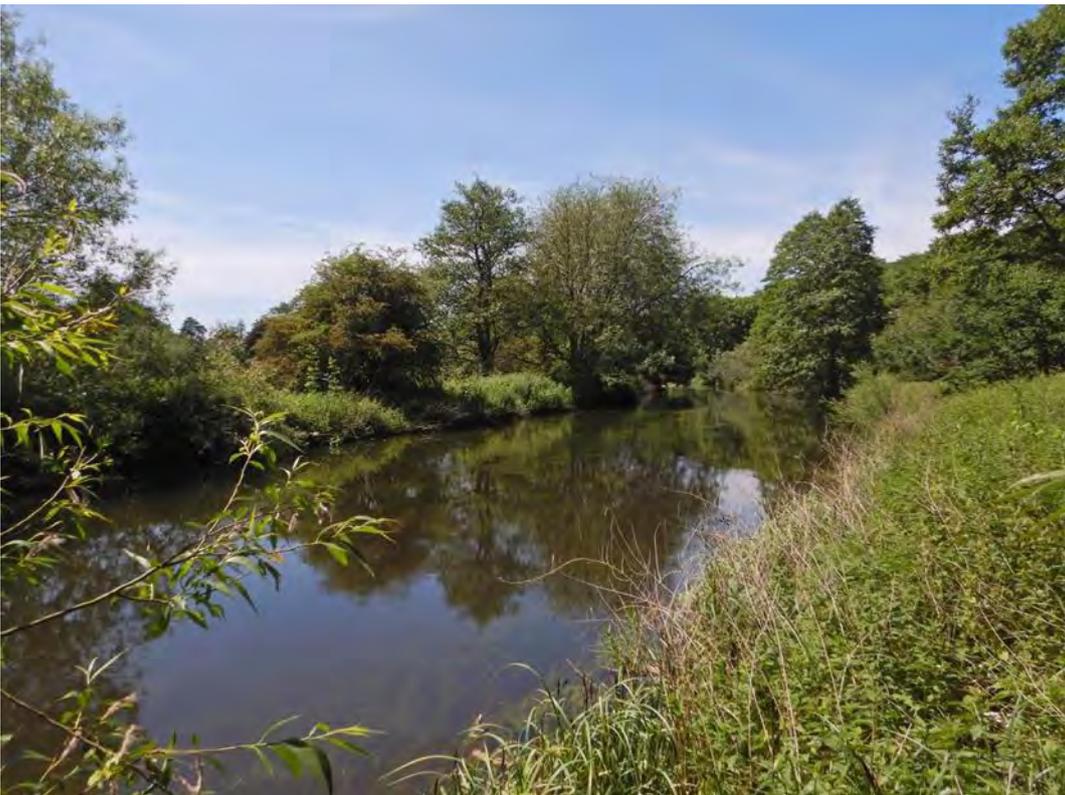
Pic 36 - The river takes on a more natural feel again without a riverside path on top of the bank.

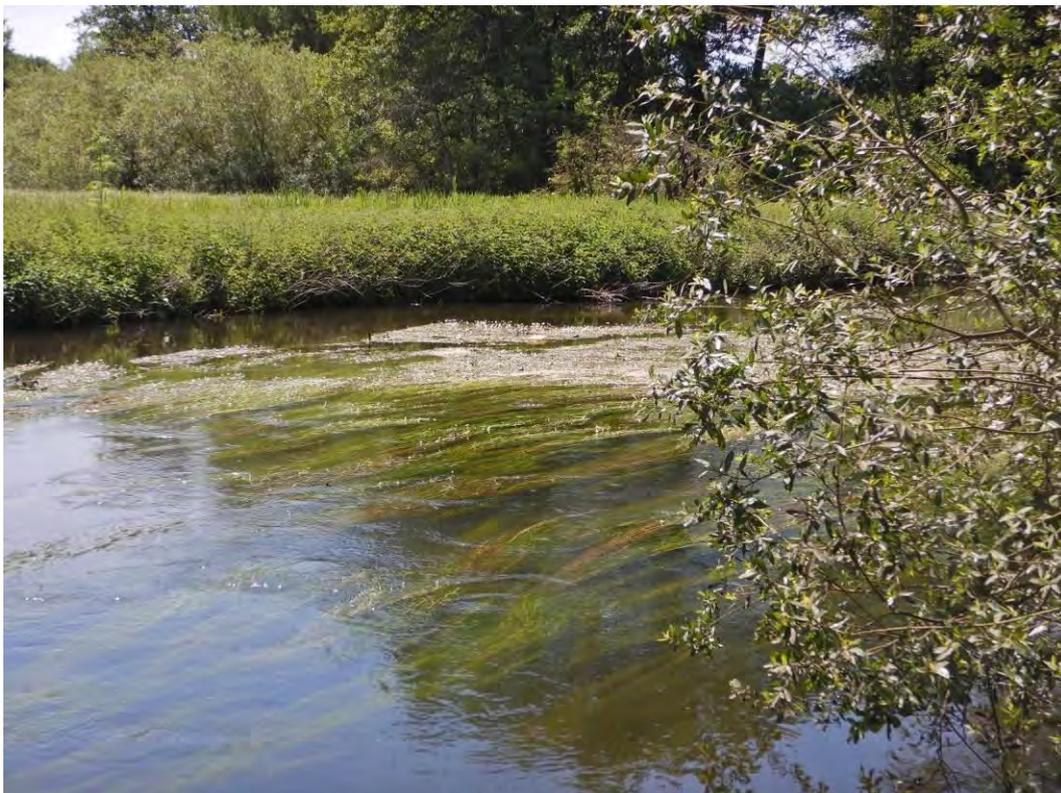
Pic 38 – Further dense stands of water crowfoot were found downstream. It was very pleasing to see it in such abundance in a lowland river at the edge of fenland.

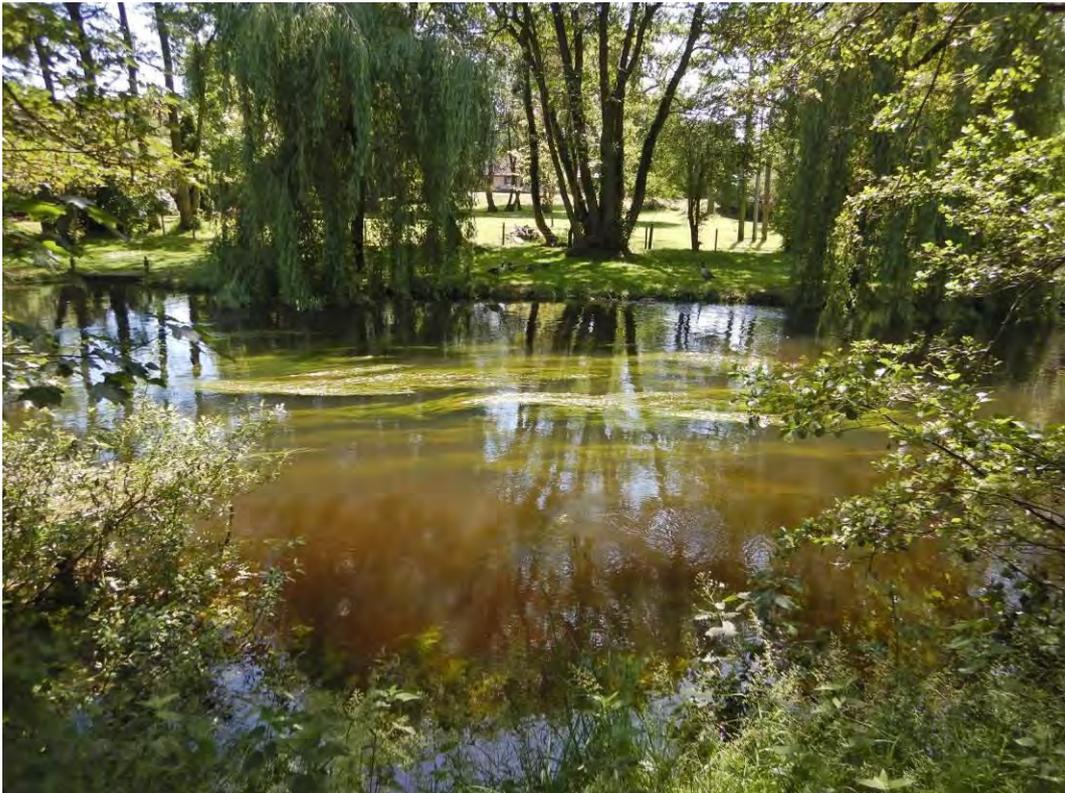
Downstream of Thetford there was only one notable garden that extended down to the river. Whilst the mowing of the riverbank is not desirable due to the removal of marginal cover, the impact is negligible given the extent

of this habitat throughout the reach. Fortunately trailing branches have been retained.

Pic 39 – Garden habitat is present but its extent was negligible. Water crowfoot grows where the canopy is broken and allows light to the river.

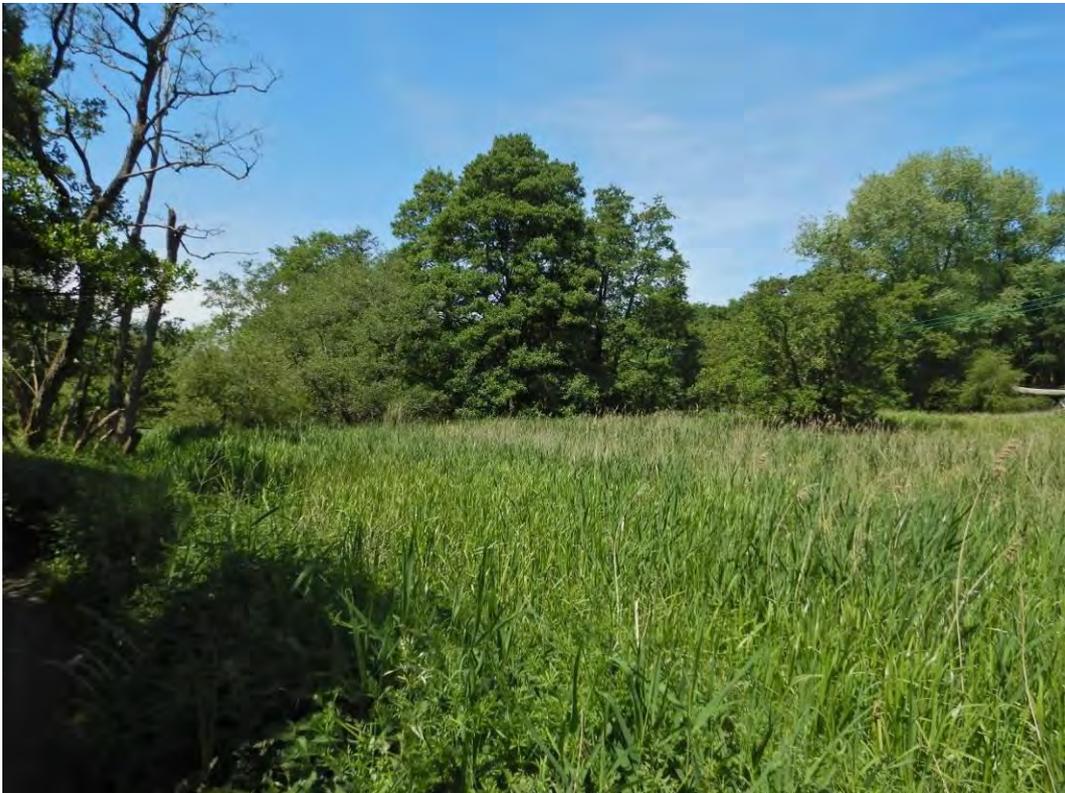
Pic 40 – Reed beds provide a valuable floodplain habitat towards the sewage treatment works is approached.

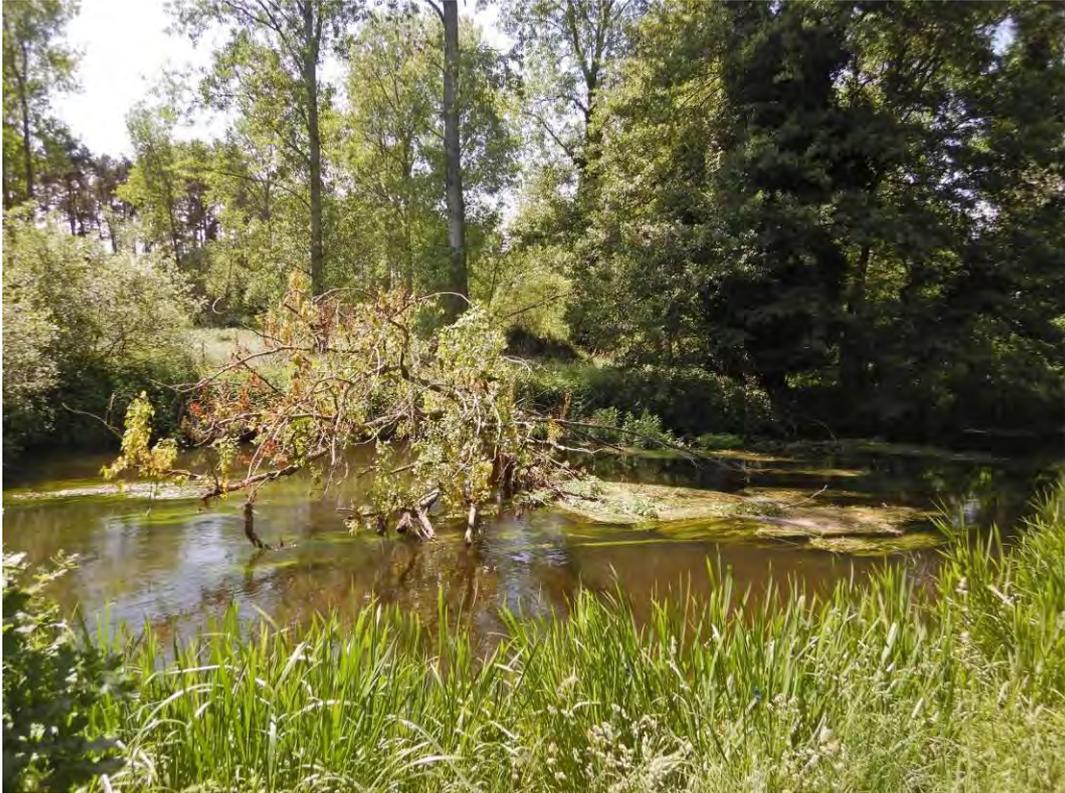
Moving away from the built-up areas a number of fallen trees were encountered. Fallen trees in the river provide excellent habitat for fish and

invertebrates by creating flow and habitat diversity. In fact, such features are often proposed as specific habitat enhancements on wide lowland rivers and their natural occurrence should be welcomed.

Pic 41 – Fallen trees provide important habitat and should be retained.

Many fallen trees were present in the channel downstream of Thetford and present important habitat features. Regard should be given to stabilising those that can be retained. Such trees can be winched to the sides and staked into position using cable rope if necessary. Removing these natural structures would result in significant habitat degradation.
