Advisory Visit  
Little Ouse River, Thetford  
June 2018

Undertaken by Rob Mungovan

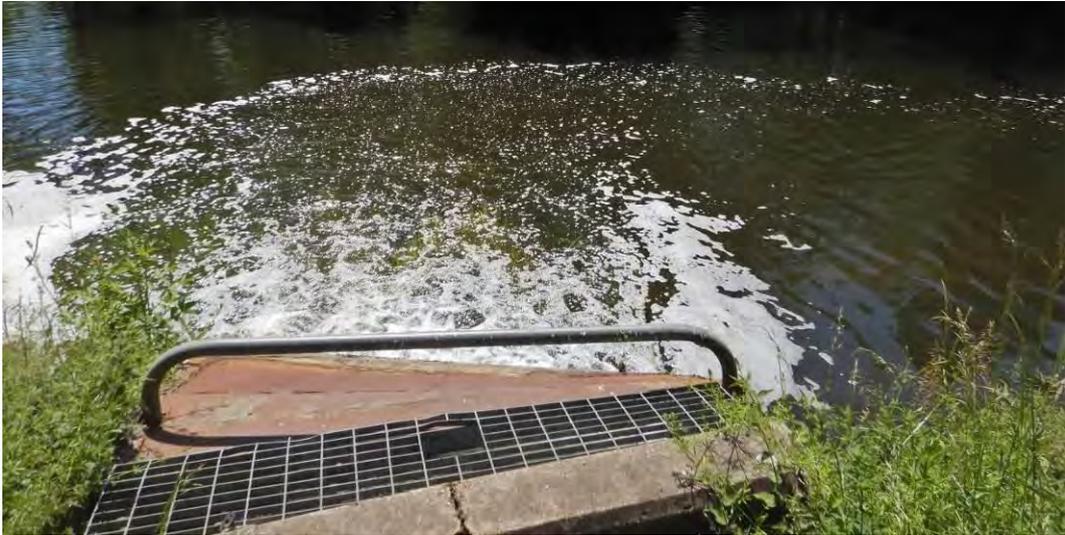
On the day of the visit, the discharge from the sewage treatment works appeared acceptable with no foul smells or high sediment loading. The occurrence of foaming is most probably related to detergents used in domestic washing. It should be remembered that the sewage discharge is given as reason for the river not achieving good status under the WFD classification and is clearly a known issue to the EA.

Pic 42 – The outfall from the Thetford sewage treatment works.

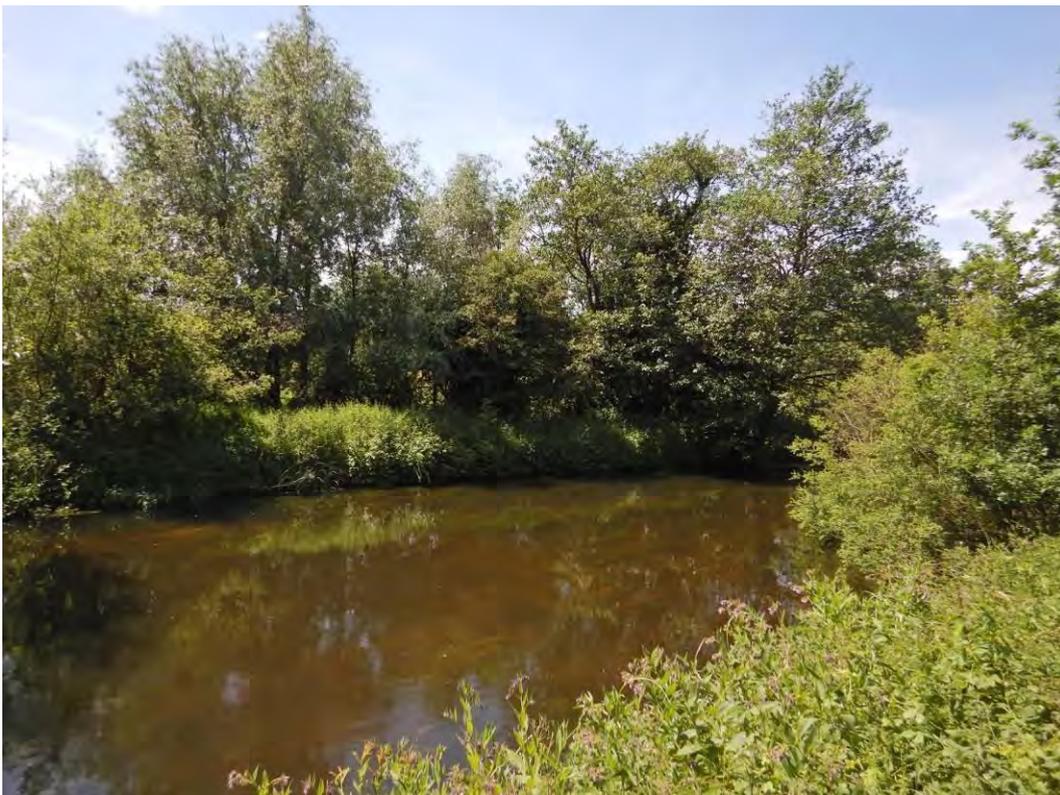
Pic 45 - A natural looking part of the river with no obvious human intrusion. These reaches contrast strongly with the treeless hard edges through Thetford.

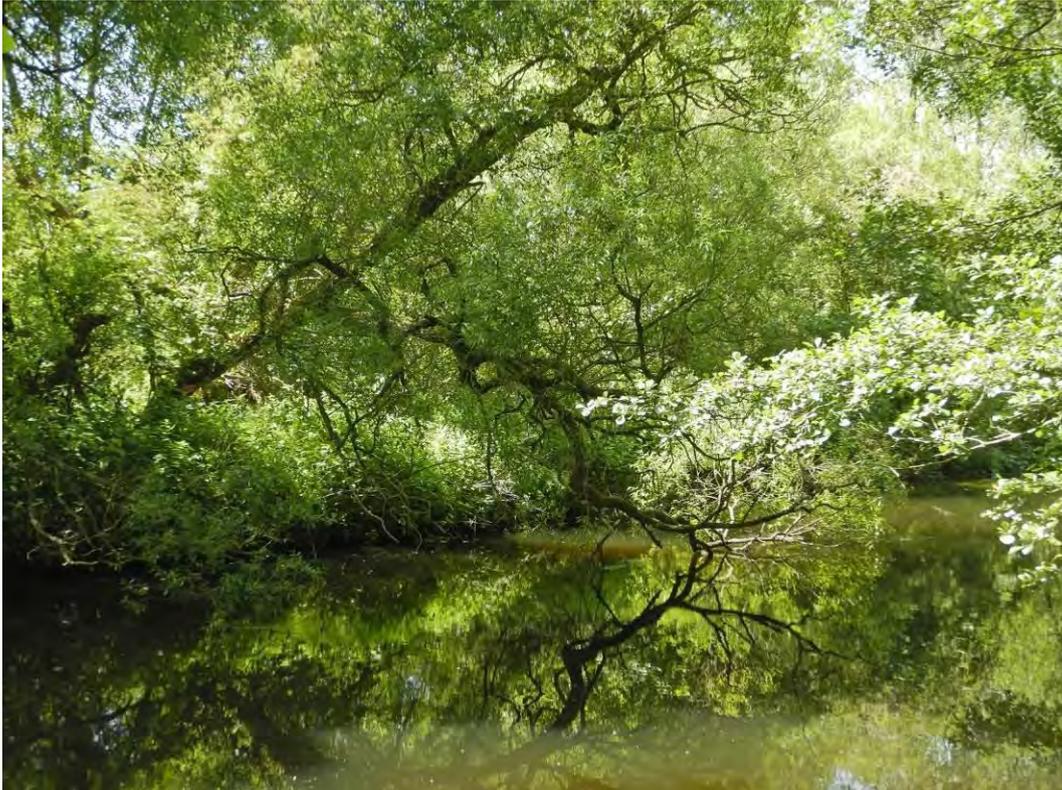
Pic 47 - The tree canopy gave total coverage at a few points downstream of the fishing lakes. Large branches trailing in the water represent excellent cover for many species of fish, especially adult brown trout.

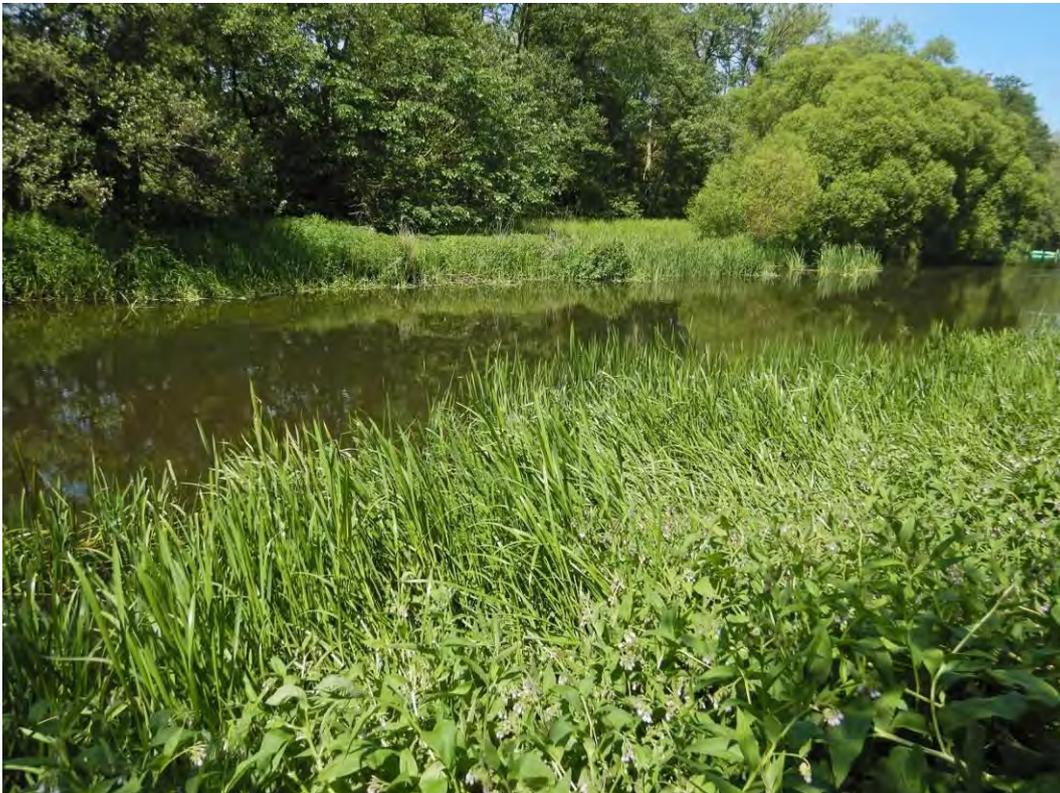
The approach to the Abbey Heath gauging station was clear of fallen trees and trailing branches resulting in an impoverished habitat. However, these smooth flow conditions (laminar flow) are necessary for accurate monitoring. The open nature of the river has allowed the growth of extensive beds of reed sweet grass which provide important marginal habitat.

Pic 48 - Above the EA's gauging station the river widens with extensive margins of reed sweet grass.

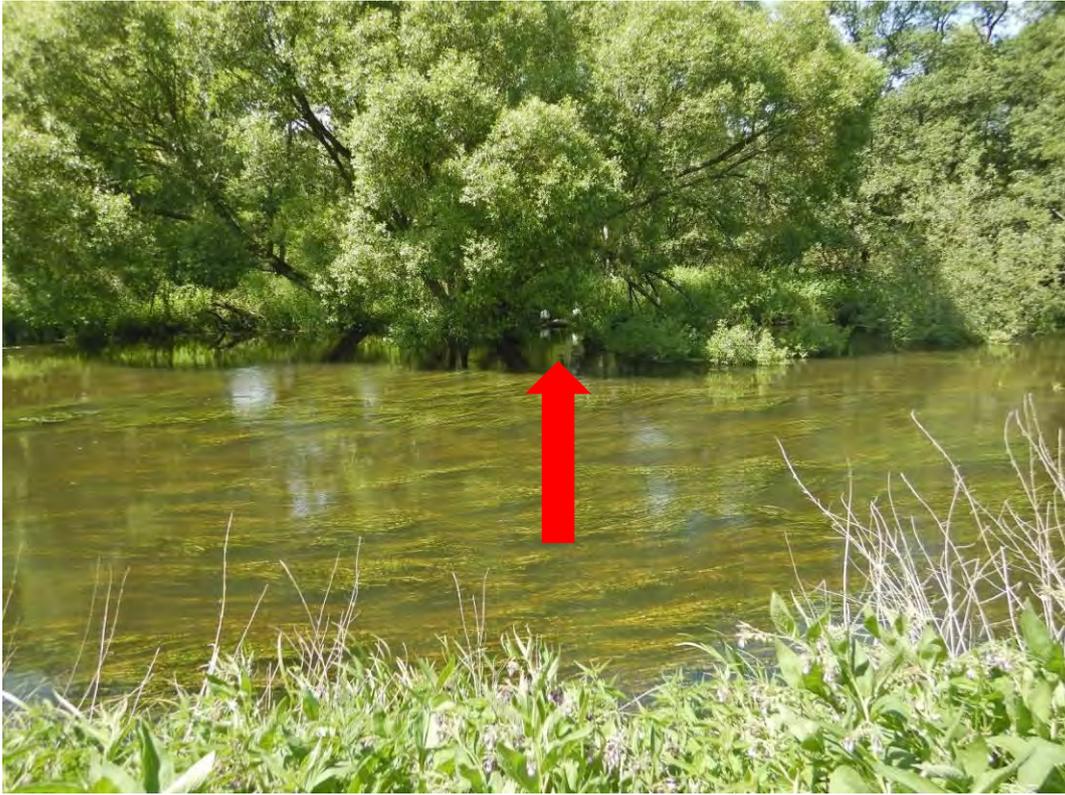
One willow tree was observed almost immediately above the gauging station with some trailing branches (presumably which came down this winter). Amongst the cover provided by the willow were nesting swans (red arrow). Note that the plant growing abundantly within the river (pic 49) is a broad leaved pond weed (a Potamogeton species not water crowfoot), likely in response to the impounded nature of the section and resulting fine sediment deposition.

Pic 49 – A swan's nest (red arrow) was observed above the EA's flow gauging station.

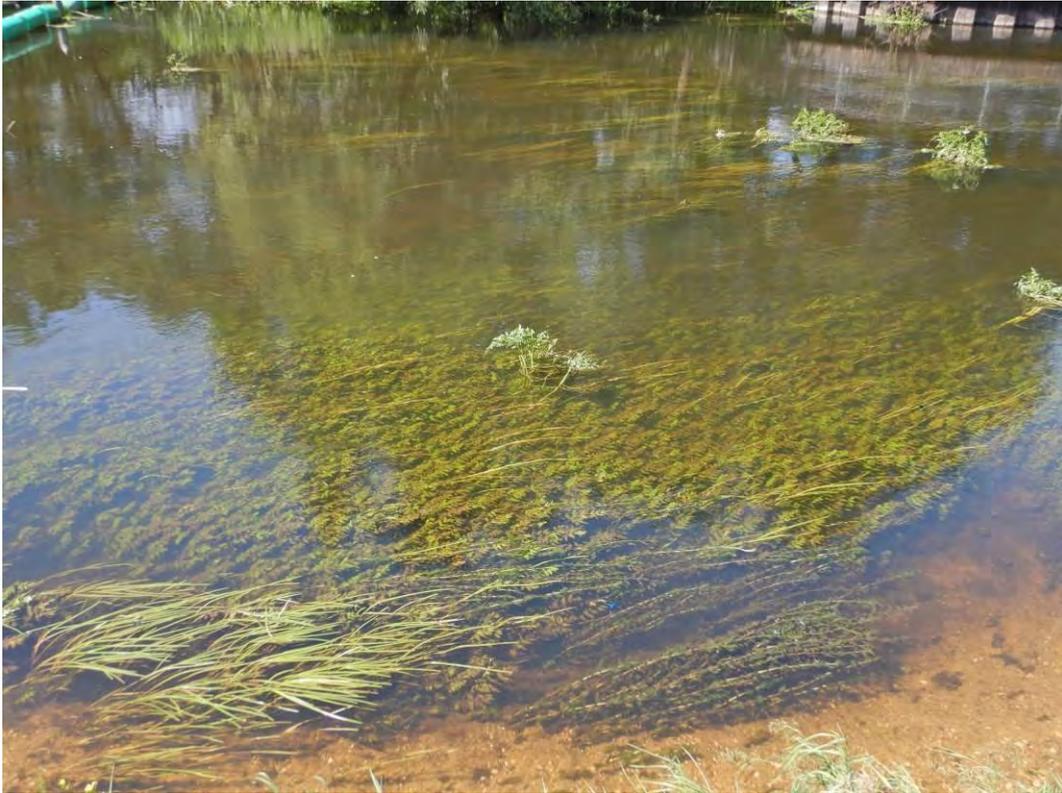
Pic 51 – Immediately above the gauging station the plant community was surprisingly diverse, with lesser water parsnip, broad-leaved pondweed, unbranched bur reed and water dropwort.

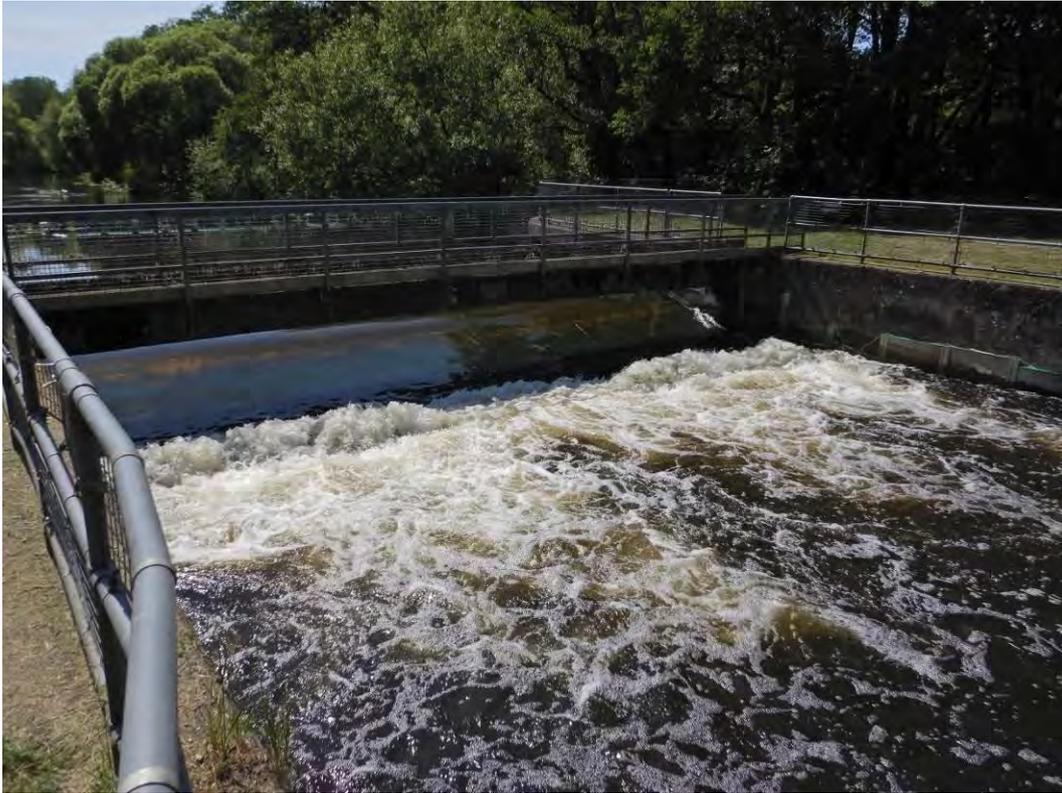
At the gauging station the water is held back by a weir to allow the measurement of flow. The smooth face presented by the crump weir makes it impossible for coarse fish species to swim up it, and it would be extremely challenging for salmonids to ascend (except once drowned out). It is reported that a feasibility study looking into improving fish passage at the site may be funded through the Water and Environment Grant (if successful).

Pic 52 – The downstream view of the gauging station.

A drainage ditch runs alongside the river and stops at the gauging station. If the ditch were connected to the river and brought around the gauging station it could be possible to create a by-pass channel. The channel would have to be carefully designed and carry a known volume of water in order not to affect the operation of the gauging station. This approach was used **on the River Cam at Byron's Pool, Grantchester.**

Alternatively, an ambitious target could be to replace the current gauging station's weir with less intrusive gauging technology. This would remove the need to maintain an upstream impoundment and would allow a natural channel to establish.

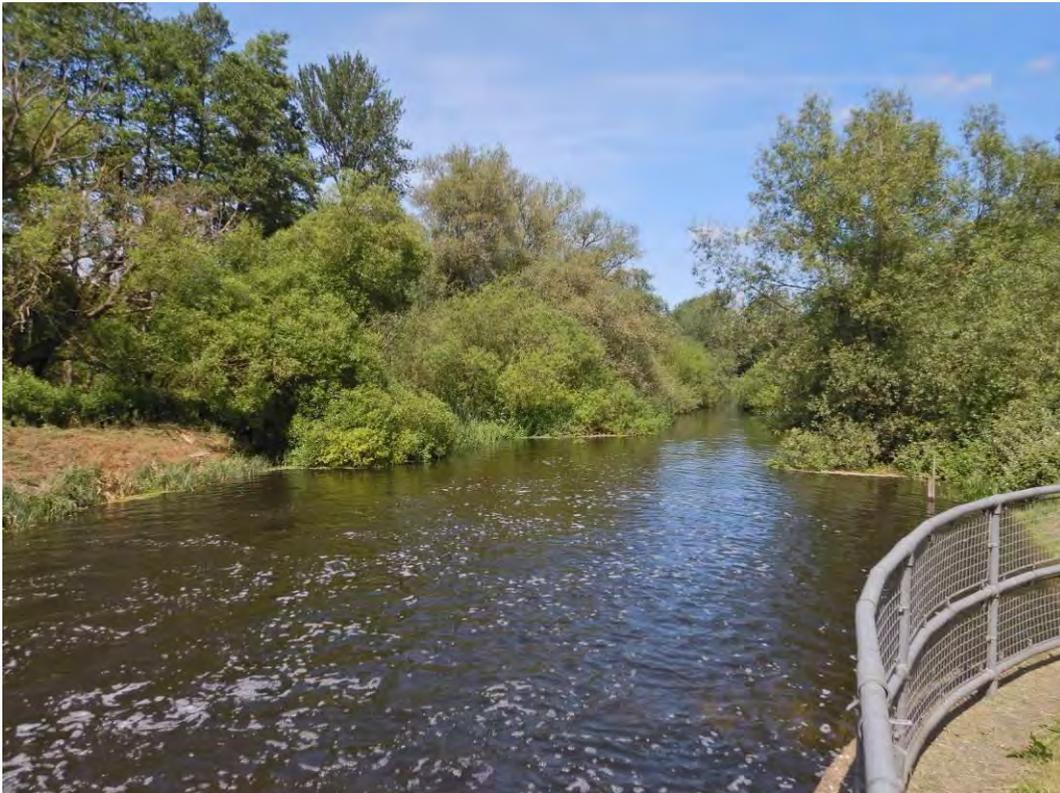
Pic 55 – The view downstream from the gauging station. The turbulent and aerated water may become a focus for fish if the river suffers from low oxygen concentrations in hot summers. Ironically, low oxygen concentrations are compounded by water that is impounded by structures like gauging stations and other weirs.

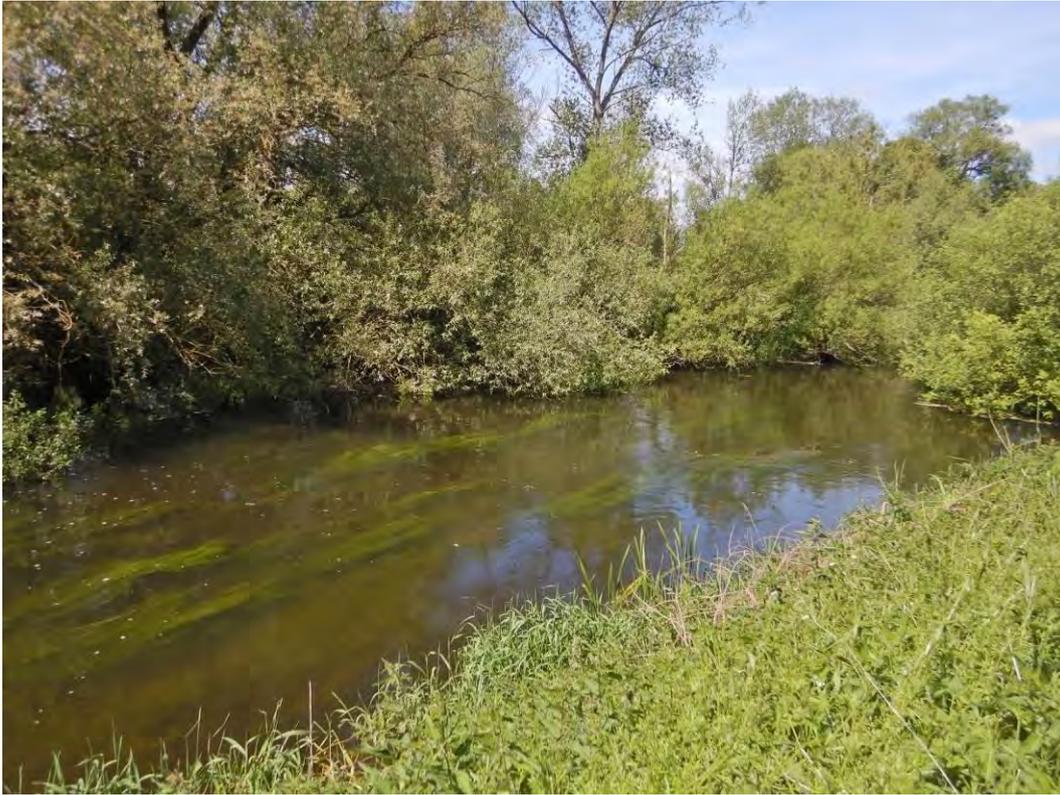
Pic 56 – Downstream of the gauging station the river became natural in its appearance again with ecologically important beds of water crowfoot and dense tree cover with plenty of trailing branches.
