Grayling Society

**Advisory Visit
Afon Cain, Powys
January, 2011**

This report is the output of a site visit undertaken by Tim Jacklin of the Wild Trout Trust to the Afon Cain, Powys, on 28th January, 2011. Comments in this report are based on observations on the day of the site visit and discussions with Tony Bostock of the Severn Rivers Trust (SRT) and Richard Dearing, Catchment Officer with the Environment Agency (EA).

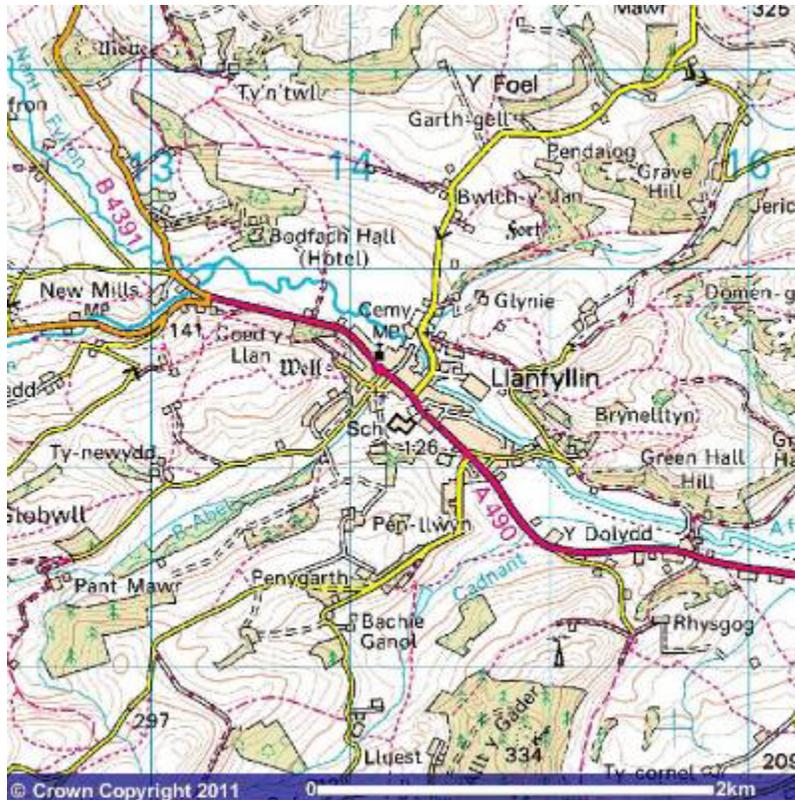
Figure 1

This section of river has a meandering plan-form with a pool and riffle sequence which provides a variety of depths and flow velocities – the basic building blocks of good habitat. This is a predominantly gravel substrate which is good for trout, grayling and salmon spawning. Some mature trees are present (mostly alder) and the root masses of these trees provide good bank stability and excellent cover for adult fish (Photo 1).

Unfortunately the in-stream habitat is compromised by highly accelerated rates of bank erosion (Photos 2, 3). The outsides of meanders in many locations are being rapidly eroded by the process of block failure, where the river cuts away the toe of the bank and gravity causes the overhanging block of earth to collapse into the river. Although erosion (on the outside of bends) and deposition (on the inside) is a natural process which promotes the desirable natural pool-riffle sequence, accelerated rates of erosion cause poor in-stream habitat for fish.

1. As a priority, grazing pressure should be reduced alongside the river. This could be achieved by changing the emphasis of the land use from livestock production to conservation grazing, for example by using low densities of traditional breed cattle. Alternatively, fencing out a generous buffer zone alongside the river would be required (5 metres minimum, preferably 10 m). Reduced grazing pressure is essential if any of the bank revetment techniques described below are to be successful.
2. Protect the rapidly eroding sections of river bank with soft revetment techniques, using materials like logs, brushwood, Christmas trees and

root wads. Advice and demonstrations of techniques are available from the Wild Trout Trust. For longer term protection of the outside of meanders it is recommended that fenced, ungrazed headlands are created and planted with native tree species.

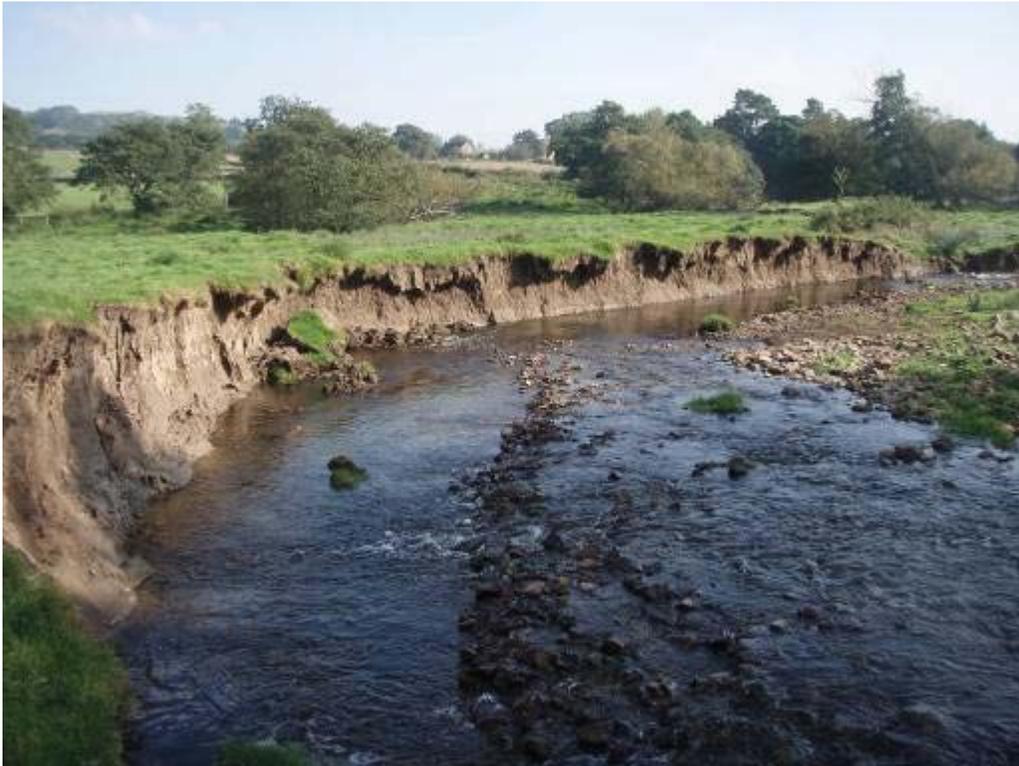
Photo 6 River Manifold, Staffordshire where severely accelerated bank erosion was treated with brushwood revetment. Before...

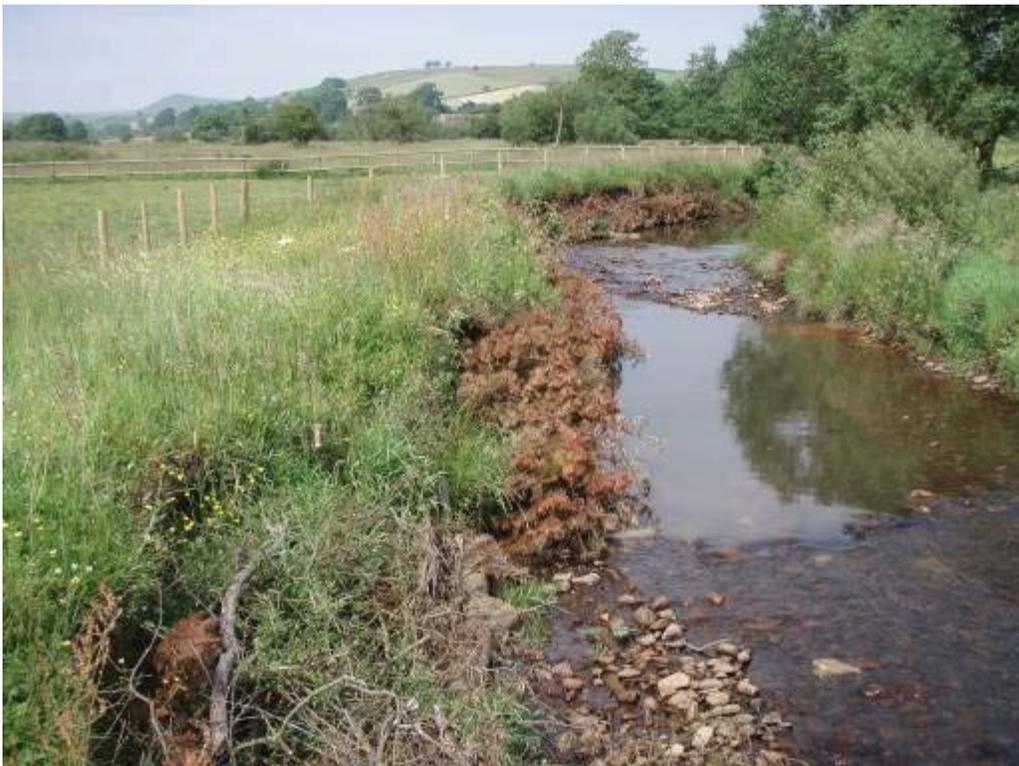
Photo 7 ...and after revetment and livestock fencing. Further guidance on techniques can be found in the WTT's Upland Rivers Habitat Manual (www.wildtrout.org – publications link).

2. On the open sections near the upper end of the beat, consider using brushwood revetment along the open banks to reduce erosion and provide in-stream cover for juvenile fish (see Photo 7 above). Stock fencing of these areas should also be carried out to allow a healthy riparian zone to develop. Careful design and positioning of the fence is required (e.g. including ‘sacrificial’ panels in areas vulnerable to flooding and debris accumulation, for ease of repair).

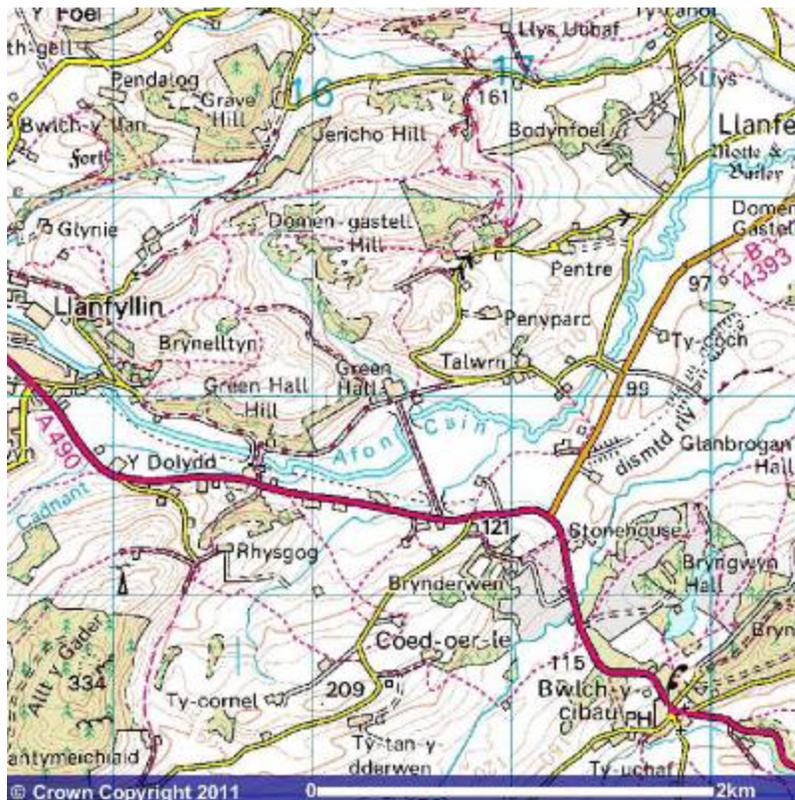
Figure 2

This section was walked upstream from Green Hall Farm (Figure 2). The plan-form of the river here is straighter than the previous section and there are fewer meanders and less of a pool-riffle sequence. It is likely that this section of river has been previously straightened (Photo 8).

Because of the straightened nature of the channel here, deeper pool habitat which could hold adult fish is lacking which will restrict the value for angling. This could be improved by the retention of naturally occurring large woody debris within the channel, or by deliberate introduction of flow deflectors to create bed scour and deepen the channel in selected areas; the tree-laying technique could easily be adapted to achieve this by positioning the tops of the trees in the river channel. This provides excellent cover for all life stages of fish, improves invertebrate abundance and diversity and helps moderate water temperatures in hot weather.

1. Introduced large woody debris to the river channel by hinging trees using the same technique as already carried out in places (Photo 9). Where trees will not hinge, tethering with steel cable to create “tree kickers” is an alternative option. Logs could also be introduced to promote bed scour; these can be fixed to the river bed by drilling and pinning with rebar.

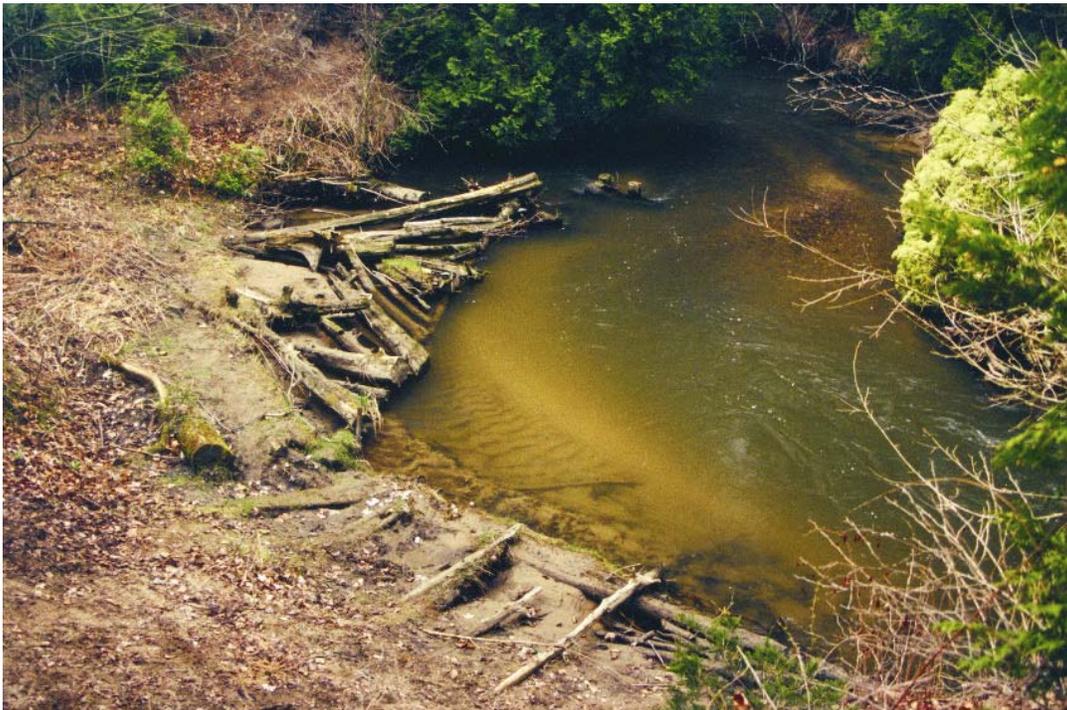
Photo 26 Engineered log-jam on a Canadian stream

1. Intervention to control excessive erosion should be a priority on this section using soft revetment techniques such as log and Christmas tree, brushwood packing and engineered log/rootwad jams. Some examples are illustrated below. The considerable lengths of river affected by the accelerated rates of erosion mean that tackling these in one go is impractical. Probably the best approach would be to undertake a demonstration project with the relevant landowners, and then encourage and facilitate further works. There may also be the possibility of using volunteers co-ordinated through SRT.

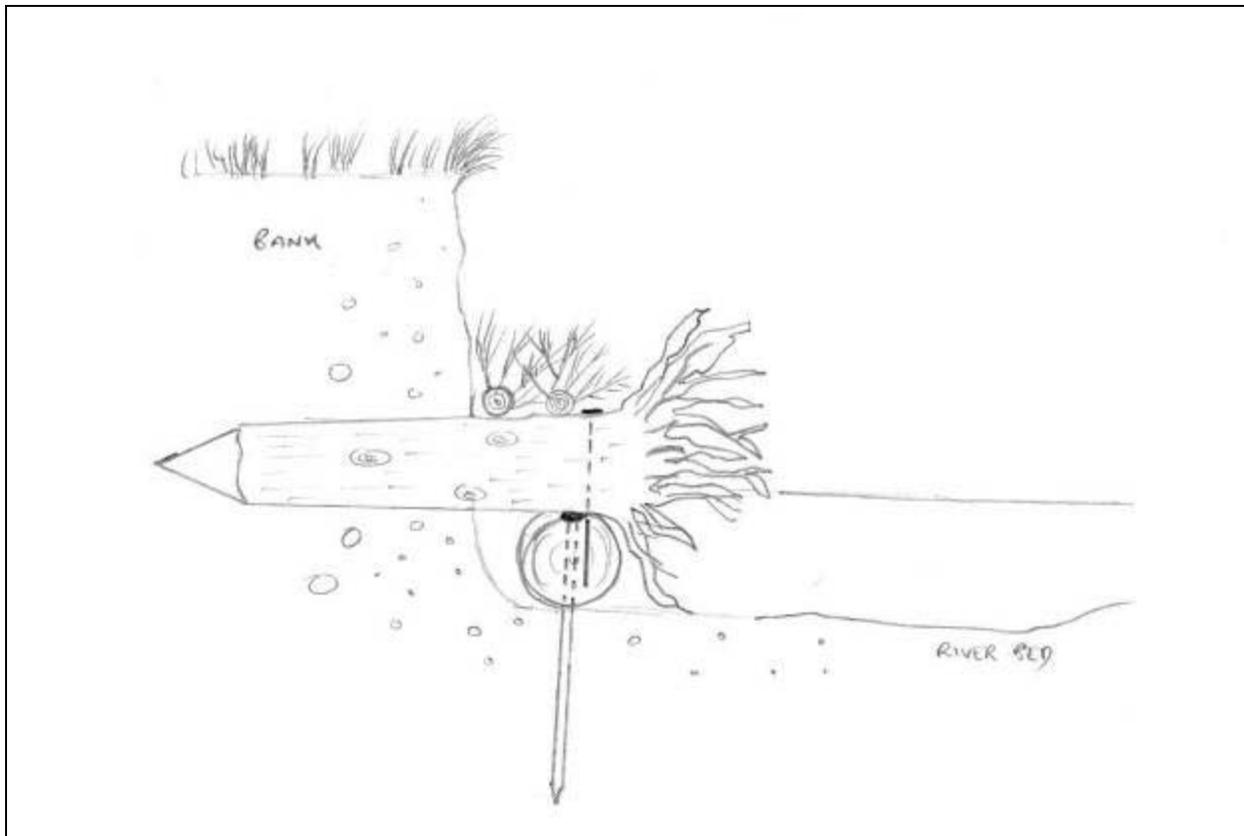
Figure 3 Root wad, log and Christmas tree revetment (cross-section)

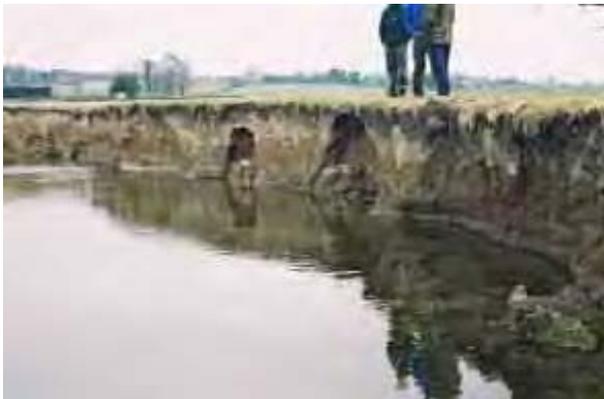
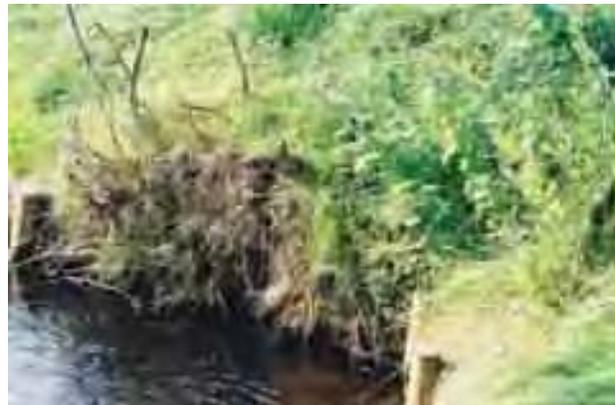
Bank erosion before and after root wad revetment (Afon Dulais near Llandeilo). See WTT Upland Rivers Habitat Manual, Section 5.

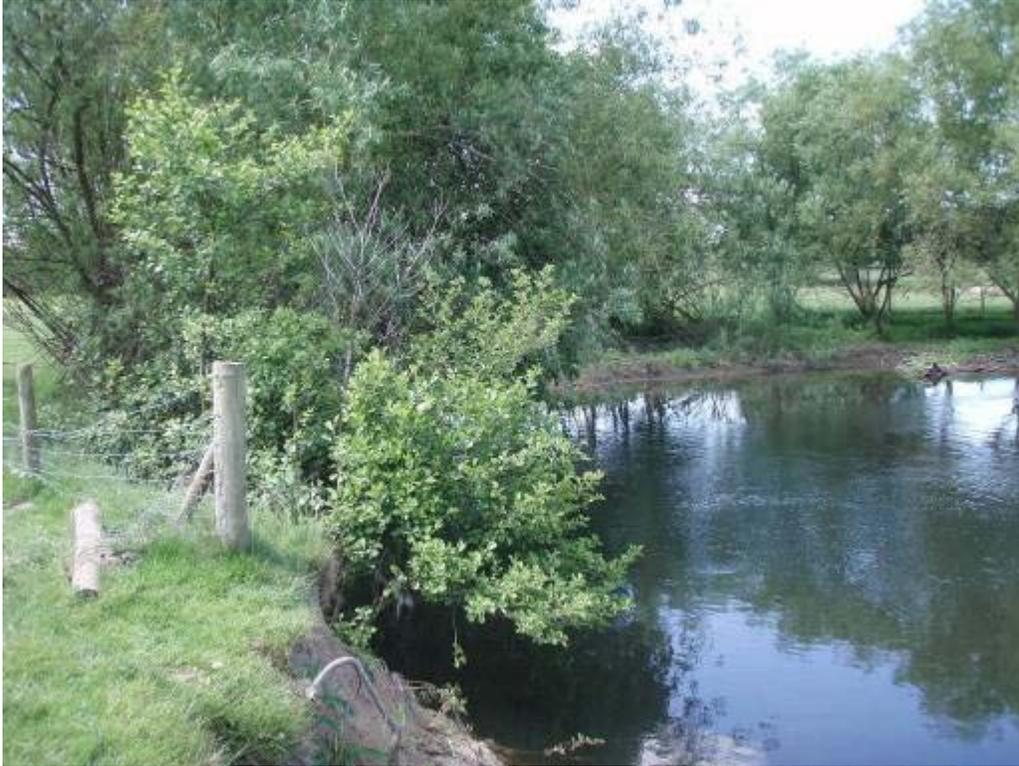
Photo 27 A fenced headland with planted willow and alder on the outside of a meander to provide long-term erosion protection (Afon Clwyd).

2. For the bank stabilisation techniques to be successful in the long term, a change of land use alongside the river is required, e.g. creating ungrazed and uncultivated buffer strips and headlands. Working with landowners and managers to encourage these changes through agri-environment schemes (Glastir) is recommended.

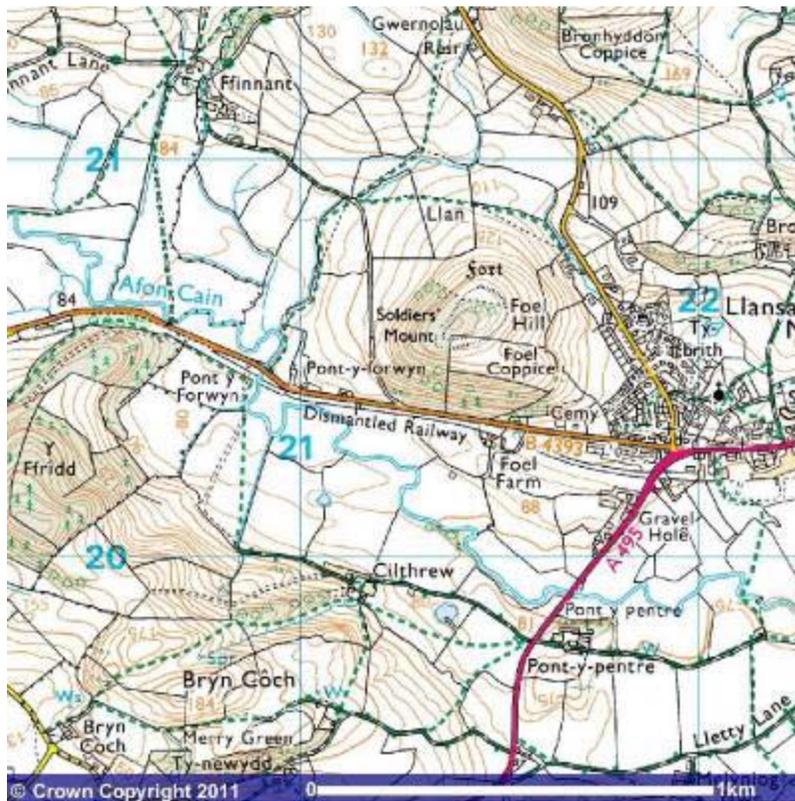
Figure 4

A short section of the Afon Cain was inspected at Pont-y-Forwyn, upstream from Llansantffraid-ym-Mechain (Figure 4). The river is larger here, being downstream of the confluence with its tributary the Brogan. The water was noticeably more coloured here which is due to the high sediment load originating from the Brogan. In-stream habitat is generally good, with a pool-riffle sequence, relatively stable banks and retain woody debris.

Some recent fencing has been completed on the left bank here in the field below the bridge; it is very close to the fall of the bank, hence unlikely to provide any meaningful bank protection through vegetation regeneration and at risk of being undermined by the river. The right bank is more open than the left, and there are several areas where rubble hardcore has been tipped down the bank in an attempt to reduce erosion.

Where the old railway crosses the river, the remains of the bridge culvert create a bed check which could be a barrier (particularly at lower flows) to upstream migrating fish; this could be relevant for species with less ability or inclination to cross such barriers (e.g. grayling), rather than trout or salmon.
