## **Hampshire Avon, Countess, Wiltshire**

**An Advisory Visit by the Wild Trout Trust November 2017**

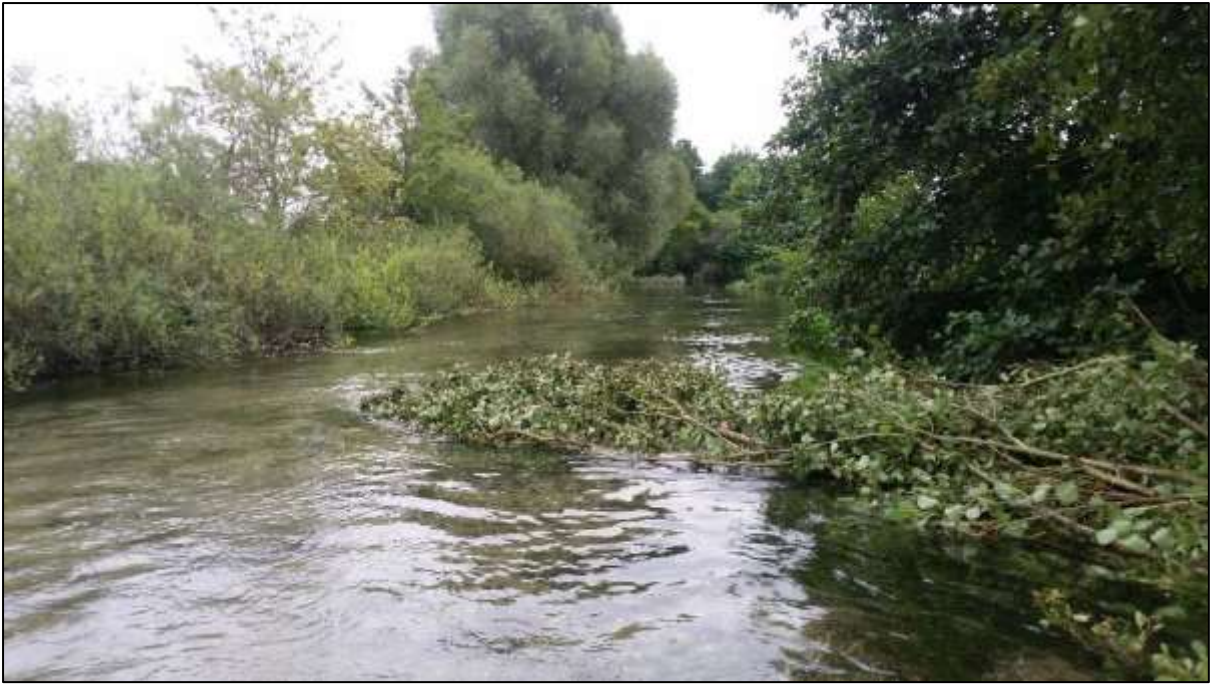
Figure 3: An example of a felled (not hinged) alder secured into the River Test near Whitchurch, Hampshire.

In addition, the accelerated flow will exert localised scour on the riverbed, flushing away fine sediment and depositing it in the lee of the deflector, diversifying habitat on the bed. In order to obtain the maximum benefit from flow deflection, structures should be positioned protruding from both banks in an alternating pattern. This will create a meandering pattern of scour and deposition that over time will help re-structure the river, creating a helping to diversify the cross-sectional depth profile and provide more resilience to low flows. Achieving this will require the co-operation of the Snake Bend syndicate and may also require the introduction of flow deflectors where bankside trees are not ideally situated or aligned for hinging. Fortunately, there are plenty of trees situated back from the path along the RB. A few small trees or large limbs should could be won and simply secured into the river margin to function as deflectors (see example Figure 3).

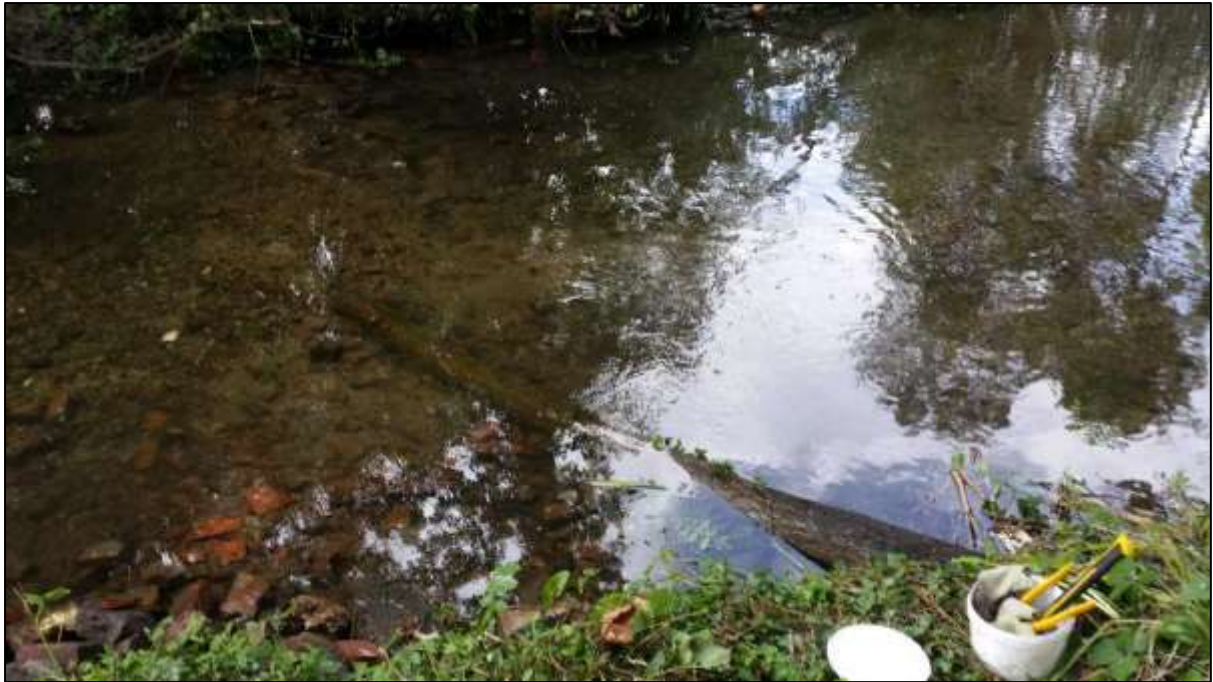
Figure 4: An example of a log deflector facing upstream and keyed in and sloping down from the bank towards the bed.

Ideally, hinges and deflectors should be kept as naturalistic as possible, mimicking the type of habitat created when a tree/limb naturally falls into the river. However, depending on the location and angler access requirements, it may be necessary to trim down branches and create simpler, more 'engineered' features. When considering such options it is important to consider the alignment of the structure. Natural, branched trees and limbs, as with hinges, should be positioned with the butt end upstream and the branches downstream. This is the orientation that naturally fallen woody debris will align in most cases. This alignment will also help prevent the structure being torn away from the bank by passing debris during spate flows. Simple, straight log deflectors should be positioned protruding out from the bank at approximately 45 degrees upstream. Water flowing over a log will be deflected by approximately 90 degrees to the long axis of the log. This is counter-intuitive at first sight. Consequently, positioning them in an upstream alignment ensures that flow is deflected across the channel and not into the bank where it could accelerate erosion. Log deflectors should be keyed into the bank and also slope down from the bank towards bed. This ensures that at least part of the log will be over-topped by flowing water over a wide range of flow conditions (Figure 4).

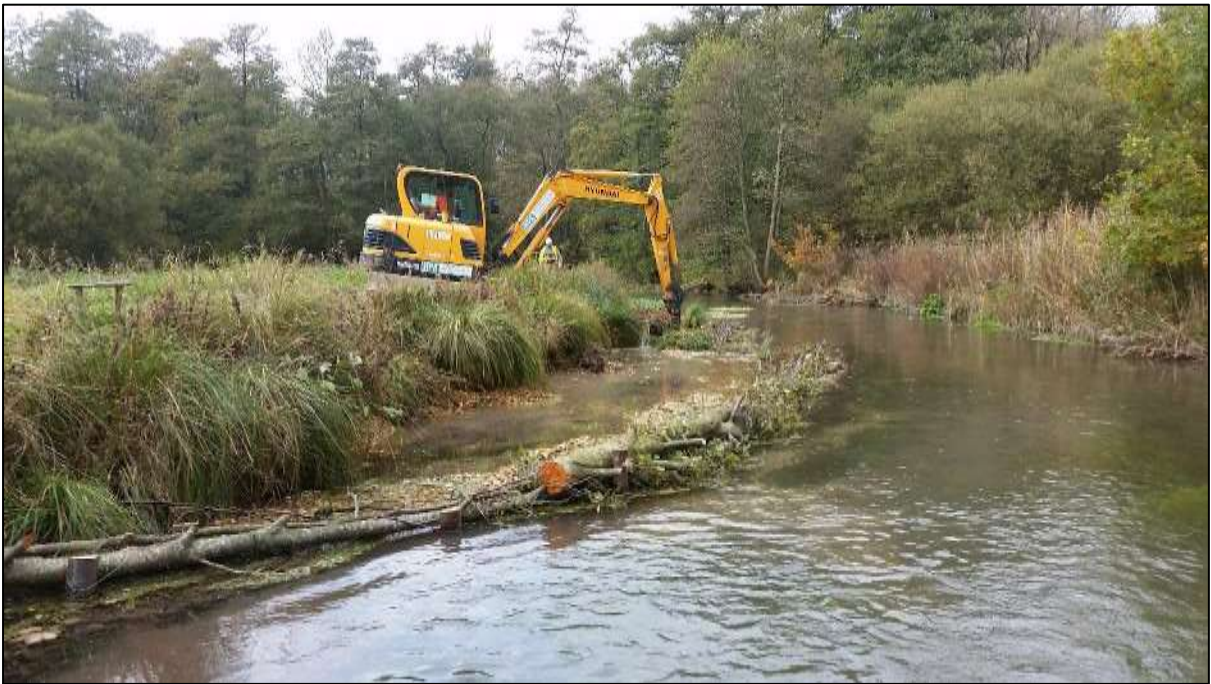
Figure 8: A new bank edge is constructed from site-won woody material on the River Dever, Hampshire.

The RB along this reach is steep, almost vertical in places (Figure 7). Fortunately there is ample space and access on the upper bank for some bank re-grading works. Creating a new bank toe from logs or brushwood and then grading the bank down to the toe with an excavator will better connect the river with its floodplain, provide a transitional habitat for a succession of marginal plants and also create some low-level angler access. Such works would also be an opportunity to slightly narrow the channel and create a more sinuous bank edge, diversifying flow patterns and boosting biodiversity (Figures 8 and 9).

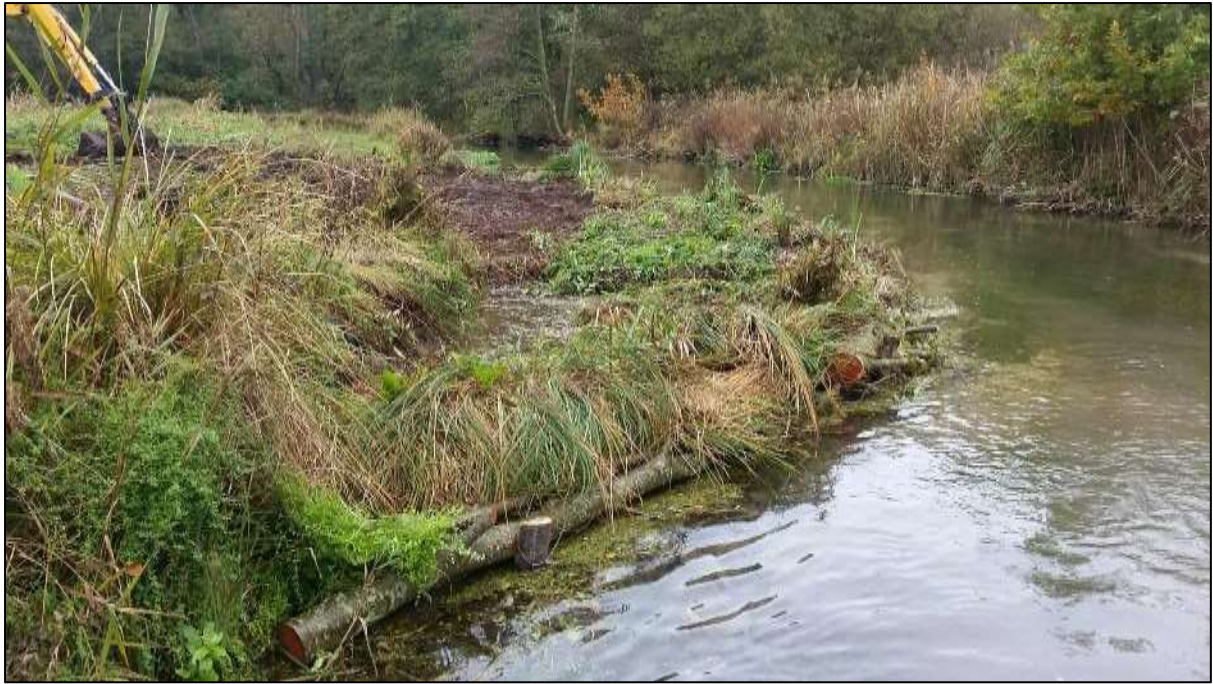
Figure 9: The same site with the bank re-graded to narrow the river, create additional marginal habitat and improve angler access.

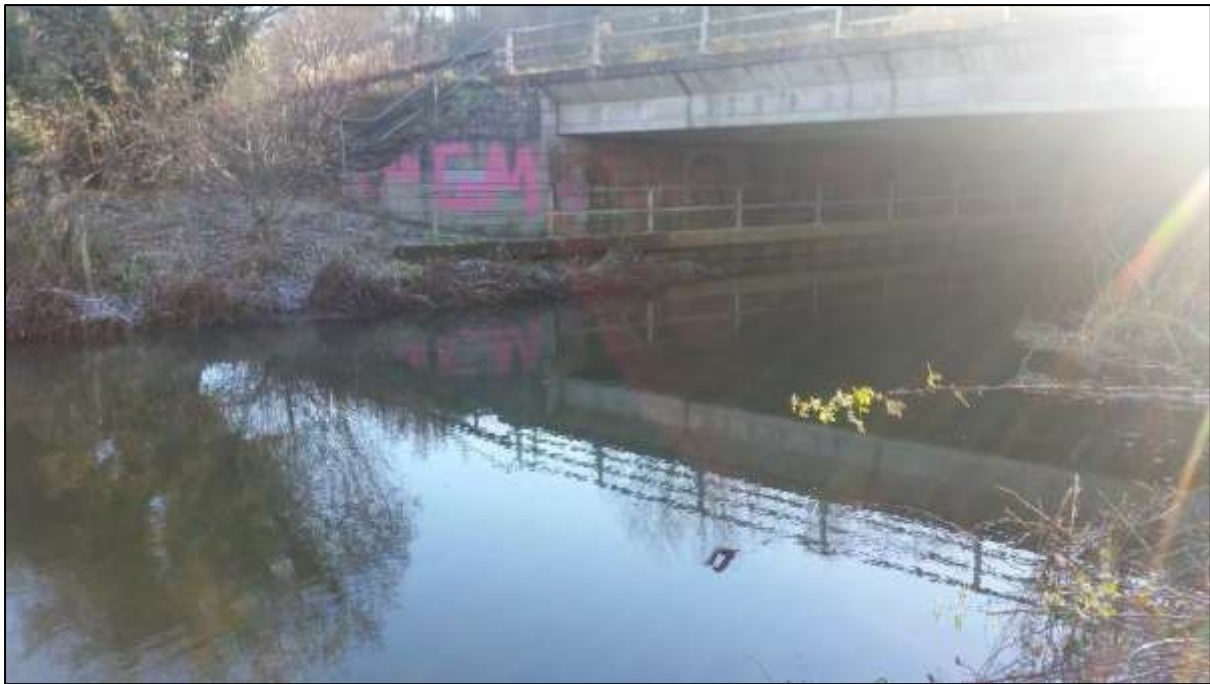
The river is deep and slow at this location because it is impounded by weirs at Bowles Hatches on the outskirts of Amesbury and has also probably been dredged in the past. Maps dating as far back as 1870 show the river upstream of the A303 was already straightened before the road was created. However, before the A303 was constructed the river used to meander sharply to the right at the approximate location of the bridge, then bend left and right again before Lord's Walk. In the 1970s when the A303 was built, a short section of the river was moved into the gentle right-hand bend now situated downstream of the bridge. This did not necessarily shorten the river but did remove some bends that would have probably provided some diversity of flow and depth conditions. The existence of the A303 also limits the number of options available for restoring the river. The fact that the river must flow under the road at the specific location of the bridge (Figure 14) and exerting minimal erosive force, could make the option of excavating a new, shallower and more sinuous channel unfeasible.

Figure 14: The Avon flows under the A303 towards Lord's Walk and Amesbury.

It is likely that the only practicable means of restoring habitat diversity to this reach is via a programme of bed raising and/or via the removal of the impoundments at Bowles Hatches. These actions are potentially very expensive and could require five or six figure budgets. The STREAM project was almost-certainly undertaken with an aim of mitigating against the symptoms of the impoundment and straightening and did not have the budget or scope to address these issues directly.
