Advisory Visit

River Aire, Bradford City Angling Association

04/02/2016

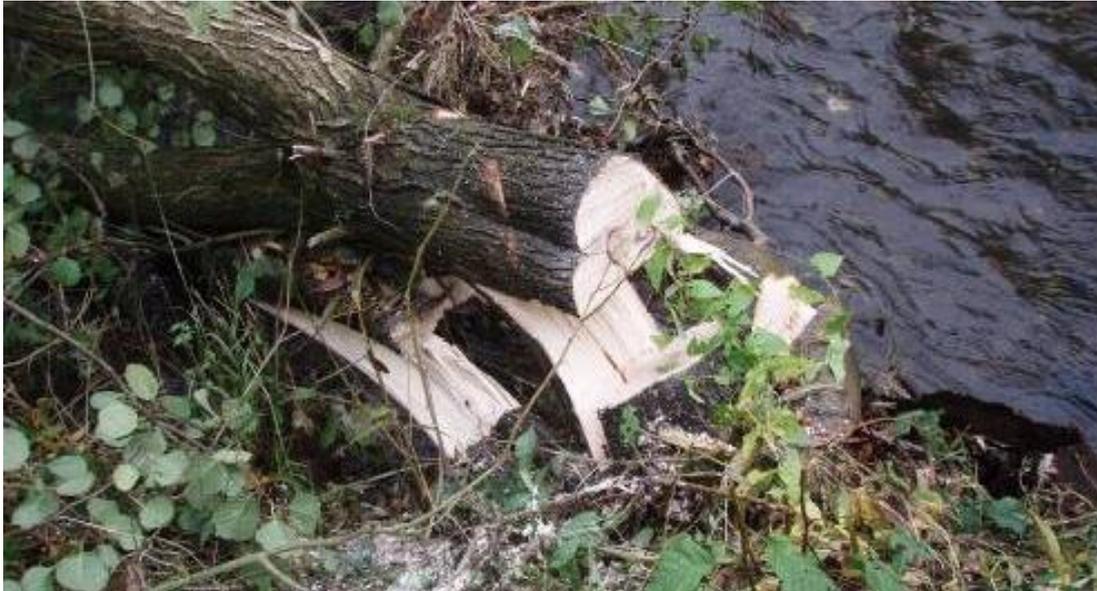
Fig 23. An example of hinged willow.

Where trees are already established along the bank, habitat improvements can be easily achieved by laying the trunks, or selected branches down into the watercourse to increase low cover and in-channel structure. This has occurred naturally at various points (Figs 7 & 11) but natural introductions of living wood and woody debris appear to have been removed or 'tidied'. The laying method is usually limited to pliant species such as willow, elm, hazel, hawthorn and small alder, but some others can be laid carefully. Small to medium shrubs tend to work best. The process involves cutting part way through the stem/trunk, a little at a time (like laying a hedge), until it can be forced over (Fig 31). The depth of the cut should be limited to only that which is required to bend the limb over, as this will retain maximum strength in the hinge.

Note, the aim would be to lay the trunks parallel to the bank and maintain a healthy hinge, i.e. the trunks are living and well attached, so as not to increase perceived flood risk.
