Project Proposal
Backstone Beck, River Wharfe, Ilkley
September 2015

1.0 Introduction

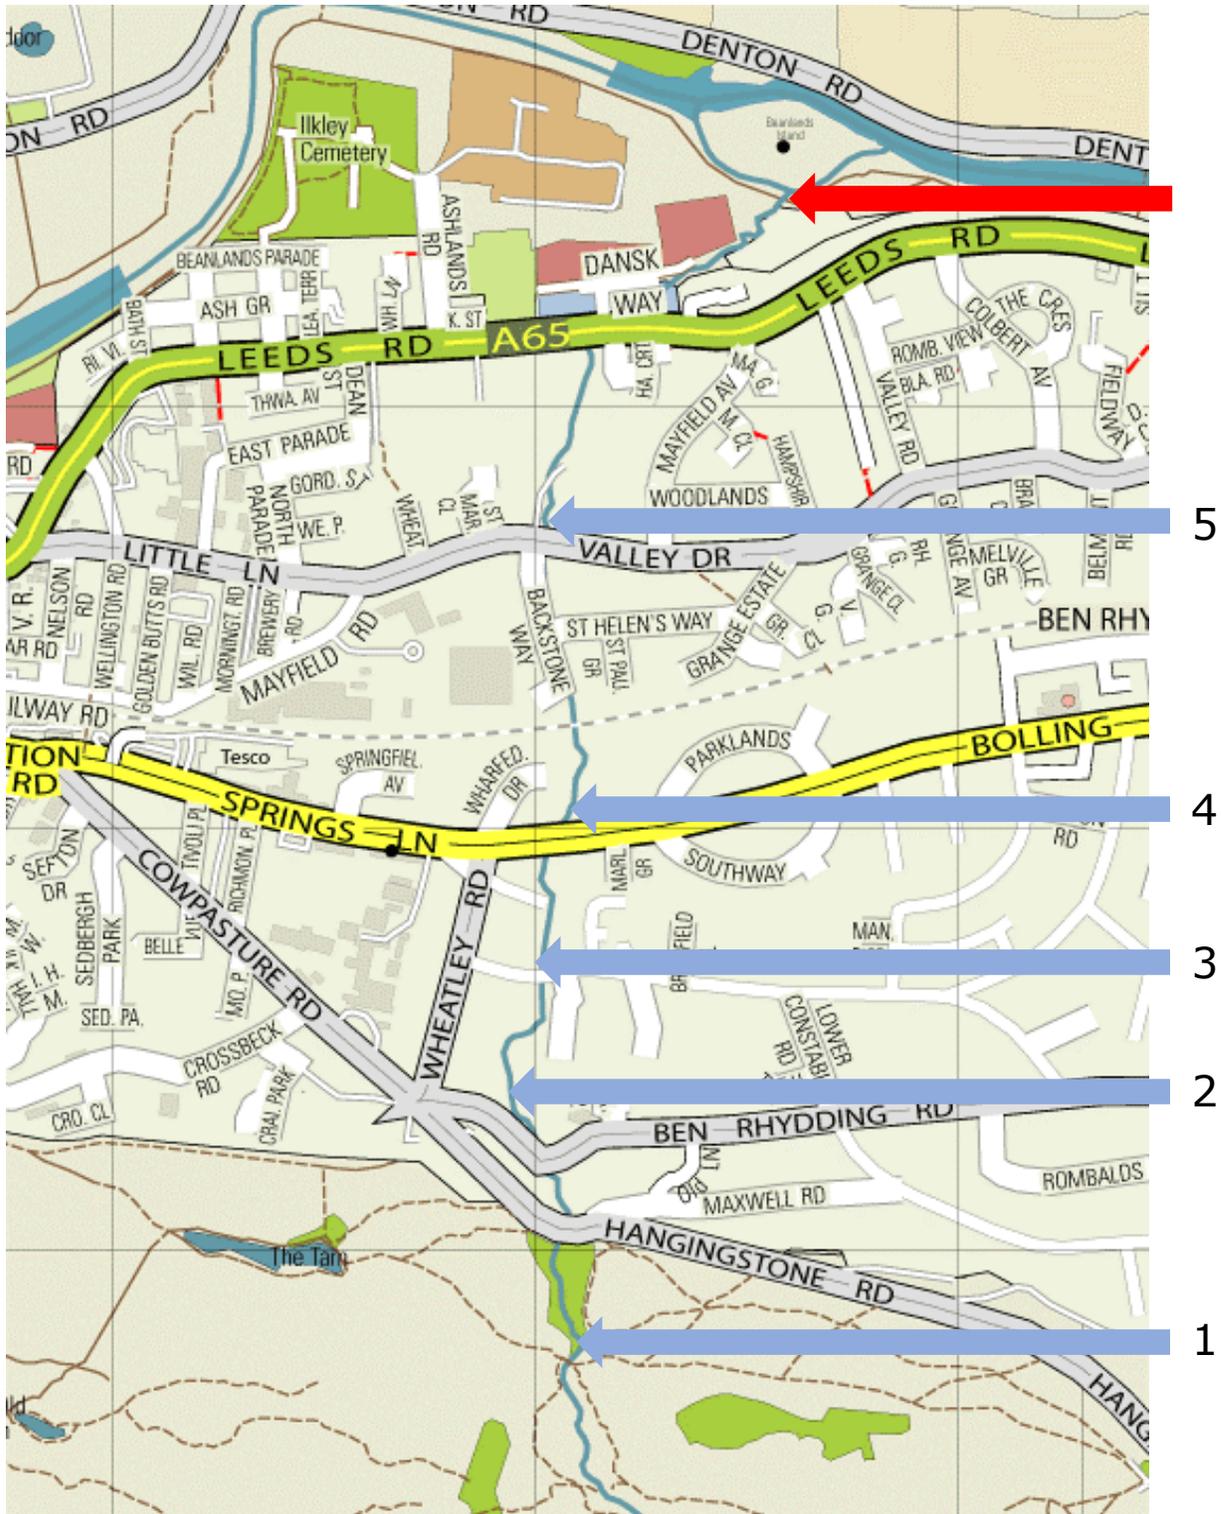
Figure 3. Map of Backstone Beck showing points accessed (numbered blue arrows) and position of the culvert (red arrow). Map created in streetmap (www.streetmap.co.uk).

The Beck was walked from SE1255546891 (arrow 1; Fig 3) in a d/s direction to arrow 2, and then a series of “spot checks” were conducted at each site indicated by the remaining arrows. The 15m section of beck

immediately u/s of the culvert (Fig. 3; red arrow) was also examined. At arrow 1, the Beck is of such a high natural gradient that it was deemed impassable to trout, and so it was not assessed any further u/s. Three impassable, man-made obstacles were noted between arrows 1&2: The culverts allowing Hangingstone Rd (Fig 4) and Ben Rhydding Rd (Fig 5) to pass over the Beck; and a vertical walled waterfall of approximately 4m at arrow 2 (Fig 6).

Access downstream from the waterfall was restricted and confined investigations to the spot checks indicated on Figure 3. At arrows 3, 4 and 5, and for the short section immediately u/s of the culvert at the confluence (red arrow in Fig 3), the hydromorphology of the Beck appeared quite natural with pool-riffle sequences typical of a high gradient headwater stream. Gravels in the 10-40mm diameter range (and hence of an appropriate size for spawning fish) were evident. The riparian (bankside) vegetation provided ample low and trailing cover, good refugia for juvenile fish and invertebrates alike. No fish were seen during the visit.
