**Walkover Assessment
Beechburn Beck
(River Wear Catchment)
County Durham
05/03/2019**

Undertaken by Gareth Pedley

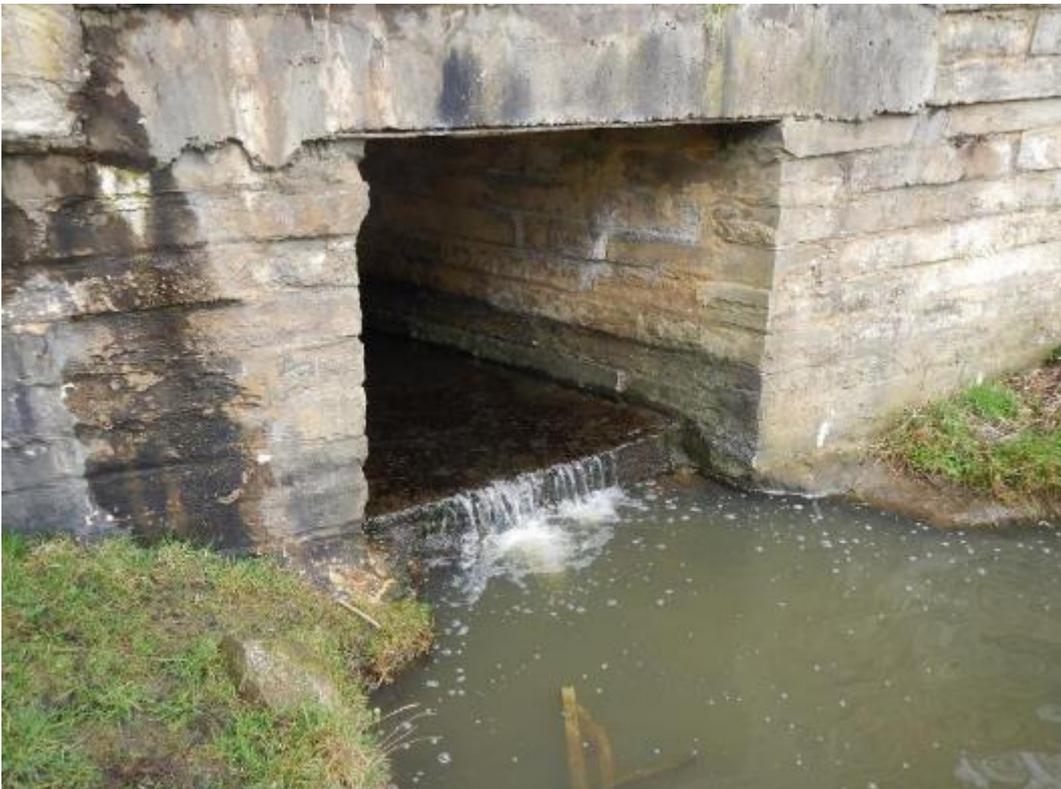
Photo DSCN0176. Obstruction Aii: the d/s end of the culvert creates a small obstruction (NZ 15888 37029).

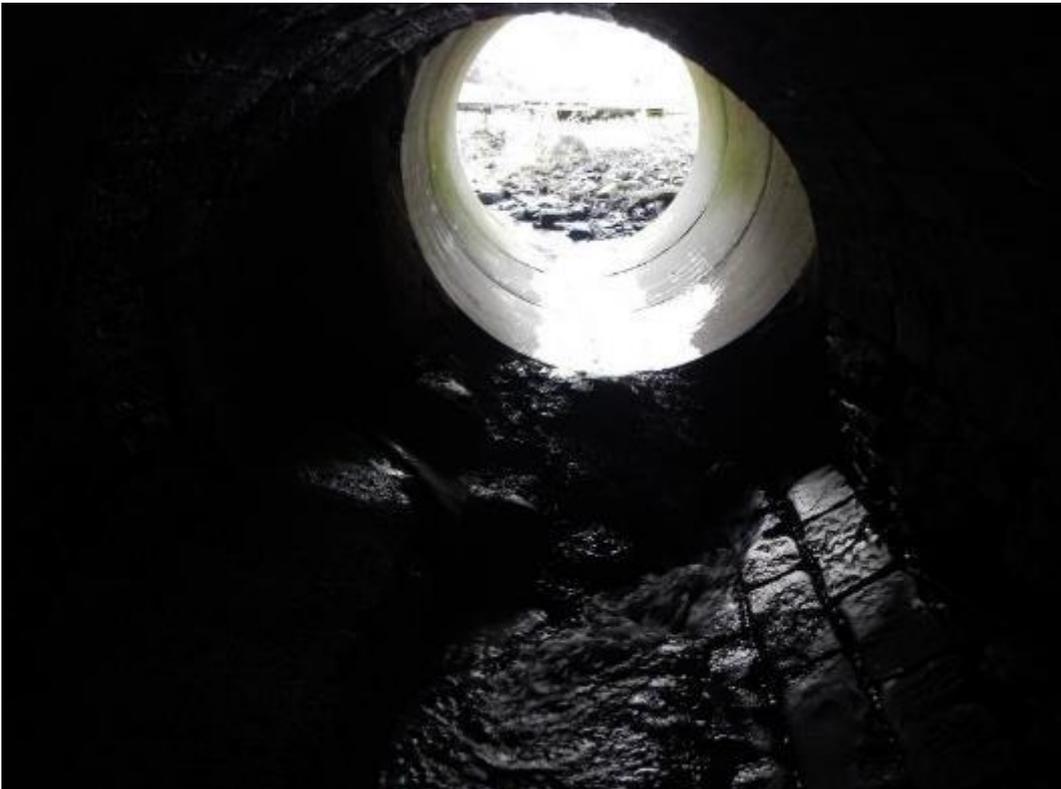
Photo DSCN0186. Obstruction Bi: a step in the invert towards the u/s end exacerbates the issue.

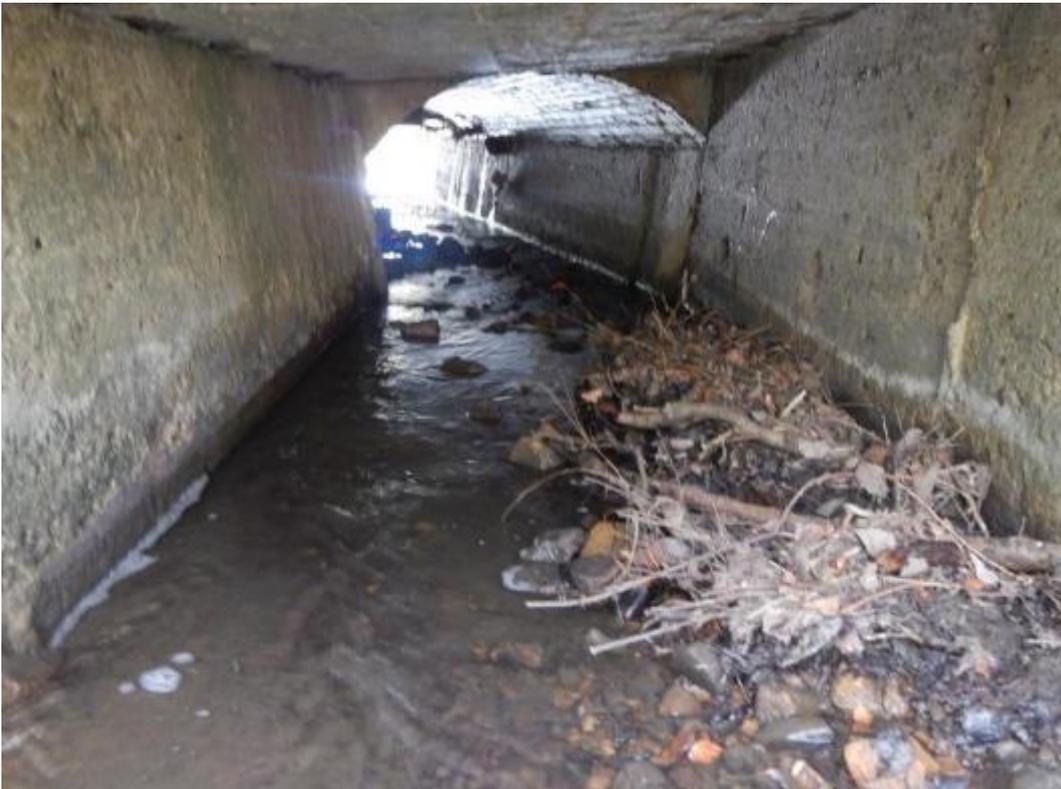
Photo DSCN0198. Natural substrate accumulation within a culvert at NZ 15993 36616 reduces the obstacle to fish passage.

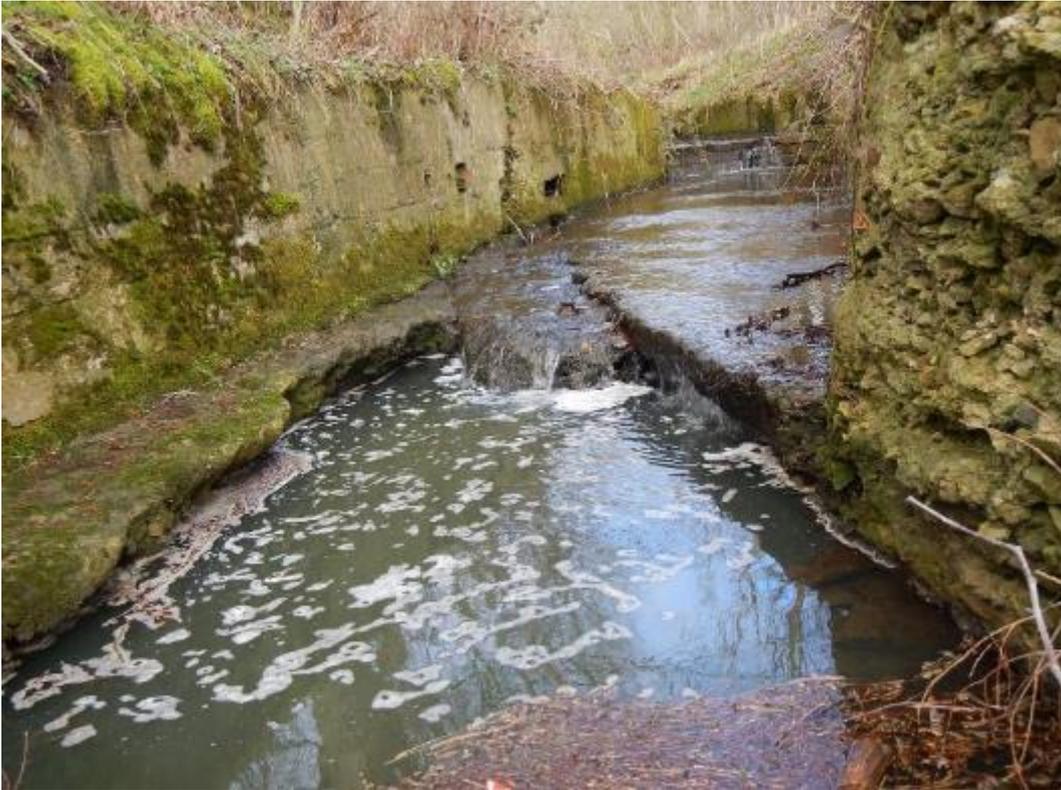
Photo DSCN. Obstruction E (NZ 16031 36522): a break within the concrete channel creates another obstacle but again provides the only real potential for increased water depth.

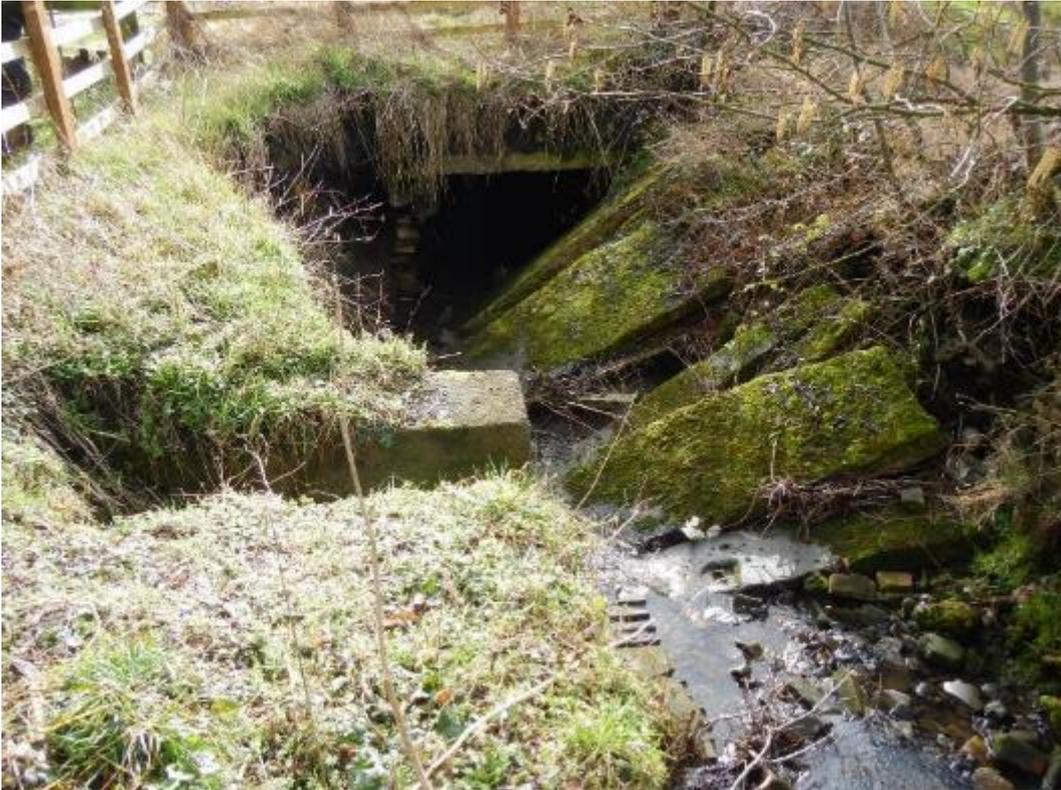
Photo DSCN0219. Obstruction G (NZ 16065 36440): the upstream end of a collapsing culvert is creating an obstruction and public safety risk.

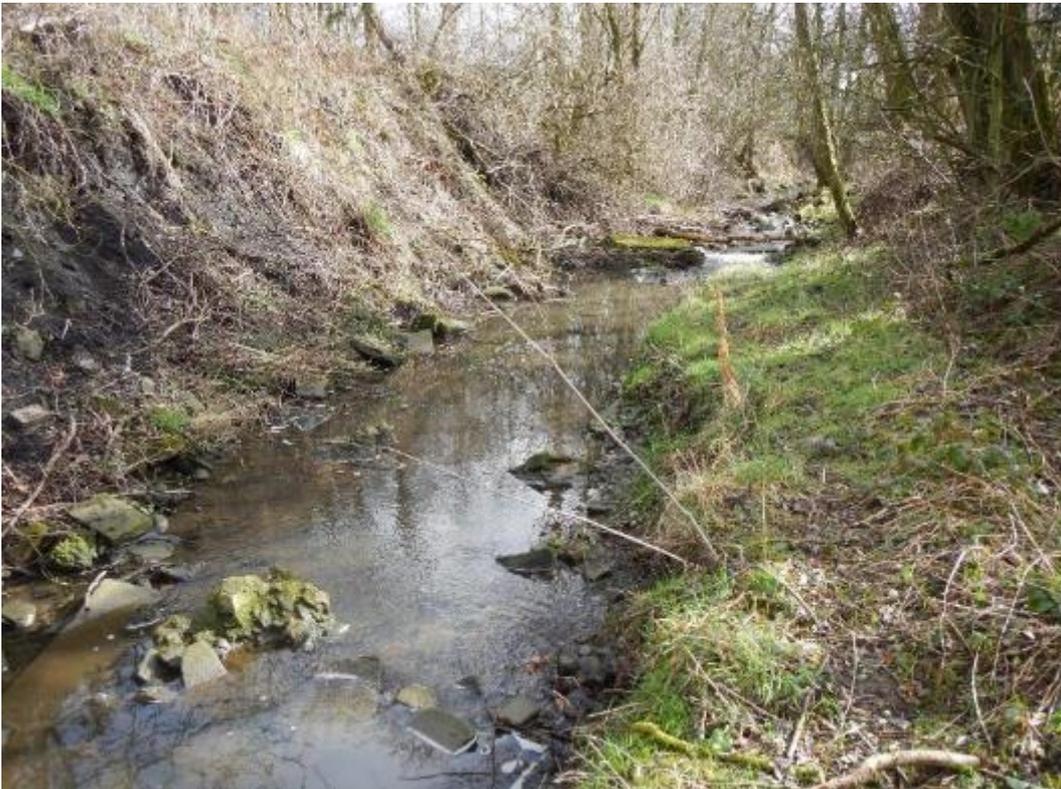
Photo DSCN0231. The channel d/s of the culvert is of an improved quality but the legacy of physical modification and land use remain.

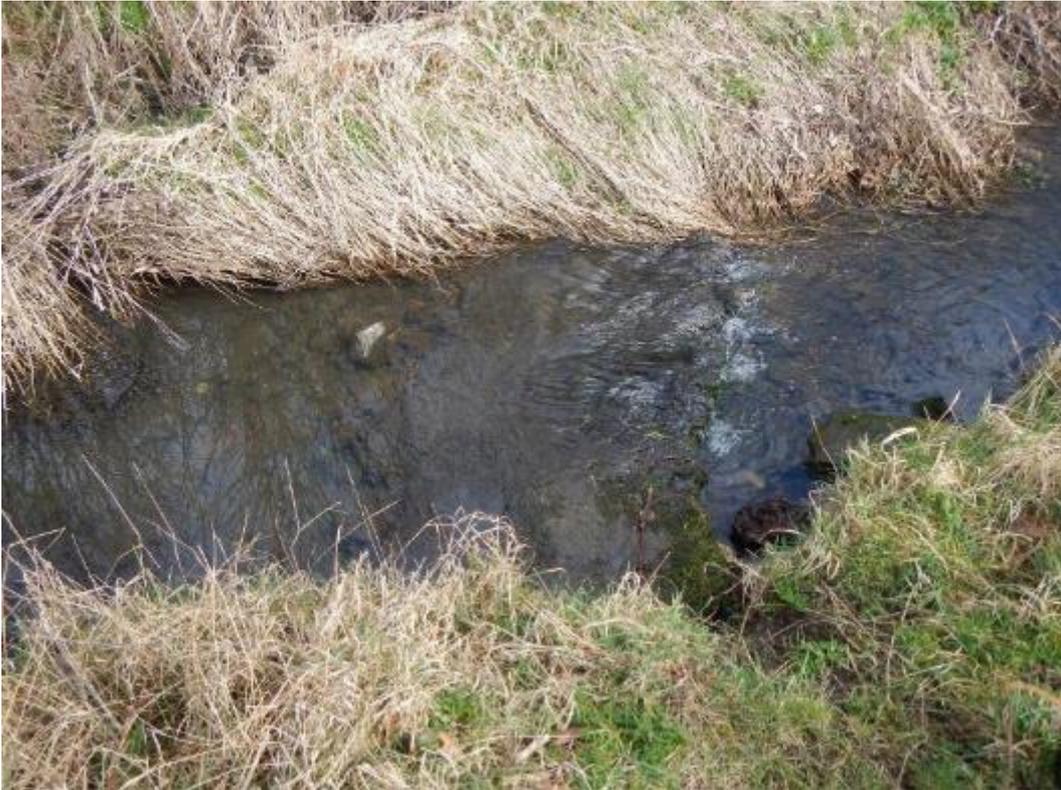
Photo DSCN0248. Obstruction K (NZ 16612 35882): another raised bed cross-section that should be removed if possible; however, it is suspected this structure may be armouring for a live sewage pipe. Such structures should be located well below or above a watercourse, not across the bed.

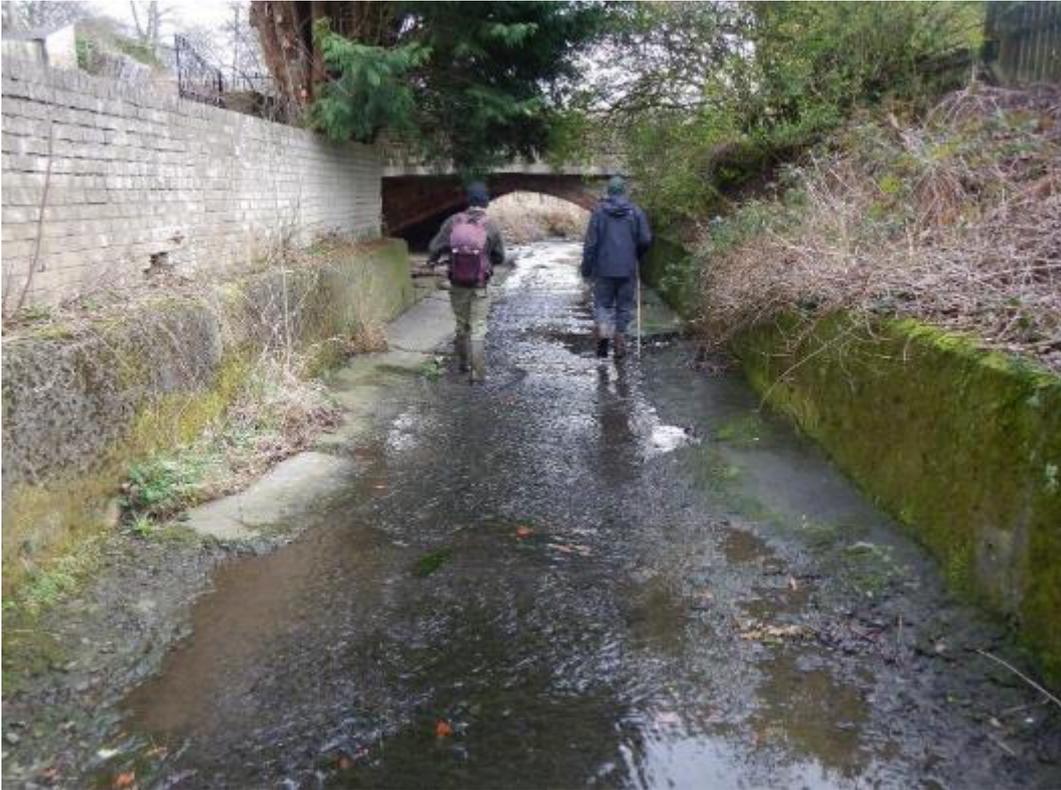
Photo DSCN0252. Obstruction L (NZ 16612 35882 - NZ 16785 35452): an extended section of concrete-lined channel through Crook creates shallow water and very poor habitat.

This site requires major restoration, within the constraints of an urban environment; coupled with water quality improvements, this could really improve the amenity status of the watercourse. Restoration would also address the physical obstruction to fish recolonisation. The actual feasibility of this within the surrounding infrastructure would require detailed investigation by engineers and river restoration specialists and constitutes a project in its own right.

If restoration is deemed completely infeasible, or impractical in the short-medium term, options to install features within the channel could be investigated. These might include breaking out sections of the concrete-lined bed, installation of engineered berm features or, as a basic minimum, installation of baffles to increase water depth to at least ease fish passage through the section. All of these options are likely to be subject to close scrutiny for potential impact upon flood risk.

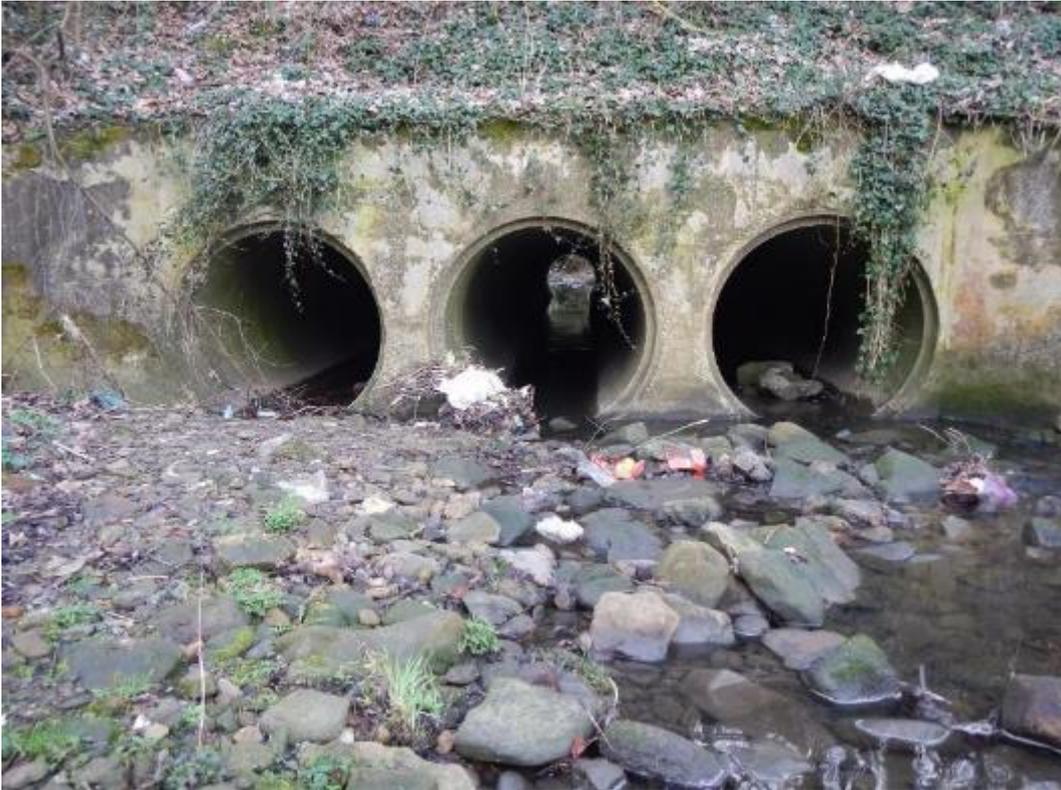
Photo DSCN0271. Obstruction O (NZ 16661 35189): a triple pipe culvert is partially sunken and relatively passable but splitting the flow three ways reduces passability especially under low flows and may encourage blocking via sedimentation over time.

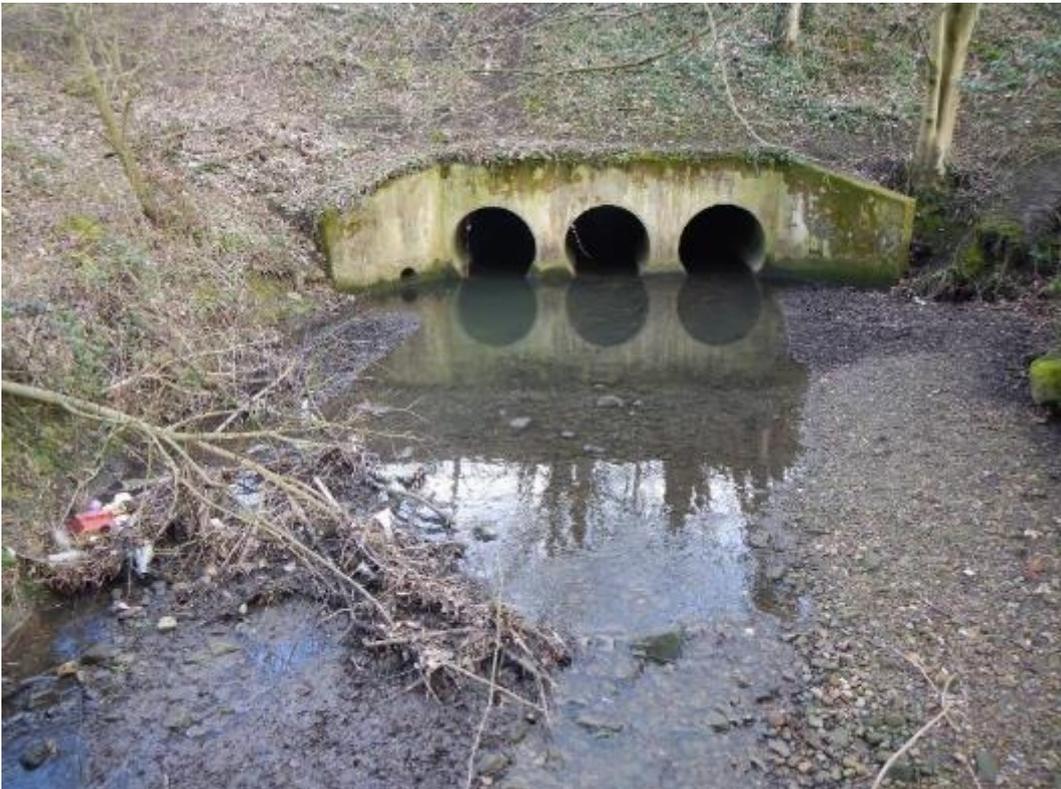
Photo DSCN0273. Obstruction Oi: the d/s end of the culvert is well sunken beneath the surface of the pool, allowing easy access.

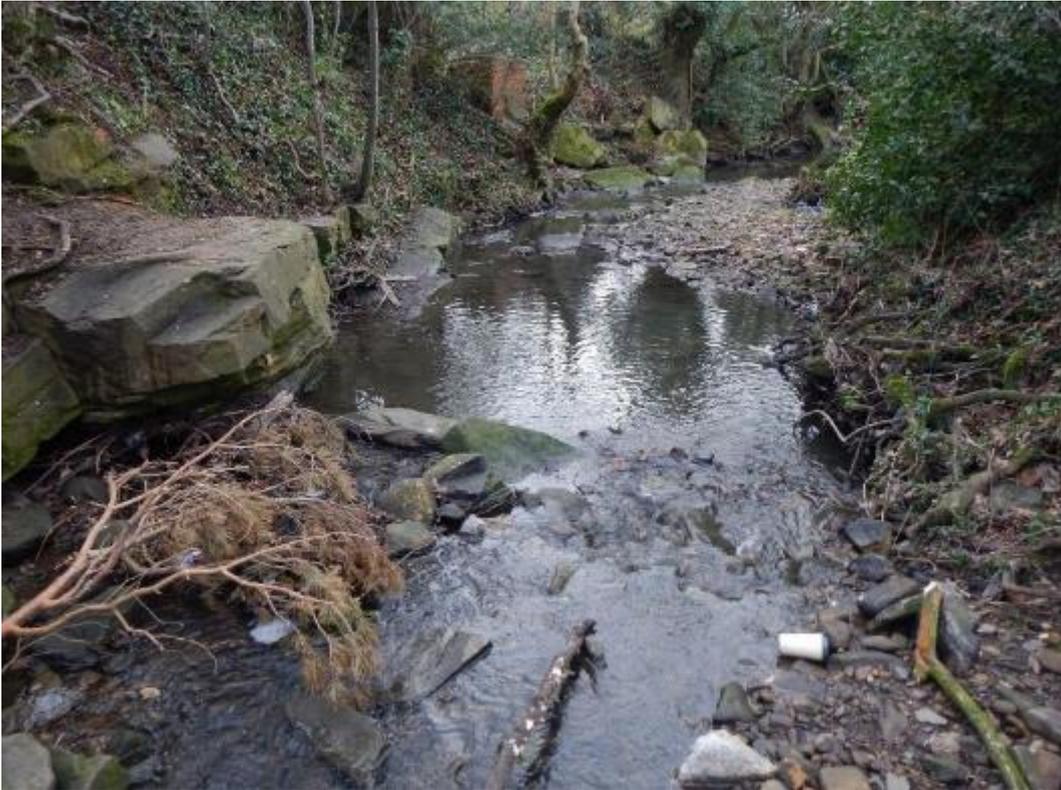
Photo DSCN0275. D/s of the culvert, the channel retains a more natural character (pool-riffle-glide sequences), with improved habitat quality.

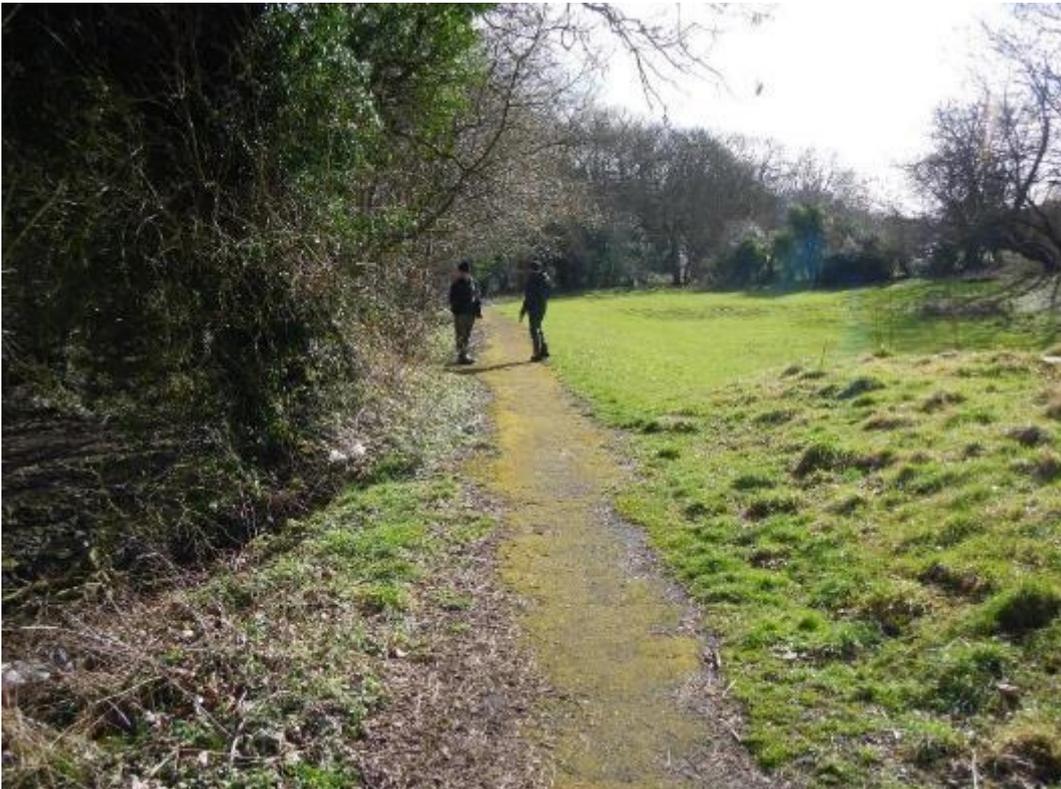
Photo DSCN0278. One of the few possibilities for improving floodplain reconnection and flood storage and/or channel re-meandering (NZ 16626 35090).

Whether this is the point of a natural meander lost through artificial straightening or simply an area of lower ground from much older paleo-channels, the currently straight watercourse could be improved by realignment to a more sinuous course to the RB side, to mitigate the many other confirmed areas of artificially straightened channel. This could also increase the potential for retention of high flows and reducing flood risk d/s while providing habitat improvements to the beck. The public access to the site is a consideration but realignment of the channel and improvement of the beck's ecology could also improve the amenity value of the site and act as a focal engagement / education opportunity.

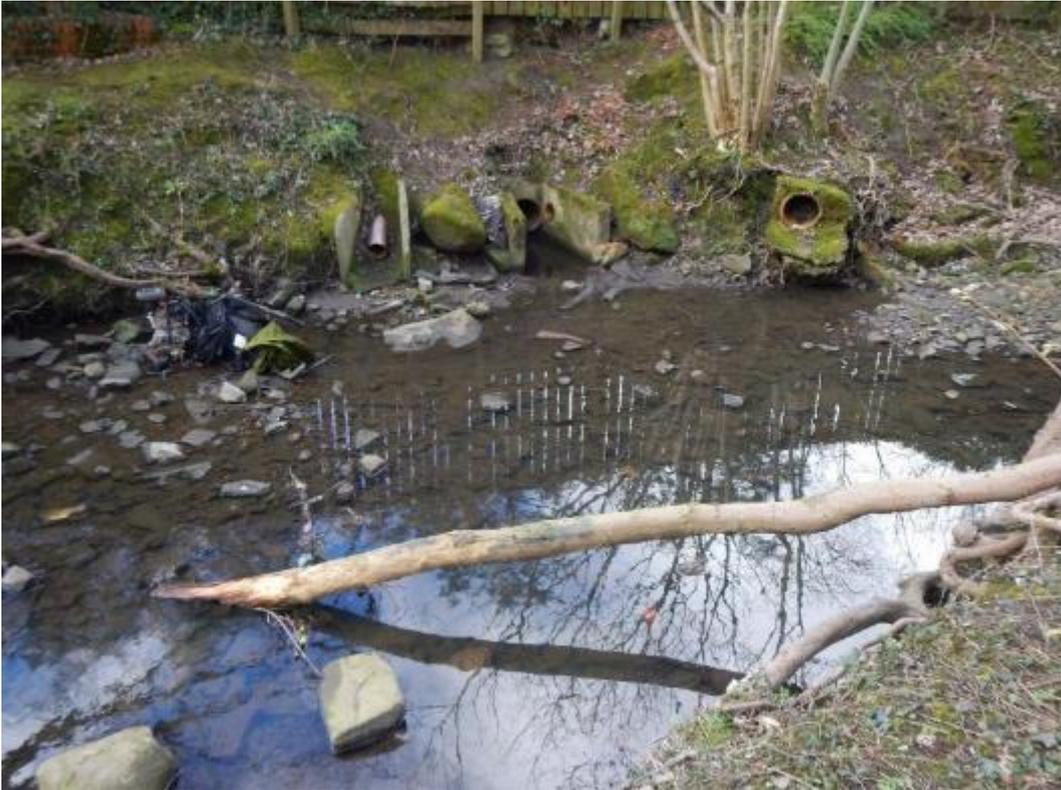
Photo DSCN0284. Point source pollution 6 (NZ 16637 34844): the grey nature of the water and sediment suggests road runoff and, potentially, domestic water misconnections.

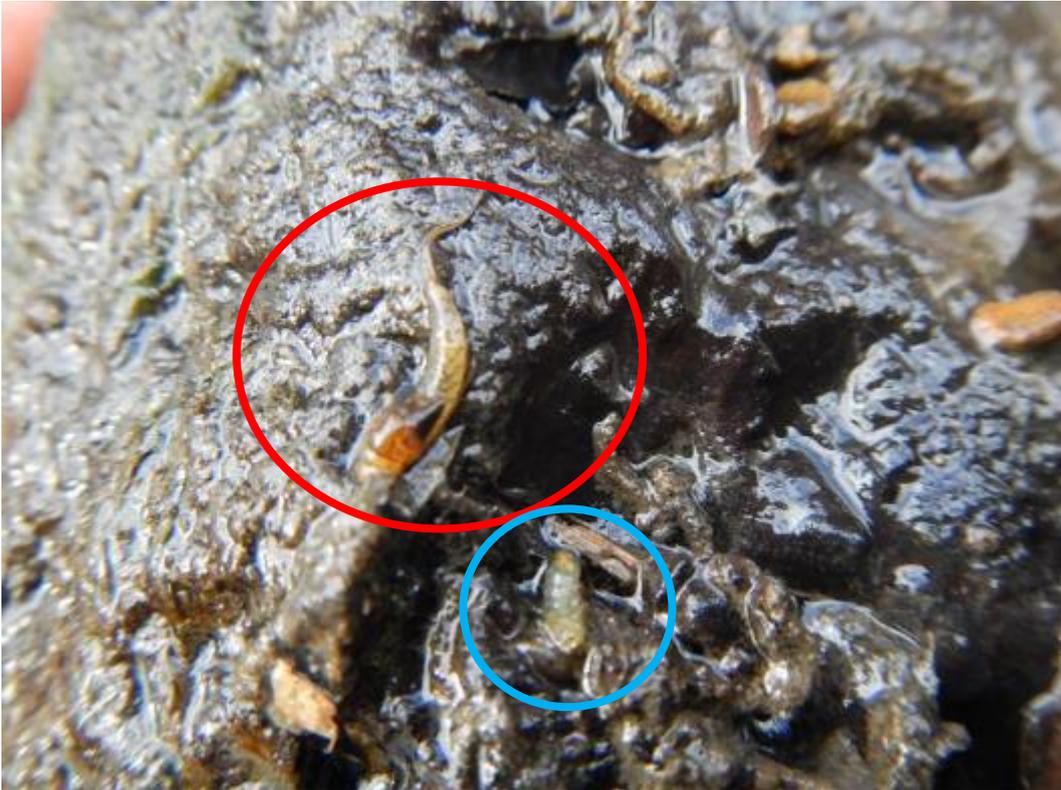
Photo DSCN0288. Despite the water quality issues, stone-turning did reveal some medium sensitivity species of mayfly (red circle) and caddisfly nymphs (blue circle).

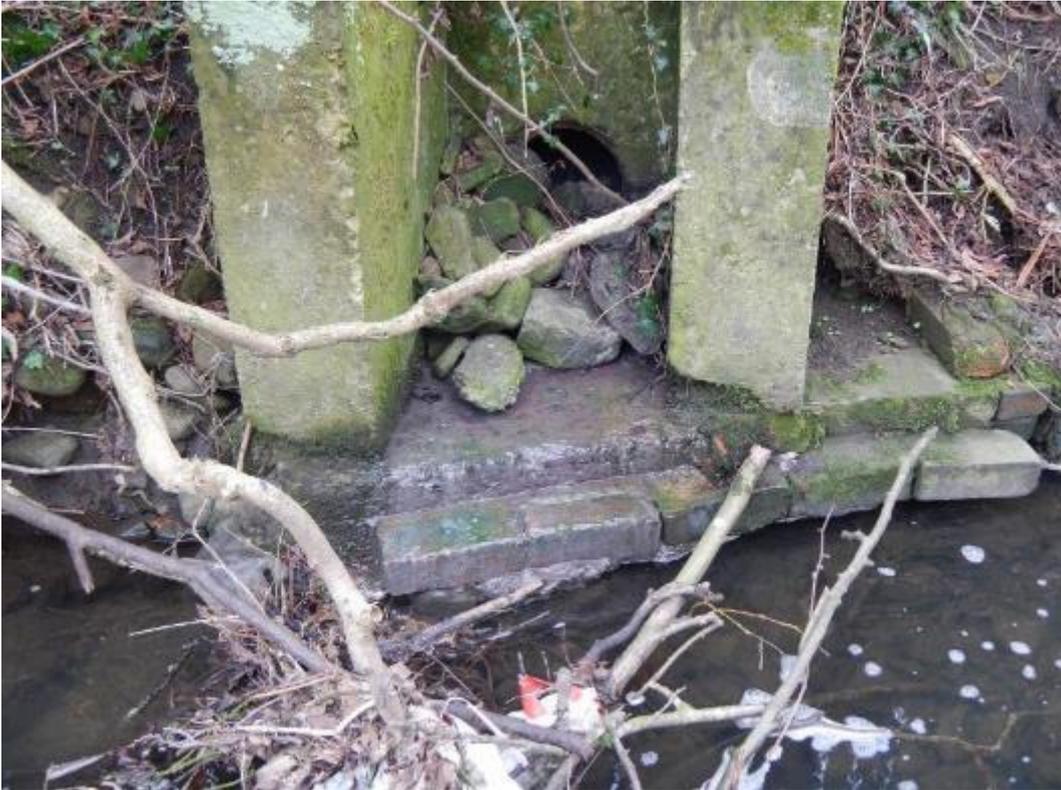
Photo DSCN0292.) Point source pollution 7 (NZ 16510 34611): high nutrient domestic discharge; suspected domestic misconnection.

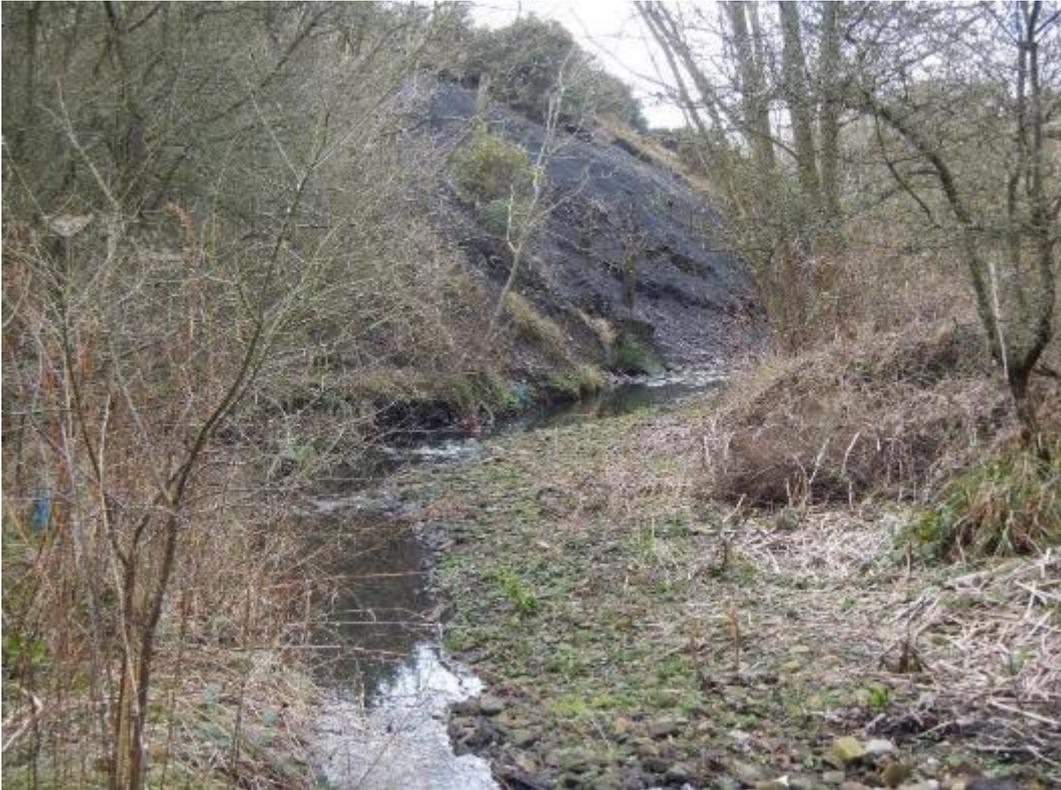
Photo DSCN0294. At NZ 16478 34513, the signs of a coal mining heritage are again evident where eroded material from a large mound of slag is entering the watercourse.

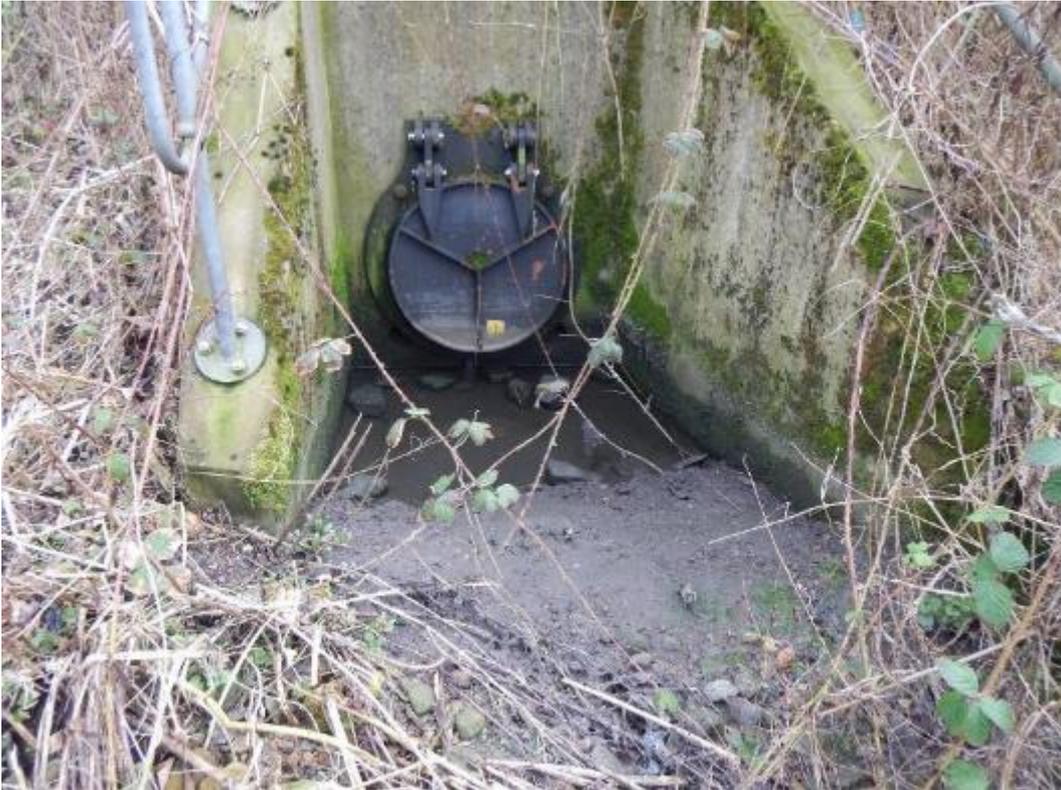
Photo DSCN0304. Point source pollution 9 (NZ 16312 33965): substantial volumes of fine sediment appear to have been entering the watercourse from a large flap valve.

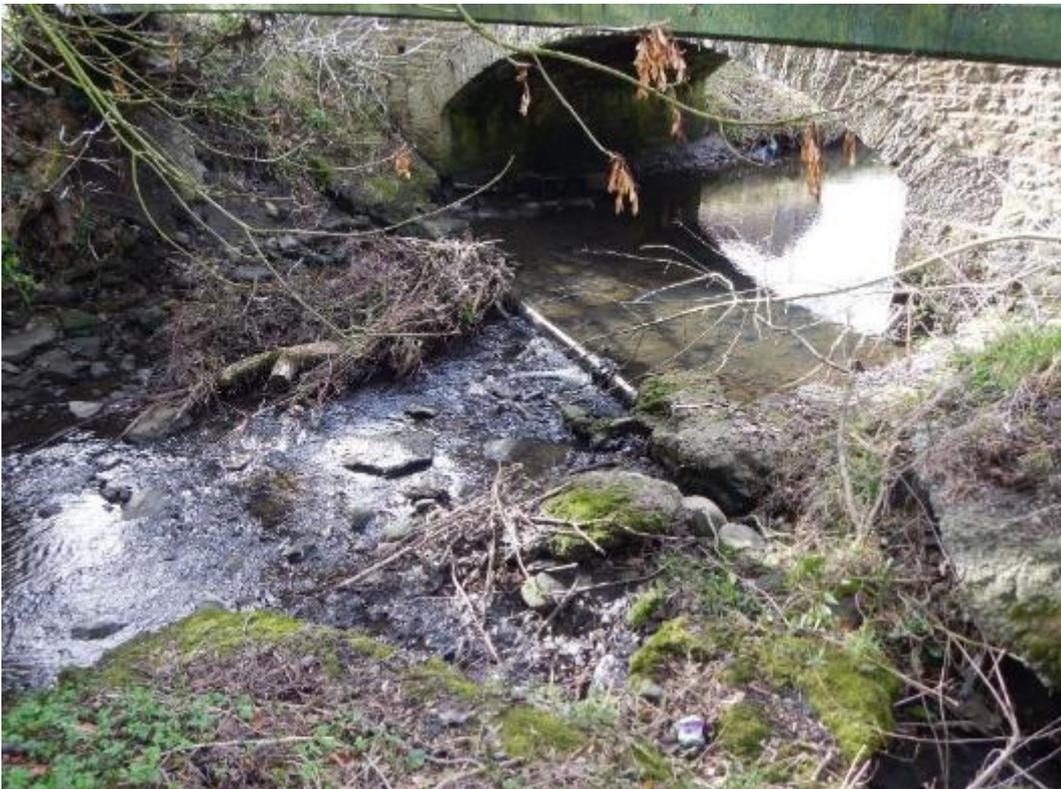
Photo DSCN0314. Obstruction P (NZ 16476 33612): a pipe crossing creates a small impoundment/obstruction.

1/2	NZ 16476 33612	Major infrastructure investment is required to sink the pipe crossing well below bed level, as should have been the case when it was installed. This pipe is now exposed sufficiently to be at risk of damage and poses a pollution risk.
Point source pollution 11 – garden waste.

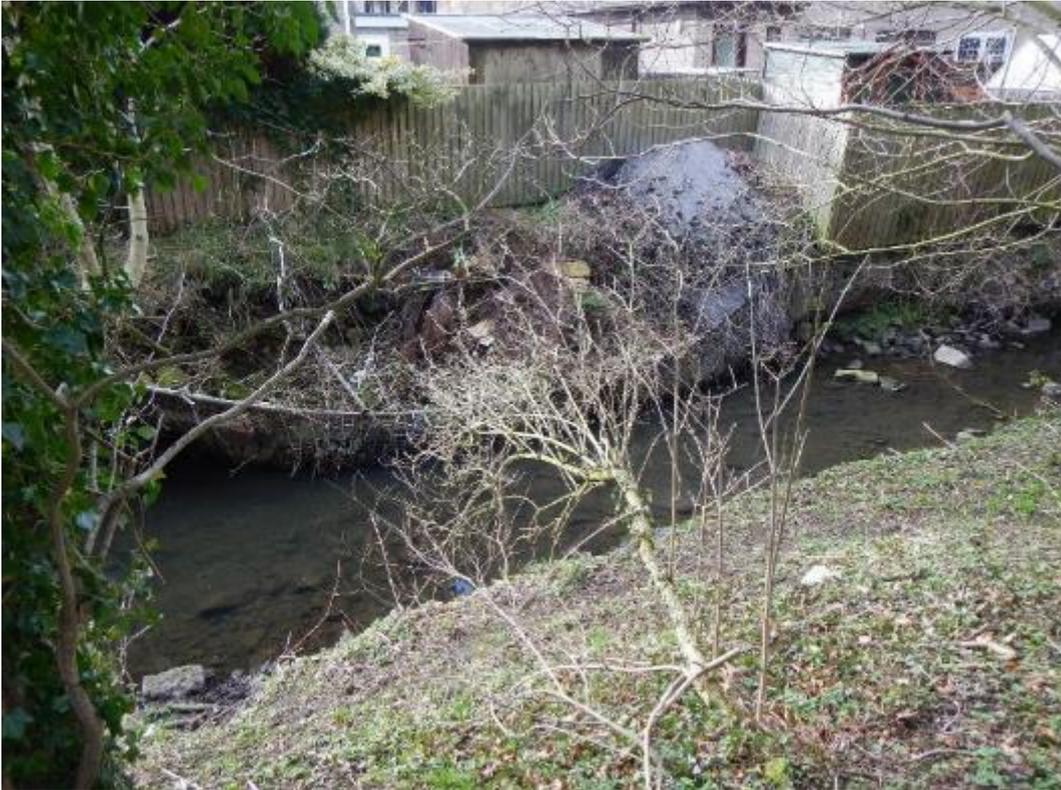
Photo DSCN0319. Point source pollution 11 (NZ 16496 33548): fire ash and other garden waste being discarded to the watercourse – if this were anywhere else it would be considered fly-tipping!

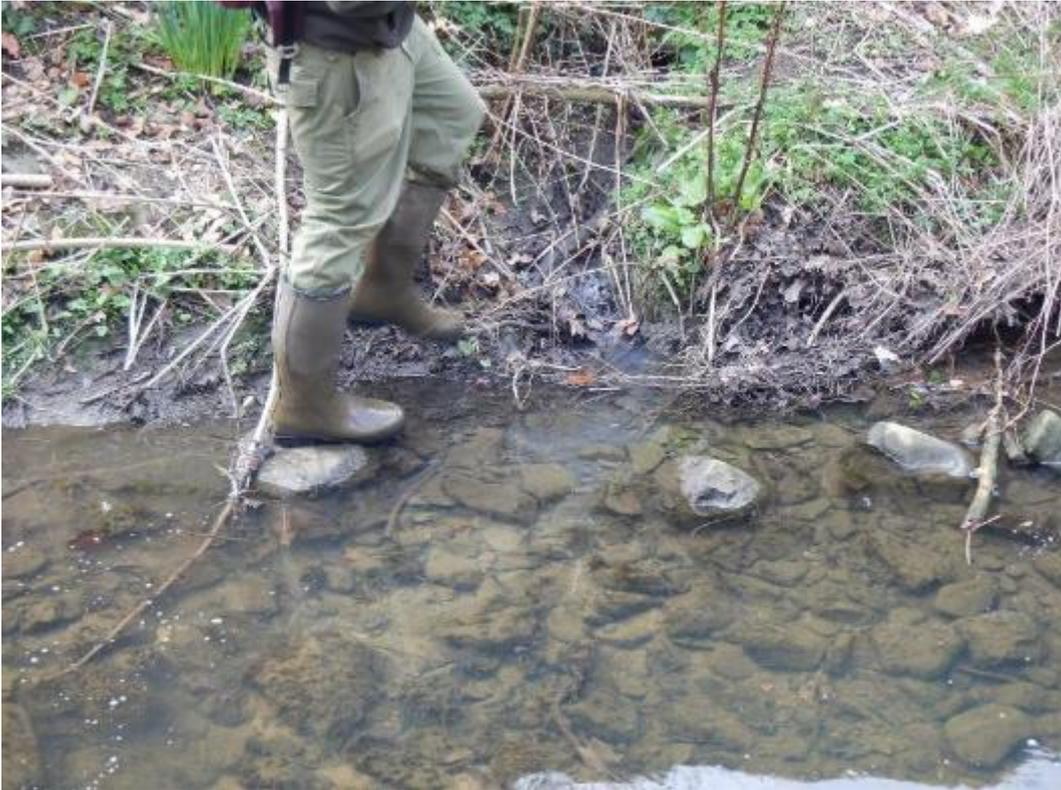
Photo DSCN0320. Point source pollution 12 (NZ 16498 33476): suspected domestic water discharge/misconnection(s).

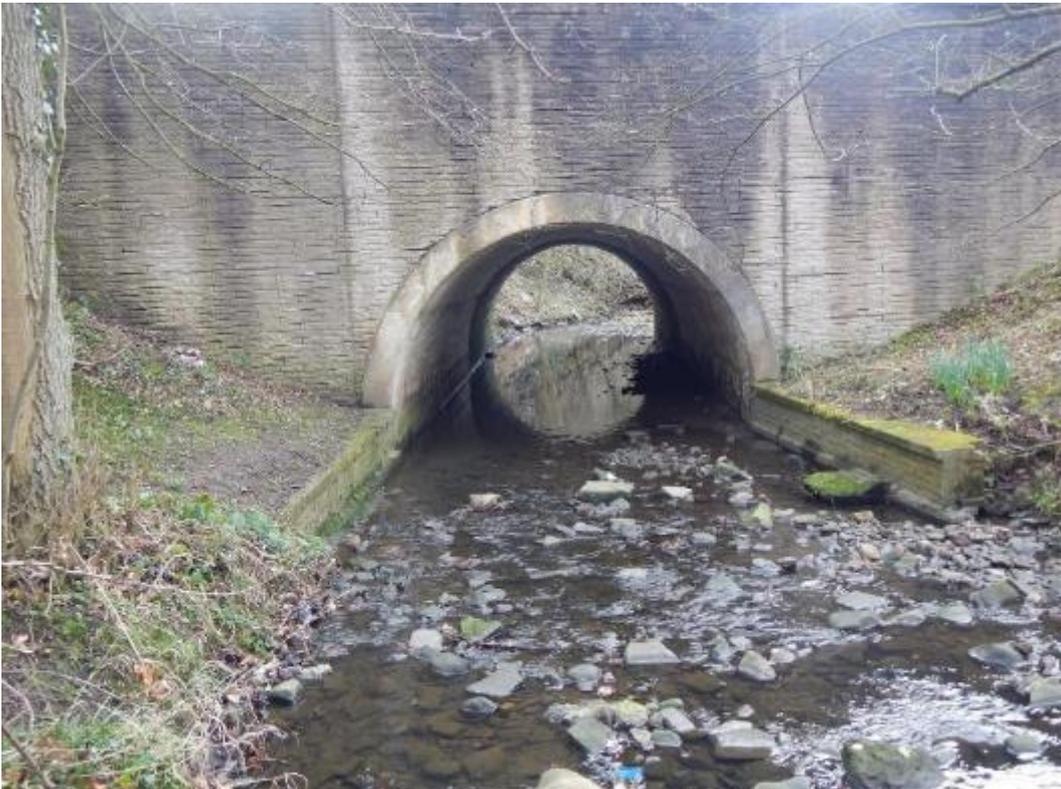
Photo DSCN0323. The B689 Bridge St. culvert poses no sediment or fish passage issues (NZ 16458 33234).

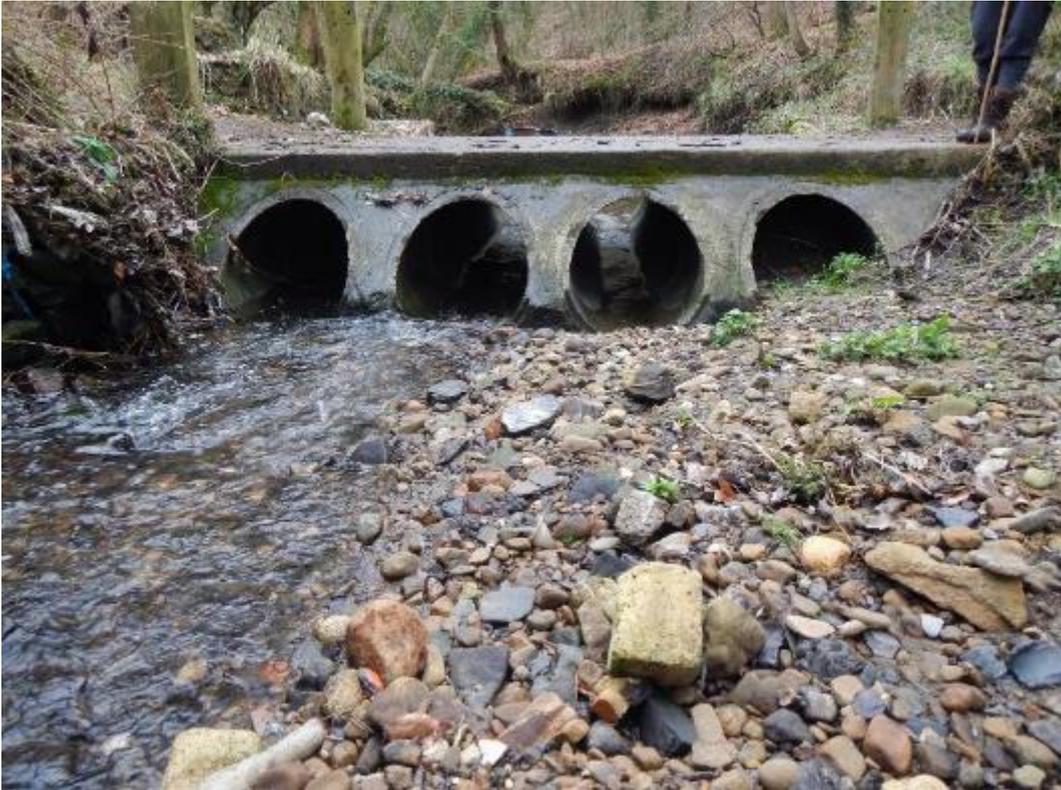
Photo DSCN0330. Obstruction R (NZ 16571 32697): a pipe culvert/bridge creates an issue for sediment transport and fish passage. Note two of the five pipes are already blocked, with one no longer even visible from the u/s side.

Pipe culverts are an outdated design and should be replaced with clear-span bridges or sunken culverts that allow natural reinstatement and retention of bed throughout. Either option is likely to be costly at this site, owing to the existing, inappropriate infrastructure, particularly the concrete-lined bed that would have to be broken out. Installation of an appropriately-sized, pre-cast culvert that can be sunken with a quarter to one third of its capacity below the bed level is likely to be the most cost-effective option that would also reduce the long-term maintenance costs (right photo).

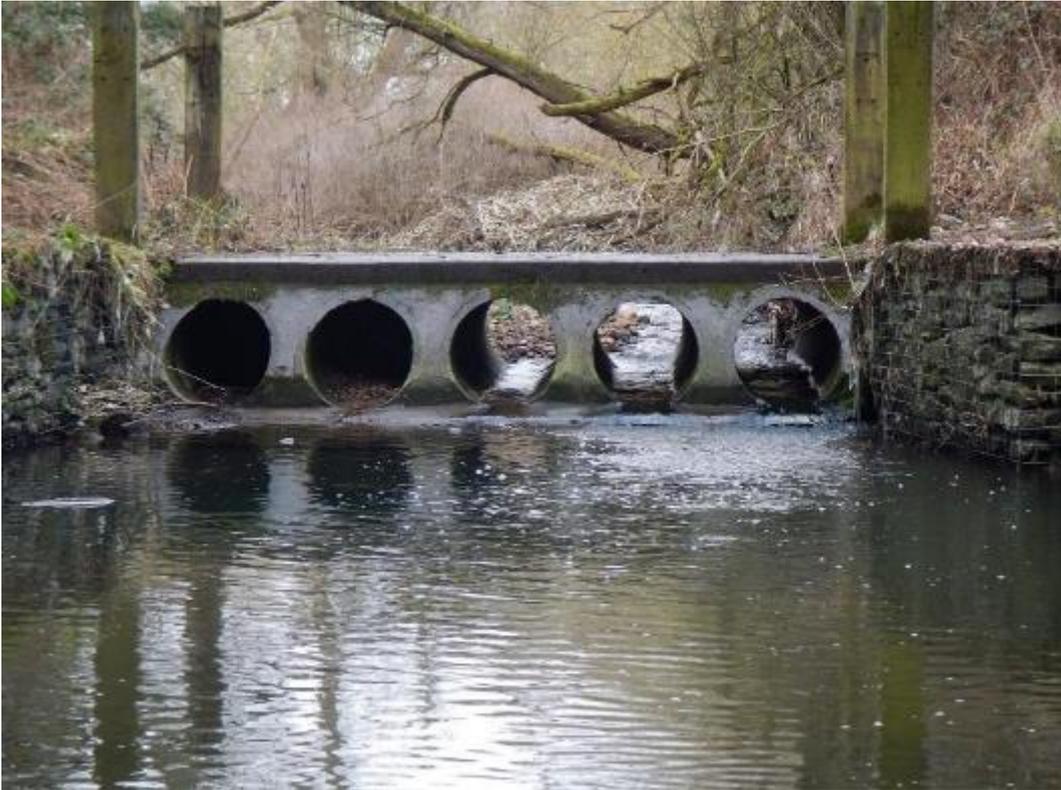
Photo DSCN0334. Obstruction R: although the d/s pool provides good access to the culvert, the apron and pipes greatly reduce the passability of the structure for fish needing to migrate u/s. This could be a particular issue for juvenile dispersal and recolonisation from spawning and higher quality habitat areas d/s.

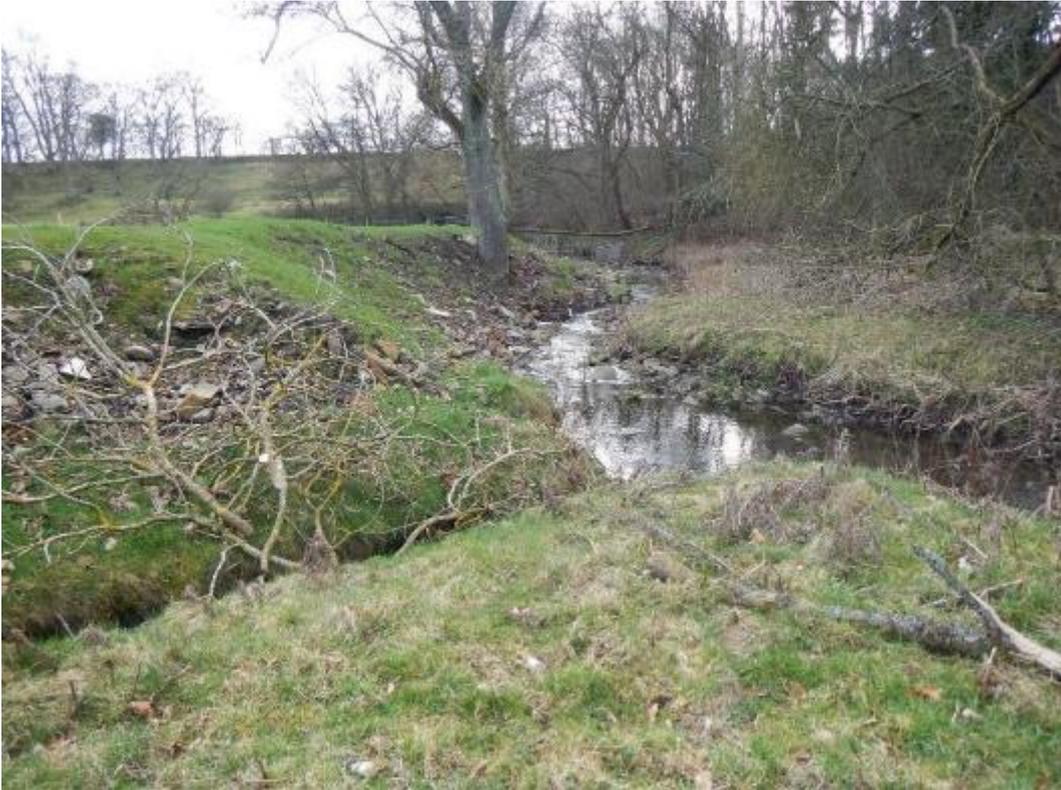
Photo DSCN0342. In the first field d/s of the wood, an area of bank has been elevated with hardcore and soil, then reseeded (NZ 16773 32289). The area is open to livestock.

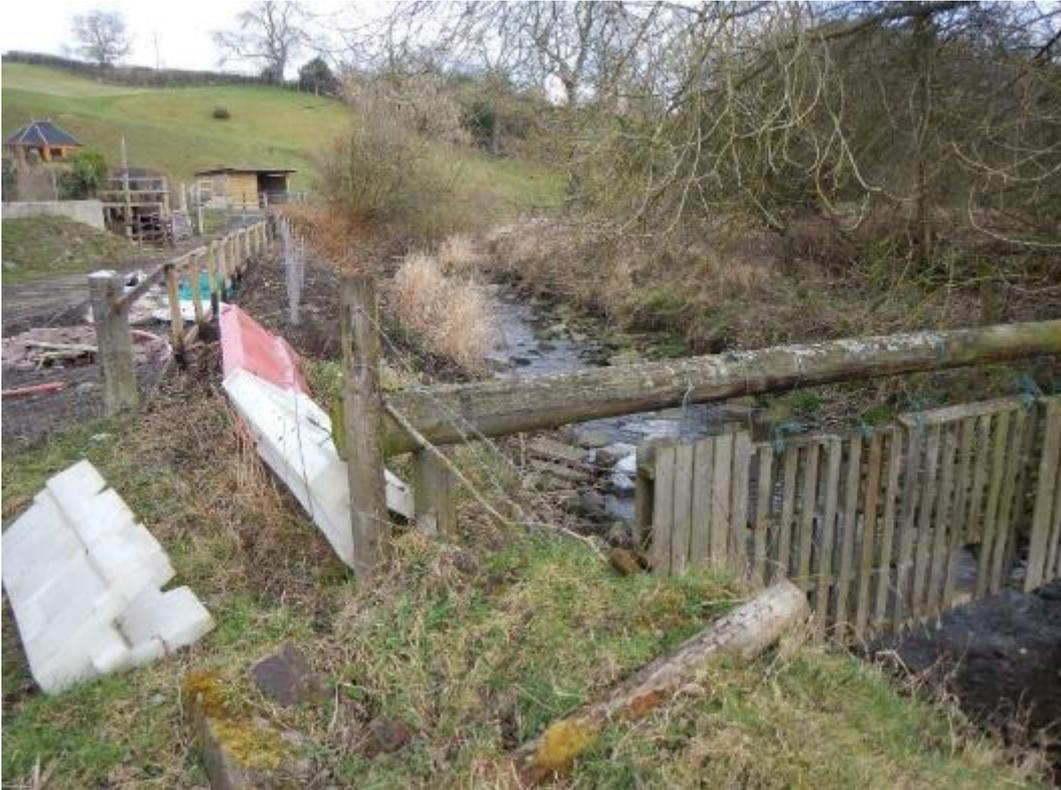
Photo DSCN0345. Several areas of raised embankment have been installed around Mill Farm (NZ 16933 32032).
