Walkover Assessment
Black Beck
(River Ehen Catchment)
20/11/2018

Undertaken by Gareth Pedley

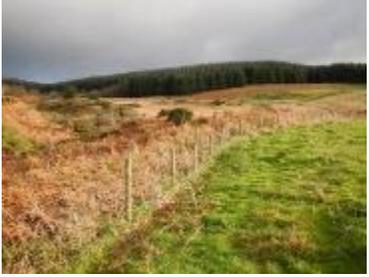
Issue	Photo (If required)	Priority (1-3)	Location	Proposed action
Buffer fencing.

3	NY 02814 12001 - NY 02394 11814	Ensure existing fencing is maintained to preserve the now significant benefit it provides.
Lack of buffer fencing and poaching of the field (LB & RB).

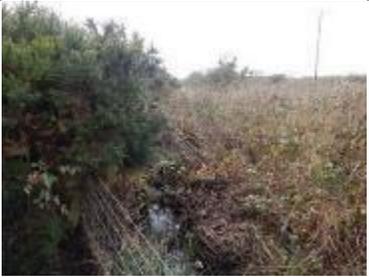
2	NY 02202 11521 - NY 02198 11372 (C. 160m)	Install buffer fencing. N.B. This area could have potential for channel restoration.
Buffer fencing.

3	NY 02198 11372 - NY 02123 11268	Ensure existing fencing is maintained to preserve the benefit it provides.

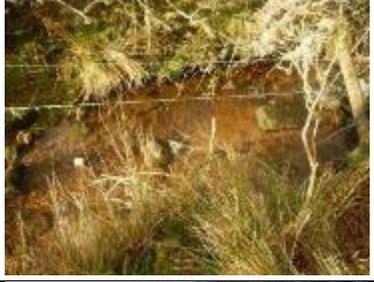
Lack of buffer fencing (LB).

2	NY 02123 11268 - NY 02059 11130 (c. 150m)	Install buffer fencing. N.B This should encompass the boggy area at the d/s end of the field.
Lack of buffer fencing on either the LB or RB between grid refs.

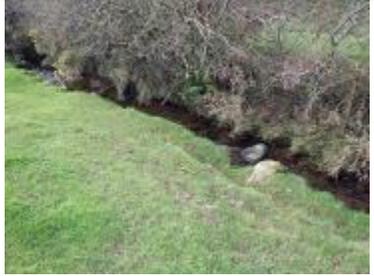
2	NY 02059 11130 - NY 01998 10942 (c. 200m)	Install buffer fencing.
Lack of buffer fencing on either the LB or RB between grid refs.

2	NY 01998 10942 - NY 01969 10875 (c. 75m)	Install buffer fencing. Additional tree planting would also be beneficial.
Lack of buffer fencing (LB).

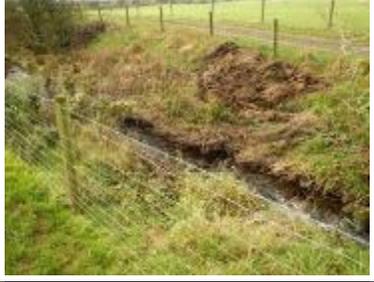
Buffer fencing.

3	NY 01880 10742 - NY 01844 10663	Ensure existing fencing is maintained to preserve the benefit it provides.
Buffer fencing.

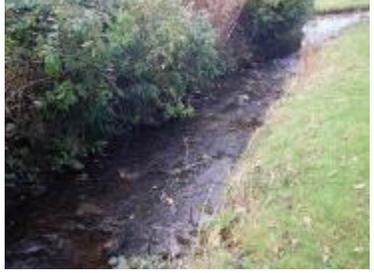
3	NY 01844 10663 - NY 01747 10494	Ensure existing fencing is maintained to preserve the benefit it provides. Additional tree planting would also be beneficial.
Buffer fencing.

3	NY 01449 10386 (c. 90m)	Install buffer fencing. Also ensure that valuable trailing and aerial cover is not removed.

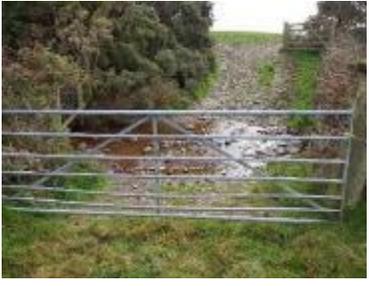
Photo DSCN5133. The crossing fording point inspected does create the first potential location for fine sediment input observed (NY 02549 11905). Ideally, the gates at either side would be kept closed when fording is not occurring, to maintain healthy vegetation cover on the banks. However, it is likely that the area is being used for livestock watering, so an alternative water source is likely to be required.

Issue	Photo (If required)	Priority (1-3)	Location	Proposed action
Fording/drinking point.

2	NY 02549 11905	<p>The crossing point should be closed when not in use and alternative stock watering provided.</p> <p>The step at the ford should also be alleviated by either an appropriately sized sunken culvert or lower level ford.</p>
Perched (at the d/s end), undersized culvert that will restrict fish passage.

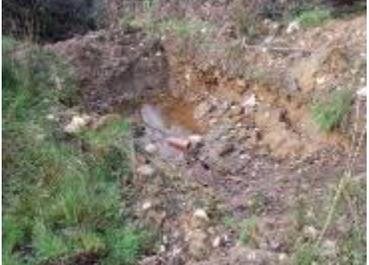
2	NY 02394 11814	<p>Culverts should be set be of sufficient capacity with c.1/3 set below the bed level and accommodate high flows and sediment transport. This will also reduce the issues of erosion at the d/s end and the potential for them becoming perched.</p>
Incomplete field drainage system.

2	NY 02266 11588	<p>Contact the landowner to make them aware of the potential pollution issues, with reference to the new Farming Rules for Water.</p>

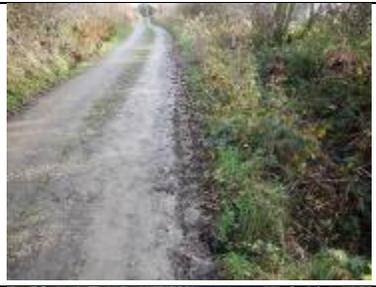
Photo DSCN5145. Problems from surface runoff were observed at the track crossing d/s. The problem and potential solution are complicated by the fact that the ditches running alongside the track also discharge directly to the beak, which is very poor practice (NY 02251 11583).

Track runoff directly into to the beck.

2	NY 02251 11583	Install cross drains and prevent direct discharge from any surface water conduits to the beck.
Small culvert.

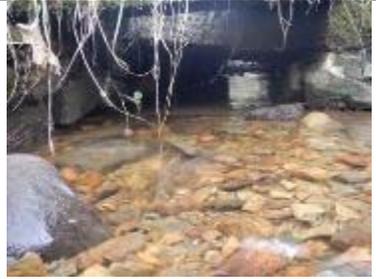
Photo DSCN5147. The culvert beneath the track is of limited size but was relatively free from debris at the time of the visit (NY 02251 11583). The structure is suitably installed to allow the movement of fish and sediment (if maintained free from debris). It may be an obstruction at higher flows, due to fluming, but is less of an issue than many of the other culverts observed.

3	NY 02251 11583	Ensure the culvert is kept free from blockages.
Major poaching and fine sediment input to the watercourse.

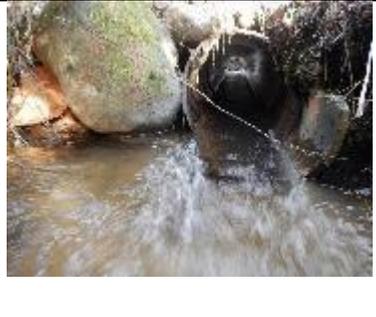
1	NY 02123 11268	The farmer should be approached and made aware of the Framing Riles for Water and encouraged to rectify the problem. If no action is taken, the issue should be raised on the Environment Agency National Incident Reporting System (NIRS).
Culvert and obstruction to fish passage.

1	NY 02123 11268	Culverts should be set be of sufficient capacity with c.1/3 set below the bed level and accommodate high flows and sediment transport. This will also reduce the issues of erosion at the d/s end and the potential for them becoming perched.

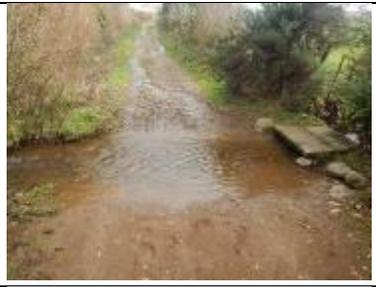
Track runoff directly into the beck.

2	NY 02059 11130	Install cross drains and prevent direct discharge from any surface water conduits to the beck.
Fording/drinking points.

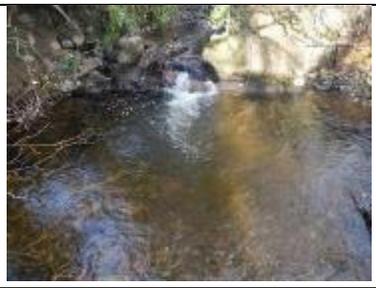
3	NY 01844 10663	Ideally exclude livestock and provide offline watering.
Weir – an obstacle to fish passage.

1	NY 01746 10511	As the weir is now obsolete it should be completely removed to reinstate natural sediment transport and fish passage.
Culvert - an obstacle to fish passage.

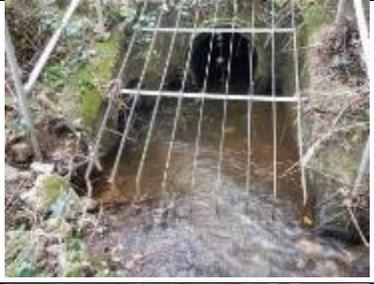
Culvert - an obstacle to fish passage.

2	NY 01582 10371	Install baffles where possible. It may also be possible to partially drown out the culvert with a structure installed at the d/s end.
Composting on the bank.

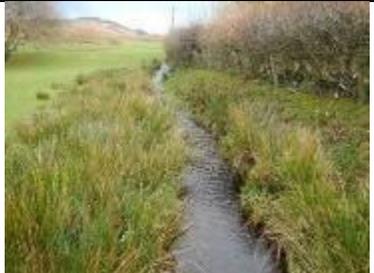
Issue	Photo (If required)	Priority (1-3)	Location	Proposed action
Lack of buffer fencing mainly both banks.

2	NY 02039 10710 - NY 01946 10666 (c. 200m)	Install buffer fencing.

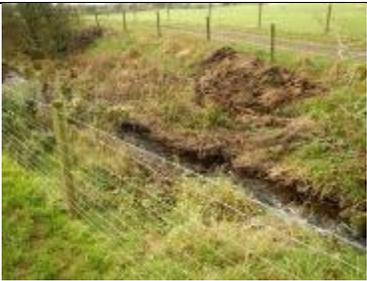
Buffer fencing.

3	NY 01880 10742 - NY 01844 10663	Ensure existing fencing is maintained to preserve the benefit it provides.
Buffer fencing.

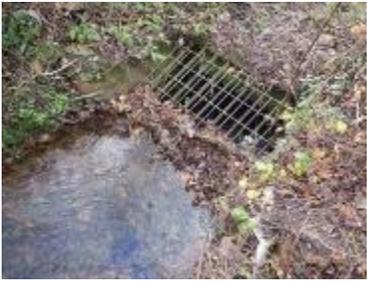
Issue	Photo (If required)	Priority (1-3)	Location	Proposed action
Completely impassable barrier created by inappropriate screening trapping substrate.

1		Investigate options to remove the culvert and reinstate the tributary as a surface watercourse. As a bare minimum, notch/remove step and additional screen at the u/s end of the culvert and ideally modify the original screen.

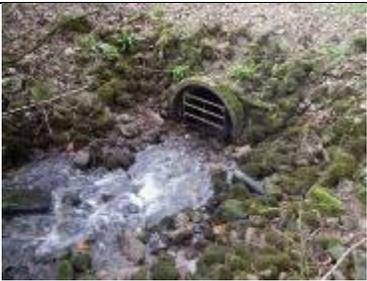
NY 01620 10344

Poorly passable culvert.
