Advisory Visit

River Blackwater, Kells Angling Association

Co. Meath, Eire

17-20th November, 2008

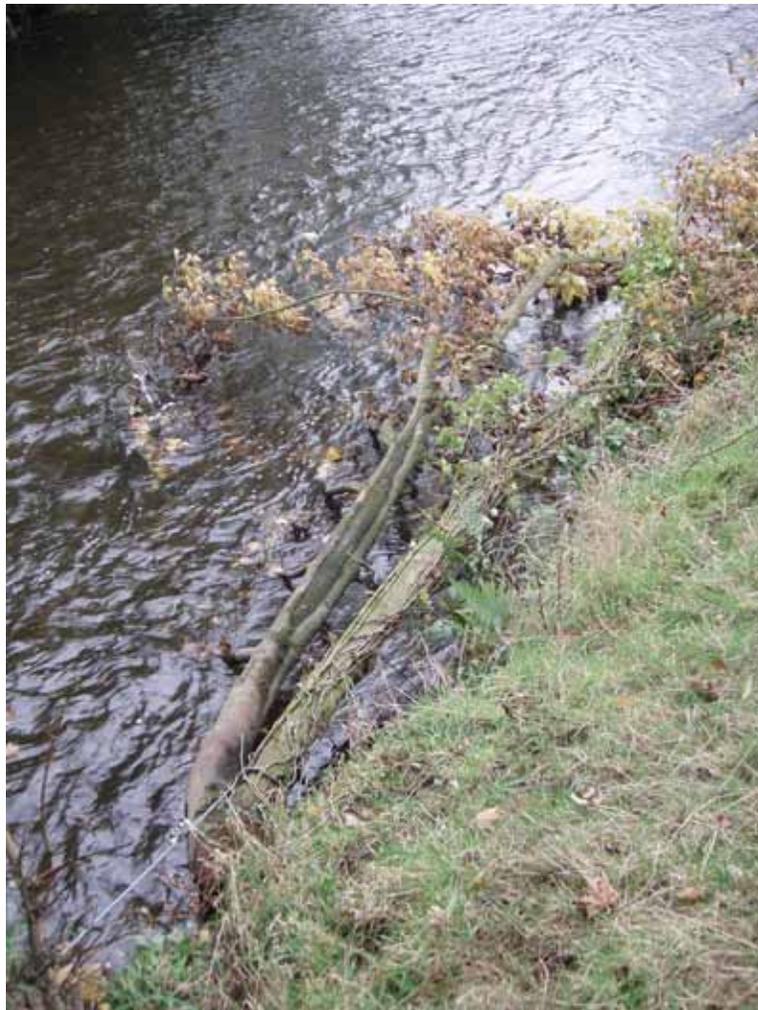
Introduction of LWD would benefit not just trout and salmon but a range of species, including crayfish and lampreys (Photo 41). O'Connor (2006) surveyed the Boyne catchment for lamprey. Overall lamprey populations and their habitats are considered to be at favourable conservation status on the Blackwater. However, lamprey densities were significantly lower on drained and polluted sections and lamprey and habitats populations here are considered below favourable conservation status. Lamprey populations in the Blackwater are currently threatened by ongoing pollution problems and drainage maintenance.

Photo 41 LWD introduced and cable-wired to secure (River Goyt, Staffordshire, UK)

Lamprey habitats can be encouraged to form by installing deflectors made of stone or logs along the sides of rivers. The deflectors create alcoves or backwaters where silt and other debris will settle. Planting of aquatic vegetation such as Sparganium erectum in these areas will further encourage silt to settle and shading can be created by planting Salix spp. on the bank. The root structures of the willows and reeds create ideal cover for ammocoetes. These areas should be fenced off from livestock and allowed to accumulate woody debris and silt.

Such structures could be installed along with LWD which would benefit salmonids, and it would make sense to undertake such works in collaboration with organisations promoting lamprey conservation.

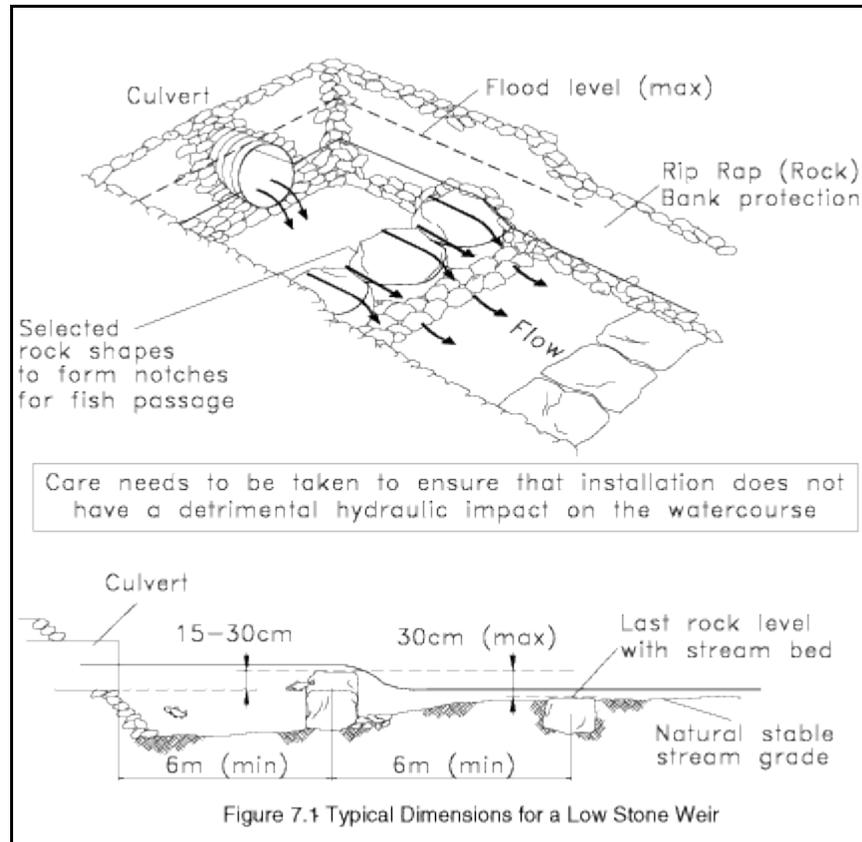
Figure 2 Pre-barrages for culverts (from Scottish Executive, 2000)

Most of the small tributaries seen on this visit were in culverts at road crossings. Culverts can prevent upstream migration of fish when the outflow from the culvert becomes perched above the downstream river level, or where water flowing through the culvert is very shallow. The Scottish Executive (2000) provides some guidelines on improving fish passage at new and existing culverts (see References). It is recommended that culverts on Blackwater tributaries are assessed and improved, particularly where the new M3 is being constructed, as it will be cheaper to ensure they are fish friendly during construction rather than afterwards.

- A more detailed look at spawning tributaries should be undertaken to make sure fish have free access to these. Small barriers could be removed (if practical) or overcome with the construction of simple pre-barrages (Figure 2).
