Advisory Visit
Bodorgan Estate, Anglesey
April 2012

1.0 Introduction

This report is the output of a site visit undertaken by Tim Jacklin of the Wild Trout Trust to the Bodorgan Estate, Anglesey on, 12th April, 2012.

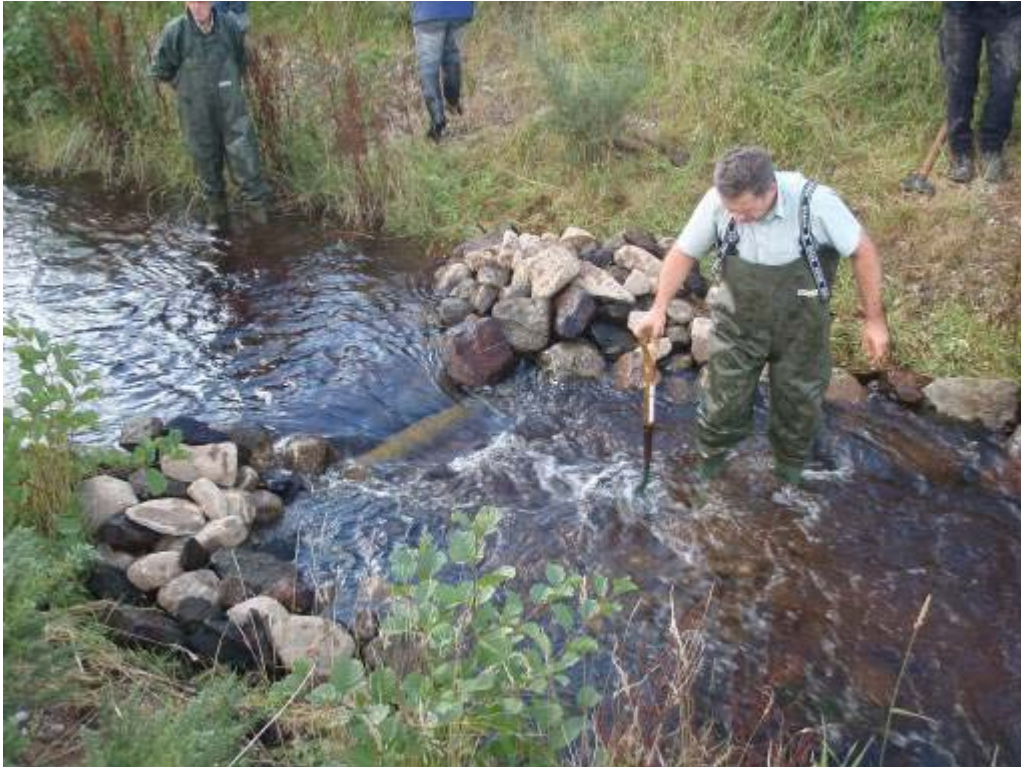
Photo 25 Example of a pinch point created using logs and stone to encourage bed scour and sorting of gravel. On the smaller watercourses on the Bodorgan Estate, large boulders could quickly and easily be positioned with an excavator to create the same effect.

Sections of stream affected by past channel modification (straightening, bed lowering) could be improved by the introduction of boulders and/or logs to create flow deflectors and channel pinch points; this will encourage scour which will promote depth variety and sorting of river bed substrates (Photo 25).

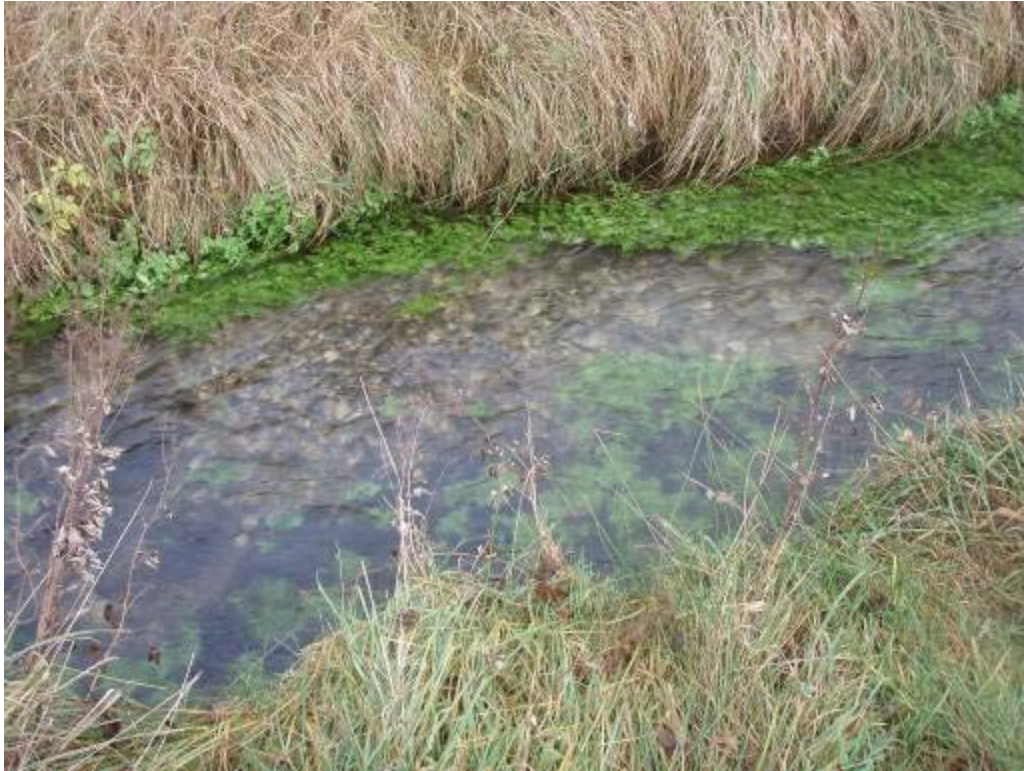
Photo 26 A trout redd cut on introduced gravel in a spawning stream entering Lough Corrib, western Ireland.

Where suitably sized spawning gravel (10 – 40 mm) is lacking, this could be introduced in conjunction with the in-stream structures (Photo 26). It is understood that there are quarries on the Bodorgan Estate so supply and transport of boulders and gravel could be relatively easy.
