Advisory Visit
Bog Burn (Bathgate Water)
River Forth Catchment
Stirlingshire

Undertaken by Gareth Pedley

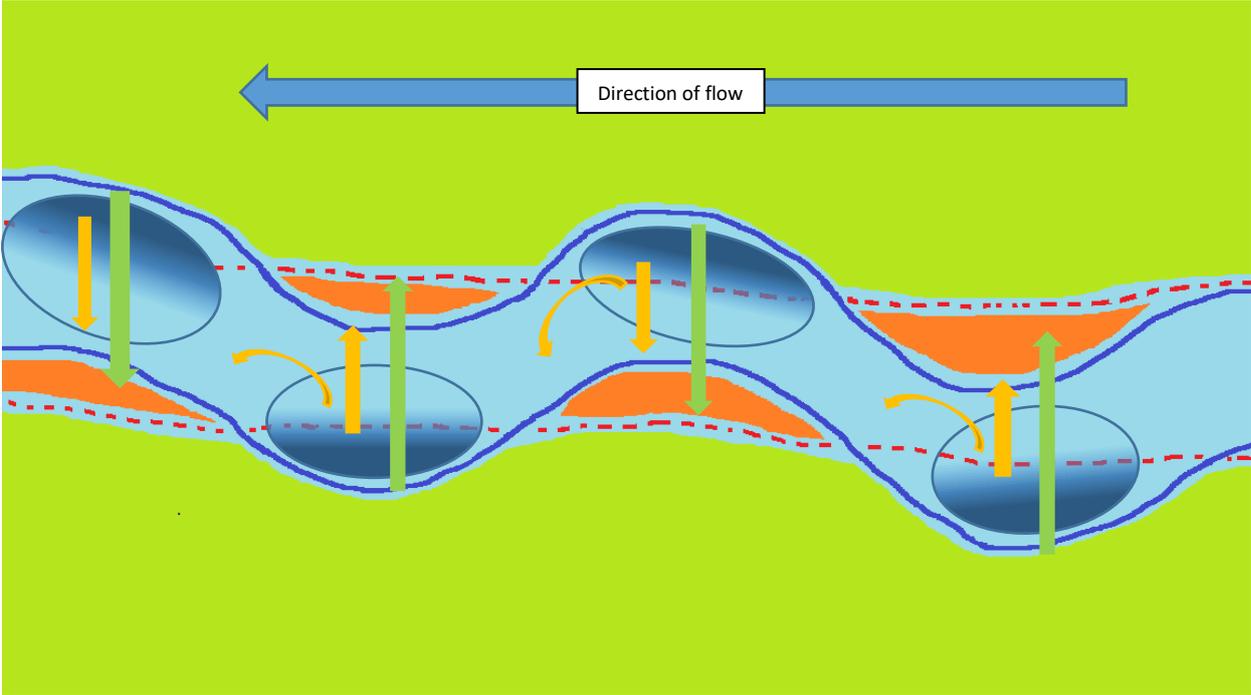
Fig 11. A simple 'dig and dump' type restoration. The dotted red lines represent the original straightened channel. The dark blue lines represent the course of the improved, more sinuous channel. The dark to light blue graded ellipses represent deeper pool to shallower areas that would be dug into the bed. Green arrows show the movement of material dug from the bank and bed to create the inside of the bend/berms (orange area). Any gravel generated would be used to create riffles d/s (curved yellow arrow) and gravel bars on the inside of the bends (straight yellow arrows) - additional gravel could also be imported.

Significant re-meandering is likely to be infeasible in this section, owing to the close proximity of the golf course and adjacent housing, so a more restricted 'dig and dump' type channel restoration (Fig. 11 & 12) is recommended. A large excavator could be deployed in several ways, depending upon the type, but a sufficiently long-reach machine could potentially work from the bank top or even from within at the channel straddling the watercourse. Alternatively, a Batemag-type excavator with adjustable legs could be set to compensate for the slope of the bank.

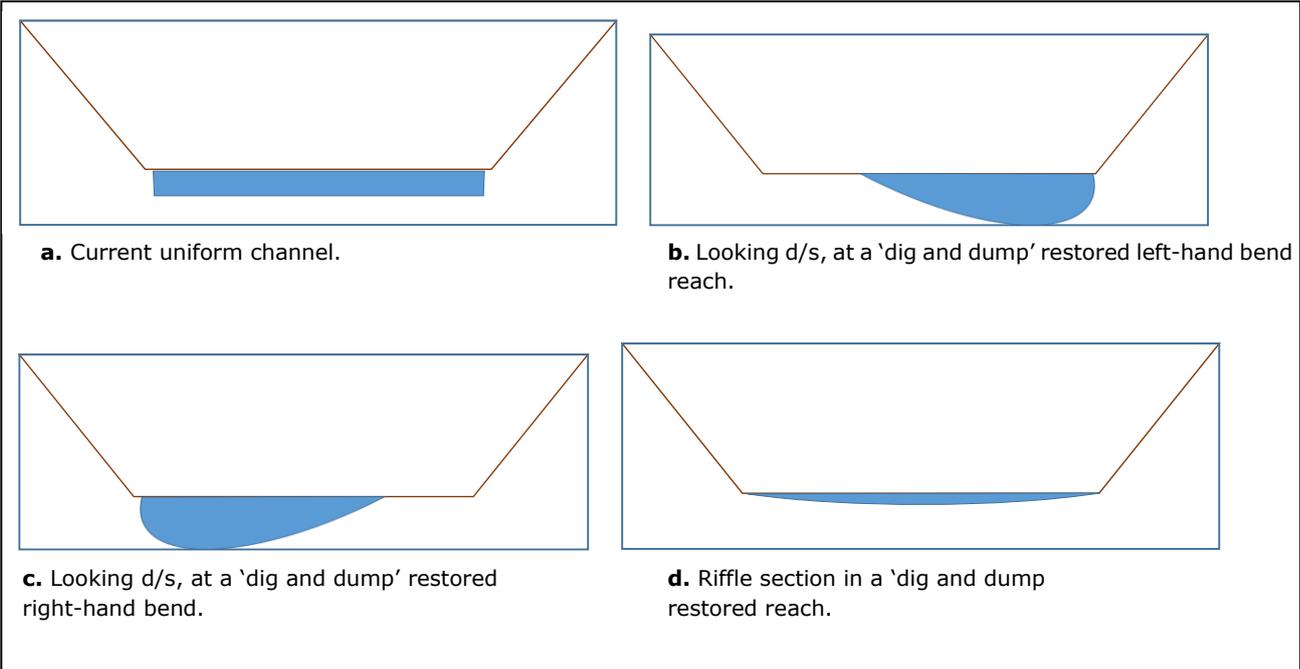
Figure 12a-d. A simplified visualisation of the current, uniform channel cross-section (a) and the nature-like features that could be created using the dig and dump technique (b-d). The cross-sections are indicative and not drawn to scale.

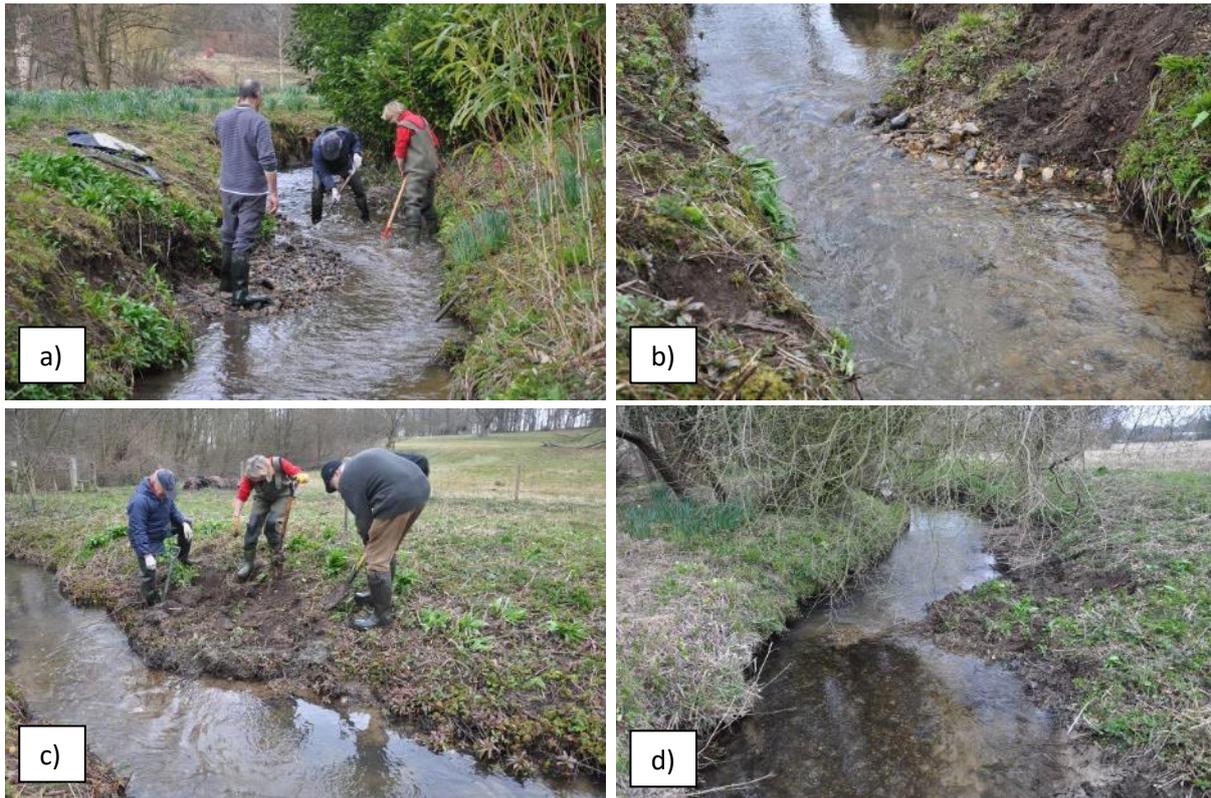
Figure 13 a-d. A range of channel improvements undertaken by hand, employing a light, 'dig and dump' approach. Note how in d), an u/s deflector has been used in conjunction with the movement of substrate to retain material and create a greater pinch point. Photos courtesy of Ian Shepherd.

If large-scale 'dig and dump' proves to be infeasible or funding is limited, more modest improvements could be achieved undertaking similar work using hand tools. This could be trialled with volunteers in a workshop type scenario, as has been undertaken previously in several English rivers including the River Glaven (Fig. 13a - d). The proposed design for the channel would remain the same but the scope of the work might have to be reduced slightly owing to the limitations of working without machinery. Nonetheless, significant improvements can still be achieved, particularly on a heavily modified channel like the Bog Burn.

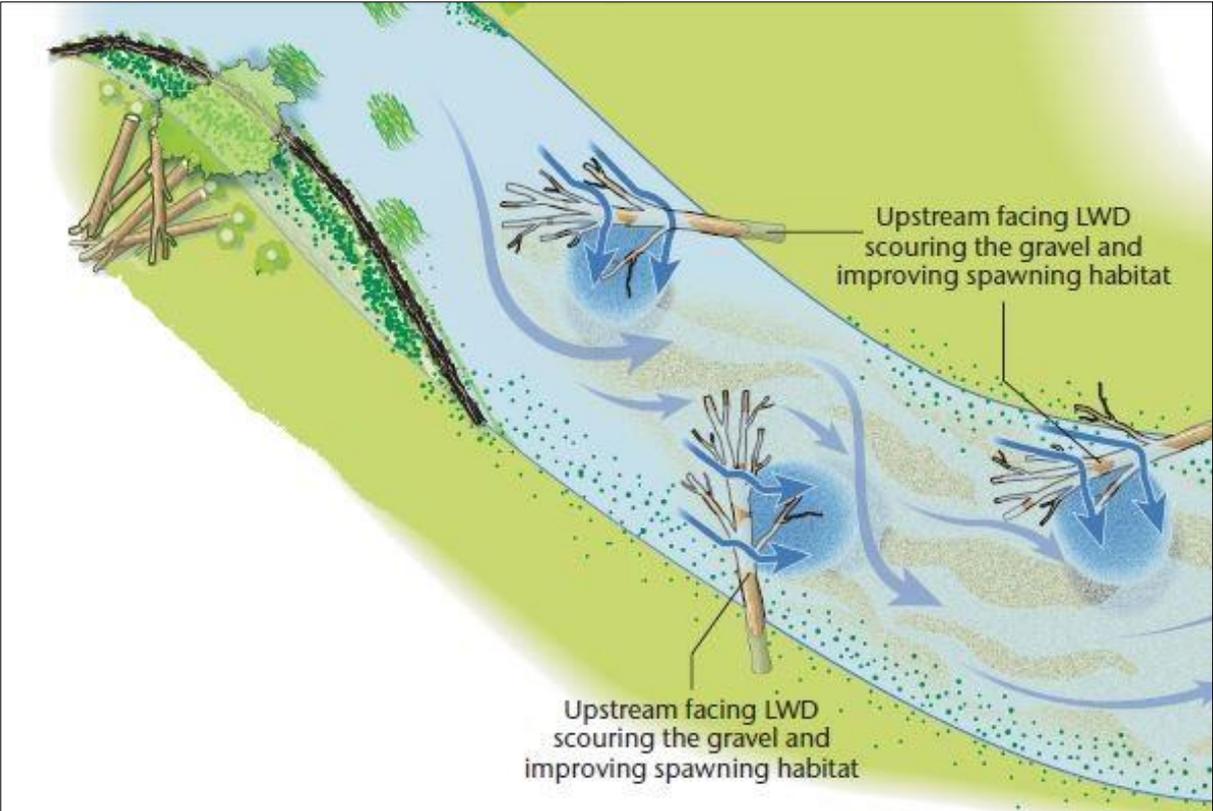
Figure 14. Upstream flow deflectors employed to create flow diversity. In the case of Bog Burn, where some destabilisation of the banks is actually beneficial to create a more sinuous course (even d/s facing deflectors that encourage d/s erosion might be worth trialling). This example depicts a diffuse type u/s deflector but solid/single log deflectors would also work well in this particularly uniform channel where maximum flow deflection and scour would be desirable.

The hand 'dig and dump' work could be complemented by the installation of in-channel structures, to drive scour into the emergent vegetation (where present) and bed (to create depth variability) and banks (to increase channel sinuosity). These needn't be complex structures as the intention is simply to create more diverse, erratic flow and encourage some channel/bank destabilisation. Log deflectors (Fig. 14) brush (Fig. 15), brush bundles or even boulders/boulder clusters could be installed on alternating banks. If wooden structures are employed, they would be pinned to the bed with posts and secured with wire. If desirable, they could even be partially dug into the bank, reducing the potential for scour in the wrong areas.

The recommendation would be to use single, alternating structures, rather than paired deflectors, which constrain flows and scour in an artificially straight line toward the centre of the channel. Paired deflectors may initially create some depth but fail to increase the sinuosity of the flow pathway. Consequently, more of the scoured material is likely to be transported through the d/s reach at higher flows, rather than being deposited. If the flow is more varied, and the scour and deposition more alternate (one side of the channel to the other), there is greater potential to establish a varied bed topography, which will ultimately improve the quality of in-channel habitat.

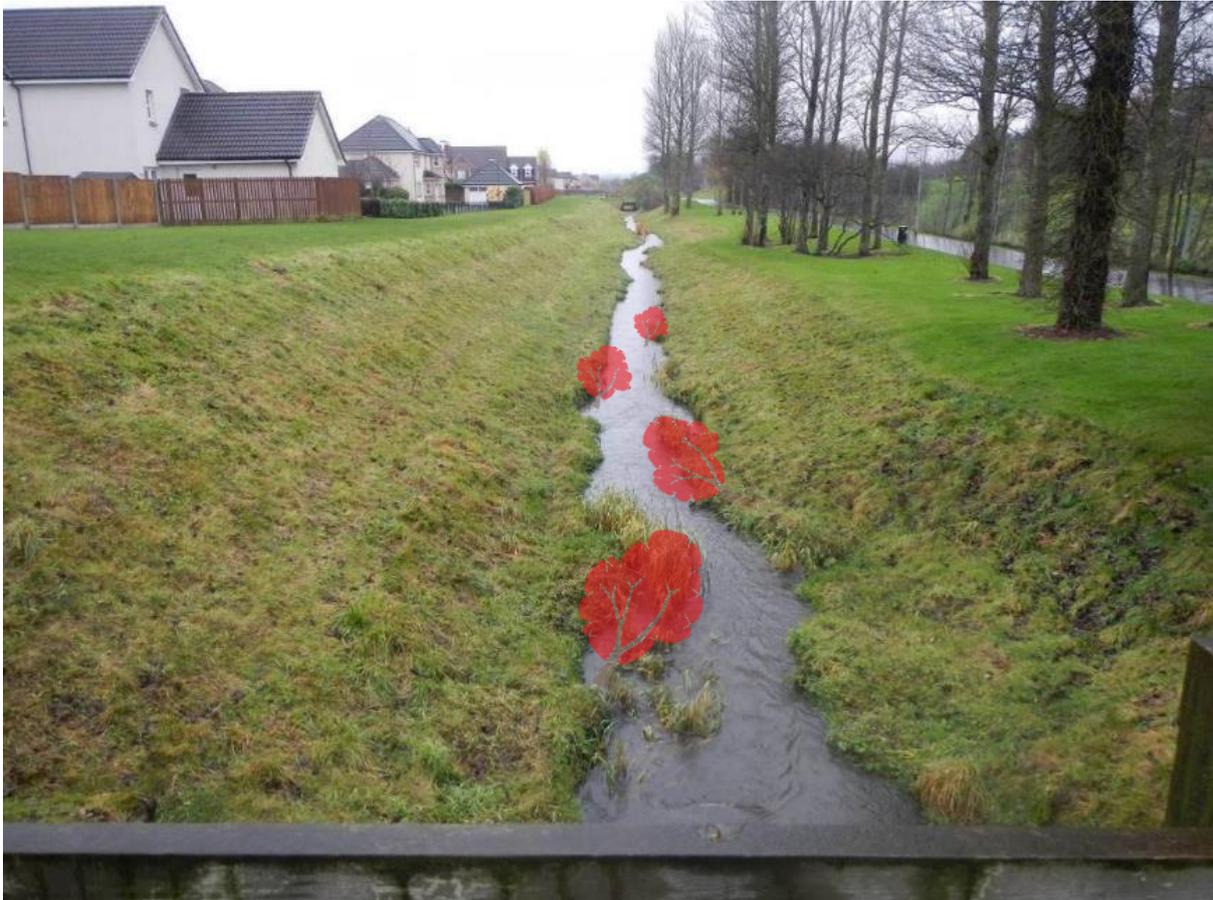
Figure 15. Pinned brush could also be employed to take up channel capacity in areas and enhance areas of scour and deposition to diversify the channel.
