Advisory Visit

Bradshaw Brook, Lancashire

August 2010

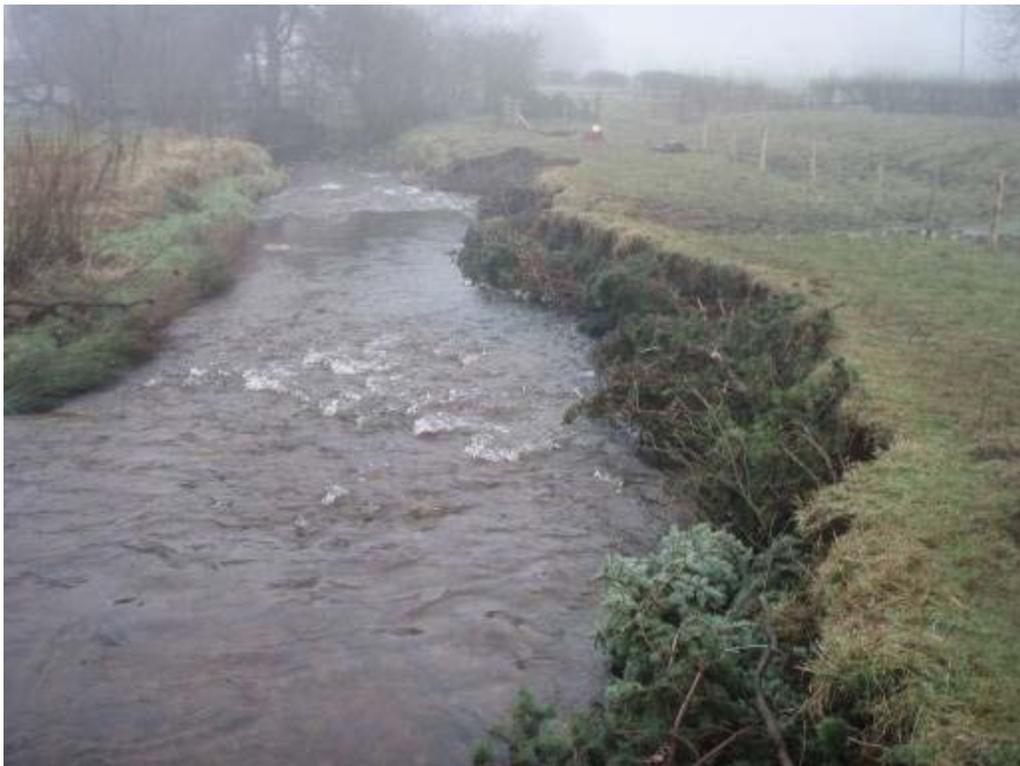
Photo 3 Soft revetment techniques can successfully reduce erosion rates and consolidate banks (River Manifold, Staffordshire)

The effects of the bank erosion could be reduced here by reinforcing the toe of the eroding bank using a suitable method (e.g. log and Christmas tree revetment, or brush-packing – see Upland Rivers Habitat Manual). It may also be possible to use a “belt and braces” approach and install a tree kicker to sit in the gap left by the erosion, if a suitable anchor point can be found (Figure 2).

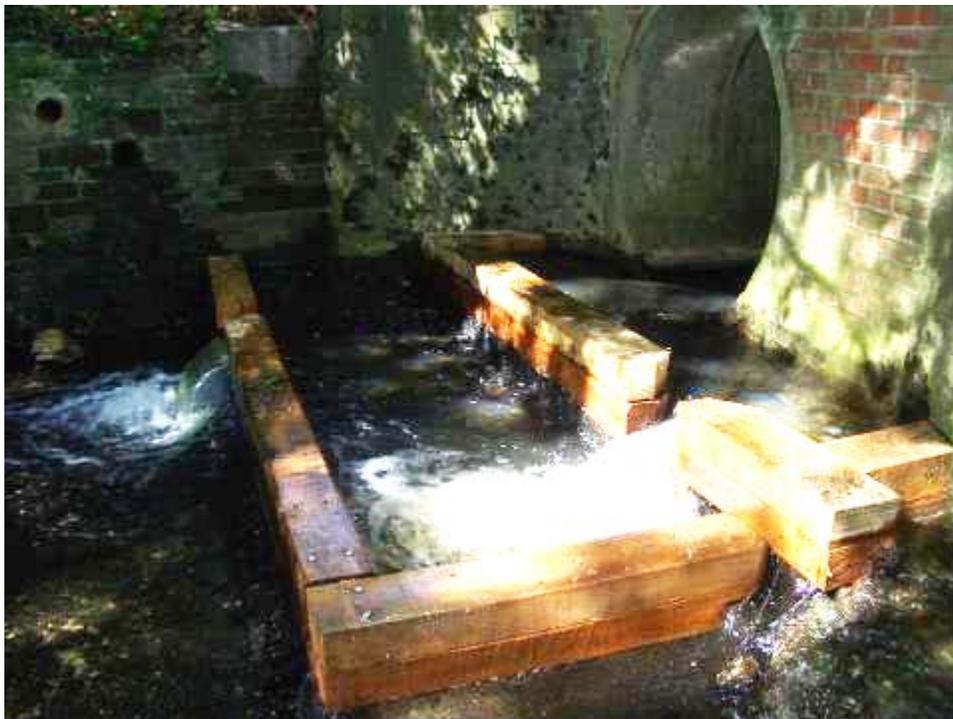
Photo 7 Timber baulks with notches used to create an easement at a barrier to fish migration (Sussex Ouse).

The pre-barrage could be constructed from timber baulks (Photo 7 shows an example on the Sussex Ouse). The idea is to raise water levels immediately downstream of the existing barrier (the pipe weir) and provide a step up over the obstacle for migrating fish (Figure 5).

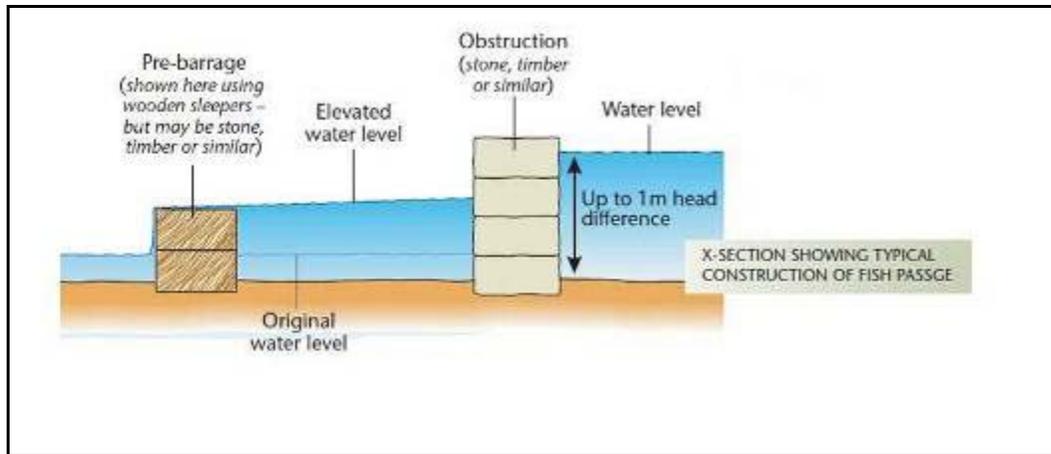
Figure 4 Principle of a pre-barrage

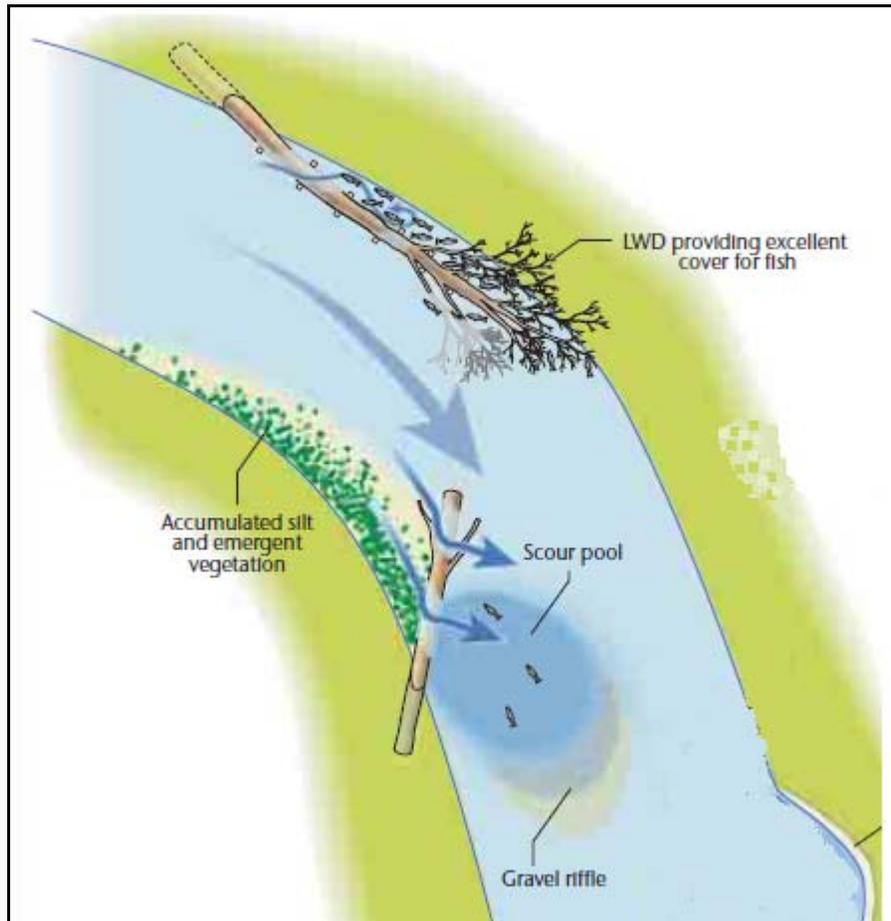
The introduction of large woody debris in the form of tree kickers (or tree sweepers) and submerged log flow deflectors has been carried out successfully on other high energy rivers in the North West (e.g. River Goyt, Disley and New Mills AC – see <http://dnmacgoyt.blogspot.com>). The River Goyt work was carried out as a partnership between WTT, EA and the angling club. These structures have a variety of effects (Figure 5) including:

- creating localised scour, increasing depths and holding water for adult fish
- trapping fine sediments and narrowing the river channel
- providing cover and refuge for fish
- trapping organic matter providing food for invertebrates (which provide food for fish)

Figure 5 Effects of large woody debris

It is recommended that BFF use LWD to introduce habitat diversity to reaches of the river where channel constrictors were previously intended. The comments from EA staff regarding the electric fishing site should be noted and this area should be avoided.
