Advisory Visit

Brailsford Brook, Derbyshire

July 2015

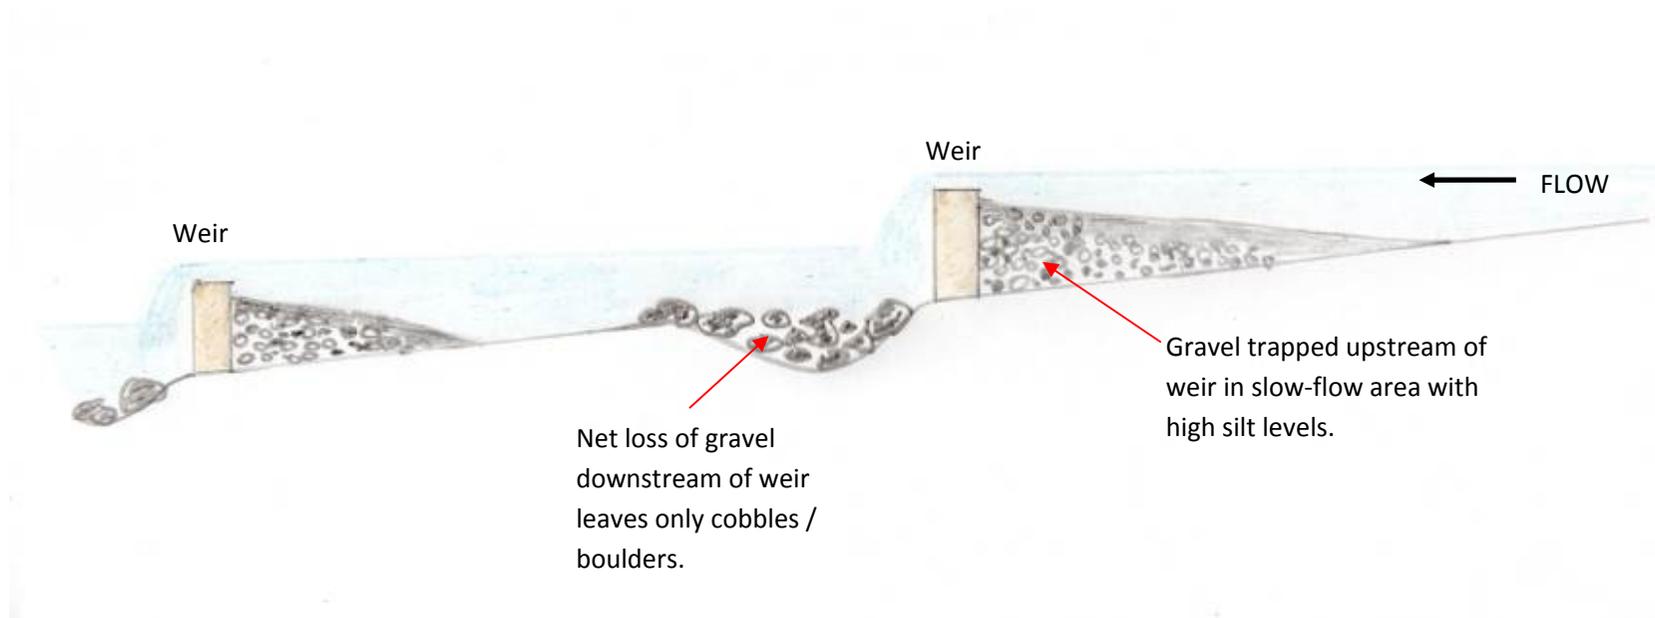
Figure 1 and Photo 1 show how gravels which would normally be transported, graded and deposited by the brook are trapped behind the weir structure. The slower, stilled water immediately upstream of weirs also promotes the settling out of finer sediments (sand and silt), uniformly across the full width of the channel, filling the spaces between the gravels, making them unsuitable for trout spawning and flow-loving invertebrates.

Figure 1 Longitudinal section of brook showing the effect of weirs on sediment transport. Coarse sediment (gravel) of the correct size for trout spawning is trapped in areas upstream of weirs where the flow is too slow and fine sediment (sand/silt) accumulation too great for successful spawning. Downstream of the weir where flow is faster and oxygenation greater, no suitably-sized spawning gravels remain (just large cobbles and boulders).

It is recommended that a number of weirs are removed to restore a degree of natural sediment transport and to improve habitat conditions for trout spawning and juveniles. Preferably blocks of weirs should be removed, rather than, for example, alternate ones; this is to give a reasonable length of river over which natural river processes can re-establish.

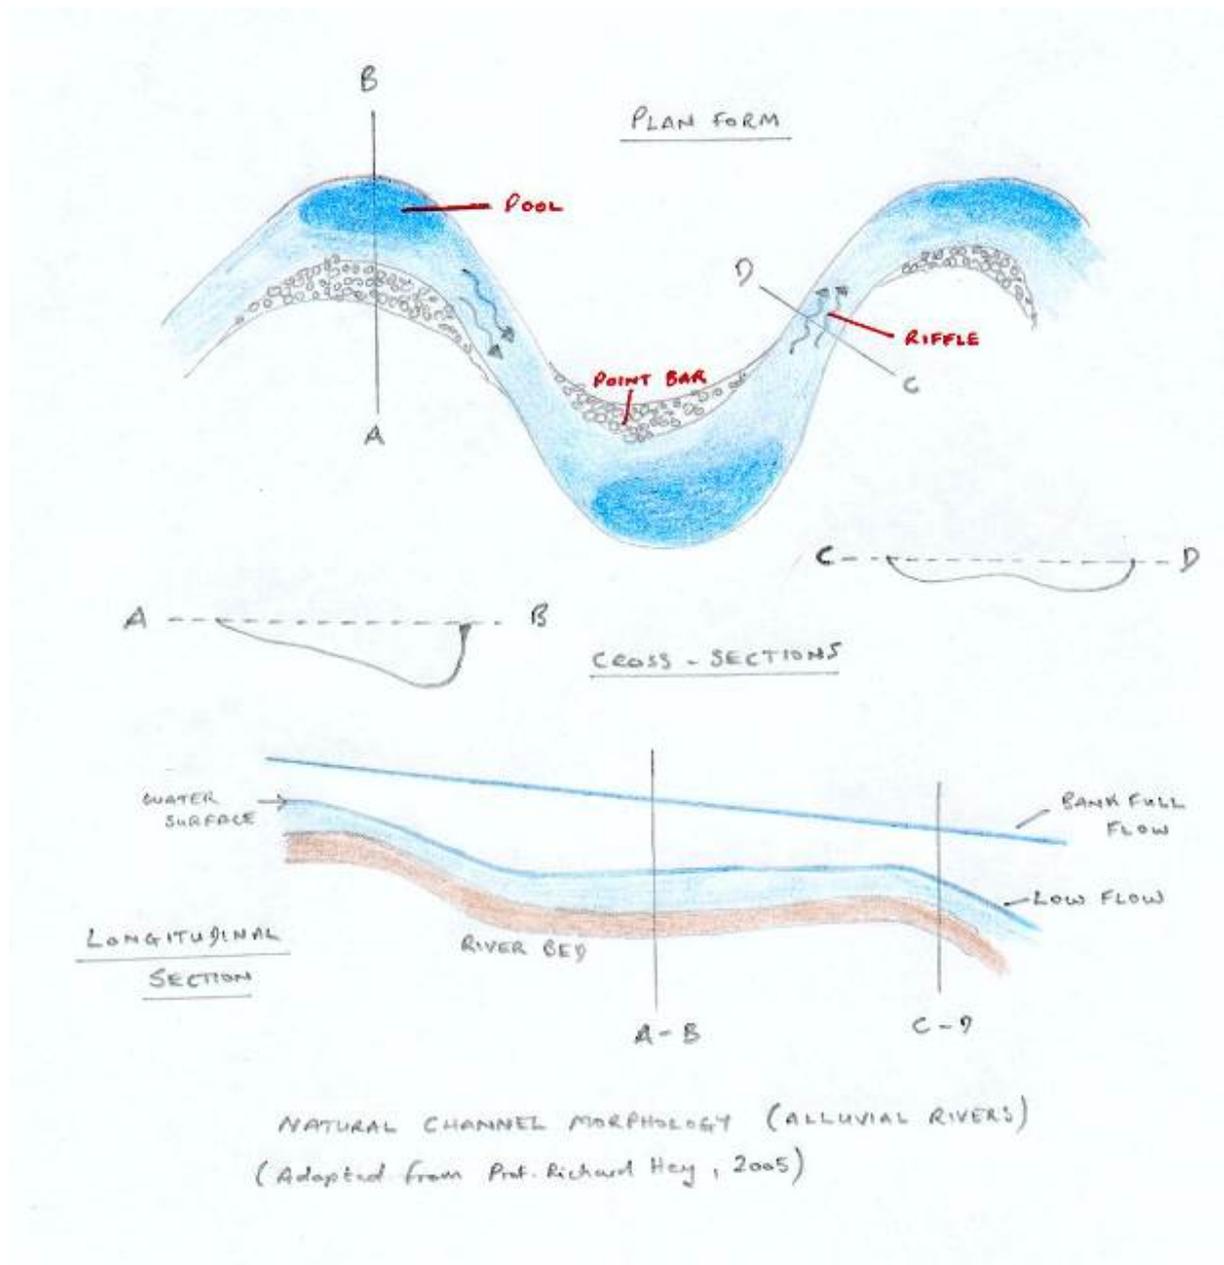
Linked to the disruption of sediment transport and impoundment of flows, weirs also change the natural shape (morphology) of the river channel, reducing bed scouring and preventing the formation of the natural pool-riffle sequence. This reduces the availability of trout spawning and juvenile habitat (Figure 2). Increased rates of bank erosion can also take place downstream of weirs where back eddies occur, leading eventually to the river bypassing the weir structure (Photo 2).

Figure 2 Natural channel morphology of lowland alluvial streams. Note the meandering plan-form, with deeper pools on the outside of bends and gravel point bars (or side bars) on the inside. Shallower, faster-flowing, gravel riffle areas are formed between bends/pools. The gradient of the river bed is unevenly distributed, with relatively flat-bottomed pools and steep riffles. The gradient break-points across the riffles promote flow of water through, as well as over, the gravels, providing areas where trout eggs buried in the gravel can survive. Deeper pools provide adult trout habitat and the shallower riffles provide spawning and juvenile habitat.

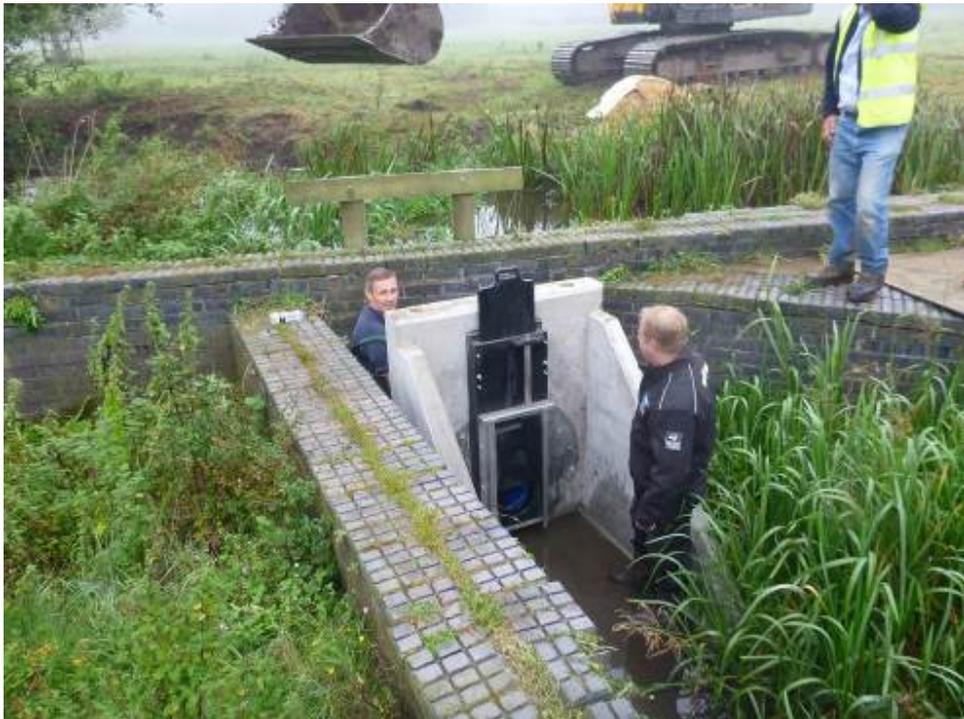
Where ponds and lakes are fed by streams, the rates of siltation are greatly increased because the stillwaters act as settling ponds for sediment washed in by the stream (especially during high water events). Ideally ponds and lakes should be "offline" (have no inflow), but this depends on whether pond water levels can be sustained without an inflow. The hatchery ponds were built for fish farming hence have been designed to allow draining and re-filling. Now they are no longer used for this purpose, the amount of flow entering the ponds could be varied to see what effect it has on water levels. Installing penstock sluices at the inflows would allow a much greater degree of control over the feed of water from the brook and facilitate experimentation (Photo 13). In addition, the flow could be shut off completely in times of flood, reducing the input of silt from the brook.

Photo 13 Installing a pre-fabricated penstock sluice at a lake inlet from the River Glaven, Norfolk.
