**Advisory Visit**

**Branston Beck, Lincolnshire**

**August 2016**

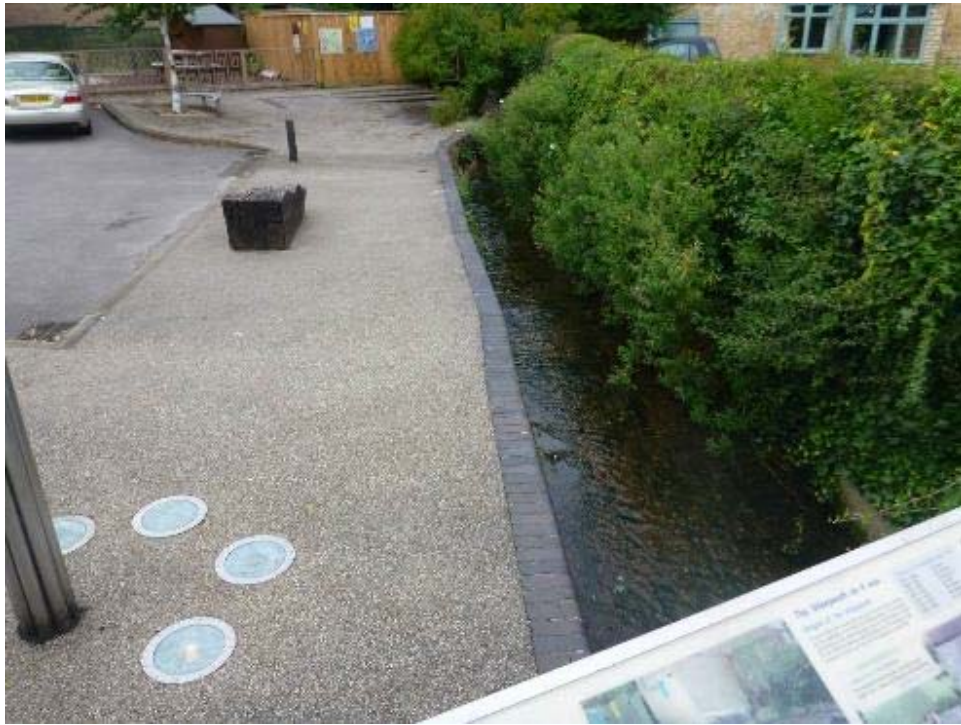
**Photo 3 Site of former sheepwash, Branston village**

Downstream of Hall Lane, the brook flows through the grounds of Branston Hall Hotel and behind some private residences (not inspected), then alongside a pub car park at the site of a former sheepwash. The brook here is confined within a walled channel and there is an interpretation board describing the old sheepwash and its archaeological investigation (Photo 3). The brook is then culverted under the B1188 High Street and flows through the gardens of a number of private residences on Paddock Lane. Downstream of the gardens, the brook flows within a concrete-edged channel, deeply incised and uniformly shallow (Photo 4).

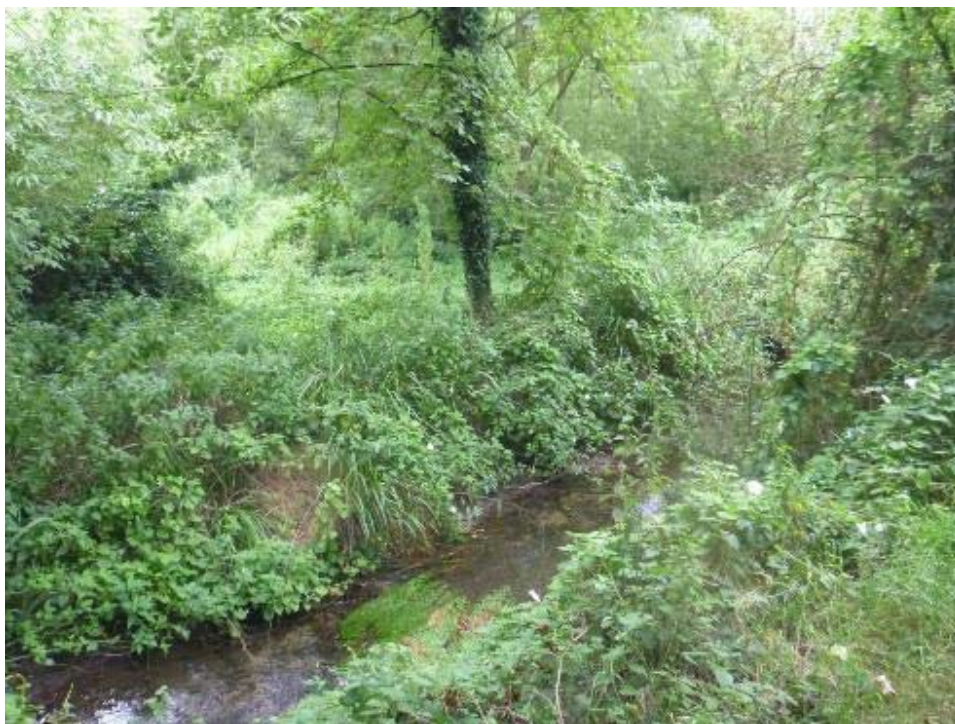
**Photo 5 Open valley area downstream of Paddock Lane.**

Throughout the sections described so far, the brook is confined within a built environment, limiting the scope for habitat improvement through channel restoration (e.g. re-meandering). However, downstream of Paddock Lane, the brook enters a wide, green corridor between residential areas (Photos 5 – 7). Presently this corridor appears to be maintained as a nature reserve and public open space, with areas of trees, bushes, wetland, mown grass, footpaths and walkways. The brook channel remains very straight along the eastern side of this area and is perched above the natural valley floor; this is particularly evident downstream of the footpath which runs perpendicularly across the valley just upstream of Laburnum Close (Photos 7 and 8). There are pipe connections (with inverts above normal water level) between the brook channel and the floodplain area, along with areas where the brook appears to overspill its left bank at high water.

There is considerable scope here for restoring the in-stream habitat of the brook by re-aligning the channel along the valley floor and re-creating a meandering channel with a pool-riffle sequence. The channel was not inspected downstream towards Dye House Farm on this visit; this is recommended, to check whether the channel is perched to provide a head of water and where a realigned channel could potentially be re-joined to the existing channel.

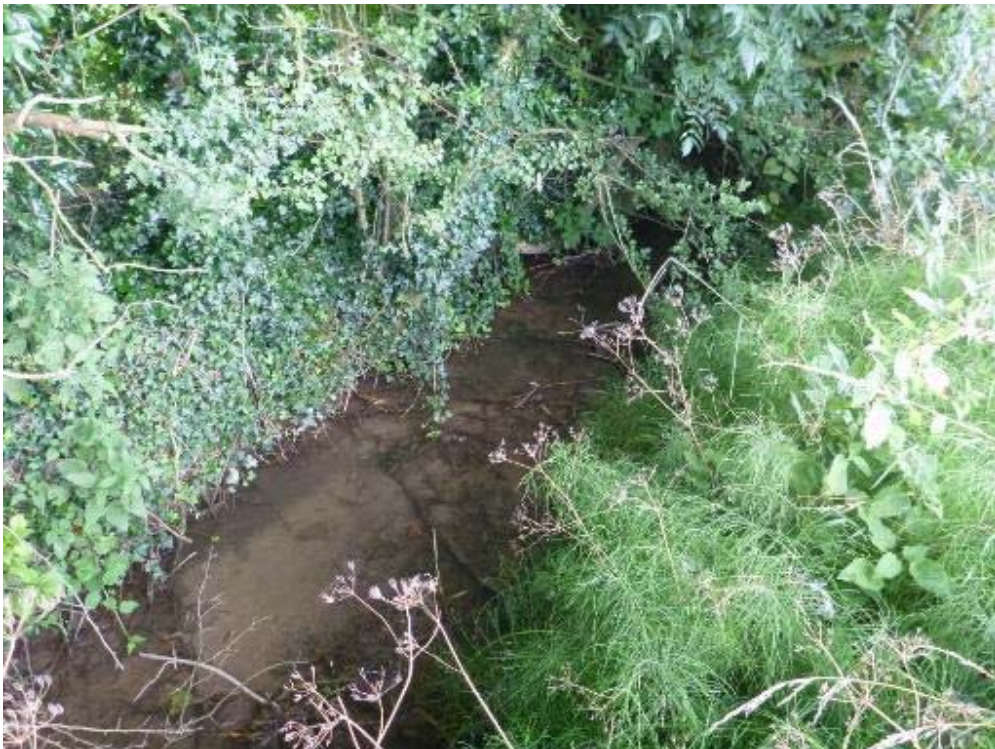
**Photo 10 Branston Beck downstream of the confluence with above tributary.**

Similar habitat is present on the Branston Beck downstream of the confluence, with the channel shaded by trees and bushes, occasional coarse woody material within the channel and a bed of fine sediment (Photo 10). Downstream of the footbridge at TF 01882 68343, the stream channel is less shaded by trees, resulting in a bankside dominated by tall, herbaceous vegetation with the occasional willow and hawthorn bush. This corridor between arable fields continues downstream to Cliff Farm and as the latter is approached, the right bank of the beck is shaded by a hawthorn hedge (Photos 11 and 12).

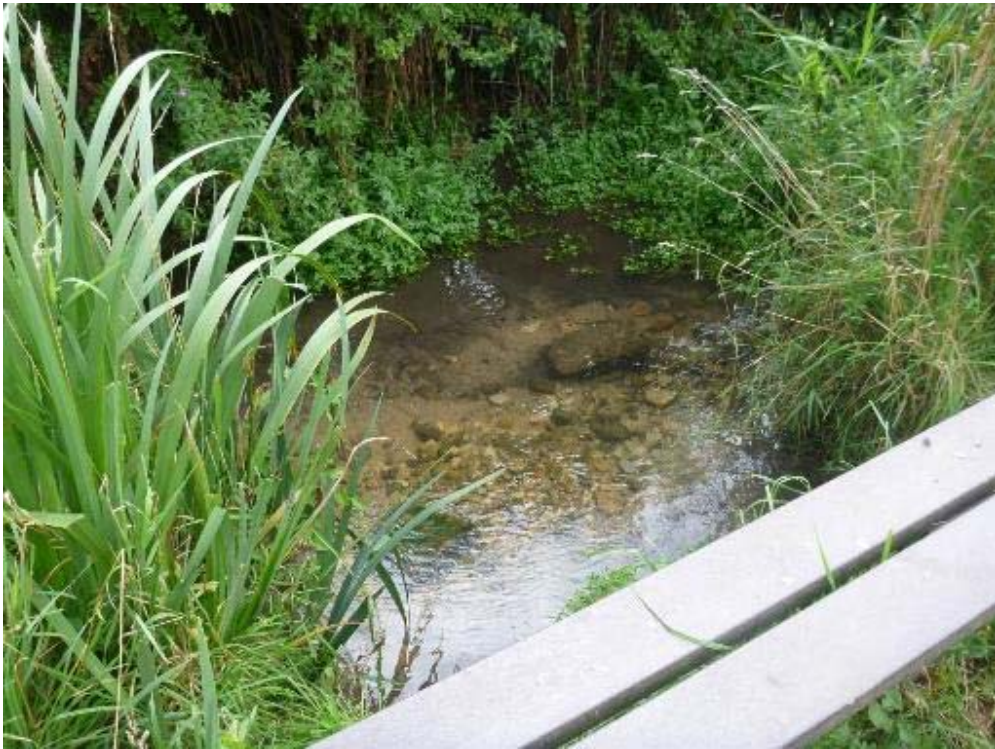
The brook here is bordered by a public footpath part of which is the Spires and Steeples Trail, a long-distance hiking trail. The brook is hidden from view for the majority of its length here, with just a very occasional opening revealing the clarity of the water and a substrate comprising some coarser sediments which could be suitable for trout spawning (Photo 13). Although the channel shape here is extremely uniform (straight and shallow), an occasional trout was seen in this section. The dense bankside vegetation provides good cover and narrows/deepens the channel, helping to a degree to offset the habitat deficiencies inherent in the engineered channel.

**Photo 13 Bench seat alongside a rare opening in the riparian vegetation, upstream of Cliff Farm.**

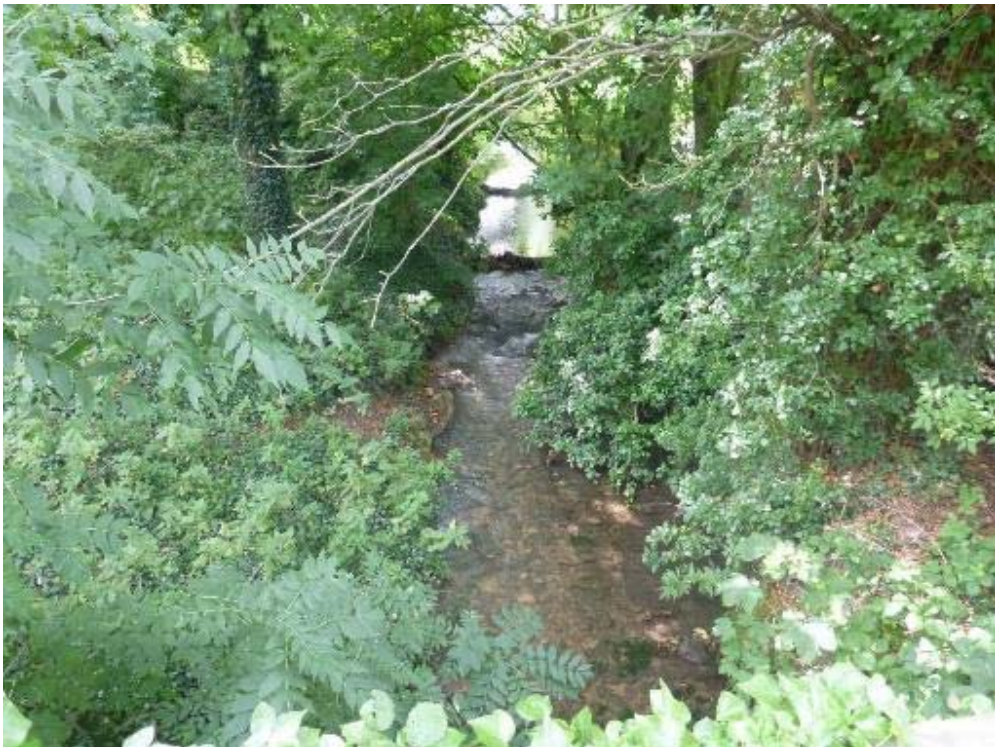
**Photo 14 Upstream of the culvert at Cliff Farm.**

At Cliff Farm, the gradient of the channel increases and the brook runs over a hard bed with larger gravel and cobble substrate. There are a couple of low, rough stone weirs before a culvert under the farm track; neither the culvert of the weirs are a barrier to fish movement. The channel is shaded by trees here and downstream of the culvert, the channel is wider and the bed is dominated by sand and silt (Photos 14 -16). Emergent vegetation including water parsnip (*Berula* sp.) and bur-reed *Sparganium* sp. is present to varying degrees depending upon shading. Trees are present along the right bank.

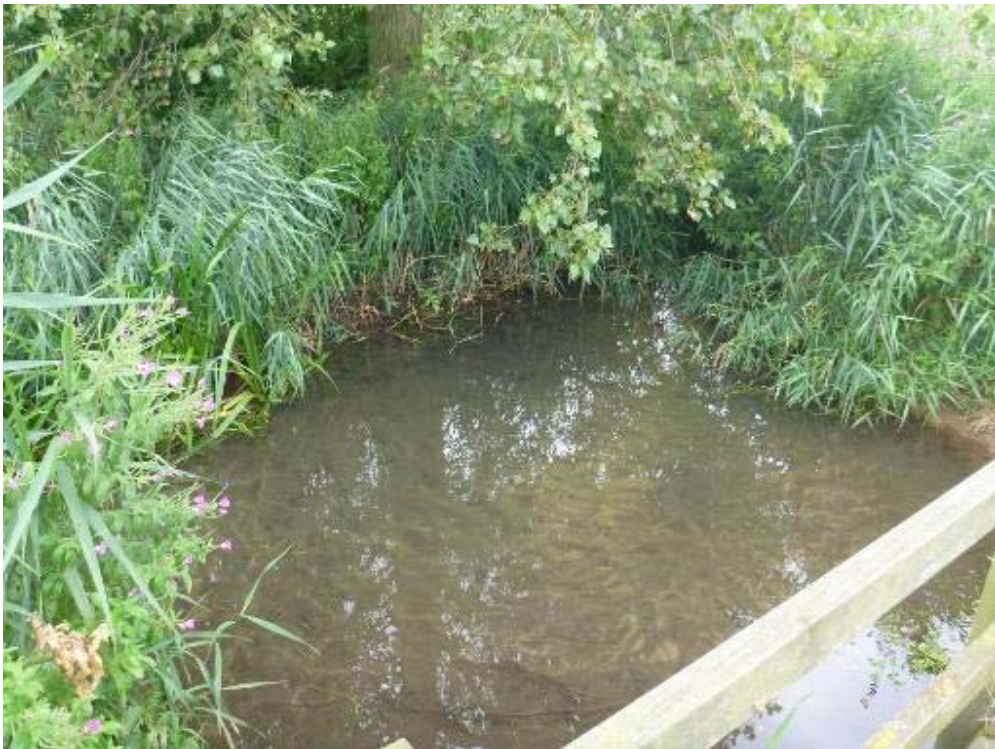
**Photo 18 Bridge and open water at TF0193669244.**

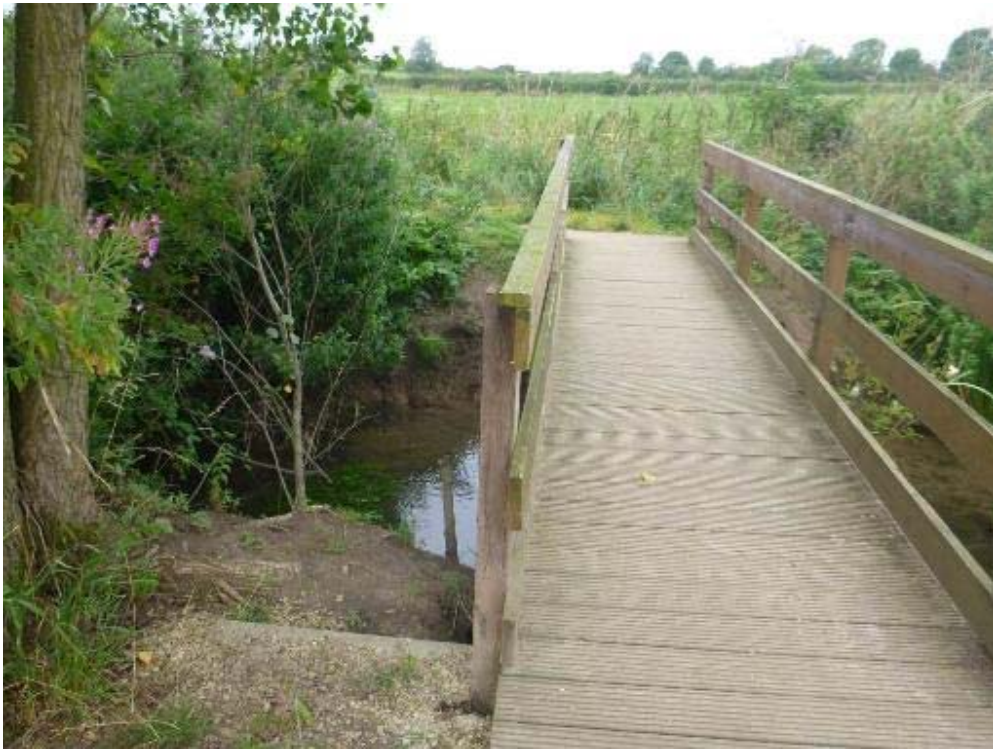
**Photo 19 Footbridge and dog scrambles.**

With progress downstream the brook enters an open area with few trees. Land use is pasture, with a wide, fenced margin along the banks. The channel here is completely overgrown with common reed (Photo 17) and it was not possible to see the brook, except at a couple of crossing points where dog scrambles are keeping the channel relatively clear. At these areas it is clear that the brook bed is dominated by fine sediment (Photos 18 and 19). Excessive inputs of fine sediment are damaging to stream habitat because it deposits on the river bed, filling in the spaces between gravel particles; this suffocates fish eggs and reduces the diversity and abundance of invertebrates.

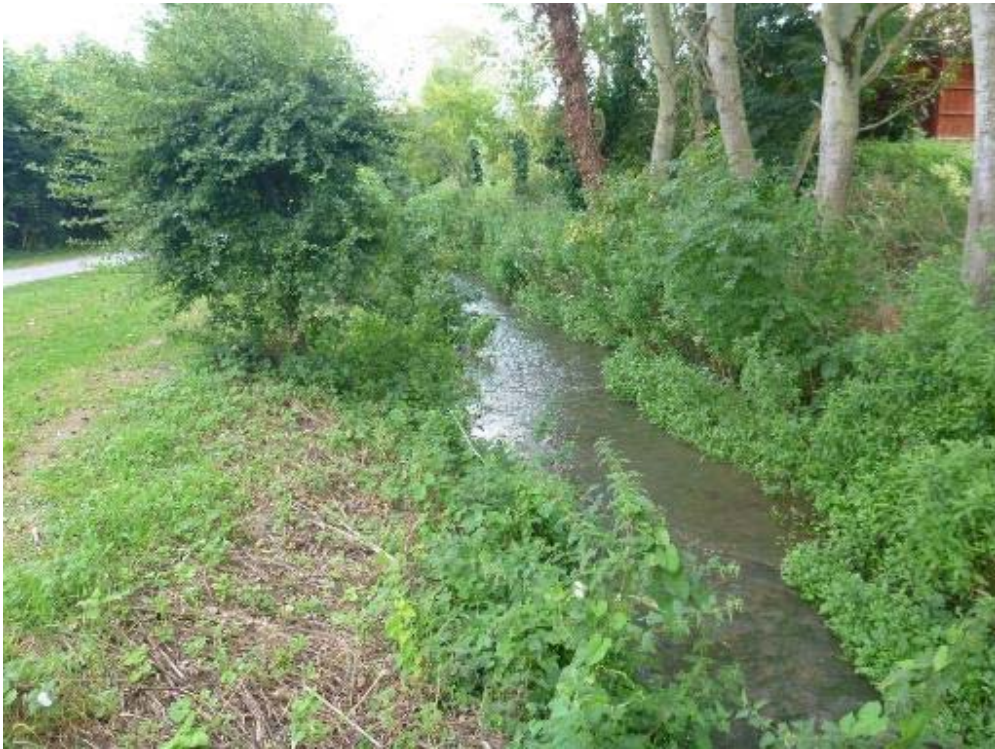
**Photo 23 Downstream of the railway culvert, Heighington**

Downstream of the railway, the brook enters the village of Heighington. The channel is bordered by gardens on the right bank and public space/cycle path on the left bank. The channel is straight, relatively wide and shallow and dominated by fine sediment. There is scope here to improve instream habitat by narrowing the low-flow channel (e.g. with brushwood mattresses), to increase sinuosity, depth variation and sorting of bed substrate. One trout was observed here and habitat improvements have the potential to significantly increase that number.

Areas on the Branston Beck where this technique could be used include upstream of Branston village (near Wheel House), downstream of the railway culvert to the watermill in Heighington, within Heighington village and selected areas downstream of Heighington village.

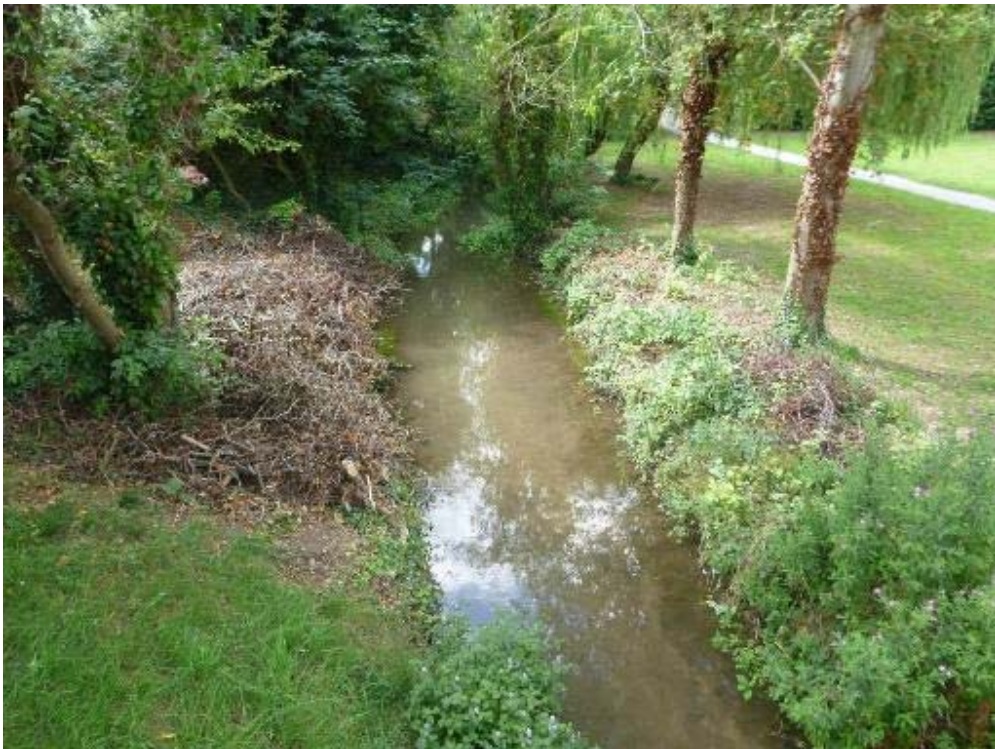
**Photo 24 Downstream of the railway culvert, Heighington, closer to the village.**

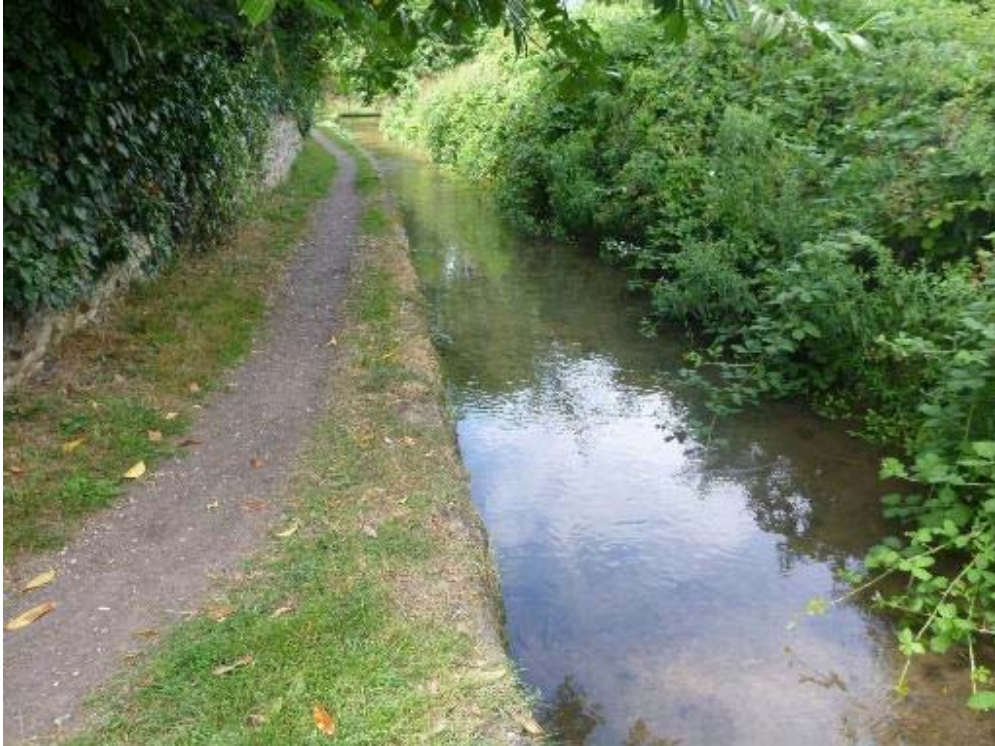
**Photo 29 As above.**

does increase in this vicinity according to the Environment Agency Flood Map. In addition, it was evident that the bed substrate in this area comprised a thin layer of gravel over bedrock, so the extent of bed scour created by any enhancement works is likely to be very limited, restricting benefits to instream habitat.

**Photo 28** Wide, shallow channel with hard edging within the village. Bedrock is only a few inches under the surface gravel here, so the opportunity for creating varied depths through channel narrowing and bed scour is limited.

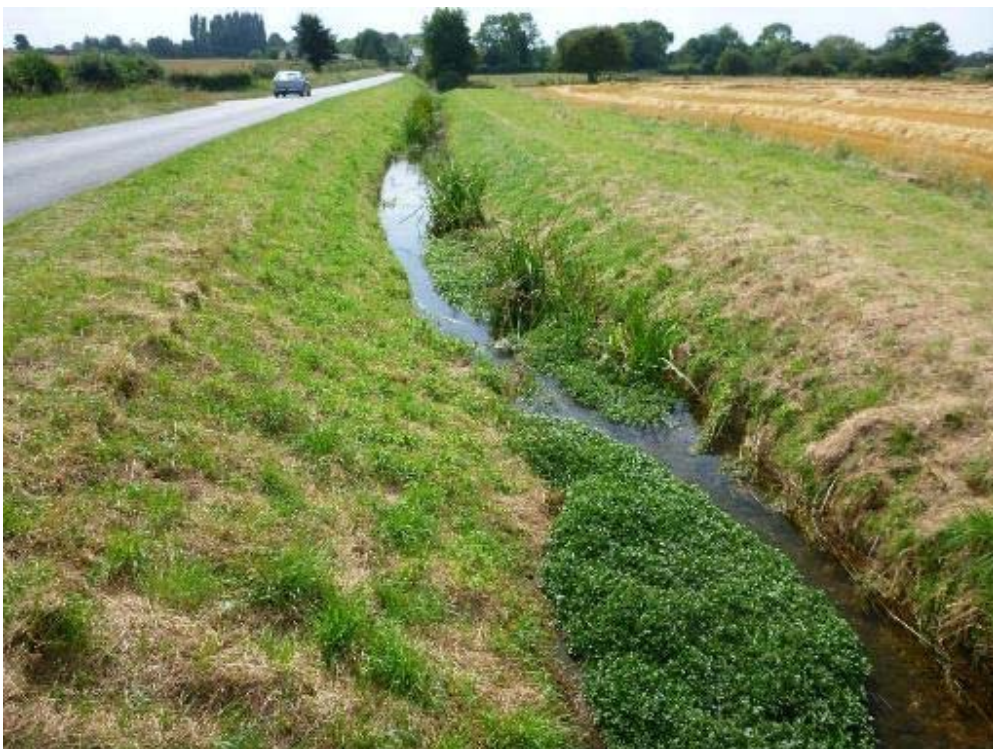
**Photo 30 View upstream from Fen Road / Brinkle Spring Lane junction TF 04393 69853**

This section of the brook, from Heighington downstream, is designated main river and maintained by the Environment Agency (EA) which includes mowing of the banks and cutting of in-stream vegetation. The latter was ongoing at the time of the visit, with emergent vegetation being cut near the Witham confluence (Photo 36). A culvert under Cowpaddle Lane is slightly perched which would impede fish movements.

Any habitat improvements within this section would have to dovetail with the maintenance regime carried out by the EA, but could include log flow deflectors to create bed scour and planting
