By Brook, Ford to Slaughterford, Wiltshire

An Advisory Visit by the Wild Trout Trust August 2016

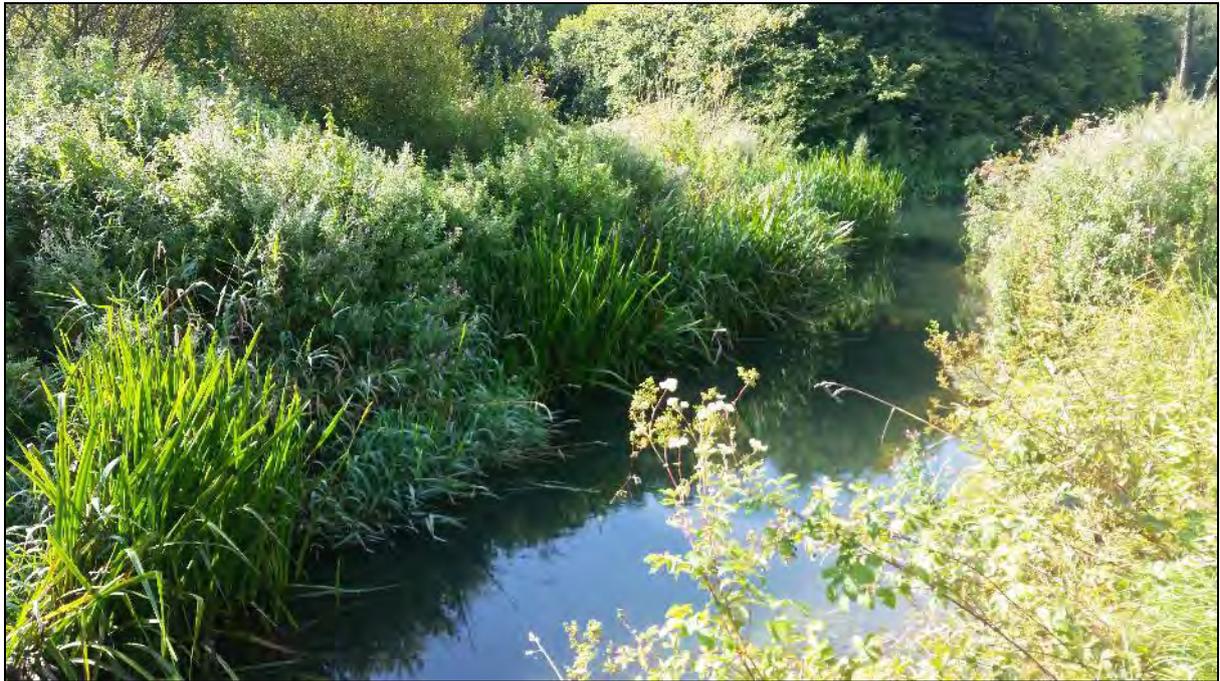
Riparian habitat was excellent both in terms of abundance and diversity of marginal (Figures 3) and upper bank (Figure 4) wetland plant species. A dense, **'shaggy' margin provides valuable refuge habitat** for fish (particularly juvenile trout) where they can more-easily evade predators. The vegetated river margins and wetland fen in the adjacent floodplain provide excellent habitat for a wide

Figure 3: Marginal plant diversity and abundance is excellent

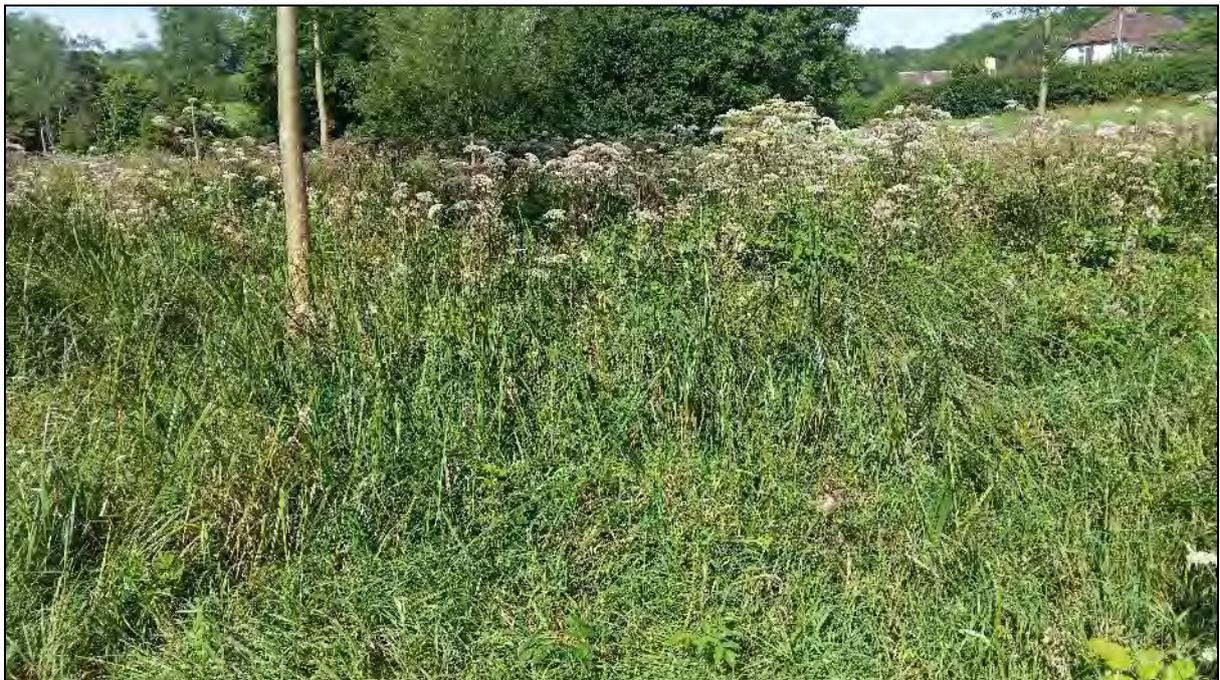
Figure 4: A rich and diverse wetland fen habitat has developed in the adjacent floodplain.

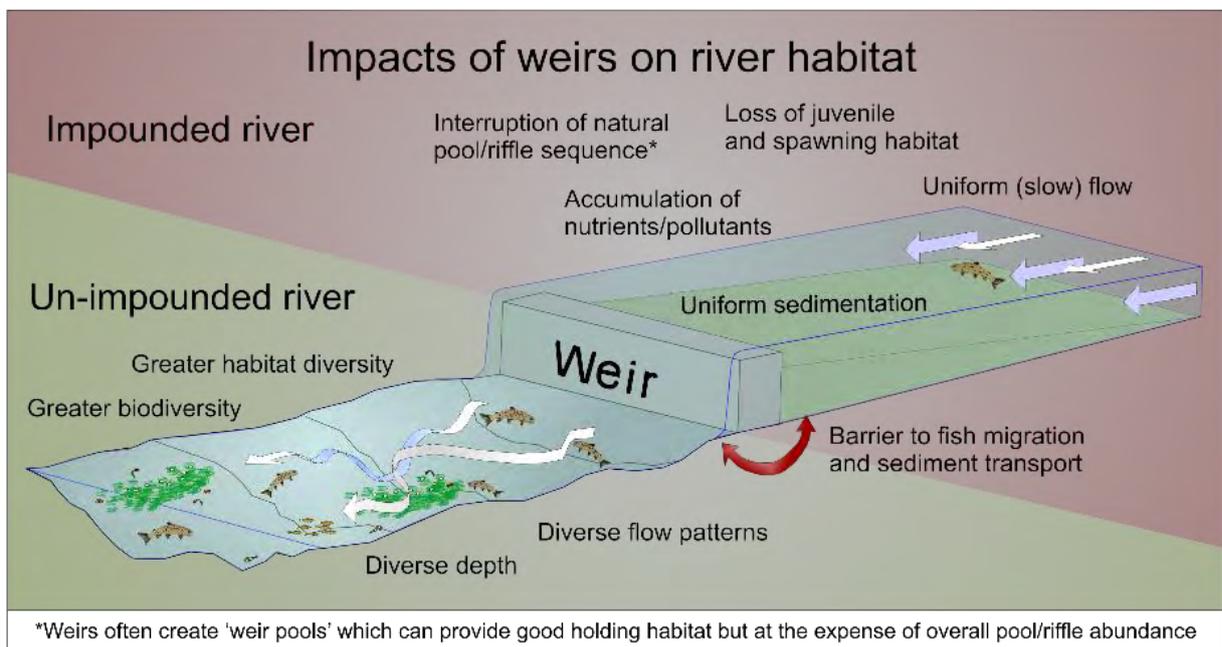
At NGR ST 83805 74520, a large weir impounds the river and presents as a complete barrier to fish passage (Figure 8). This structure is severely reducing habitat quality upstream (as illustrated Figure 9) as well as having other impacts on the river downstream (as illustrated Figure 10).

Figure 9: An illustration highlighting the impact of impoundments on river ecology

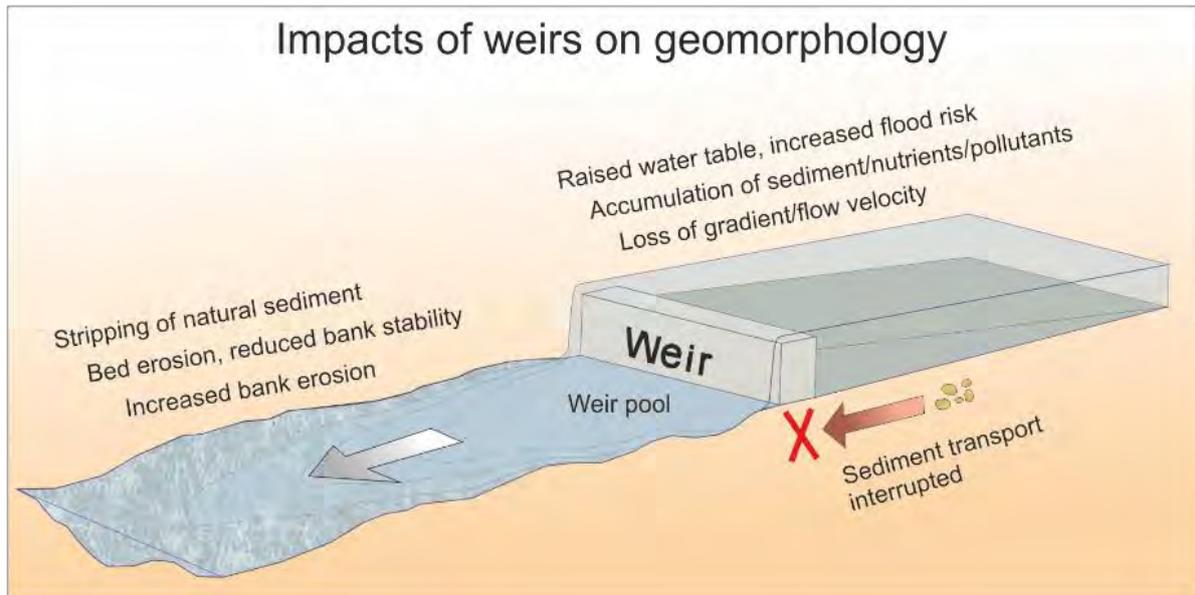
Figure 10: An illustration highlighting the impact of impoundments on geomorphology

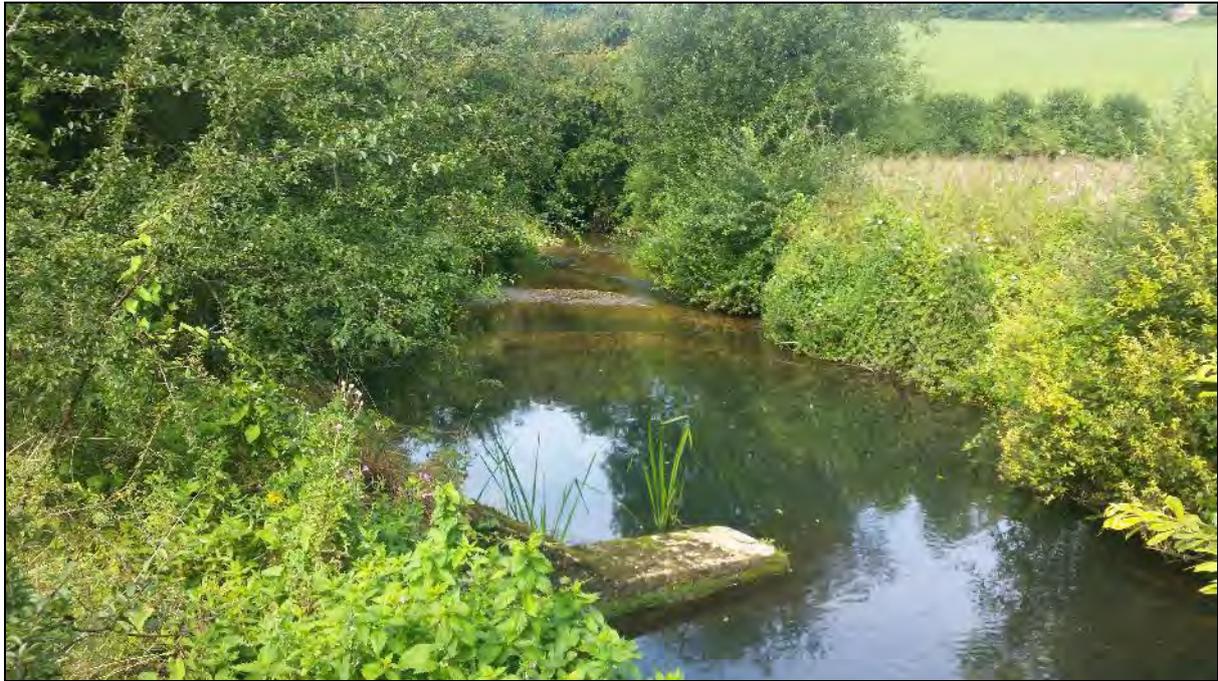
A good example of natural processes forming good quality trout habitat was observed within the un-impounded reach where a concrete structure (possibly remnant of an old sluice) protrudes only part-way across the channel (Figure 18). This feature has acted as a flow deflector and scoured a deep pool, emphasising an excellent (albeit short) pool-riffle sequence. This feature **demonstrates the By Brook's ability to develop** good holding habitat for trout if **provided with the right 'toolbox' of in-channel** structure and lack of impoundment. Securing simple log deflectors to the bed in sections of free-flowing river (Figure 19) can have equally impressive results but with the additional benefit of providing good quality habitat for fish and invertebrates in their own right.

Figure 18: The remnants of an old concrete structure (not impounding) deflects flow and has scoured a deep pool

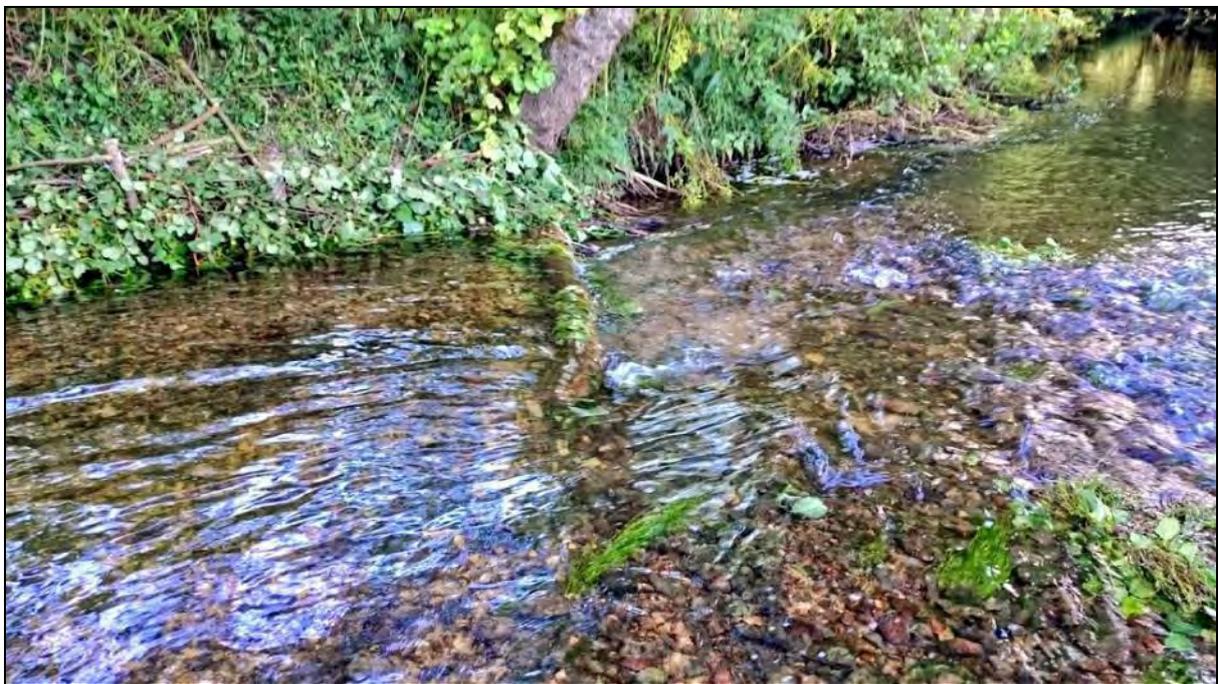
Figure 19: An example of a simple log deflector in shallow water starting to scour a new pool

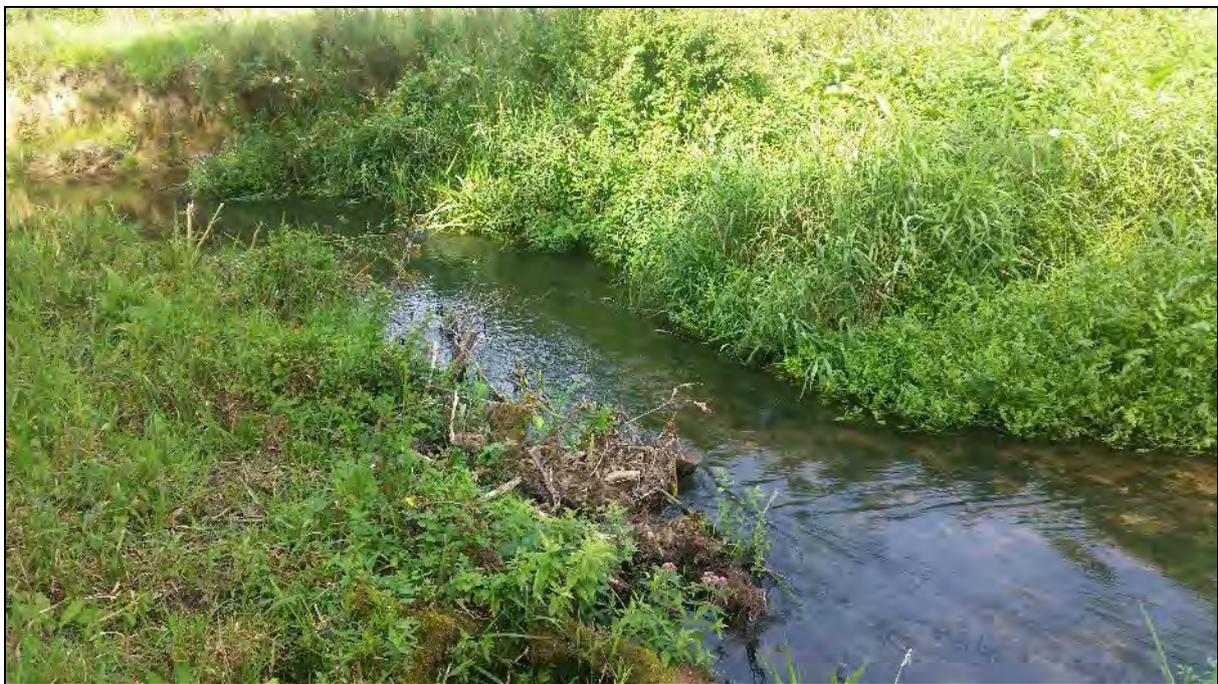
Channel width through the un-impounded reach varies, providing both wide, shallow riffles (Figure 20) and narrow fast-flowing runs (Figure 21). A good diversity of depths is also present **providing both large pools and small 'pots'** where trout are likely to lie up and feed. Improving access to these sections of river will provide anglers with some excellent sport. It would be worthwhile securing some woody flow-deflectors to enhance existing small pools/lies. Techniques for doing this are explored in the *Recommendations* section.

Figure 21: A narrow pinch point creates a fast-flowing run. A great feeding lie for trout.

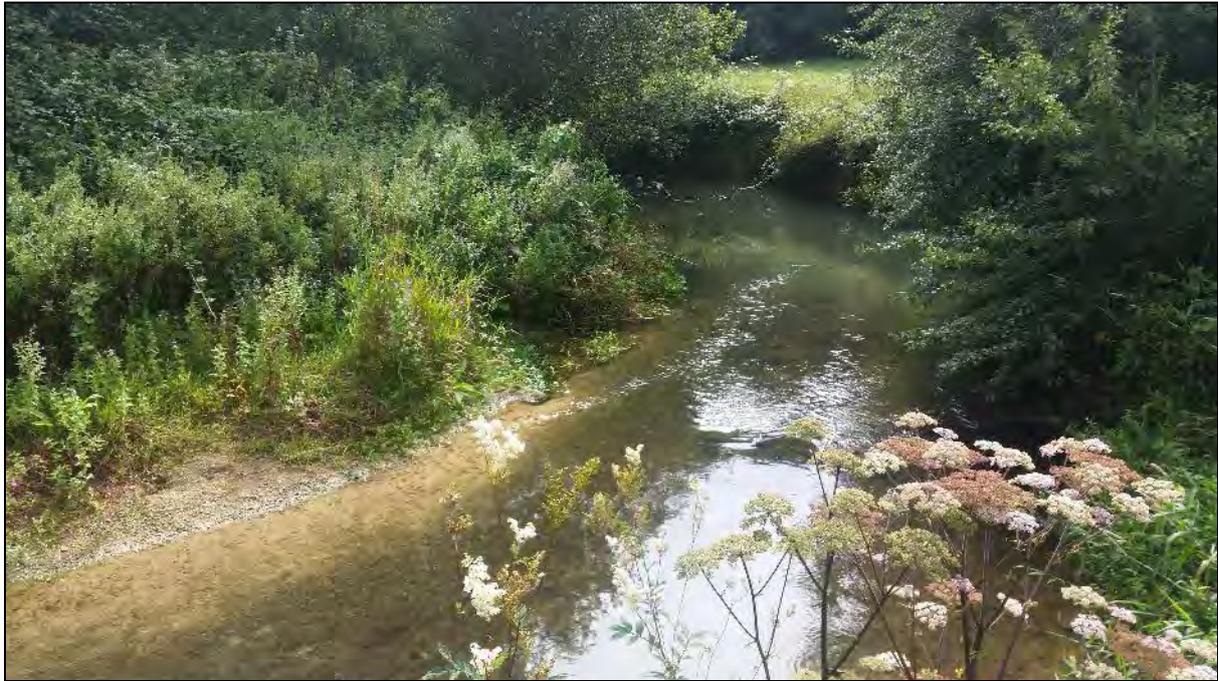
In the free-flowing conditions below Rag Mill Weir, wild trout were observed in abundance and exhibiting a range of natural behaviours including holding in feeding lanes, feeding from the surface and darting to cover. As with the unimpounded reaches observed upstream, the brook here had a good diversity of flows and depths and should provide both good habitat for trout and opportunities for angling (Figure 27).

Figure 27: Free-flowing again the river exhibits some excellent natural features.

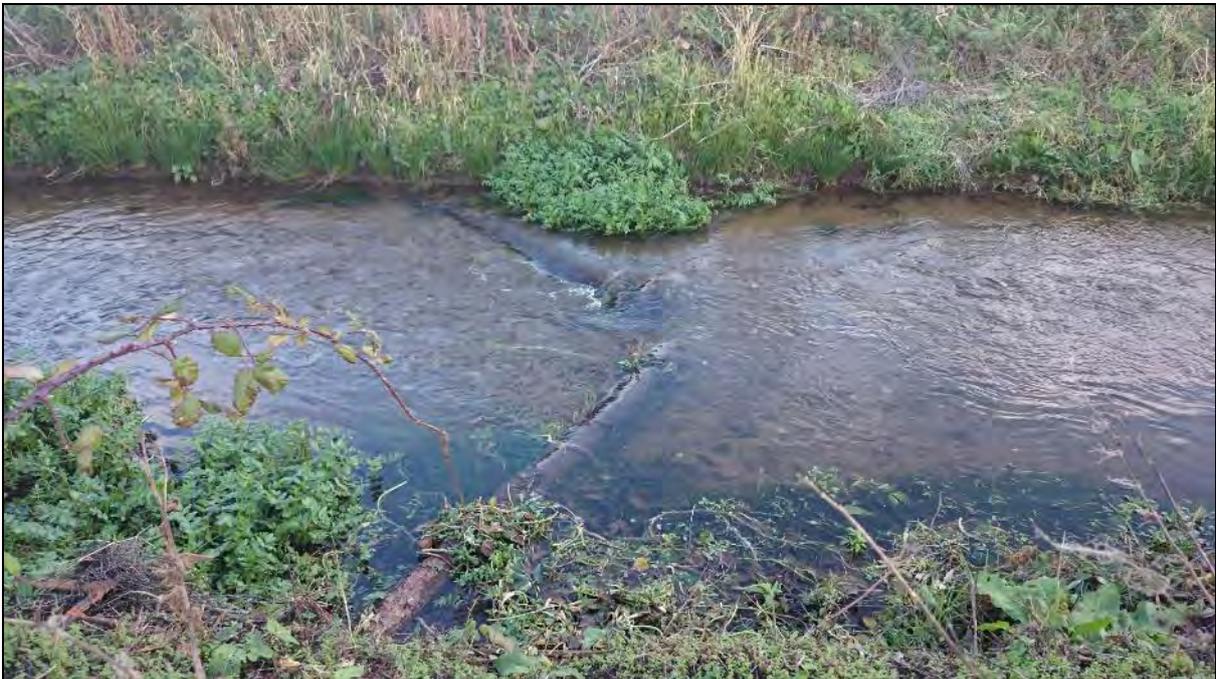
Figure 32: Log deflectors positioned in an 'upstream V' formation focus scour and accentuate a pool

2. Continue to engage with land owners/tenant farmers with regards to protecting the river margins from grazing livestock. Even relatively short sections of temporary electric fencing could heavily poached sections recover, improve biodiversity and reduce the input of fine sediment.
3. In the un-impounded reaches (hopefully one day to include the whole of the water visited), install some simple log flow deflectors to amplify the existing natural processes scouring small pools and runs (Figures 32 and 33). Also consider introducing some marginal brushwood structures alongside potential spawning sites to provide refuge habitat for juvenile trout (Figure 34).

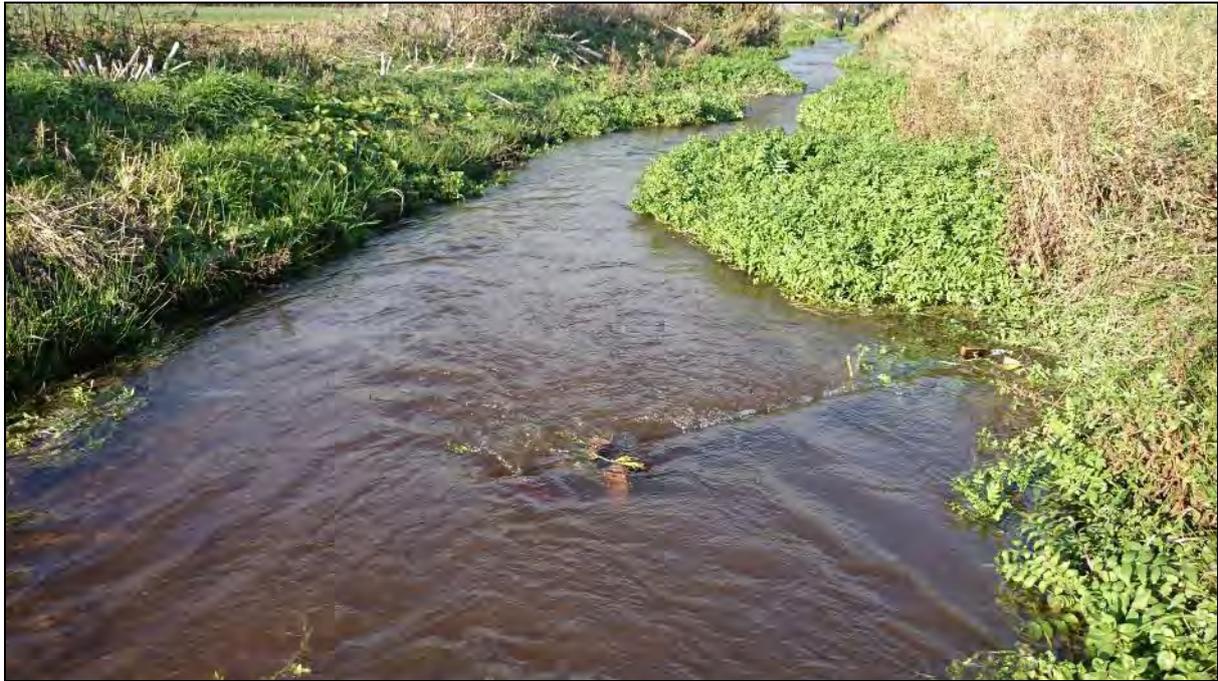
Figure 33: A log deflector scours the bed and also kicks flow around a bend

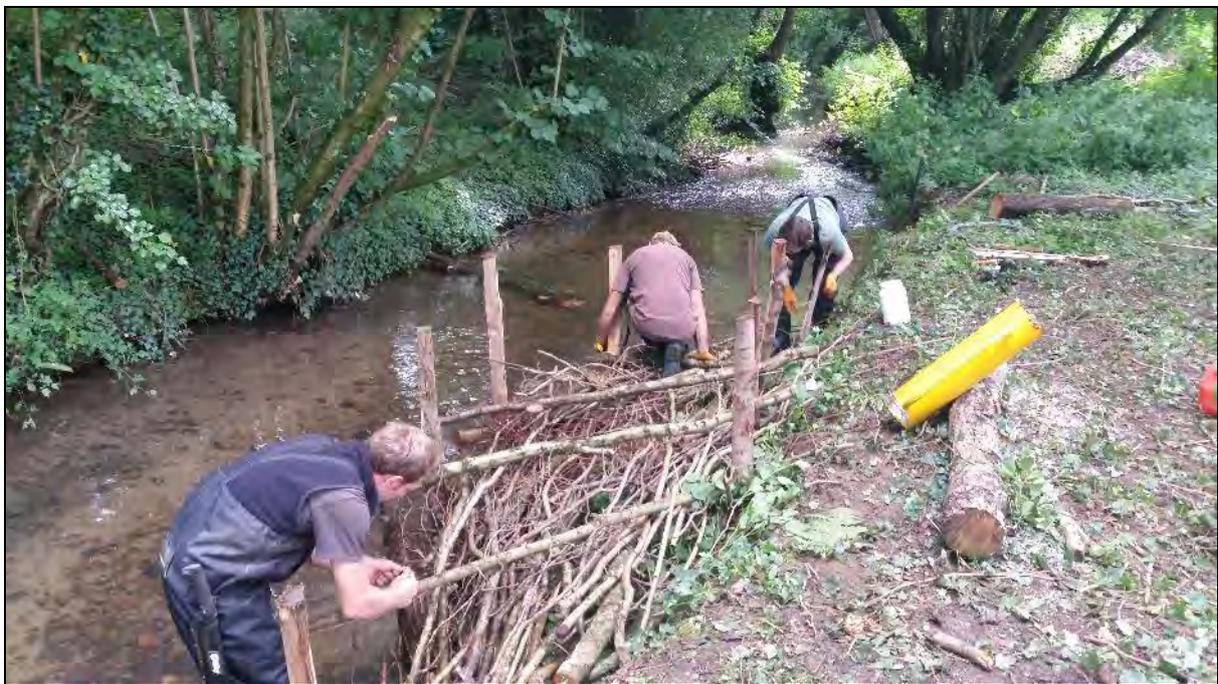
Figure 34: Volunteers introduce marginal brushwood habitat alongside a known trout spawning site.

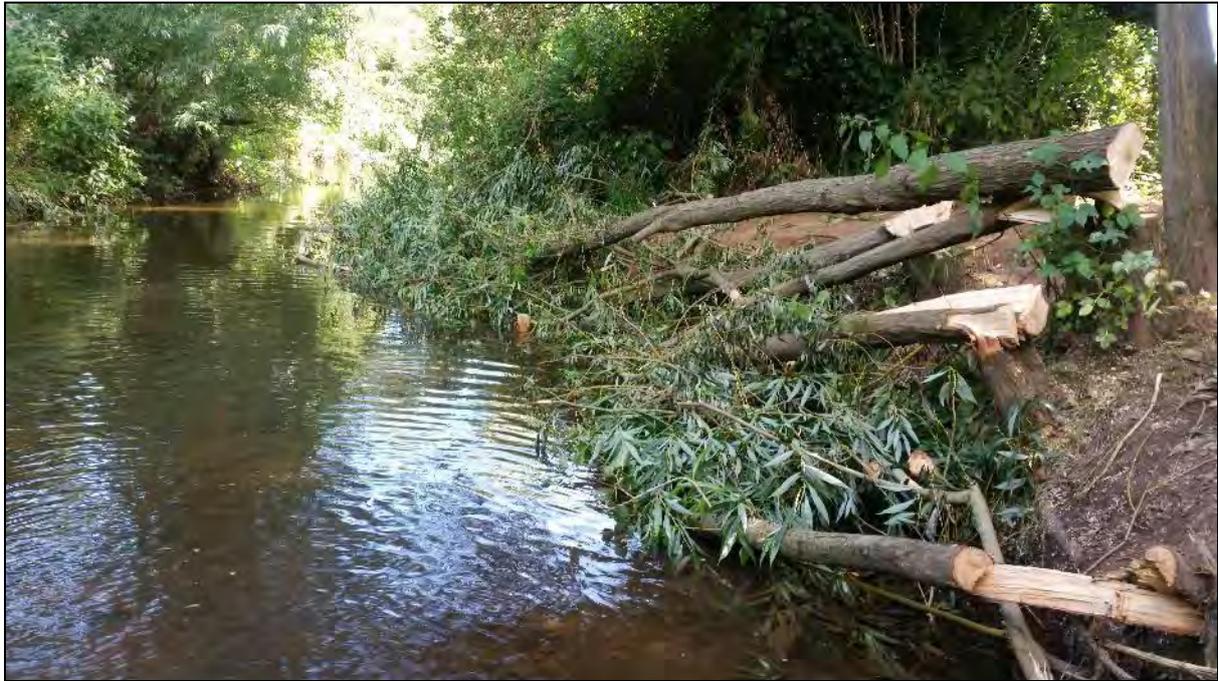
Figure 35: Live willow hinged along the bank downstream

4. Through the wooded reach below Rag Mill, consider opening up sections of tree canopy and introducing flow deflection and cover by hinging or felling trees into the channel and securing with sweet-chestnut stakes (Figures 35 and 36). These features are the best means of safely reproducing the fallen tree habitat that trout (along with countless other fish and freshwater invertebrates) have evolved to utilise.

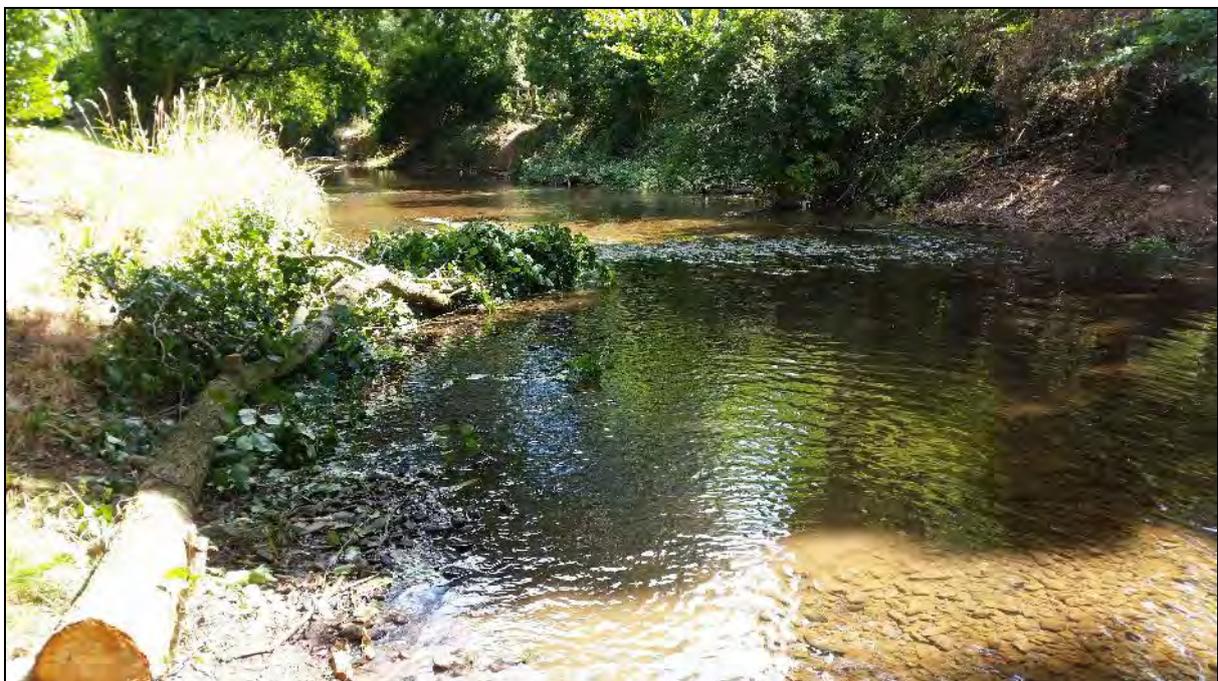
Figure 36: A felled tree secured to the bed. In winter flow this will scour a deep run and create a new trout lie.
