Advisory Visit

Catlow Gill, River Aire, Carleton Village Residents

July 2017

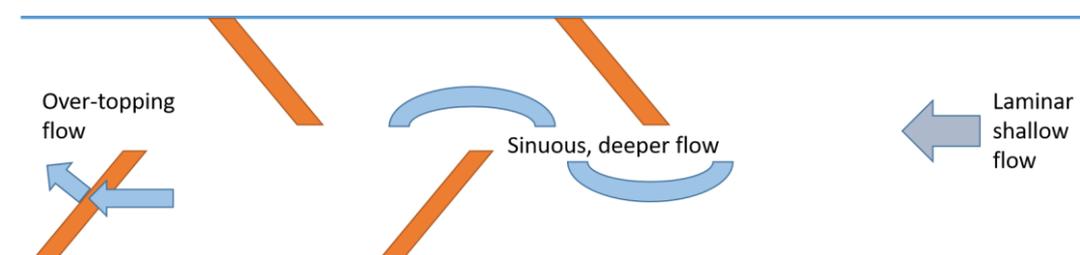
Fig 15. Schematic of offset u/s deflectors which convert a shallow, laminar skim of water into more sinuous path with deeper water maintained by the baulks. Any flow over-topping these is deflected toward the centre of the channel. Fixing is normally achieved using threaded bar, resin-fixed into pre-drilled holes in the concrete

The extent of concrete channel that does not retain any natural bed substrate and hence presents a shallow, relatively laminar skim of water is considerable, but because of its shallow gradient, is not insurmountable. Fixing a series of alternating u/s deflectors of $\sim 1\text{m}$ in length and $0.1\text{-}0.2\text{m}$ in height along the length of the open concrete channel would retain a greater depth of water throughout the reach for fish to swim in and create slack water refugia for fish to rest in. These do not increase flood risk as under spate conditions, the water simply passes over the top, and the u/s angle ensures that when each deflector is over-topped, the water (leaving it at a perpendicular angle) is directed toward the middle of the channel and hence, not causing erosion at the sides – see Fig 15. The major restriction to peak flow capacity in the system is the aperture of the culvert under Heslaker Lane in Fig 6 (upper panel).

Notching of the two ornamental wooden weirs would probably provide the simplest solution. Cutting a 0.6-0.8m wide and 0.1m deep notch into the crest will focus flow, especially under summer flow conditions, thereby providing a target for fish moving in either direction. Under high flows, the weir behaves exactly the same as it currently does. A pre-barrage is required for below the first wooden weir as there is no plunge pool on the concrete channel for fish to leap from; paired deflectors (i.e. directly opposite each other with a narrow aperture between) at the head of the series of alternating offset structures (outlined above; Fig 15) will probably suffice.

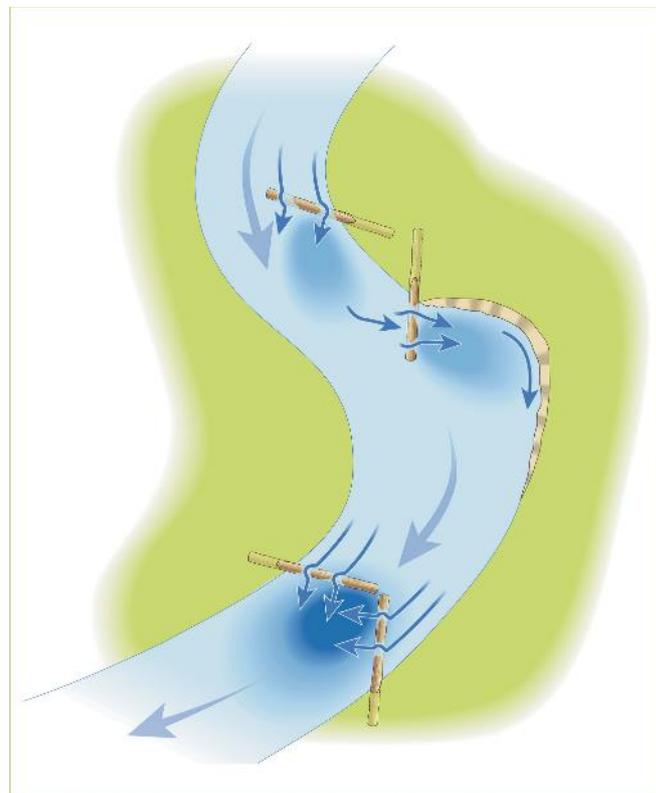
Fig 15. Conceptual diagram of use of woody (or stone block) material as deflectors. From the top of the figure:

Upstream angled – diverts flow to the centre of the watercourse, and creates localised scour; locating deflectors on opposite banks of a straightened section, but off-set in position can create sinuosity of flow without eroding the banks.

Gravel retention for spawning habitat is an issue in the lower, straightened and impounded sections, essentially from the footbridge and d/s. To emulate natural pinch-points and treefall where there is no living wood available (i.e. through the fields), paired deflectors or individual stub deflectors could be installed: short (<1m), well anchored / pinned trunks of wood (<300mm diameter); see Fig 15. The purpose of such installations would be to cause small-scale,

localised scour and 'hummocking' of the bed, thereby focussing and retaining smaller gravels in their lee (see WTT video, here: <https://vimeo.com/32317564>).

Wood of this size can also be installed under Environmental Permitting Regulations exemptions. Such wood might also introduce an element of sinuosity to the flow under low-flow conditions. Angling the deflectors u/s focuses flow toward the middle of the channel (i.e. away from the bank and hence reduces erosion risk there) when they are overtopped. In terms of perceived flood risk, because these structures are relatively small (<5% of bank height) and occupy <50% of the cross-sectional channel width, they are completely overtopped during high spate flow. The stone blocks from the defunct stone weirs (See 3.1.2) could be arranged to perform the same function in the sections of beck through the village.
