Advisory Visit

River Ceiriog, Brynkinalt Estate, Chirk

August 2016

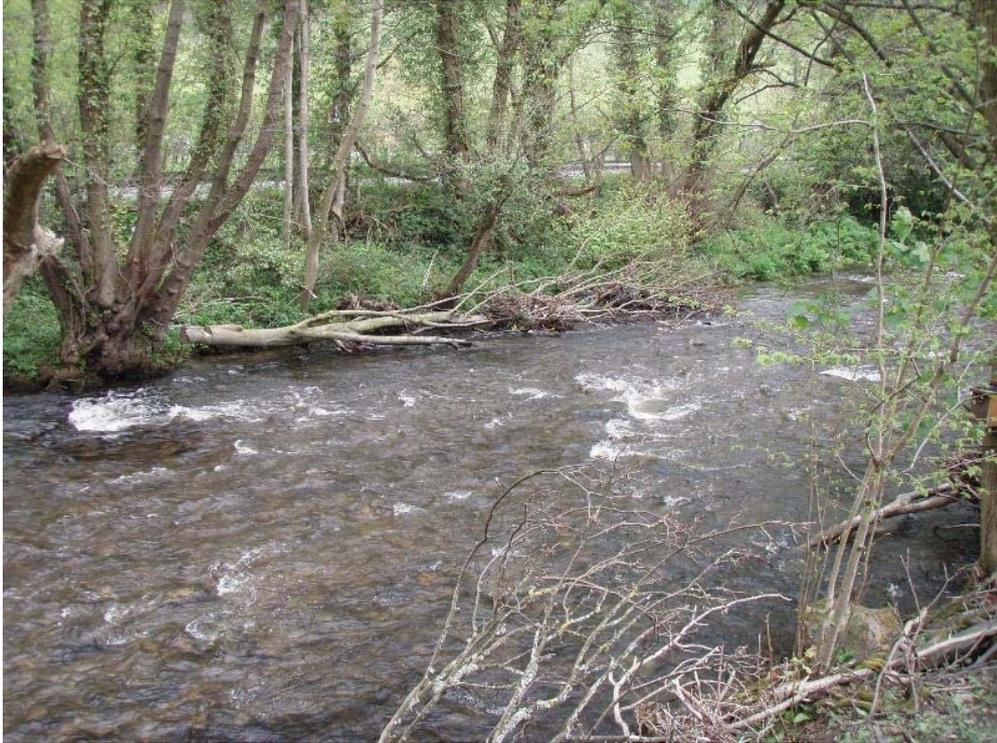
Photo 30 A tree kicker installed on the Ceiriog upstream of Brynkinalt waters. Laying a series of overlapping trees would increase the effect.

- The reach of river between the viaduct and Lady's Bridge could have some tree kickers installed. These are whole trees felled into the watercourse and attached securely to their stumps with steel cable. They are generally swept parallel to the bank in high water events. Their presence changes flow patterns and creates localised scour and deposition and hence depth variation. The viaduct to Lady's Bridge is a particularly straight section which would benefit from some variation. Downstream of Lady's Bridge is similar, but the river bed there is largely comprised of bedrock so would not scour.

Trees are felled into the watercourse and winched back as close to their stump as possible. A hole is drilled through the tree trunk and stump with an auger (or a boring cut with a chainsaw) and steel cable and fixings used to secure. The short cable prevents the floods from lifting the tree onto the bank. If commercial forestry equipment is in use then installing tree kickers at the same time should be very straightforward.

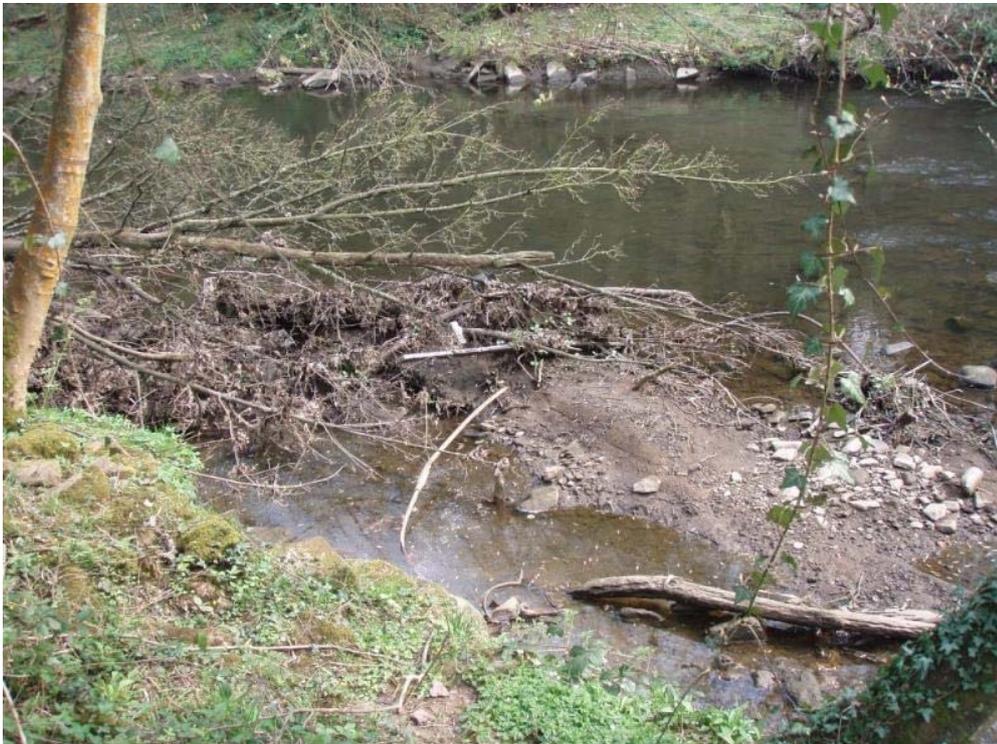
Photo 31 An example of deposition in the lee of a tree kicker with channel deepening beyond.

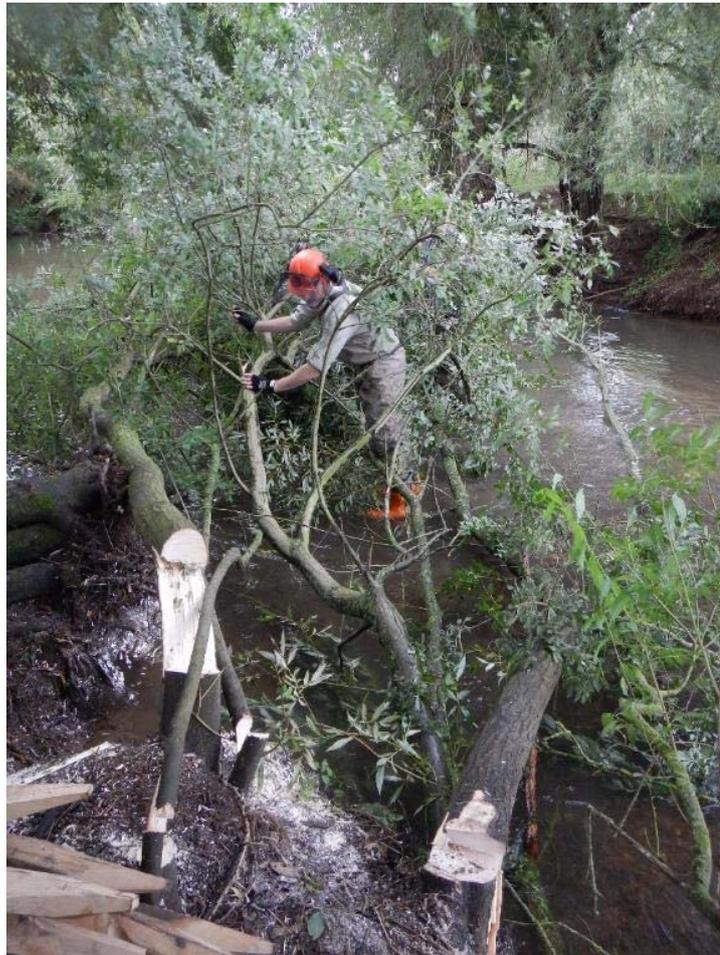
Photo 32 Several willow limbs laid into a river margin to provide cover and in-channel structure.

- Hinging of trees to provide marginal cover and channel narrowing can be undertaken throughout the river, where there are suitable opportunities. Smaller, pliable species of trees alongside the river can be partially cut and laid into the river margins, in a similar manner to laying a hedge (Photo 32).
