Little Avon, Charfield, South Gloucestershire

An Advisory Visit by the Wild Trout Trust February 2016

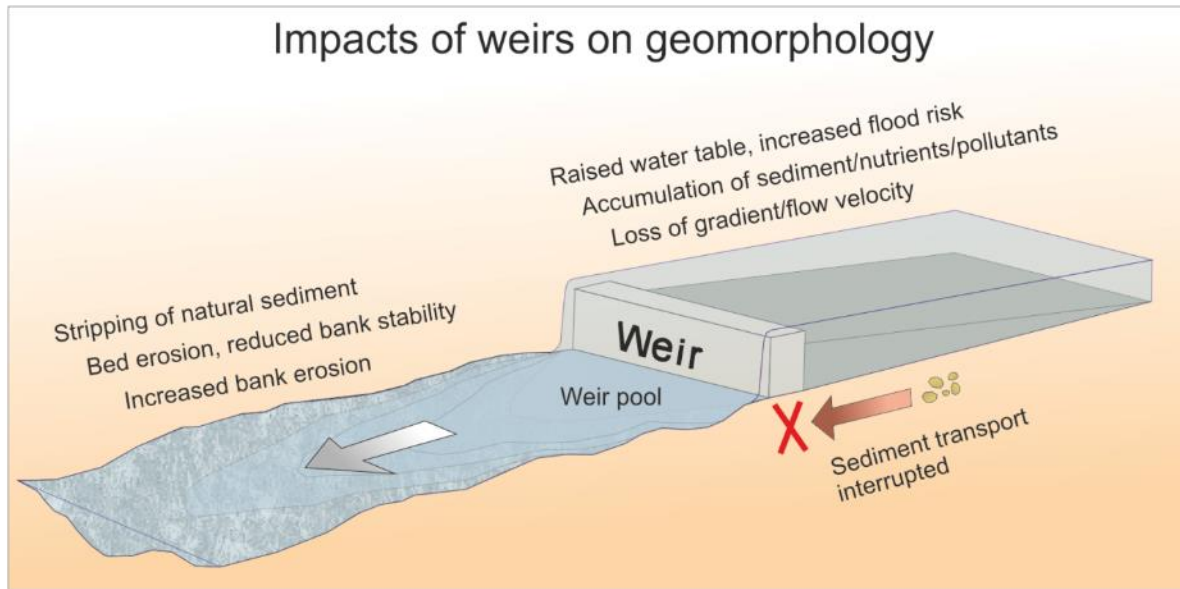
Figure 2 and 3 show the effect of weirs on geomorphology and habitat.

Fig 2 & 3: Illustrations of the impacts of weirs on geomorphology (above) and habitat (below)

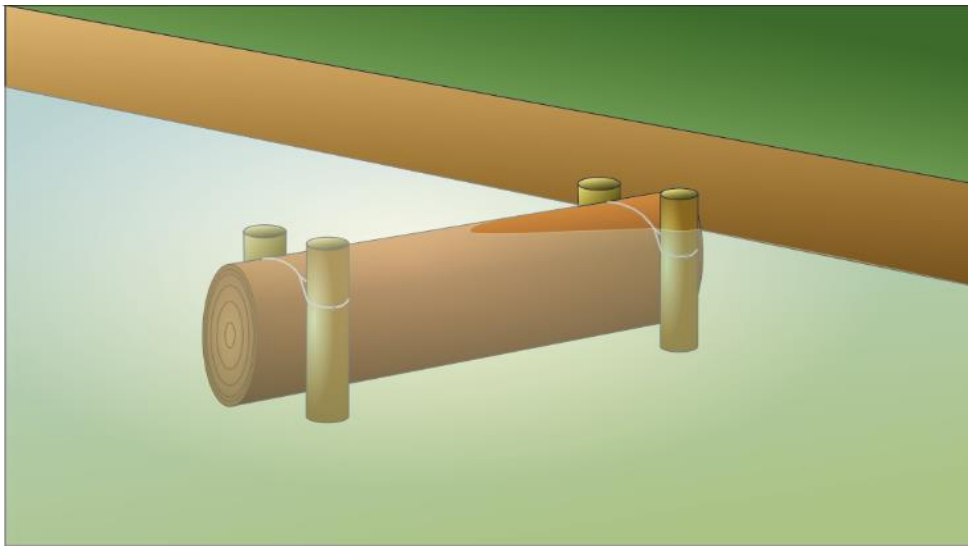
Fig 4: Close-up drawing of pinned LWD

A post should be driven into the river bed on either side of the log or branch (If the bed is hard then a pilot hole for the post should be driven using a sledge hammer and iron bar). Loop the galvanised fencing wire around the posts either side of the log and use fencing tacks (preferably large) to pin the wire to the posts. Leave several inches of slack wire above the log (this allows the wire to tighten down onto the log during post driving). Drive one post into the bed part way, then drive second post in until wire starts to tighten over the log. Do not over-tighten the wire. Eventually the wire should tighten over the log, pinning it to the river bed. It can be made easier if you have the weight of several people standing on top of the log to hold it down whilst the posts are being driven. Always use the personal protective equipment when working in this way i.e. hard hat gloves and eye protection.

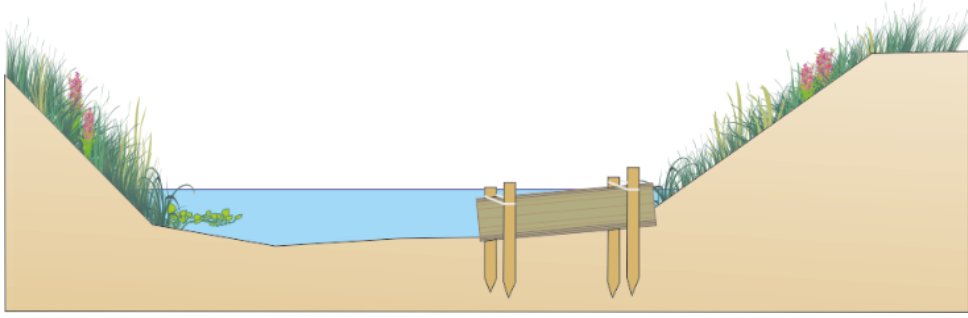
Fig 5: Pinned log deflector with paired posts and galvanised wire

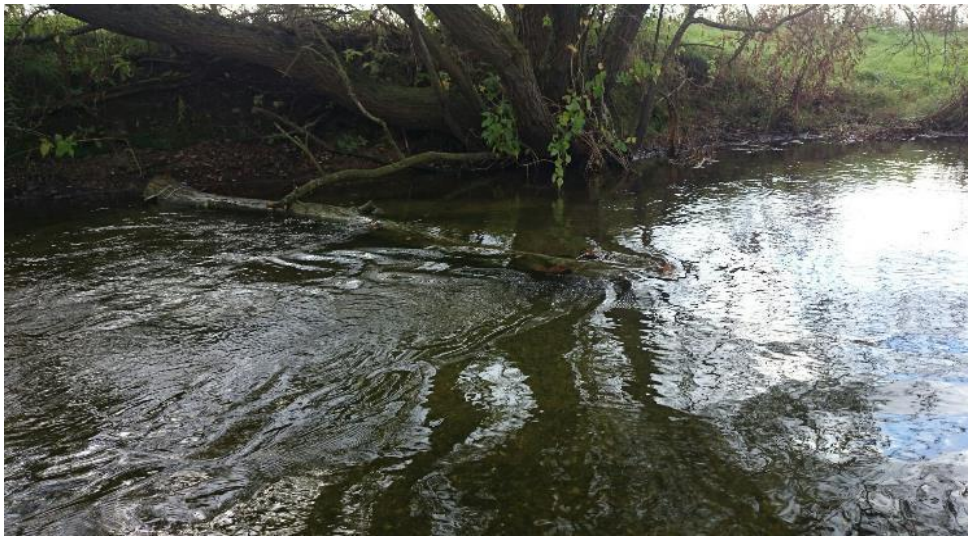
Photo 13: Log deflector pinned with posts and wire (angled upstream, creating bed scour to gravel immediately downstream)

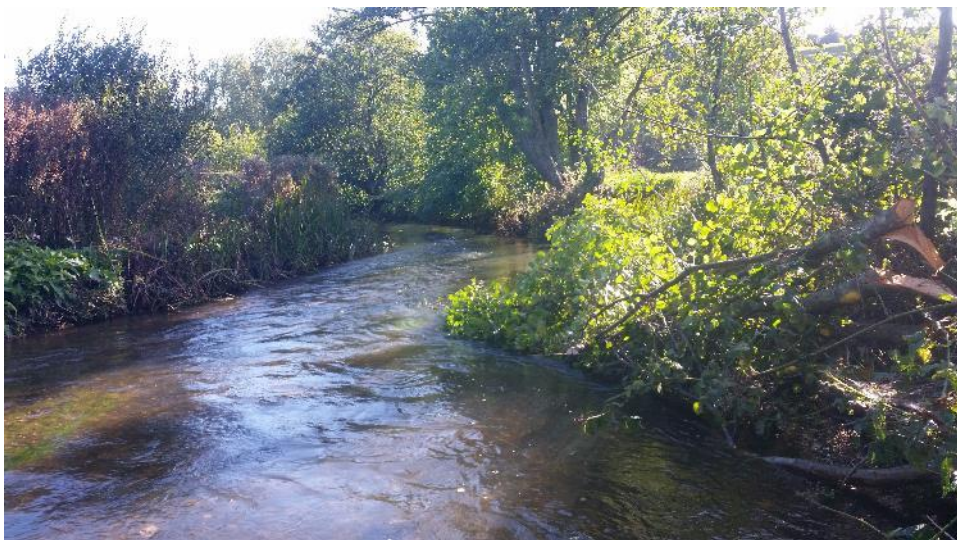
Photo 14: Alder tree with 'living hinge' still attached (angled downstream)

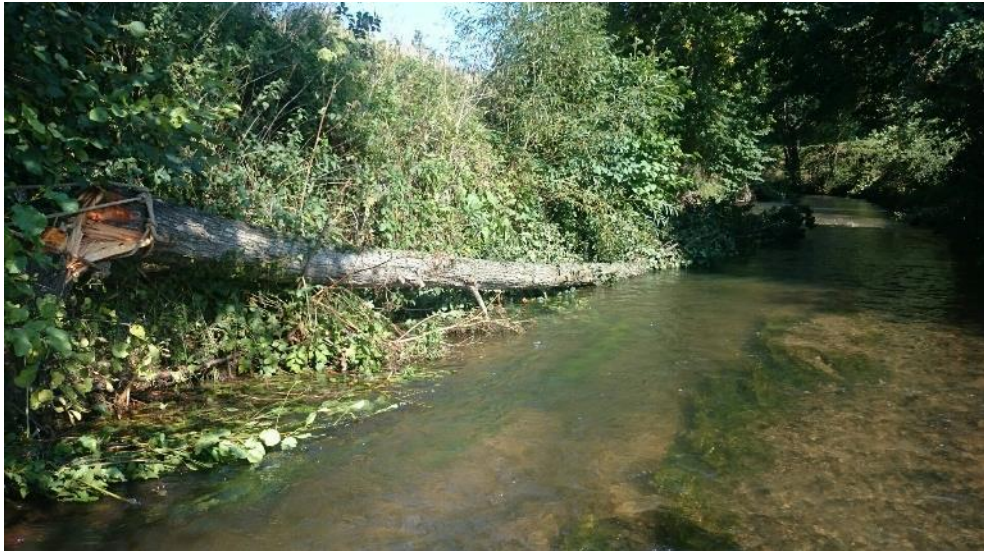
Photo 15: Large hinged Alder tree (Willow is just as good and often responds well to hinging)
