WILD TROUT TRUST

Advisory Visit

Cound Brook, Shropshire

June 2020

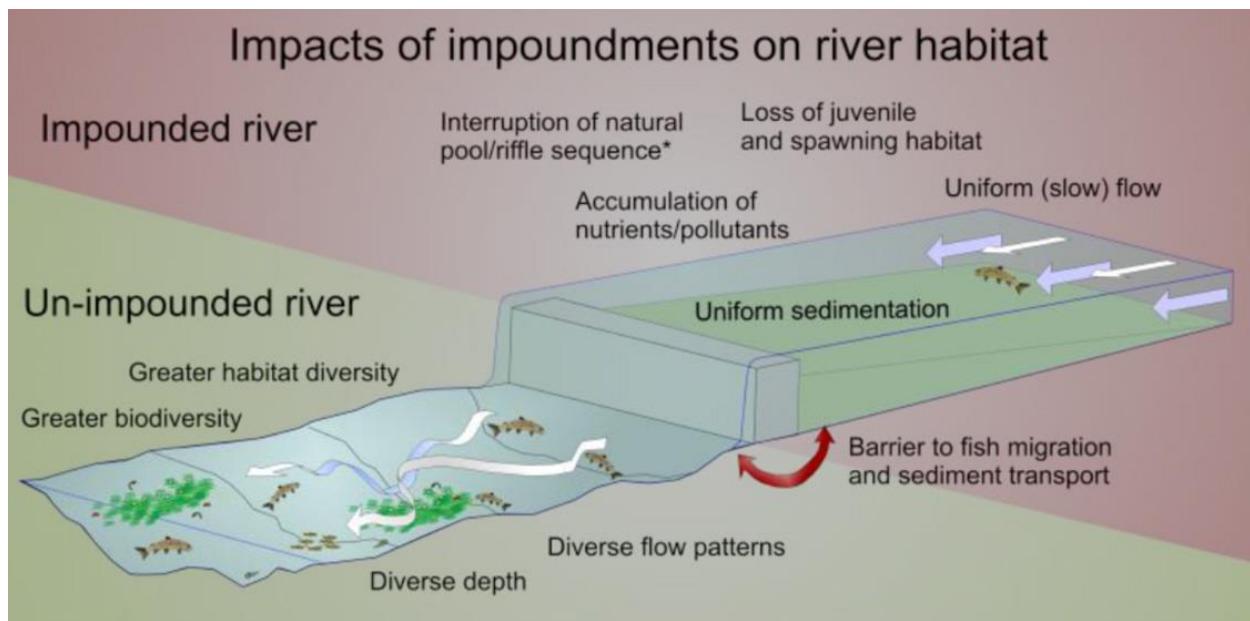
Figure 1

Weirs are detrimental to river habitats, interrupting fish migration and natural sediment transport, and raising upstream water levels which 'drowns' natural in-stream habitat (Figure 1). In the specific case here, there is little negative impact: the impoundment is small and does not extend a significant distance upstream; there is also no impediment to fish movement because of the open structure of the boulders. However, if there is no longer a need for the raised upstream water levels it would have been simpler and more beneficial simply to remove the old weir.
