Habitat Advisory visit to the River
Dikler, Lower Swell, Gloucestershire
Undertaken on behalf of the Wild Trout
Trust, Vaughan Lewis, Windrush AEC
Ltd
June 2012

1.0 Introduction

2.0 Habitat assessment

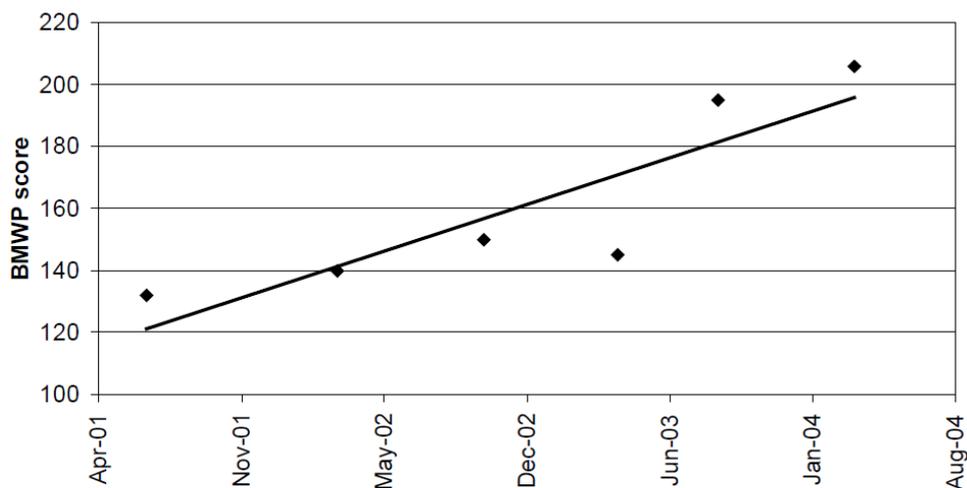
Figure 5.0 BMWP scores for Lower Swell

Water quality is also reflected in the macro-invertebrate fauna present in the watercourse. Using the results from a 3-minute 'kick' sample from the river, invertebrates are scored depending on their pollution intolerance; the species most sensitive to the effects of pollution are given the highest score. The results are weighted to reflect the relative abundance of each invertebrate group, with the final results expressed as a Biological Monitoring Working Party (BMWP) score. Typically, a good quality stream in the Cotswold would be expected to have a BMWP score of >150 . Fig. 5.0 shows that the river has exceeded this figure since mid-2002, rising to a score of nearly 200 in summer 2004.

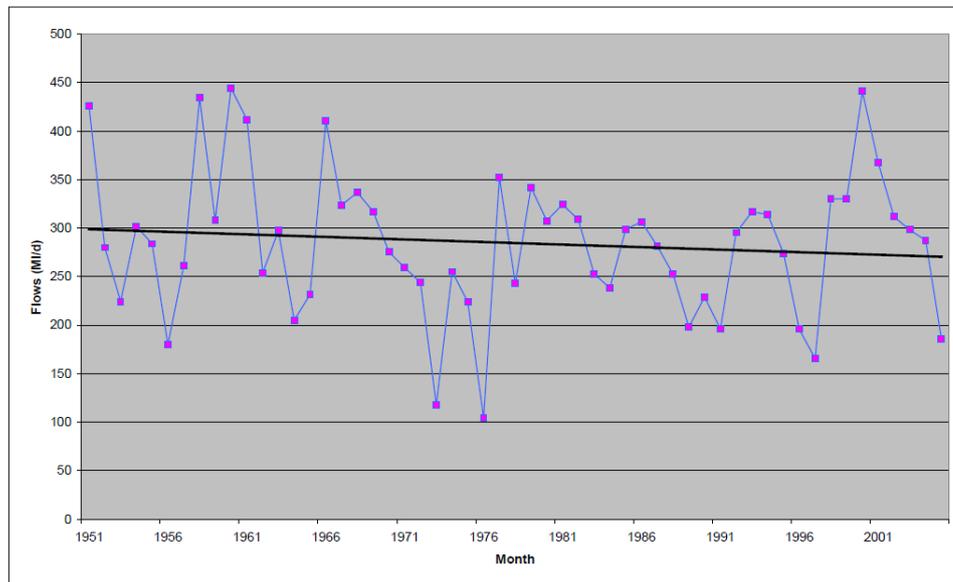
Figure. 6.1 Annual average flow recorded at Newbridge gauging station (Standlake) (1951-2005)

Data from Newbridge gauging station at the downstream limit of the River Windrush show a significant decline in average rainfall since the early 1950's. Detailed analysis had linked this decline causally to the reduced rainfall in the west Cotswold during this period. A similar impact on flows is therefore to be expected within the River Dikler catchment.
