Advisory Visit

River Dove

May 2018

This report is the output of a site visit undertaken by Tim Jacklin of the Wild Trout Trust to the Derbyshire County Angling Club (DCAC) section of the River Dove, Crowdecote, Derbyshire on 1st May, 2018. Comments in this report are based on observations on the day of the site visit and discussions with members of the DCAC committee.

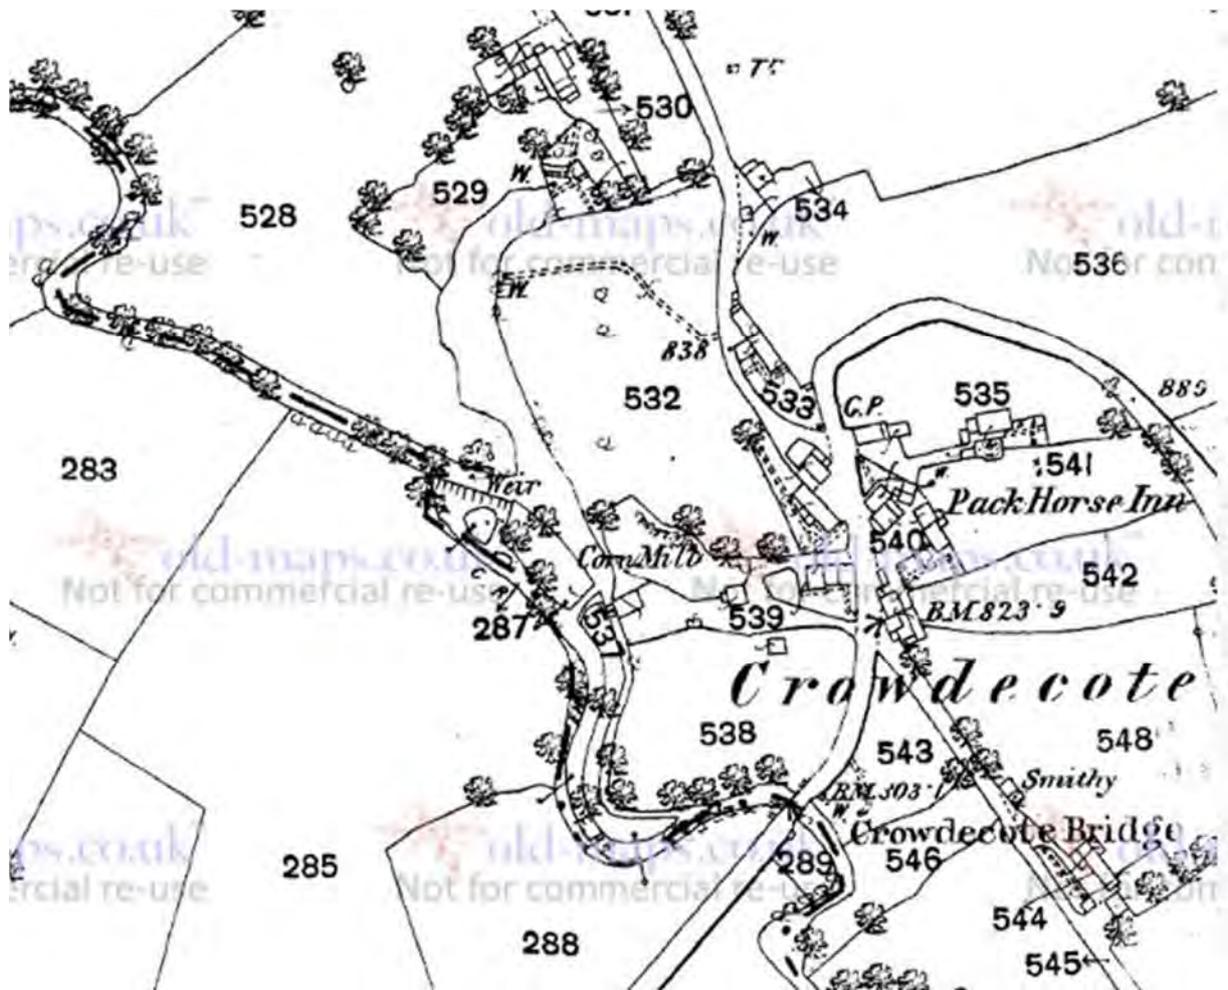
Figure 1 1879-1880 OS County Series Staffordshire. www.old-maps.co.uk

Just upstream from the sewage works are the remains of structures associated with a former corn mill. From the 1879 map (Figure 1), there appears to have been a substantial impoundment of the river (and possibly the spring) forming a mill pond. All that now remains is a stone-lined channel carrying the spring water, some rubble where the weir stood (Photo 5) and a low-lying, scrubby area where the mill pond was.

Despite the absence of the mill and weir, the straight reach immediately upstream (for circa 100m) shows evidence of regularly fluctuating water levels caused by water backing up; a "tide line" of about 18 inches of bare bank is visible above the water line (Photo 5). This is being caused by a substantial debris dam downstream of the old weir location (Photo 4).

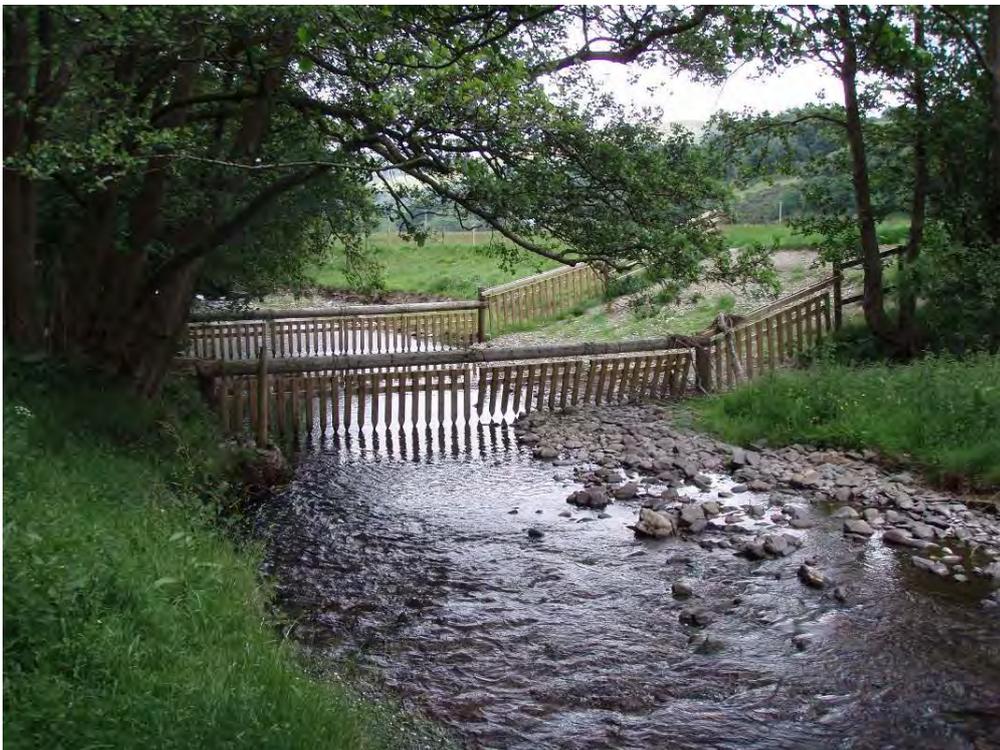
Photo 27 Example of livestock drinking area tied into bankside fencing. If only cattle are present, just the telegraph poles (without the hanging panels) will suffice and have been used successfully on the Dove downstream of Crowdecote.

- Maintain the existing fencing along the river and keep it stockproof. This is the single most important factor in maintaining good habitat on this fishery.
- Liaise with the landowner and fishing interests on the opposite bank (RB) to improve and extend the fencing there, in particular, the area highlighted in Photo 22. The ideal solution would be complete exclusion of livestock and provision of an alternative watering source. It may be possible to utilise pasture pumps, depending upon the requirements of the livestock. If complete exclusion is not possible, a livestock watering point similar to Photo 27 could be created here if the RB was fenced.

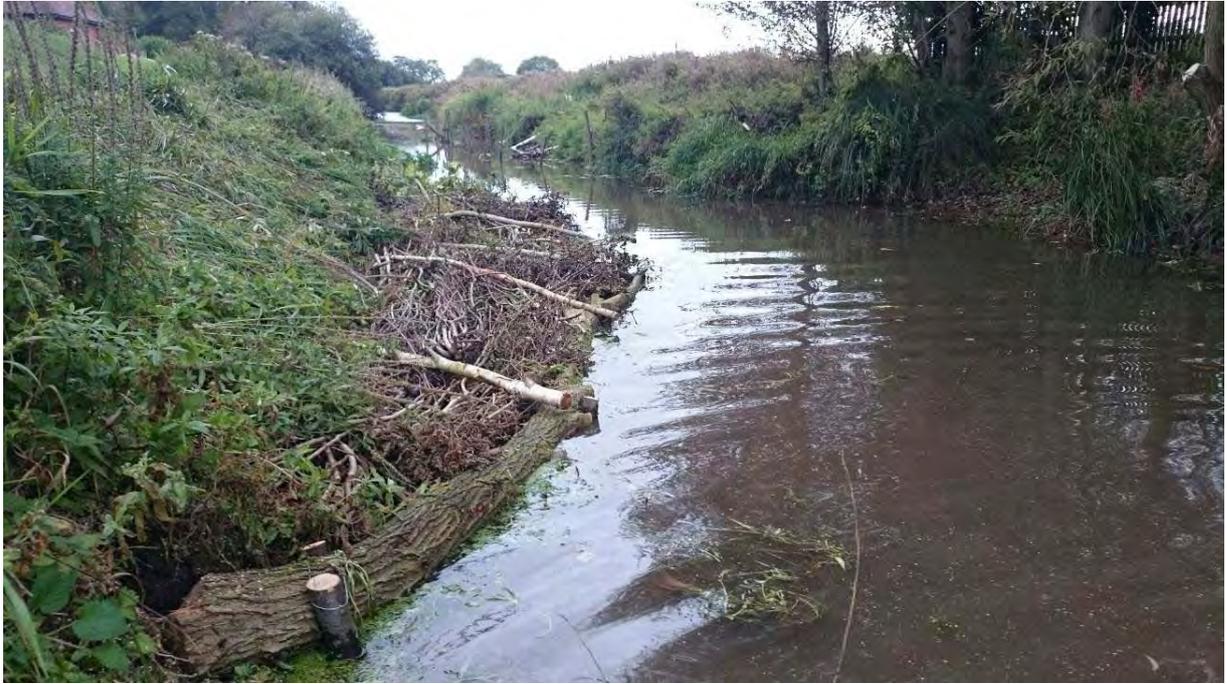
Photo 28 Brushwood mattress. NB stakes must be driven into the riverbed for this technique, so check this is possible first.

Introduce more structure to the straight channel section upstream (Photos 5 & 6) in the form of brushwood mattress (Photo 28) and tree kickers (Photo 30).

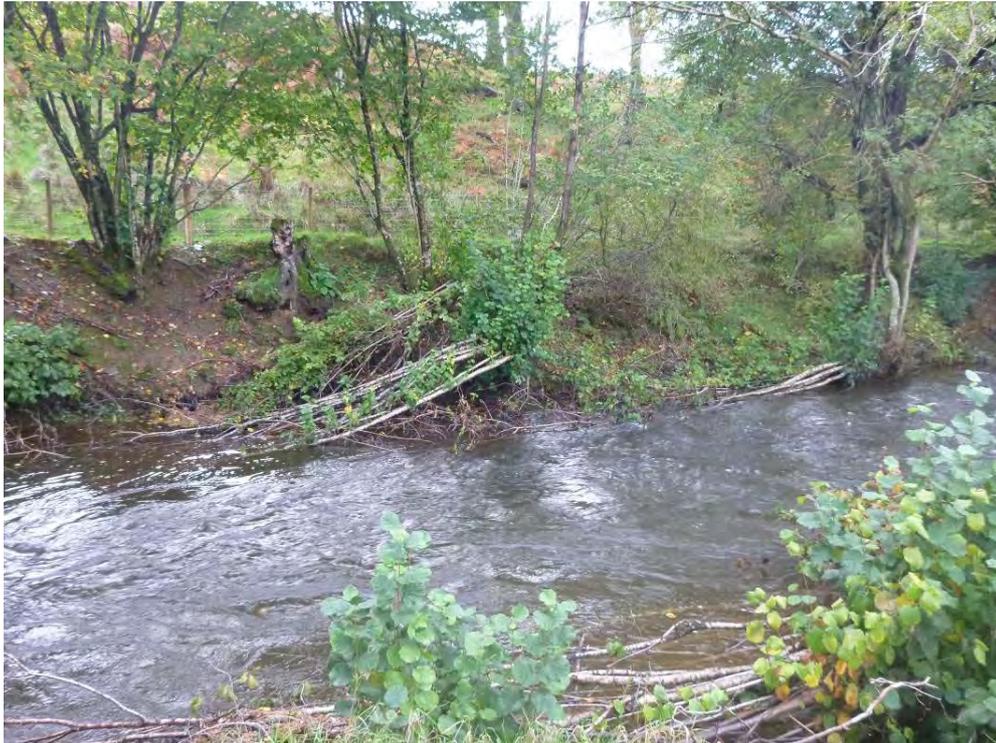
Photo 29 Smaller trees partially cut and laid to create good cover.

- Adopt a policy of retaining woody material in the river channel to provide cover and refuge habitat / resting lies for trout. Good cover is absolutely critical in increasing the fish holding capacity of a generally small, shallow river like this.
- Introduce more cover to the areas identified in section 3.2 (and similar). This can be achieved by hinging suitably located trees (similar to hedge laying) or making a tree kicker by fixing a tree/bush to a suitable anchor point on the bank with cable.

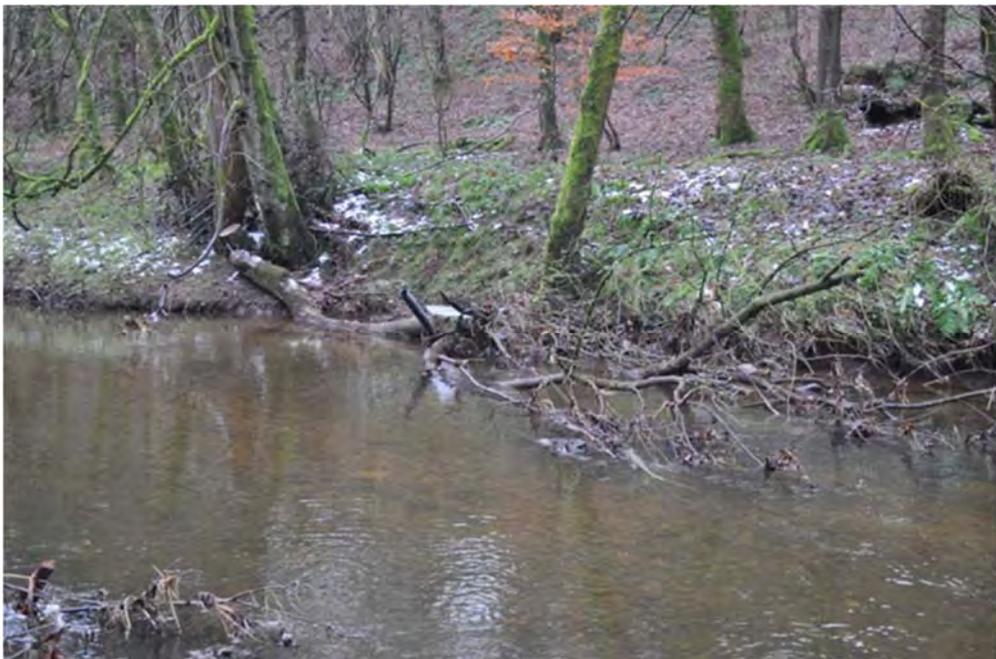
Photo 30 A larger tree, felled and attached to its stump with cabled wire.
