**Advisory Visit**  
**Eastburn Beck, R. Aire**  
**07/07/2015**

## **1.0 Introduction**

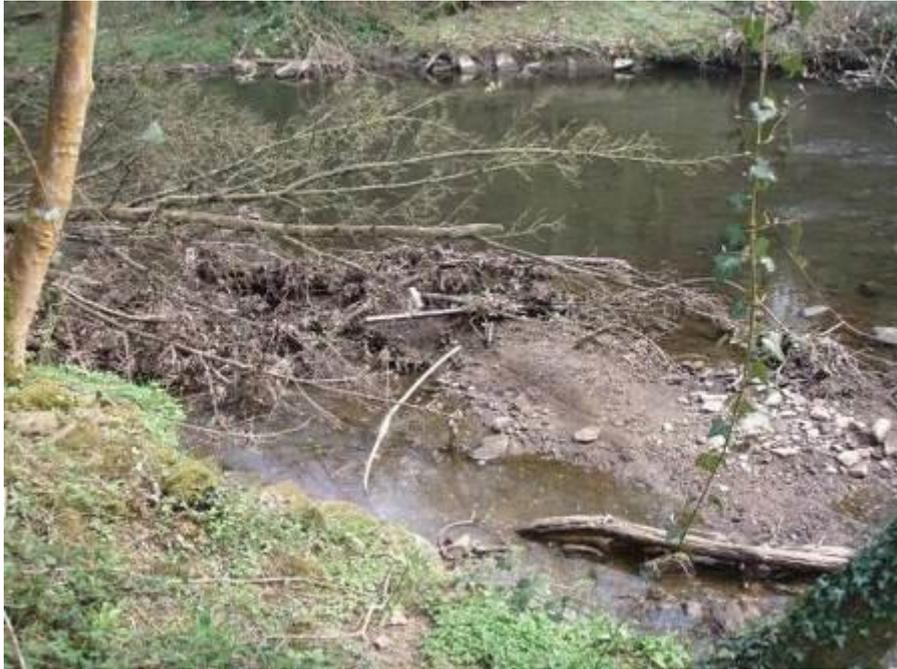
**Fig 22. A tree kicker (or trunk / log depending upon effect scale required) laid parallel to the bank to narrow the channel, introduce scour and sinuosity, and retain substrate d/s and toward the bank side. It should become embedded over time.**

This could be achieved by introducing a series of cabled 'tree kickers' or trunks securely pinned next to the wall banks, which are essentially mimics of natural tree fall organised to maximise habitat potential (Fig 22). Arranging these in an alternating, staggered fashion will promote meandering flow, whilst arranging in a matching pair on opposing banks will achieve a degree of channel pinching or narrowing. Both alterations to the flow are desirable and should be considered where possible to augment any remaining weir structures.

LWD deflectors may eventually become consumed naturally by the deposition of bed substrate. However, their physical presence will still be deflecting flows, something which is severely lacking at present.
