Advisory Visit

River Elwy, Rhyl & St. Asaph Angling Association

May 2017

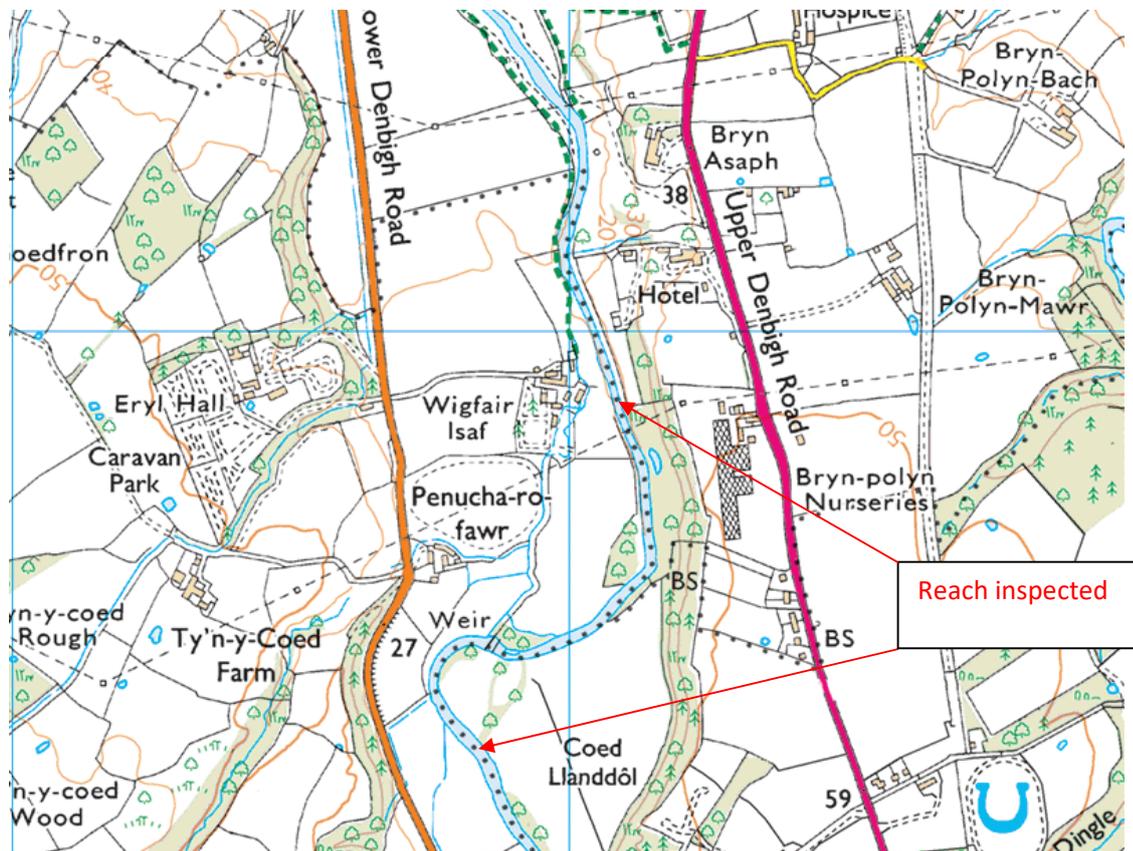
Figure 1 Reach inspected, river flowing south to north.

The actively eroding bank is on the right hand bank adjacent to the steeply sloping, wooded valley side leading down from Bryn-polyn Nurseries (Photos 1 & 2). RSAAA members and the landowner stated that the channel had been realigned here in the past and previously it had been further to the east, closer to the base of the valley slope. A relict channel is visible in the wood (and on Figure 1, the small pond on the RHB).

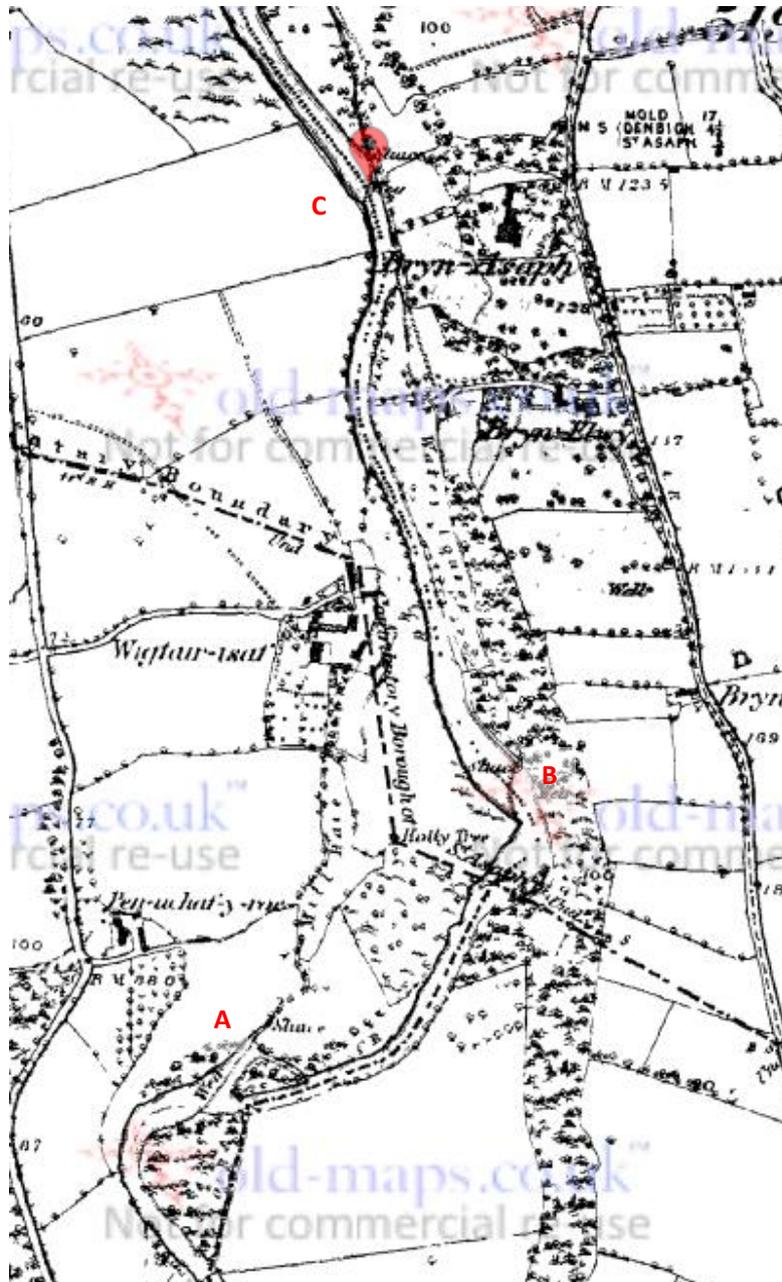
In addition to the former weir at Bryn-polyn, another weir structure existed approximately 730 metres further downstream at Bryn-Asaph (Figure 2), with a mill channel extending downstream into St. Asaph. According to the dates of the maps, this structure disappeared in the mid-1960s.

Figure 2 OS County Series 1:10560 Flintshire 1878-1880, showing three weirs including the existing weir (A), a weir at Bryn-polyn (B) and a weir at Bryn-Asaph (C). Weir B at Bryn-polyn appears on the 1874-92 1:2500 map (Figure 2), but is absent on the 1899 map (Figure 3). Weir C at Bryn-Asaph is present on the 1964 (1:10560) map and absent on the 1968-69 map of the same scale.

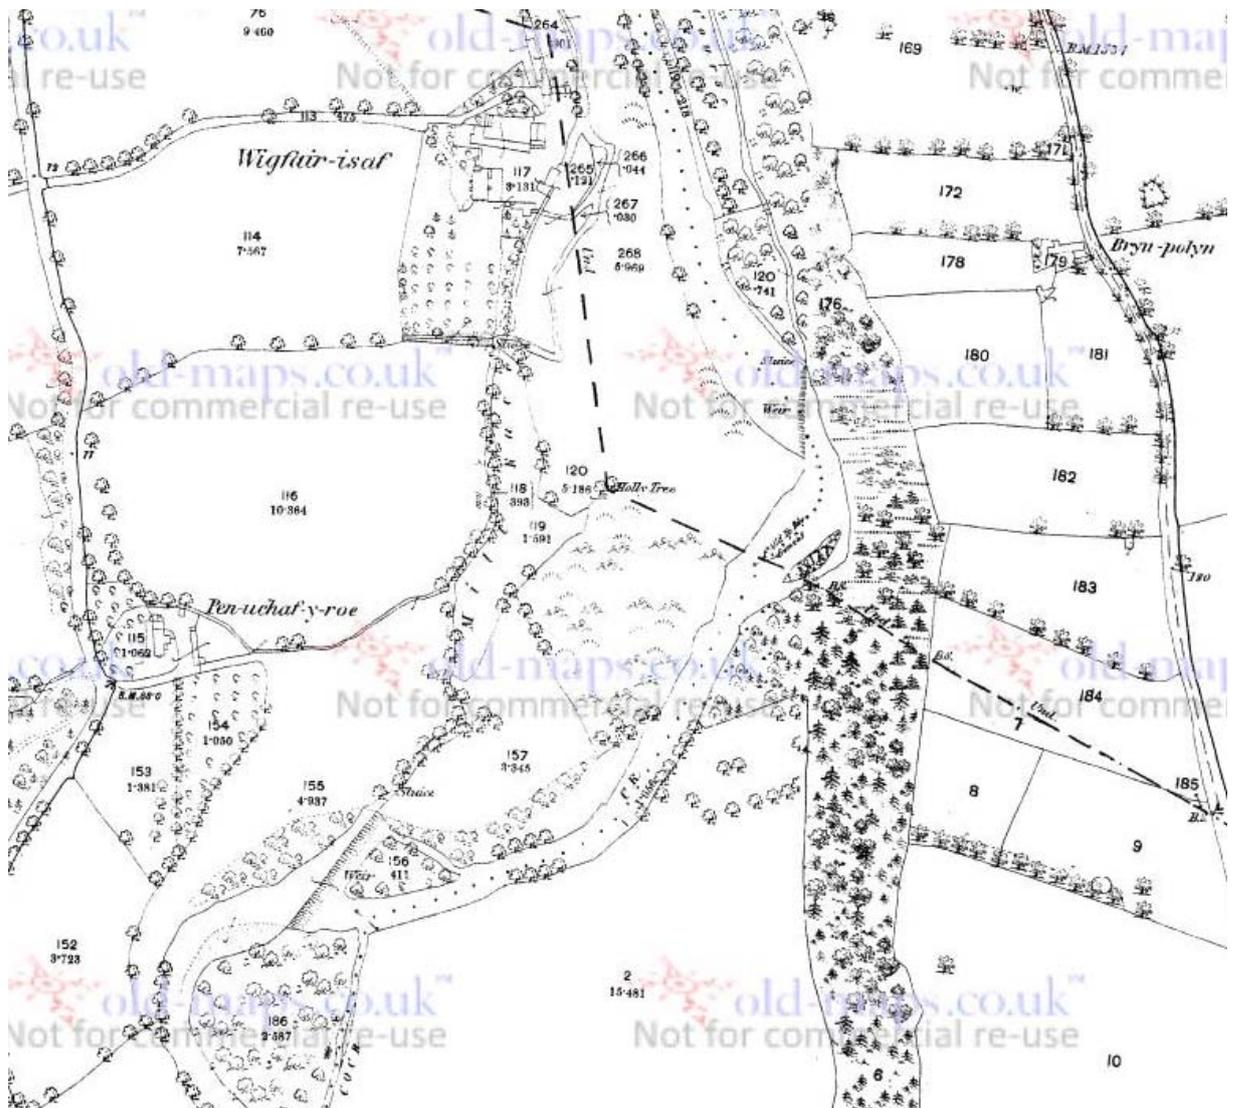
The effective increase in weir crest height may also have implications for flood flows circumventing the weir via a relict channel which bypasses the meander (Photos 13 – 15). The channel is visible on the 1874-92 map (Figure 3, Appendix), labelled COCR (Centre of Old Course of River). It is too straight to have been a former natural course and may have been a temporary flow diversion during original construction of the weir, which was subsequently back-filled. RSAAA report that during floods in recent years, mass slippage of material has occurred at the downstream end of this channel, caused by water seeping through and destabilising the ground (Photo 15). If flood flows and/or sub-surface flows are being diverted via this channel more regularly, there is the potential for the river to eventually break through and bypass the weir.

Figure 3 OS County Series 1:2500 Flintshire 1874 – 1892 showing existing weir and former weir near Bryn-polyn.

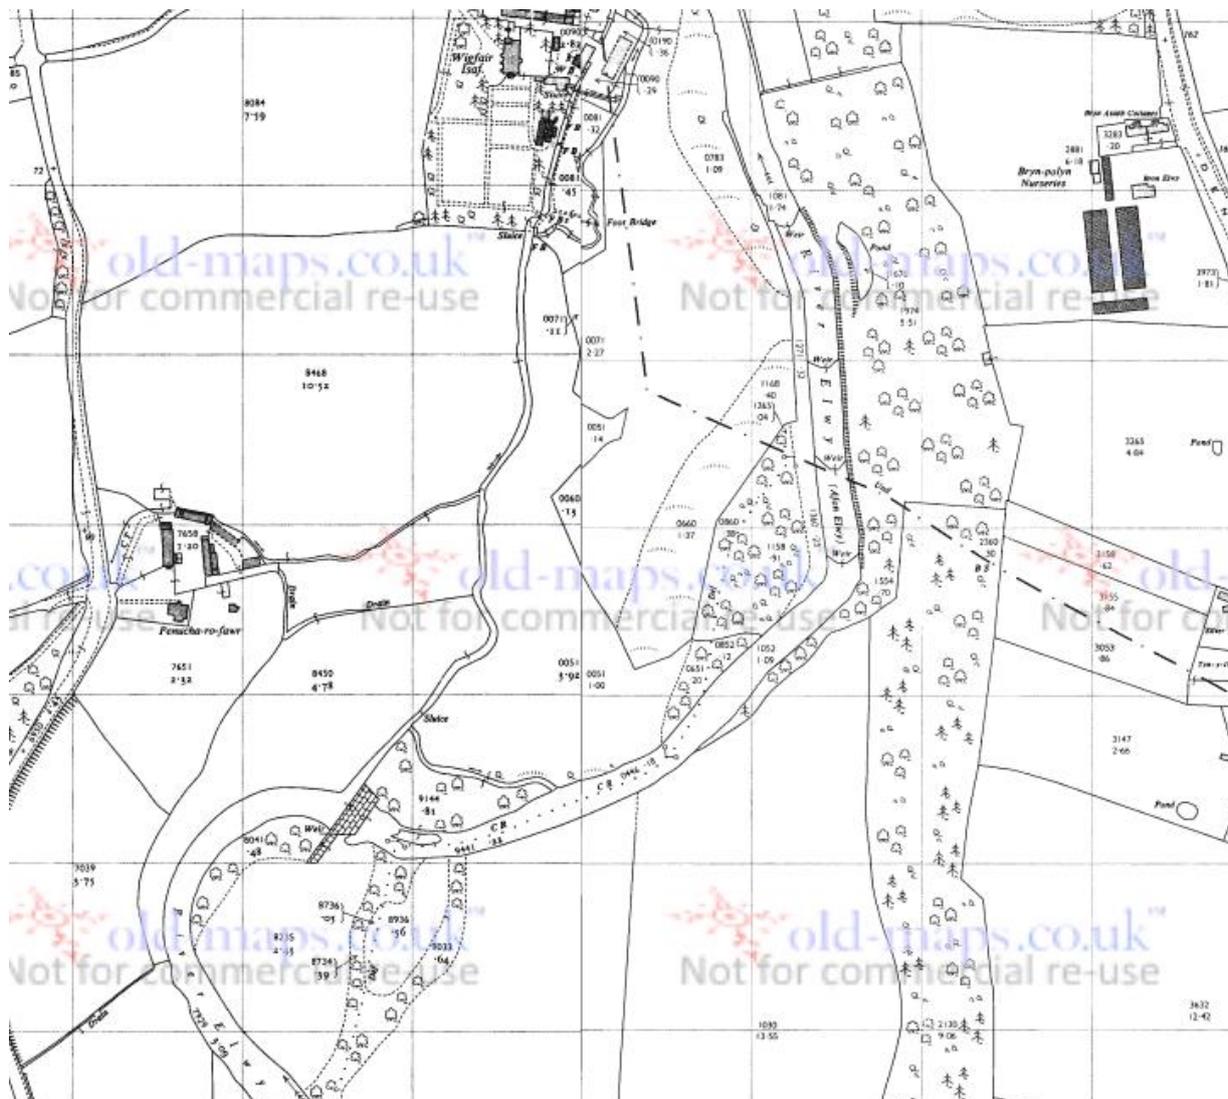
Subsequent research using old maps available online (www.old-maps.co.uk) gives an indication of the historic plan-form of the channel in this location. Figures 2 – 5 in the Appendix give examples of historic maps for this location and indicate that there was a weir and sluice here circa 1892, but it had disappeared by 1899. This weir is shown supplying water to a mill channel on the RHB leading to a hydraulic pump at Bryn-Elwy and returning to the main river just upstream of Bryn-Asaph. The river is shown following the course further east up until the mid-1960s, after which it is shown as straightened with four new weirs; the latter are presumably the blockstone channel constrictions seen on this visit (Photos 4 and 5).

Figure 5 OS Plan 1:2500 1962 – 1963 Showing straightened course of the river at Bryn-polyn and four weirs within the straightened section. The river is also shown in this course in t1968 – 1969 1:10560 map.
