**Advisory Visit**

**River Elwy, Rhyl & St. Asaph Angling Association**

**May 2017**

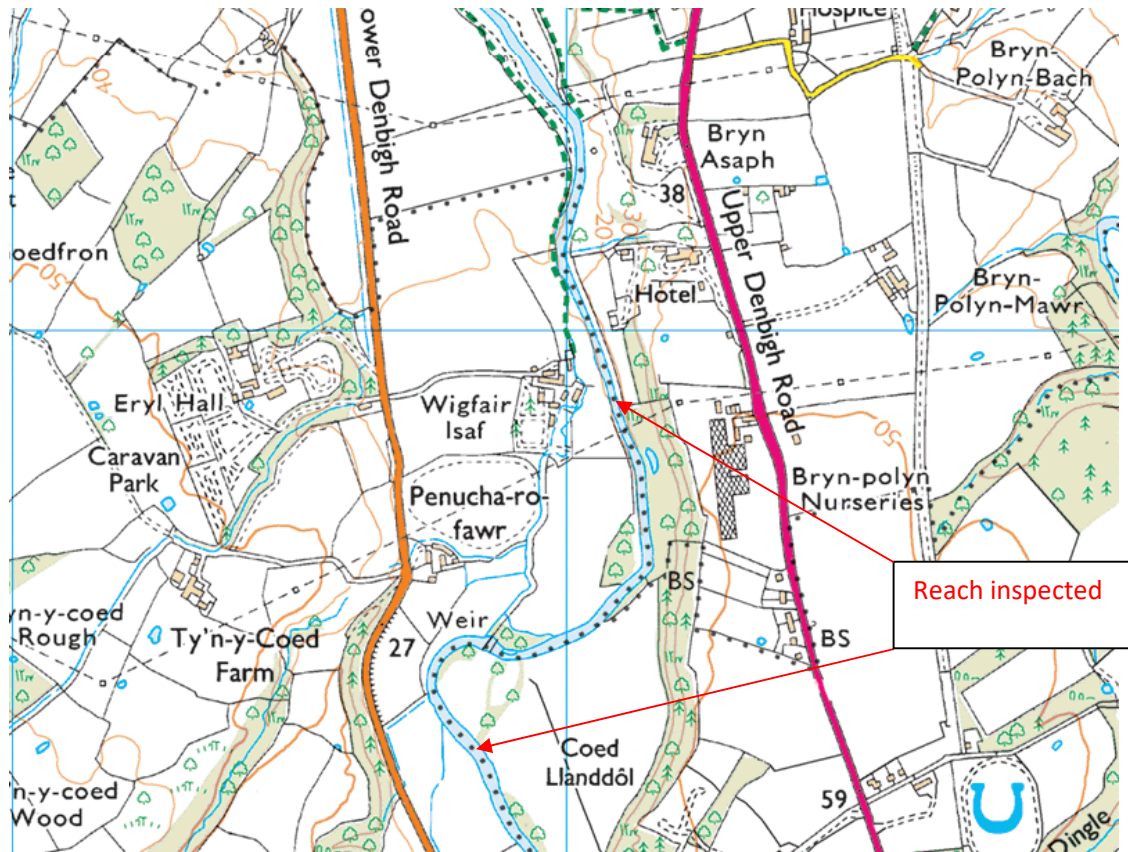
Figure 1 Reach inspected, river flowing south to north.

The actively eroding bank is on the right hand bank adjacent to the steeply sloping, wooded valley side leading down from Bryn-polyn Nurseries (Photos 1 & 2). RSAAA members and the landowner stated that the channel had been realigned here in the past and previously it had been further to the east, closer to the base of the valley slope. A relict channel is visible in the wood (and on Figure 1, the small pond on the RHB).

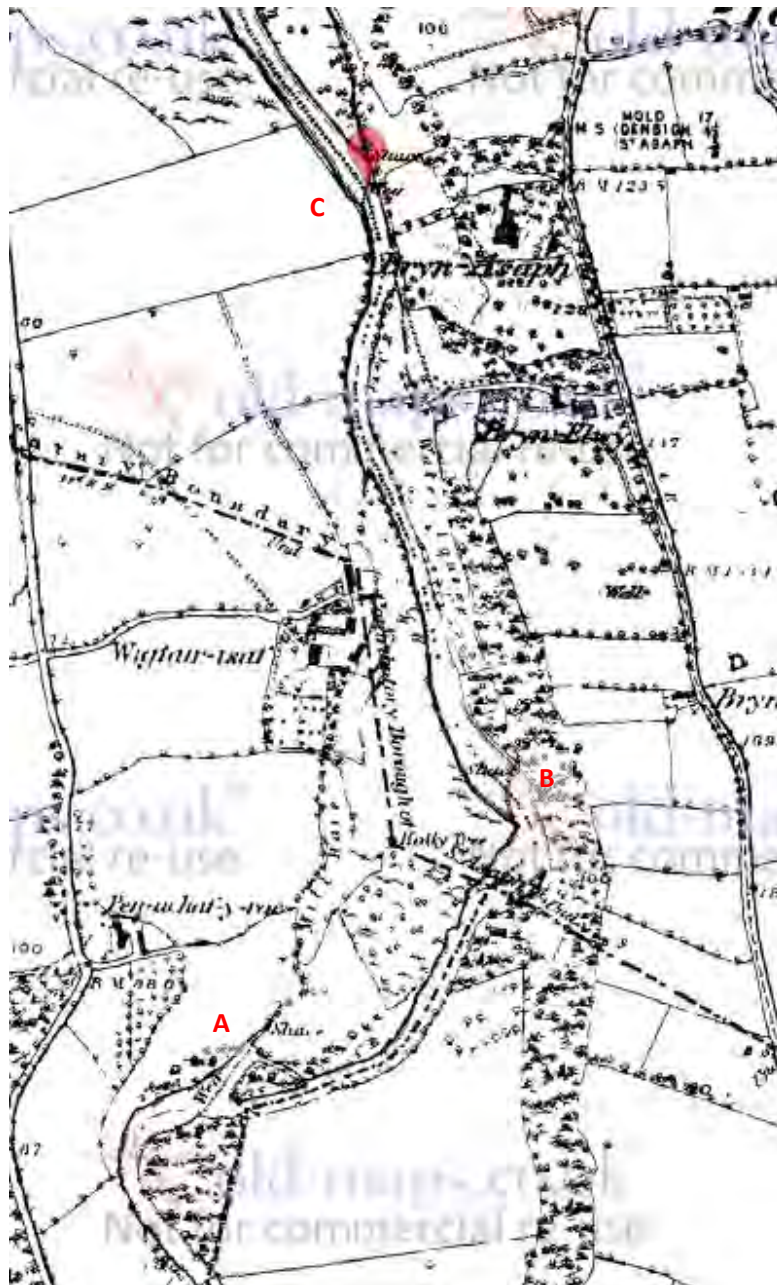
In addition to the former weir at Bryn-polyn, another weir structure existed approximately 730 metres further downstream at Bryn-Asaph (Figure 2), with a mill channel extending downstream into St. Asaph. According to the dates of the maps, this structure disappeared in the mid-1960s.

Figure 2 OS County Series 1:10560 Flintshire 1878-1880, showing three weirs including the existing weir (A), a weir at Bryn-polyn (B) and a weir at Bryn-Asaph (C). Weir B at Bryn-polyn appears on the 1874-92 1:2500 map (Figure 2), but is absent on the 1899 map (Figure 3). Weir C at Bryn-Asaph is present on the 1964 (1:10560) map and absent on the 1968-69 map of the same scale.

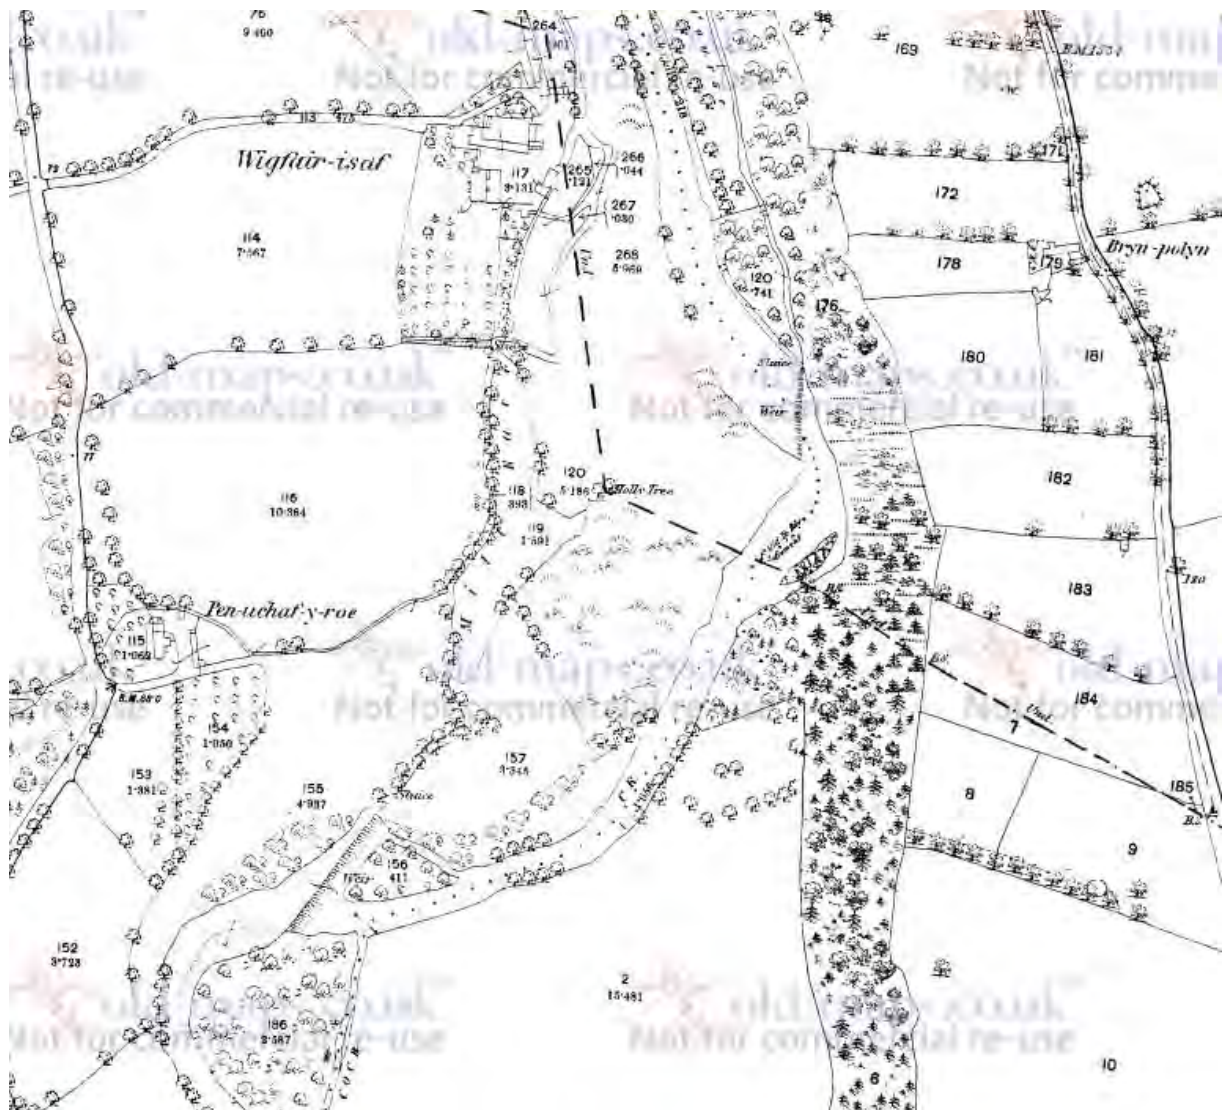
The effective increase in weir crest height may also have implications for flood flows circumventing the weir via a relict channel which bypasses the meander (Photos 13 – 15). The channel is visible on the 1874-92 map (Figure 3, Appendix), labelled COCR (Centre of Old Course of River). It is too straight to have been a former natural course and may have been a temporary flow diversion during original construction of the weir, which was subsequently back-filled. RSAAA report that during floods in recent years, mass slippage of material has occurred at the downstream end of this channel, caused by water seeping through and destabilising the ground (Photo 15). If flood flows and/or sub-surface flows are being diverted via this channel more regularly, there is the potential for the river to eventually break through and bypass the weir.

Figure 3 OS County Series 1:2500 Flintshire 1874 – 1892 showing existing weir and former weir near Bryn-polyn.

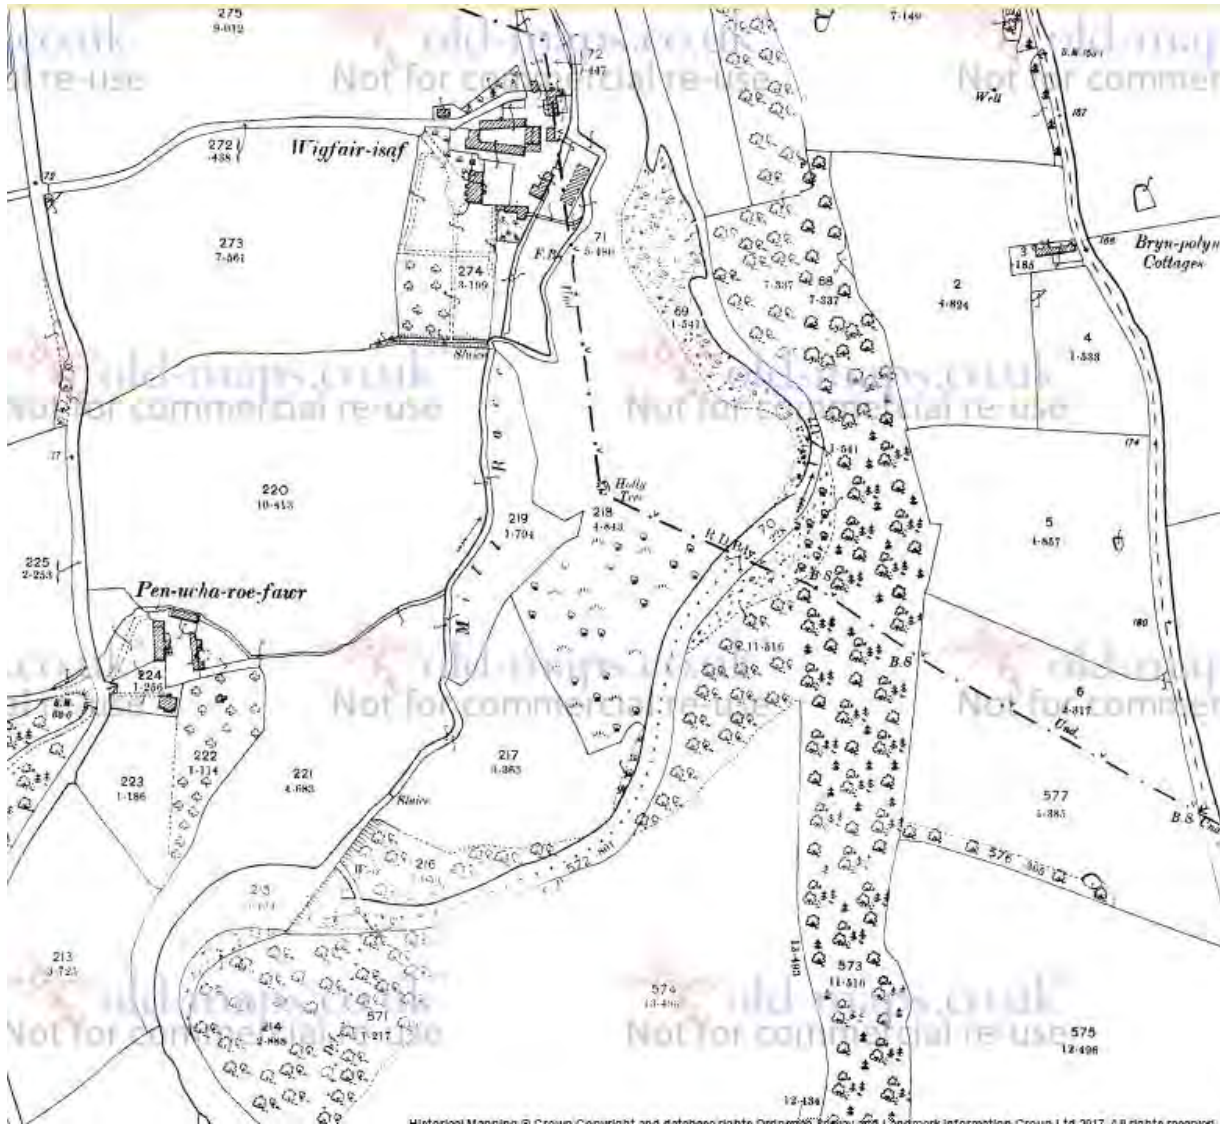
Figure 4 OS County Series 1:2500 Flintshire 1899 showing existing weir and absence of Bryn-polyn weir. The river is shown in the same course as this in subsequent maps up to and including the 1964 1:10560 map.

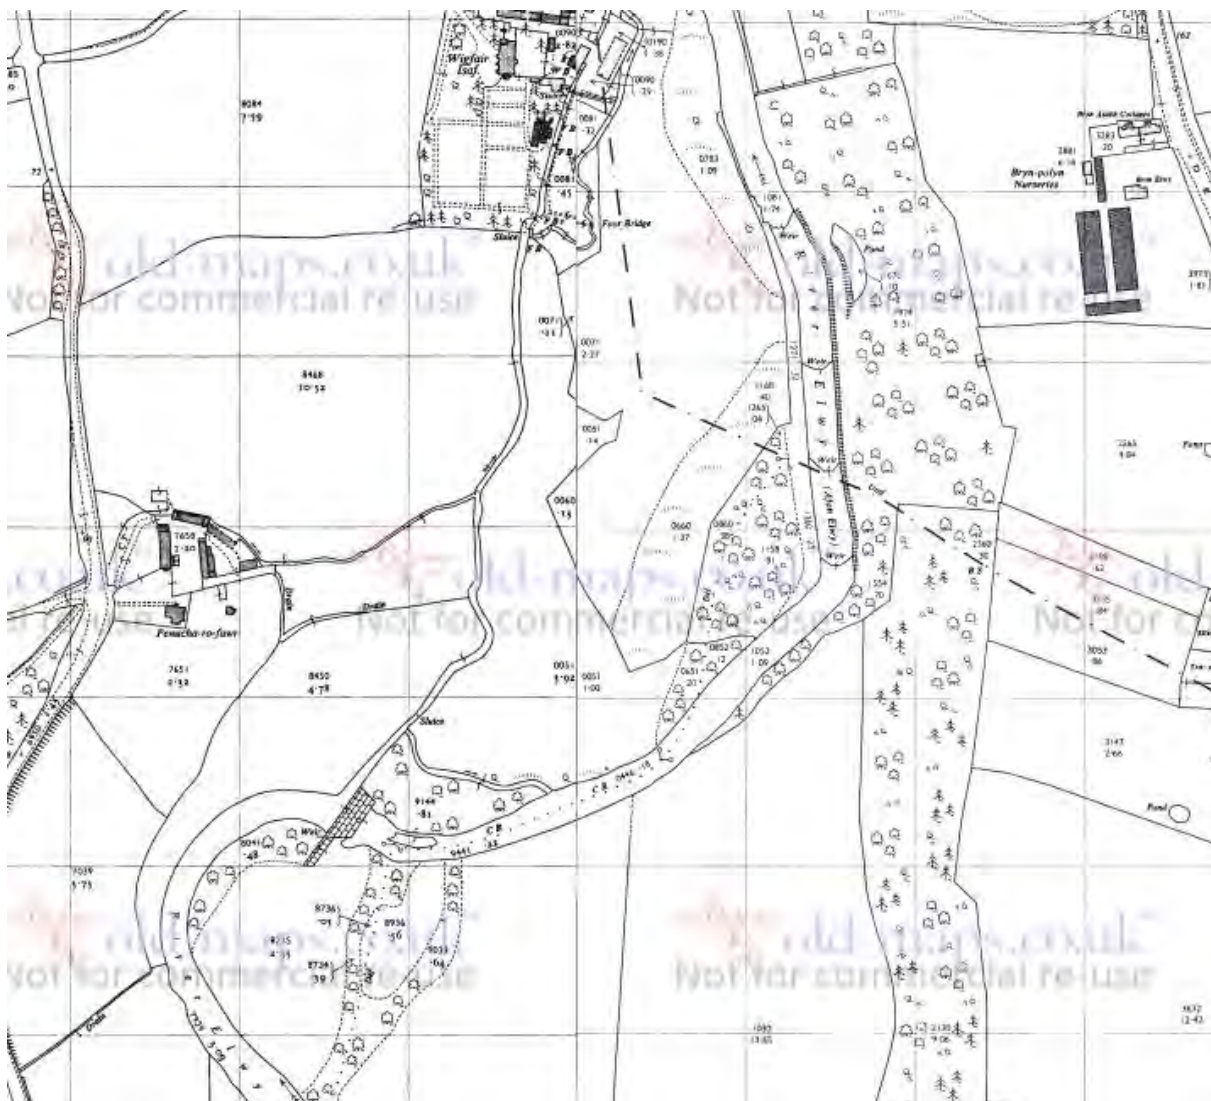
Subsequent research using old maps available online ([www.old-maps.co.uk](http://www.old-maps.co.uk)) gives an indication of the historic plan-form of the channel in this location. Figures 2 – 5 in the Appendix give examples of historic maps for this location and indicate that there was a weir and sluice here circa 1892, but it had disappeared by 1899. This weir is shown supplying water to a mill channel on the RHB leading to a hydraulic pump at Bryn-Elwy and returning to the main river just upstream of Bryn-Asaph. The river is shown following the course further east up until the mid-1960s, after which it is shown as straightened with four new weirs; the latter are presumably the blockstone channel constrictions seen on this visit (Photos 4 and 5).

**Figure 5 OS Plan 1:2500 1962 – 1963 Showing straightened course of the river at Bryn-polyn and four weirs within the straightened section. The river is also shown in this course in t1968 – 1969 1:10560 map.**
