Project Proposal

Forth Fisheries Trust

River Allan, Killandean Burn and Bog Burn

30th September 2015

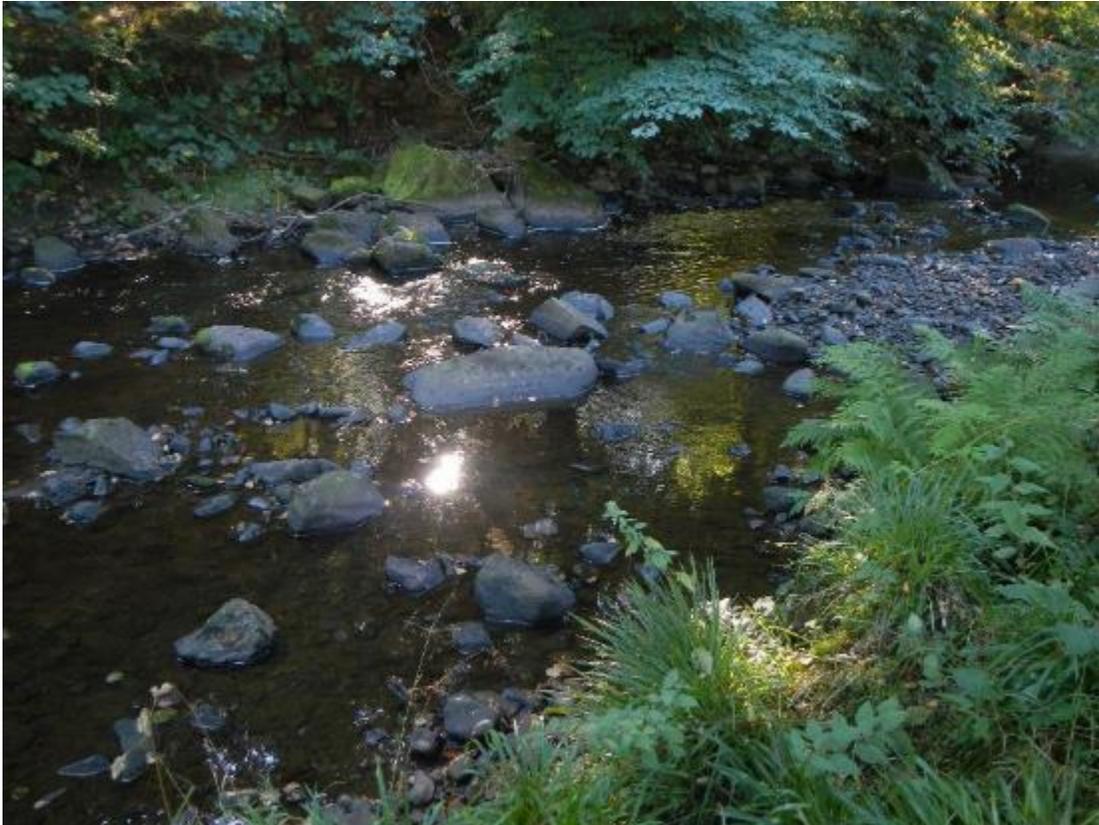
Figure 5. High quality fry and juvenile salmonid habitat provided by a range of shallow slow flowing areas interspersed with faster riffles, with a range of substrate sizes from fine gravel up to boulders.

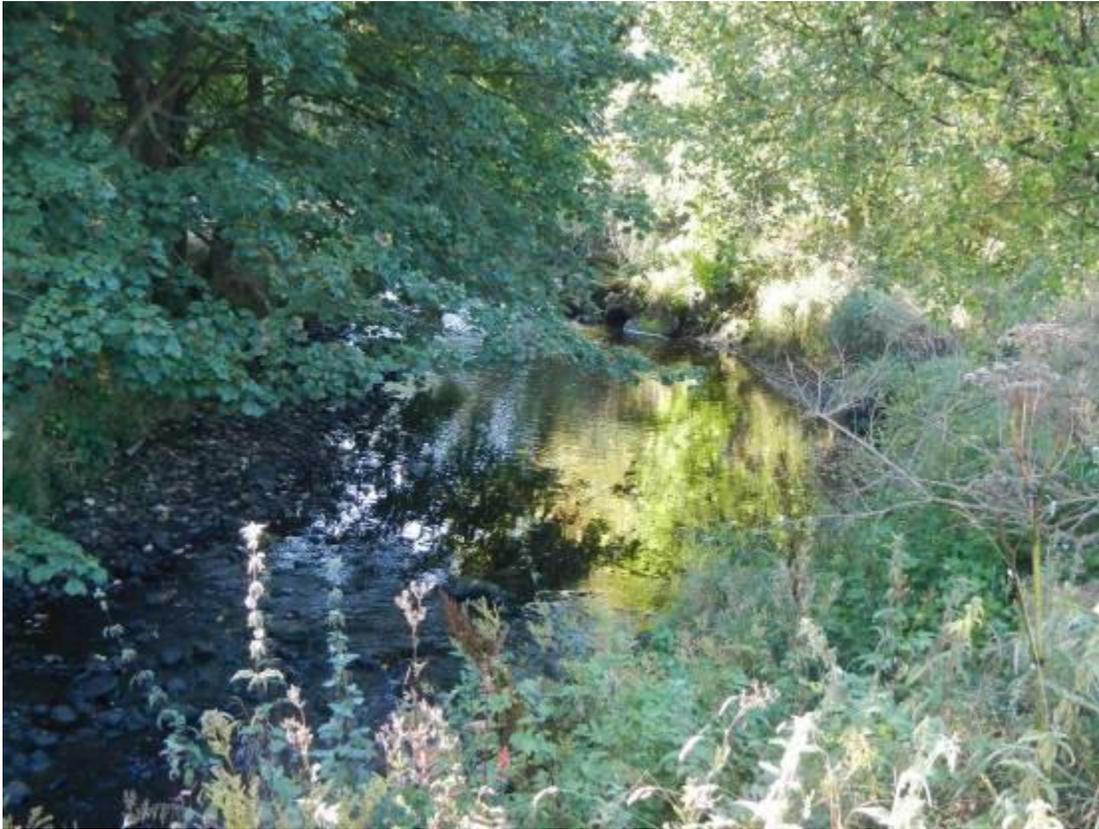
Figure 6. Good adult trout habitat is provided by deeper pools with well vegetated margins, over hanging bankside vegetation, and a healthy mixture of shade and light, provided by overhanging trees.

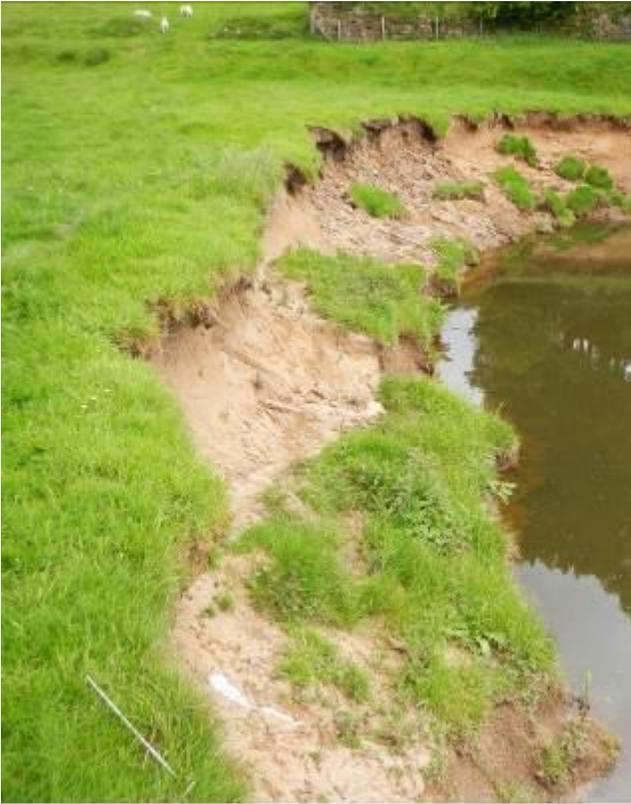
Figure 19a. Before fencing.

The above measures alone were used to address a very similar issue on the River Esk in North Yorkshire (effects after one year; Fig 19a&b and 20a&b). Two years on now, stock are still excluded and the banks remain stable.

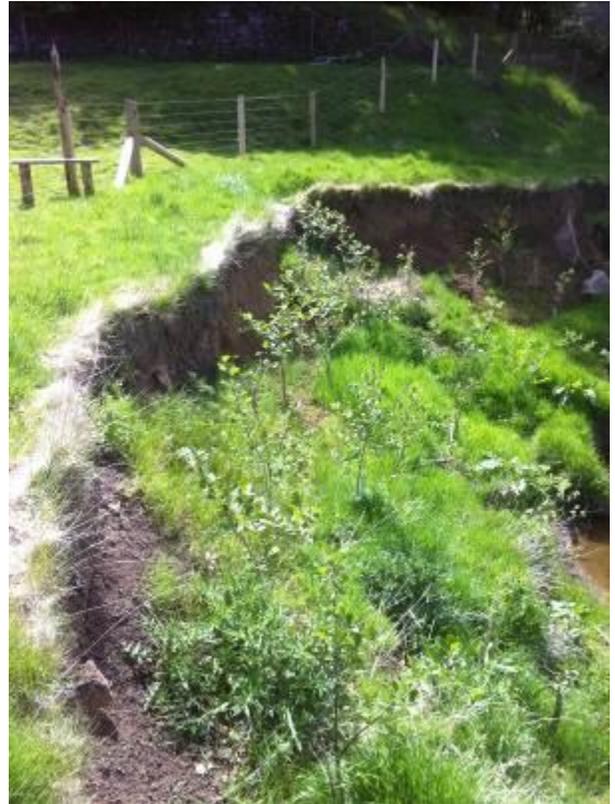
Figure 19b. 1 year after fencing, grass seeding and tree planting. The bank is already much better vegetated and more stable.

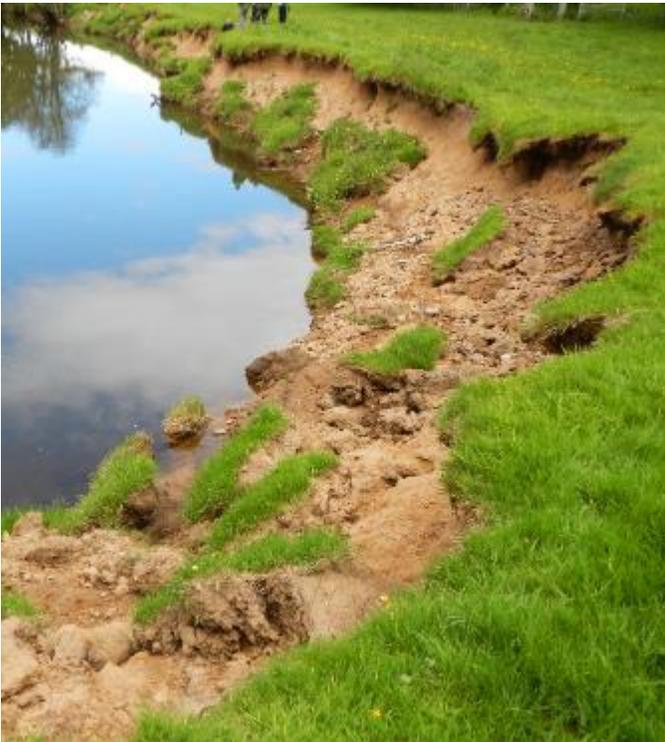
Figure 20a. Before fencing.

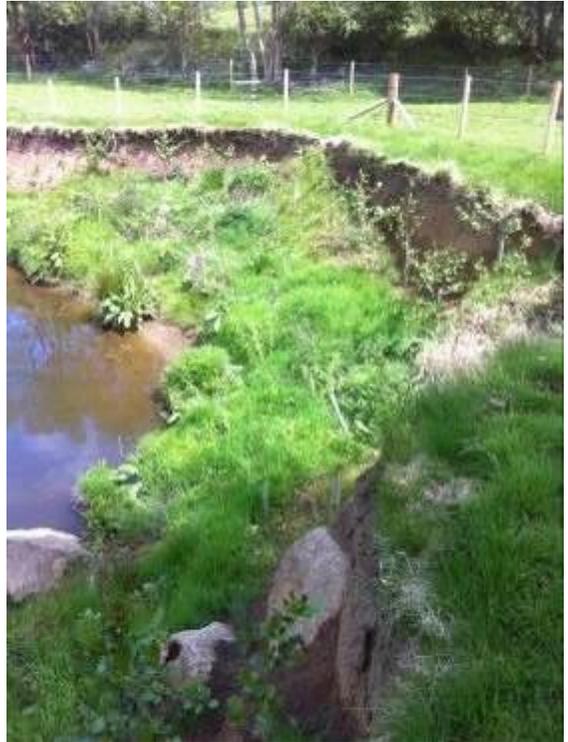
Figure 20b. 1 year after fencing, grass seeding and tree planting. The bank is already much better vegetated and more stable.

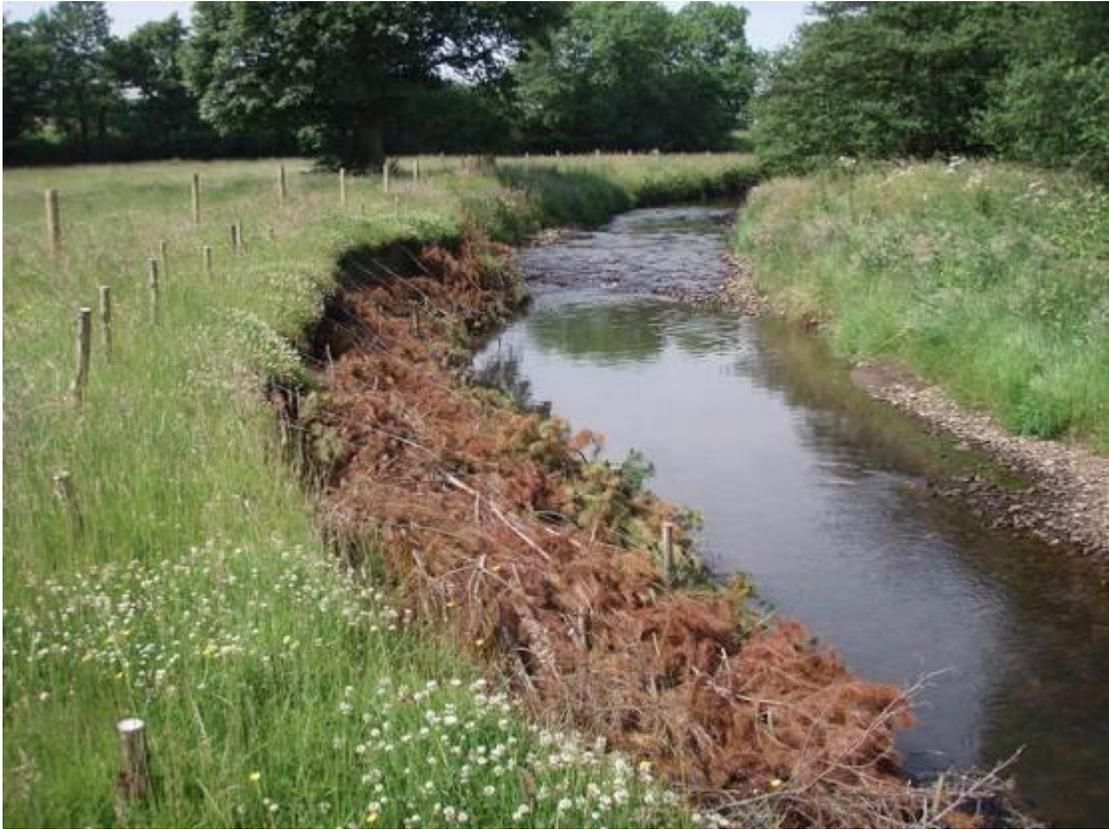
Figure 21. Brush mattress installed along a section of eroding bank to provide flow dissipation and increase sediment deposition in the area.

Stock exclusion, planting and seeding has a good chance of stabilising the banks of the River Allan; however, the additional soft revetment bank protection measures could be applied to increase the chances of success first time and provide valuable additional marginal habitat. This could be achieved by installing a matrix of brash (including living willow) which would be wired over the bank to dissipate the energy of high flow and encourage sediment deposition (Fig. 21). Alternatively, a simple line of brash/willow could be staked along the bank toe to protect and retain the lower section of bank and prevent it slumping for long enough that vegetation can consolidate the bank material (Fig. 22).

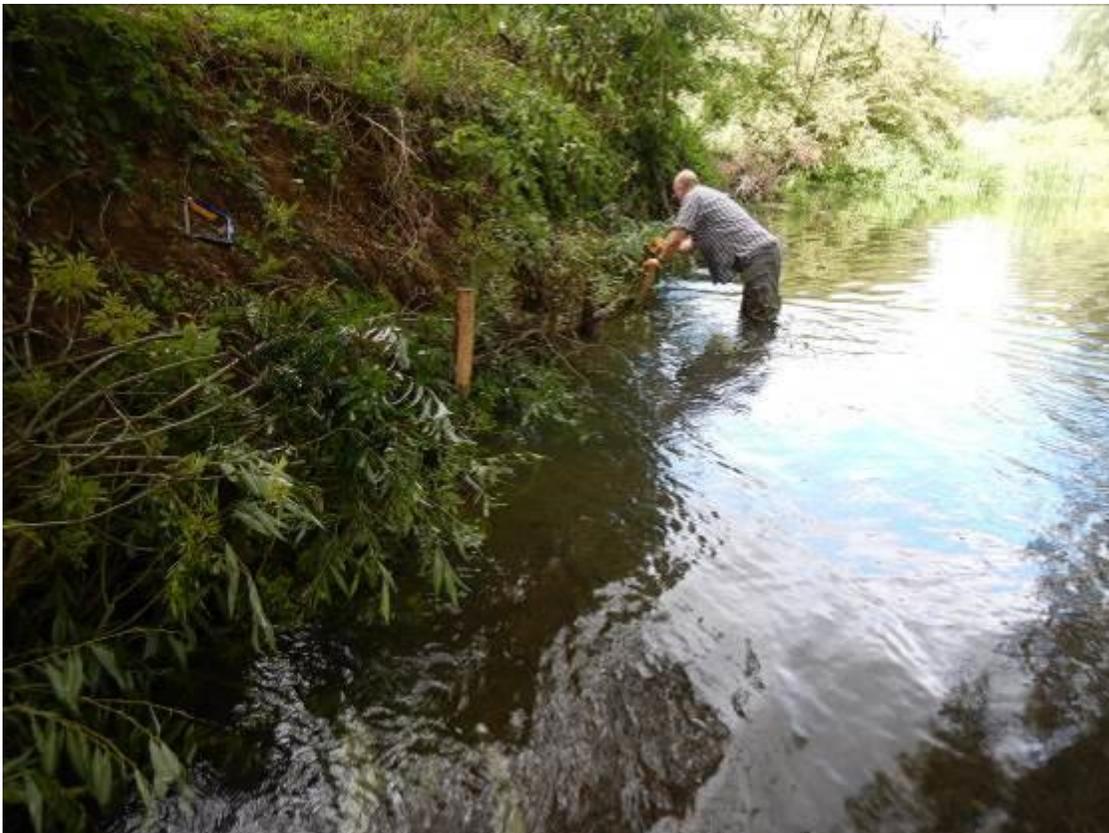
Figure 22. A line of willow brush being installed along the bank to prevent further bank slumping and allow the bank to re-vegetate and stabilise.

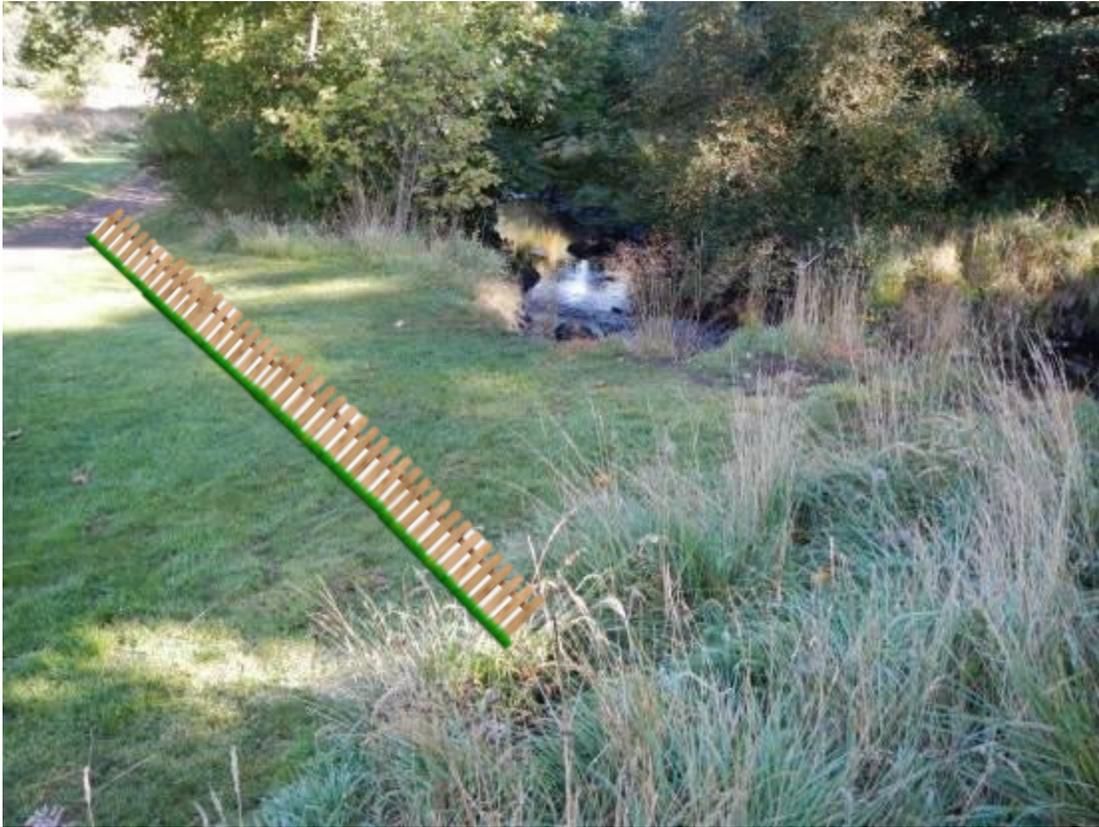
Figure 23. Possible solution for discouraging access to the riverbank and preventing mowing of the marginal buffer strip with a small (c.20-30cm high), unobtrusive ornamental fence or line of posts.

To help stabilise the banks where unnaturally high rates of erosion are occurring, several simple measures would be beneficial. Continued treatment of the knotweed will be vital, as this is undoubtedly one of the major underlying causes. Reducing the access at those locations where the bank stability is already compromised would also be beneficial and could easily be achieved by allowing a larger, unmown buffer between the footpath and the river bank (minimum 3 metres). This could be aided by the installation of posts or boarding around the obvious access point to simply discourage further access to the river and prevent mowing of the grass past that point as depicted in Figure 23.

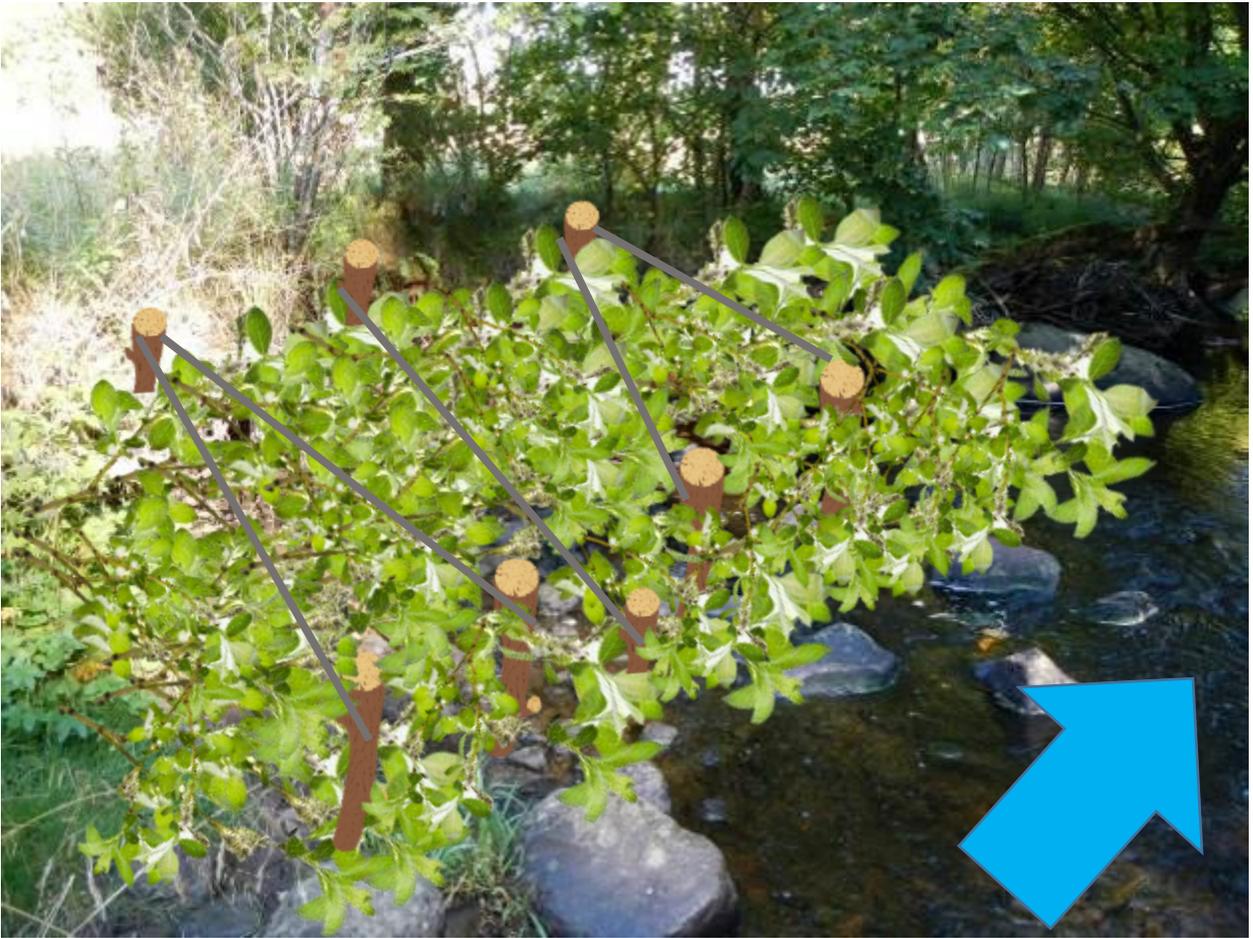
Figure 24. Example of how a brush mattress could be employed protect the river bank and footpath by plugging the erosion hole and encouraging deposition of sediment in that area. The river side line of posts brush should not extend further into the channel than the existing bank line, maintaining a clear channel for conveyance of higher flows (blue arrow).

In the d/s area of Figures 12 & 23 significant erosion (emanating from the knotweed stand) that threatens the bank and footpath could be prevented with a dense brash mattress as depicted in Figure 24. This would reduce the flow impact upon the bank, prevent further erosion, and encourage deposition of sediment that could then revegetate to form the new bank line. The success of reinstating the bank is likely to hinge upon the efficacy of knotweed treatment.

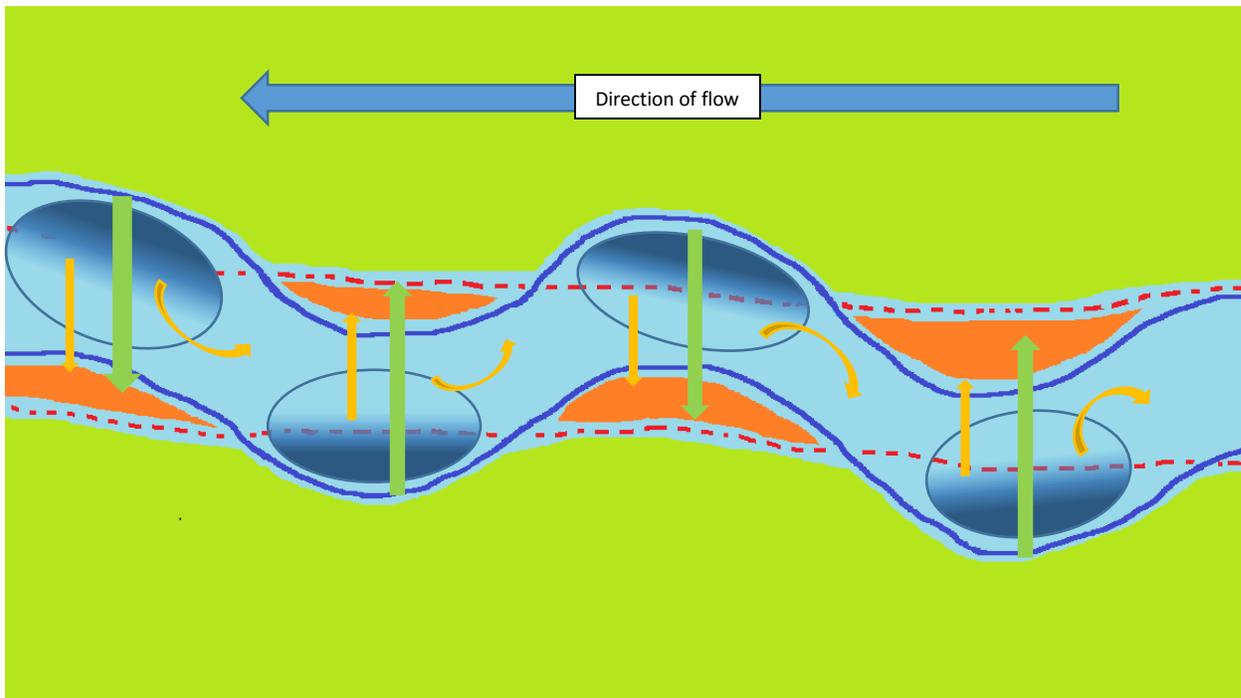
Fig 25. Diagram of a simple 'dig and dump' type river restoration. The dotted red lines represent the original straightened channel course. The dark blue lines represent the course of the improved, more sinuous channel. The dark to light blue graded ellipses represent deeper pool-shallower areas dug into the bed. Green arrows show how material dug out of the bank and bed would be used to create the inside of the bend and gravel bars (orange area), and the coarser gravel material generated is used to create gravel riffles (curved yellow arrow) and the toe of the gravel bars on the inside of the bends (straight yellow arrows).

Using the 'dig and dump' technique, it should be possible to create more natural features within the straightened channel and provide improved habitat for rheophilic (flow-loving) wildlife. The main issues stem from a lack of gradient and the uniform channel width and depth, and while nothing can be done to increase the gradient, increasing the variation in width and depth and creating a channel that has a less uniform cross-section should reinstate a more natural sediment transport regime. This will allow the channel to adapt to the range of flows it receives, providing areas that high flows can scour and hence maintain pools alongside areas of deposition where mobilised substrate can be deposited to form a naturally varied bed profile. A basic diagram of the 'dig and dump' technique is depicted in Figure 25.

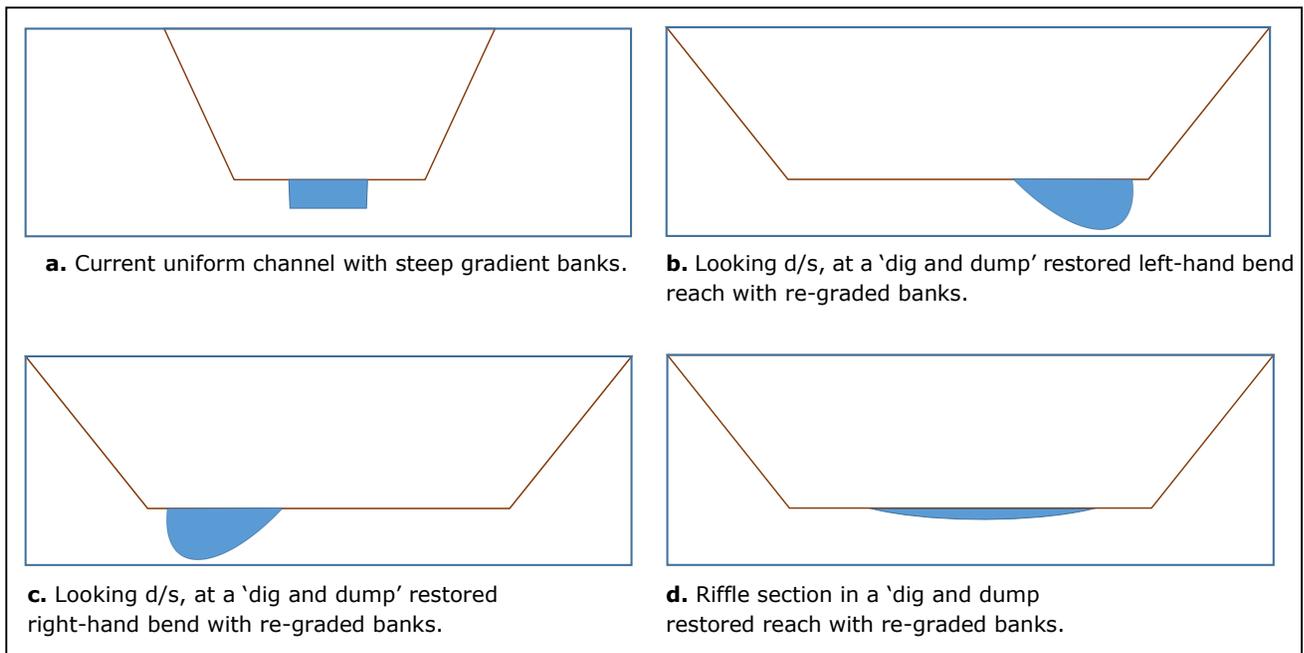
Figure 26a-d. Visualisation of the current, uniform channel (a) and how 'dig and dump' restoration techniques could be employed to reinstate a more natural, self-maintaining channel morphology (b-d) with greater sinuosity. The cross-sections are indicative and not drawn to scale.

Ideally, in conjunction with the 'dig and dump' restoration, re-profiling of the surrounding banks would also be undertaken to widen the second stage of the channel and allow higher flows to spill out onto a broader area. This would reduce the pressure of higher flows and also create an area for limited natural channel adjustment to occur (Fig. 26).
