Water Framework Directive Advisory Visit

River Frome, Gloucestershire

December 2012

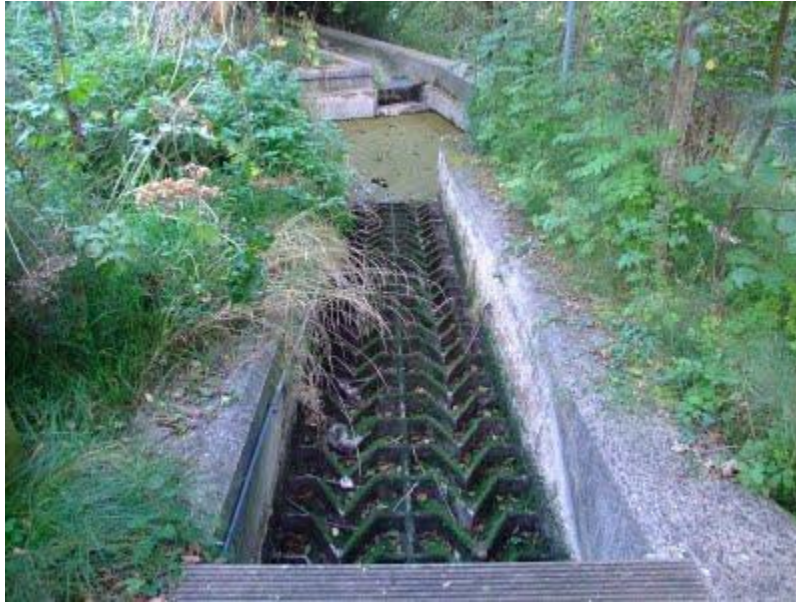
Photo 27 Example of a 1.2-m wide Larinier fish pass showing the two adjacent sets of 0.6-m wide baffle units (direction of water flow away from camera).

It would be worth considering installing one-and-a-half Larinier units (which would occupy 0.9m of the channel width) and including an angled bristle mat for eels in the remaining 0.3m (Photo 28). This would improve the opportunity for eel passage by providing a pass on both sides of the channel, whilst detracting little from passage opportunities for other species.

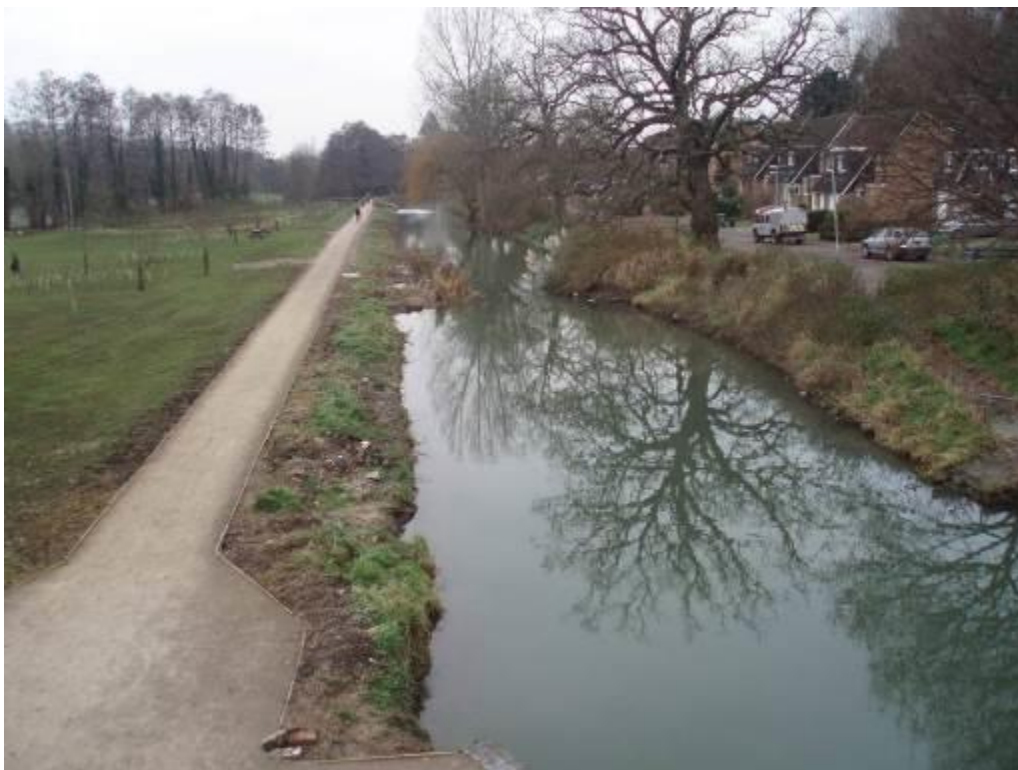
Photo 29 Stroudwater Canal. River is to the left (near trees); overspill weir / fish pass is in the background

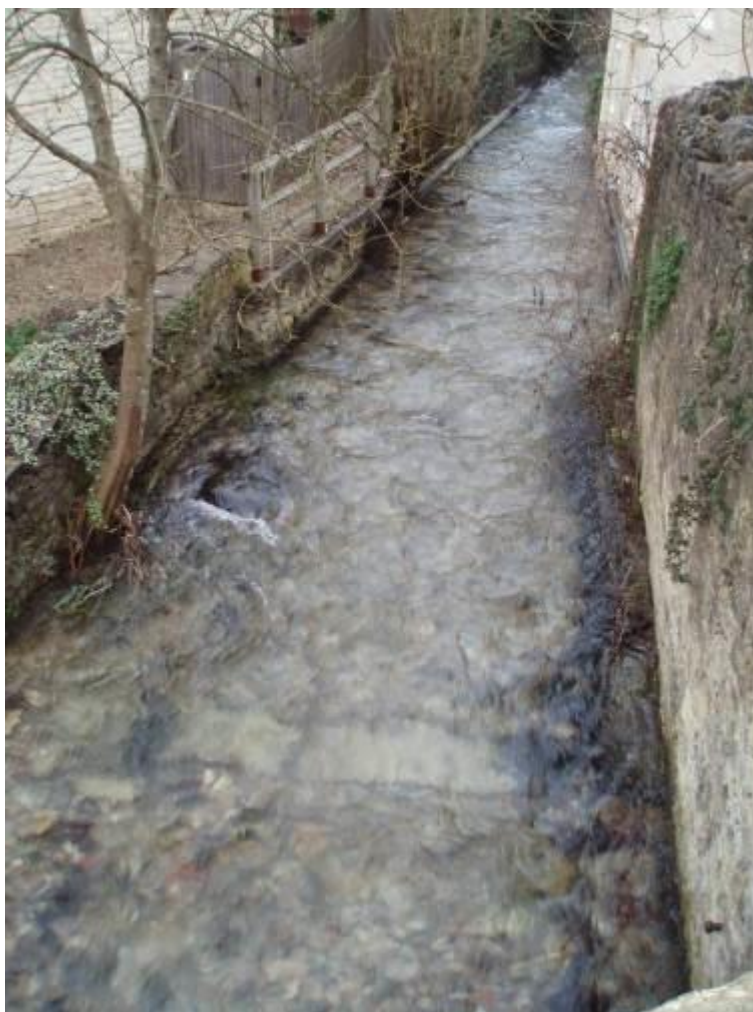
The river here has a steep gradient as it descends from the Cotswolds into the Severn Vale. The channel is confined between walls and buildings which form vertical sides and maintain a narrow, uniform width. As a result of the gradient and confinement, there is little smaller than cobble-sized substrate retained on the bed here (Photo 35); this may provide some opportunity for salmon spawning, but is too large for trout. The fast flows and uniform channel make this a relatively hostile environment for fish.

Photo 35 Narrow, steep channel near A419 (SO8956902514)

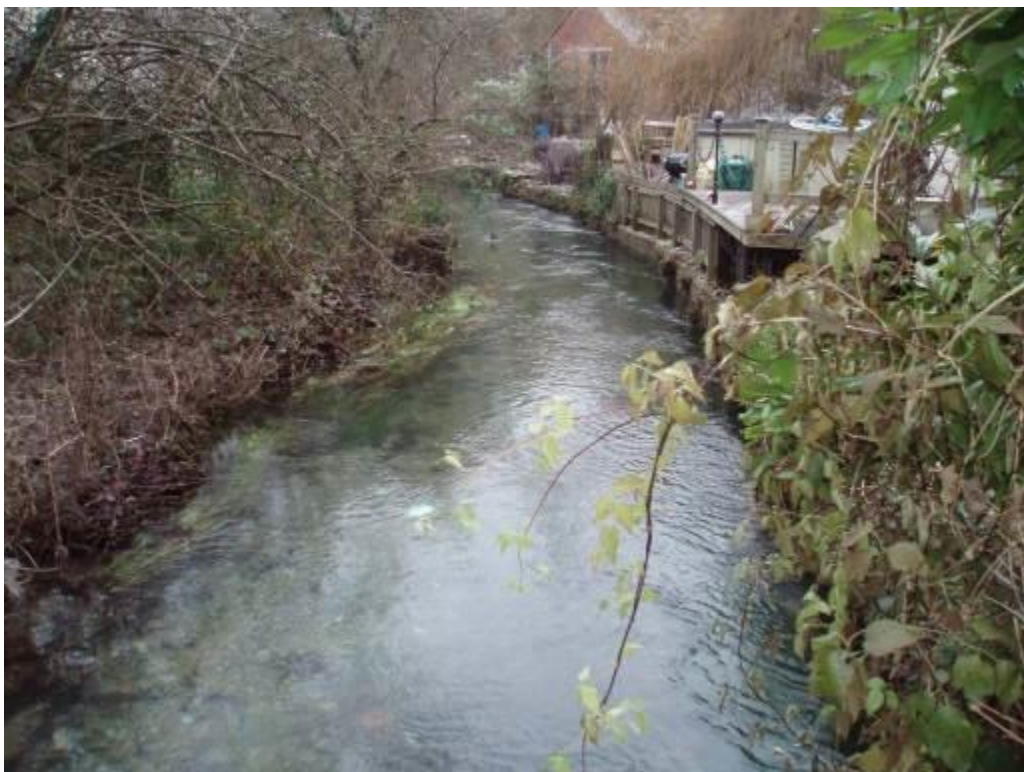
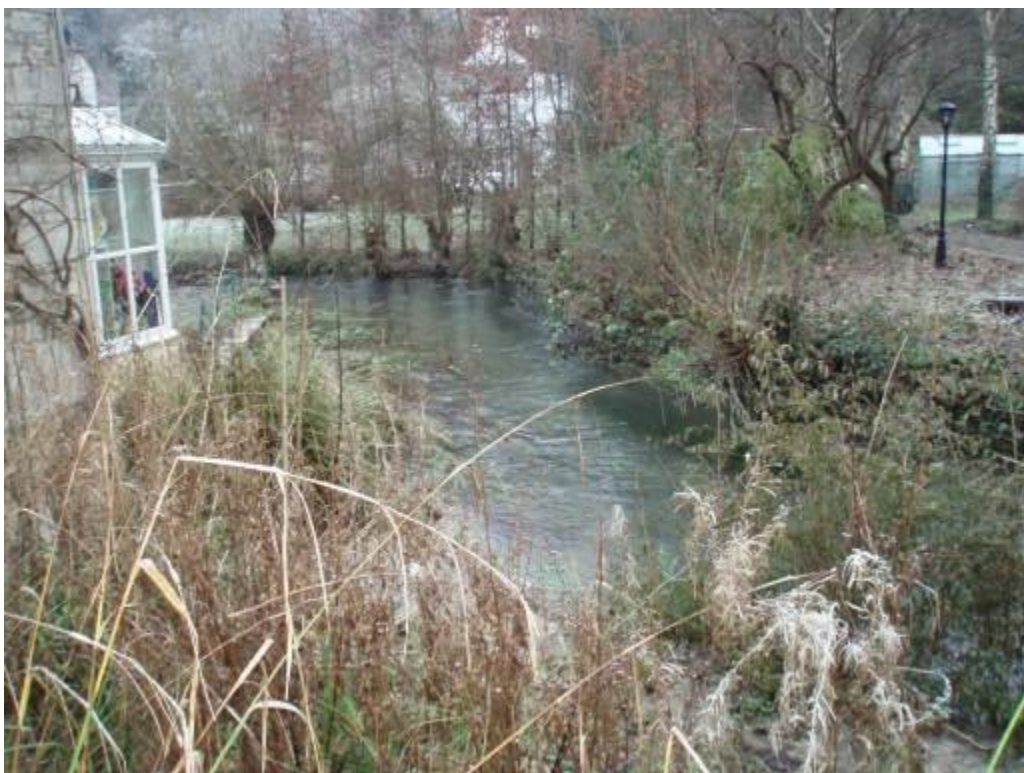
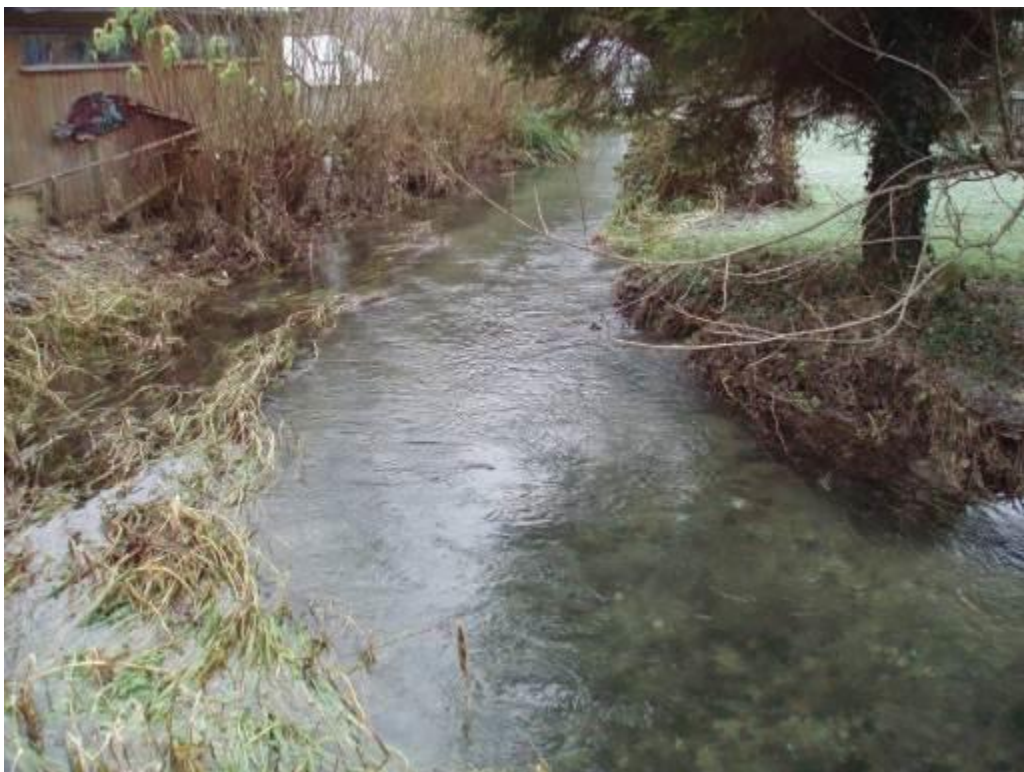
Upstream of the steep-fast flowing section is a weir (and barrier to fish migration) and footbridge at approximately SO8981602515; this impounds the river for only a short distance upstream because of the channel gradient here (Photos 36, 37). Progressing further upstream, the river flows through the village, bordered by gardens, houses and the road (Photos 38-40); in-stream habitat is good here with a gravel substrate and good marginal cover.
