## **Galmington Stream, Taunton**

**An Advisory Visit Report by the Wild Trout Trust**

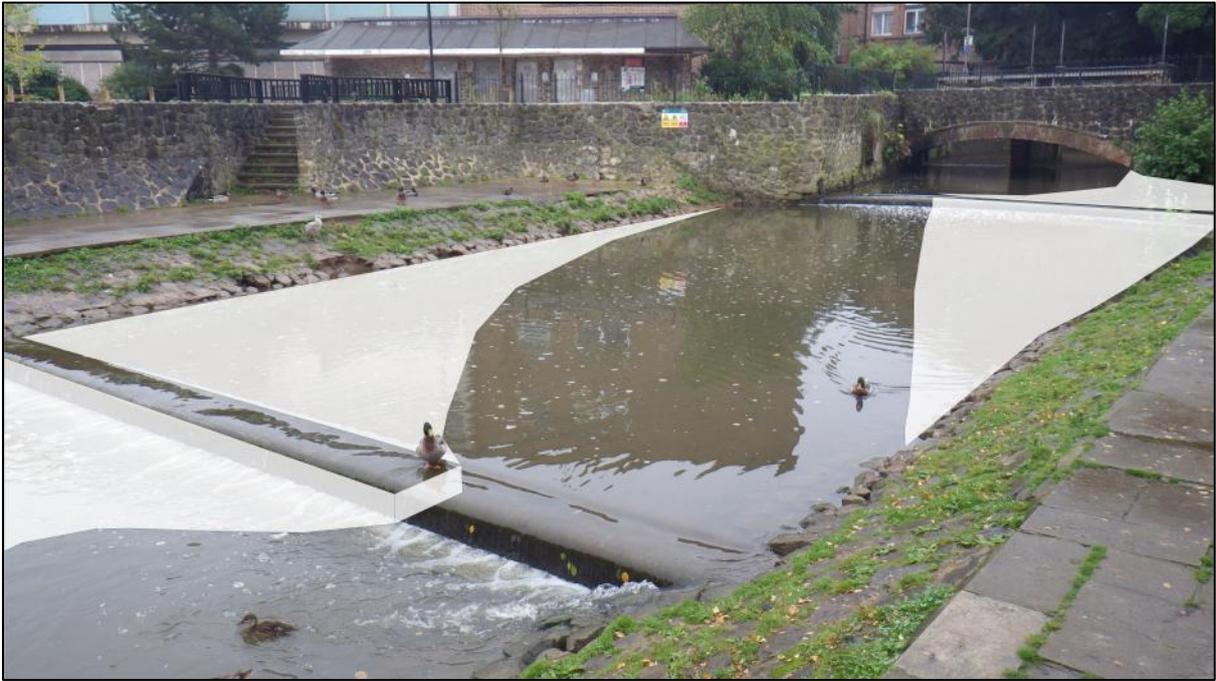
Figure 23: An illustration of the existing weirs with 1/4 removed and the remainder used as mid-points for berms (white areas) to re-shape the channel

3. The downstream confluence of the Mill Stream and the River Tone should also be improved for fish passage as this appears to be the main access to the Mill Stream for fish populations in the River Tone. The ideal solution would involve the complete removal of the weirs. If however, this option proves impractical (for flood defence purposes etc.); it may be possible to remove approximately ¼ of each weir at alternating ends, using the remnants of the weirs as mid-points for rocky point-bar berms that would improve channel structure between the weirs (Figure 23).

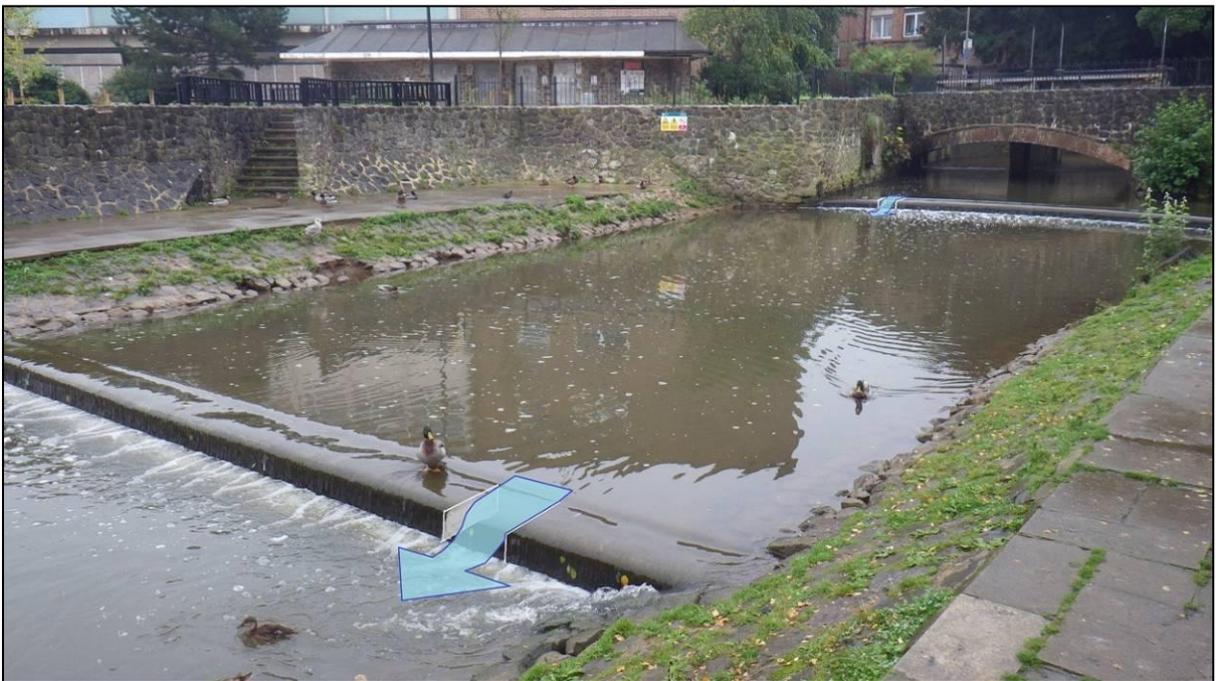
Figure 24: An illustration of simple notches that could be cut into the weirs (blue arrows indicate a smooth-flowing column of water).

At the very least, the option of cutting deep notches into the weirs should be explored in order to improve fish passage without affecting the flow regime of the Mill Stream (Figure 24). Notches should be cut as low as possible so as to avoid the requirement for a jump and with an appropriate width to maintain a suitable depth of water and flow velocity for fish passage.

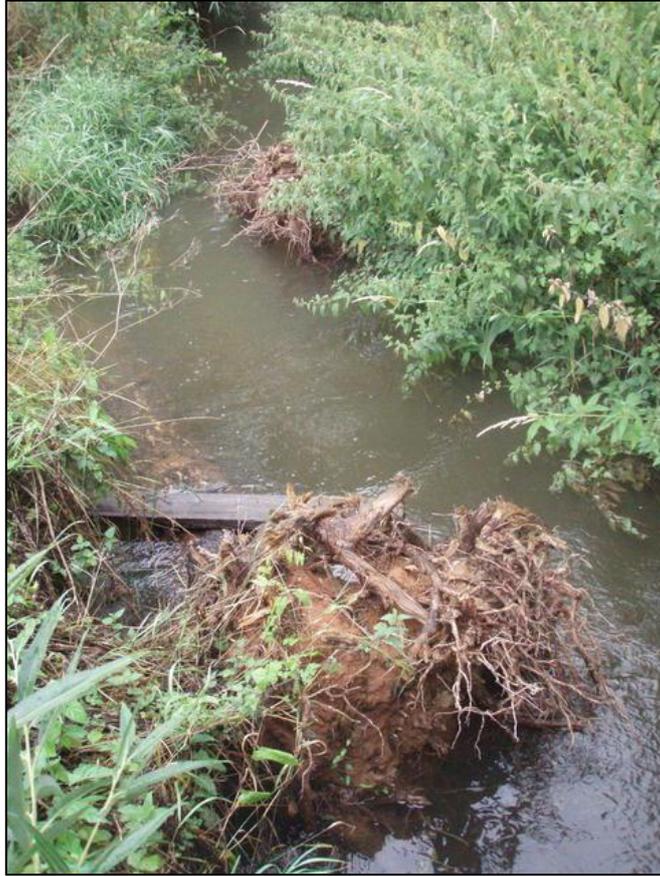
**Figure 25: An example of LWD root wads positioned in-channel to diversify flow patterns**

A 5 year rotational programme of tree works is recommended with the aim of maintaining a diverse range of light conditions over the water.
- 6.** Some of the heavily-engineered sections of the stream would benefit from the introduction of some fixed LWD to introduce some physical diversity into the homogenous habitat. Thick branches from the proposed tree works could be pinned to the bed to promote localised scour and create a more sinuous channel form.
