Gatwick Stream – Riverside Garden Park, Horley

An Advisory Visit by the Wild Trout Trust – January 2014

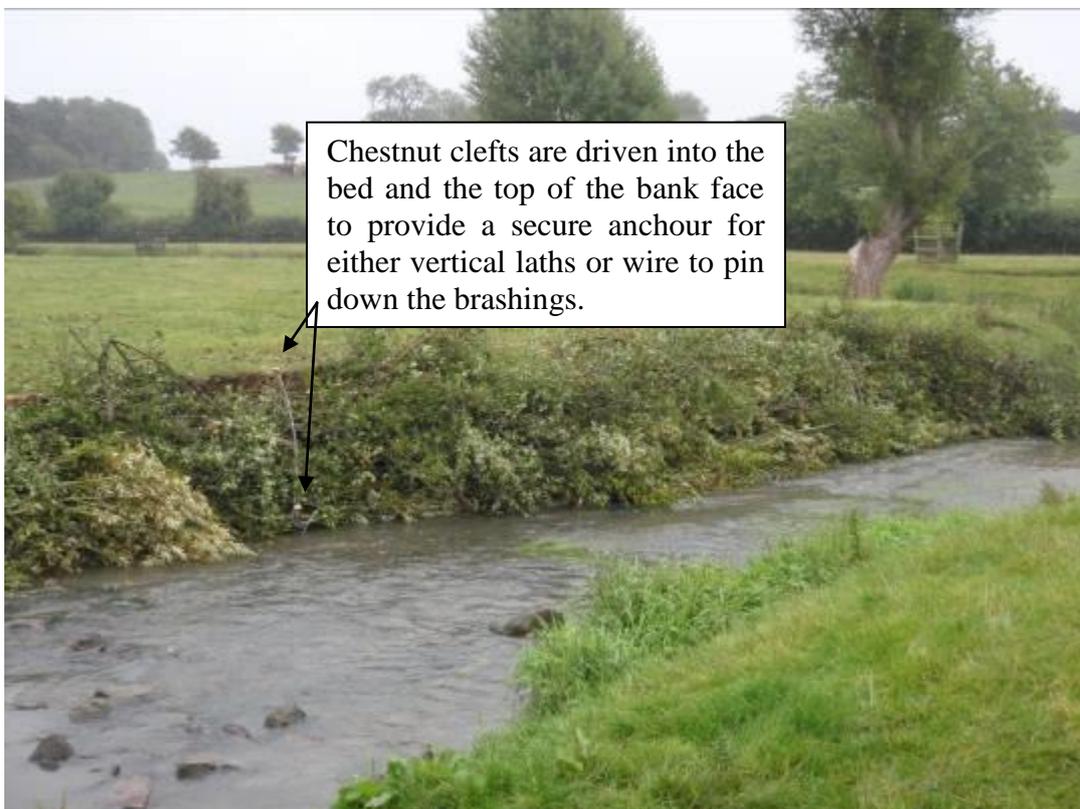
Photo 4. A brushwood mattress packed against an eroded bank face on the river Great Ouse

Several options are available. Measures to slow down the high energy, erosive flow can be undertaken using simple techniques using materials won from riverside trees. For the site depicted in photo 1 a stub flow deflector made from a tree trunk or thick branch section could be keyed into the bank and configured to kick the flow away from the margin and towards the centre of the channel. The bare eroded bank faces at both sites can be protected by installing a brushwood mattress against the face to flow down water velocity and trap sediment (example depicted in photo 4). Ideally there should also be a managed retreated and the formal path should be either moved back, or narrowed to make space for defensive planting between the path and the top of the bank.
