Advisory Visit
River Greet, Nottinghamshire
March 2014

1.0 Introduction

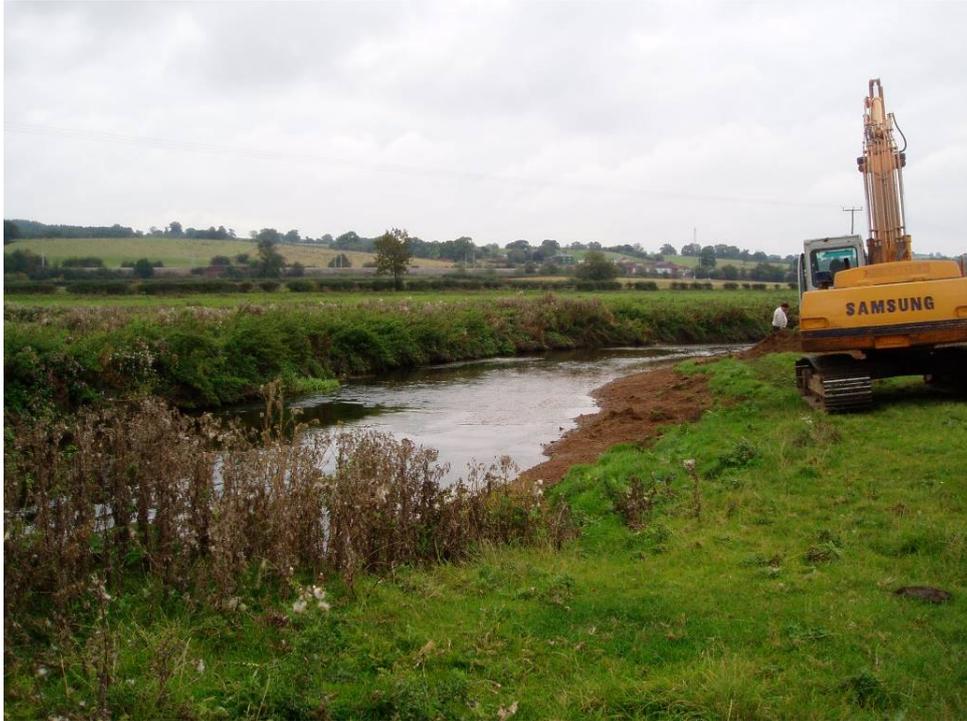
Photo 13 Example of re-profiled bank, River Trent, Aston-by-Stone.

- Plant trees, particularly on the outside of meanders where deeper water is present. These should be native trees species, preferably of local provenance. Most suitable would be low-growing species with a bushy habit that could be coppiced; these include willow (*Salix caprea*, *S. cinerea*), hawthorn, blackthorn, hazel, and field maple. Willows are common along the Trent and could easily be transplanted from cuttings.
- Re-profile the river banks on the inside of bends to create low-level, wet margins alongside the river. This may require the re-alignment of existing embankments (Photos 12, 13, Figure 3). Liaison with the body responsible for channel maintenance may provide the opportunity for partnership working to achieve this, as it would also improve channel capacity and flood conveyance.

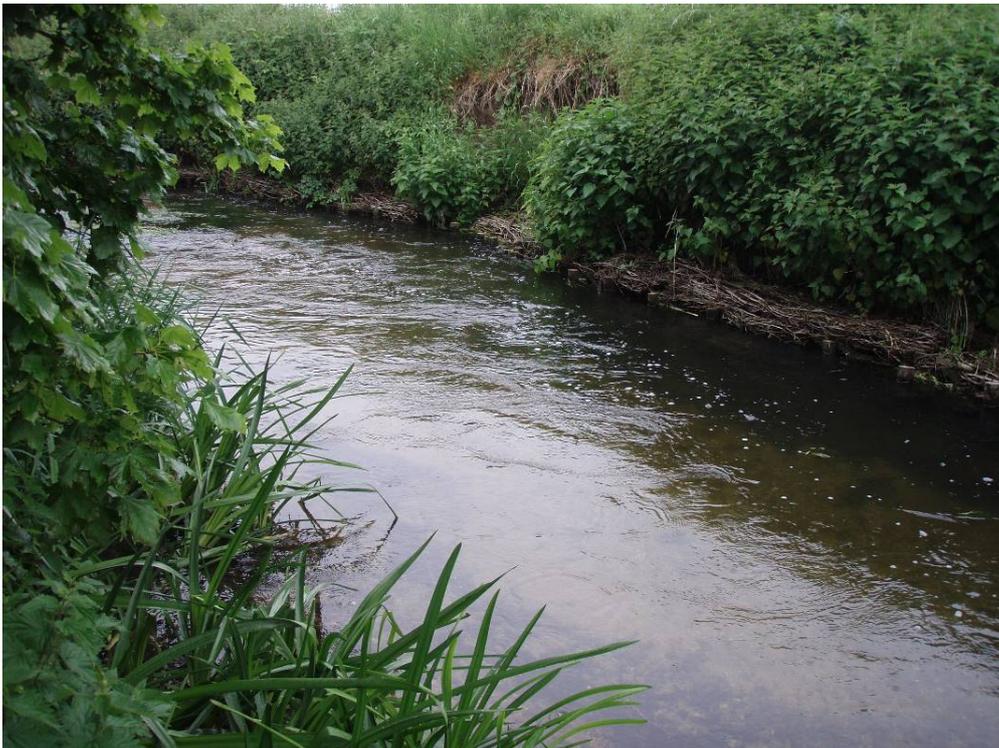
Photo 14 Brushwood bank protection, River Cam, Cambs., lining the far bank.

- Install brushwood bundles on the outside of bends which are experiencing erosion (Photo 2). These will take up minimal channel capacity and provide protection to the toe of the bank, plus some fish shelter (Photo 14).
- On straighter sections of channel, create a submerged berm that can colonise with emergent plants, providing improved marginal habitat for fish fry, invertebrates, etc. (Figure 4). Liaison with the body which carries out routine channel maintenance may allow this to be incorporated into their programme of works, i.e. bank works carried out by machine, re-planting carried out by NPS.

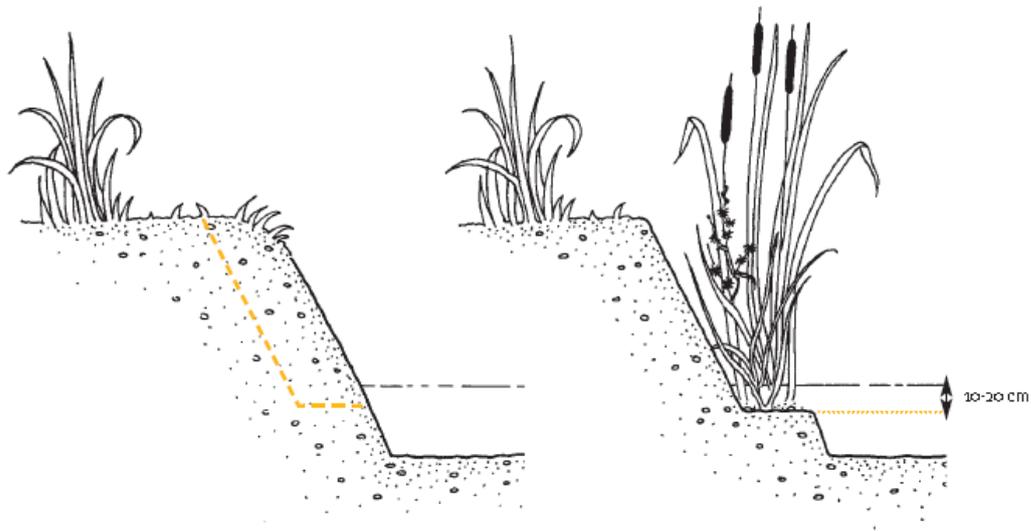
Figure 4 Creation of a marginal berm
