Halse Water, Norton Fitzwarren, Somerset

An Advisory Visit by the Wild Trout Trust November 2014

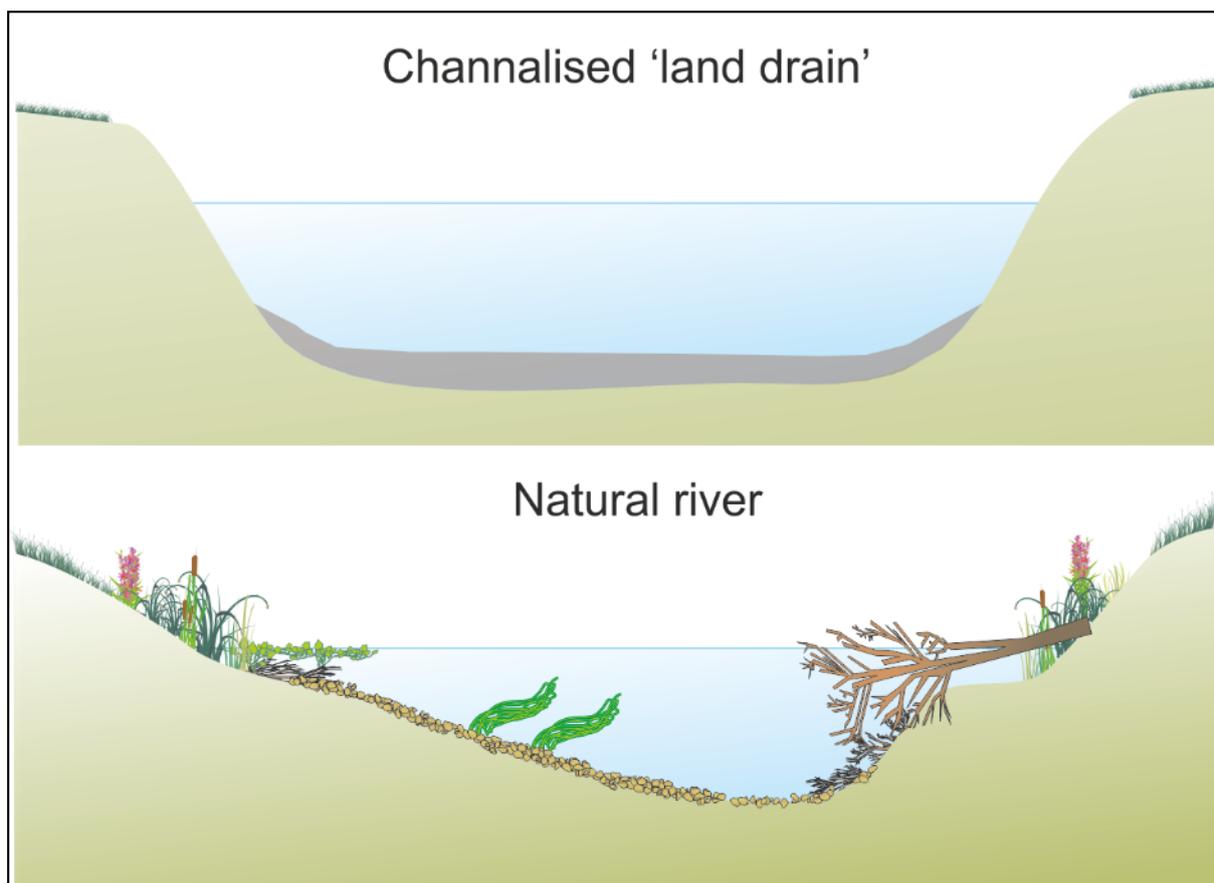
Straightened, dredged or otherwise 'channelised' rivers are often very poor freshwater habitats. The uniform depth and width results in an environment with a limited range of distinct habitat niches. The biodiversity of a stream is proportional to physical diversity of bed topography, channel widths, flow speed and direction and submerged habitat features such as woody debris (Figure 9).

Figure 9: A healthy and biodiverse river contains a broad range of different physical conditions and features. Conversely, channelised rivers provide a much more uniform habitat, unable to support a broad range of plant and animal species.

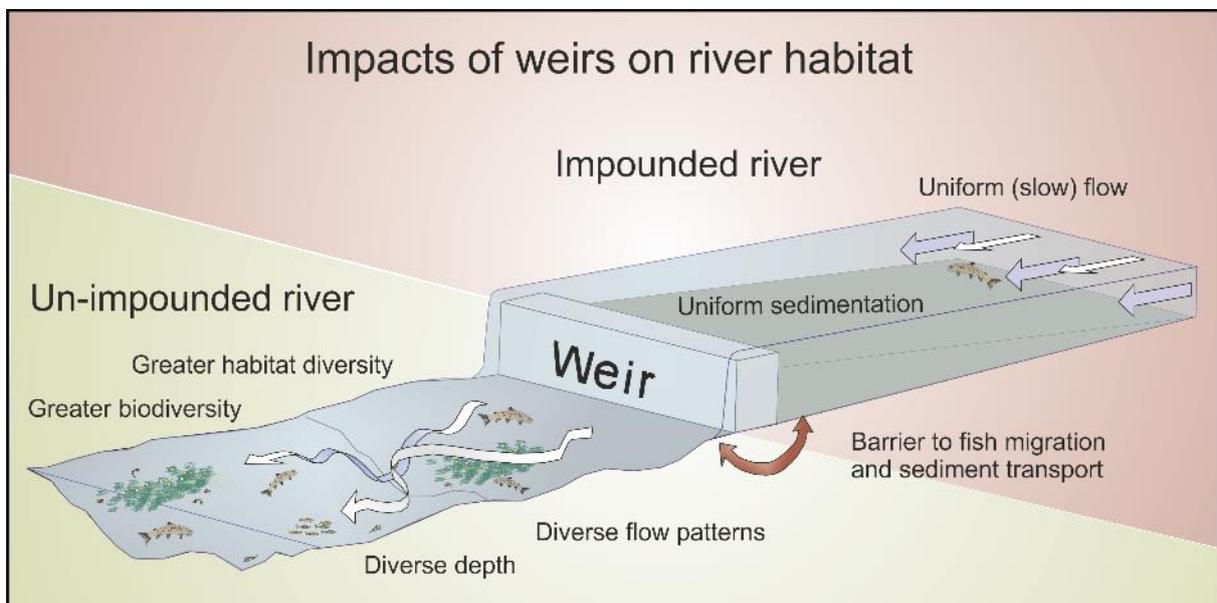
Impounding structures such as weirs not only pose a barrier to fish passage and fragment river habitats into smaller, more vulnerable ecosystems; they also interrupt natural bed load transport and slow flows upstream, resulting in sedimentation and reduced habitat diversity (Figure 15).

Figure 15: An illustration showing the various impacts of weirs on river habitat

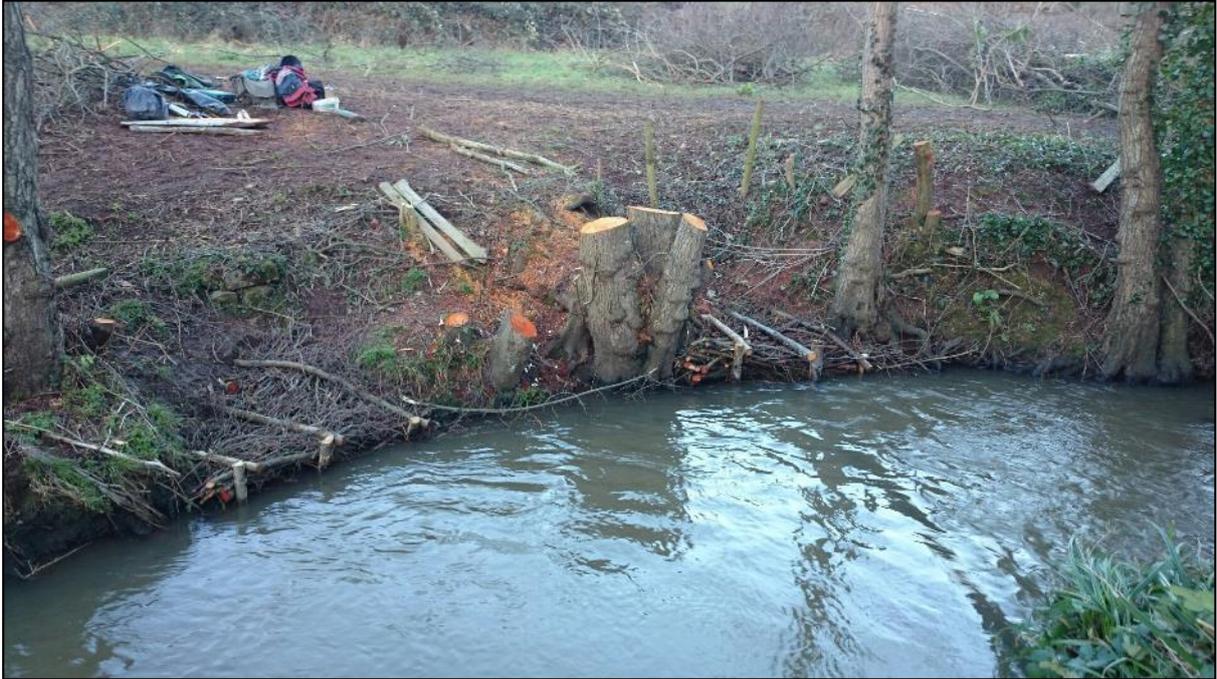
Figure 17: Eroded bays patched up on Wellow Brook at Midsomer Norton, Somerset. Brushwood from felled trees is packed behind a row of sweet-chestnut stakes securely driven into the bed (image taken immediately following installation)

Fortunately, the bankside trees that are presently casting shade over the banks also give rise to a cost-effective solution to repair the erosion. Coppicing the surrounding hazel (*Corylus avellana*) will allow direct sunlight onto the banks and will also give rise to coarse woody material which can be used to create a brushwood 'marginal mattress' to patch up the erosion and provide a growth medium for marginal plants (Figure 17).

Densely packed brushwood structures quickly accumulate fine sediment and with sufficient sunlight should eventually become colonised by emergent river plants. The roots of these plants will replace the brushwood as it decays over time, locking in accumulated sediment and forming a natural lower bank.

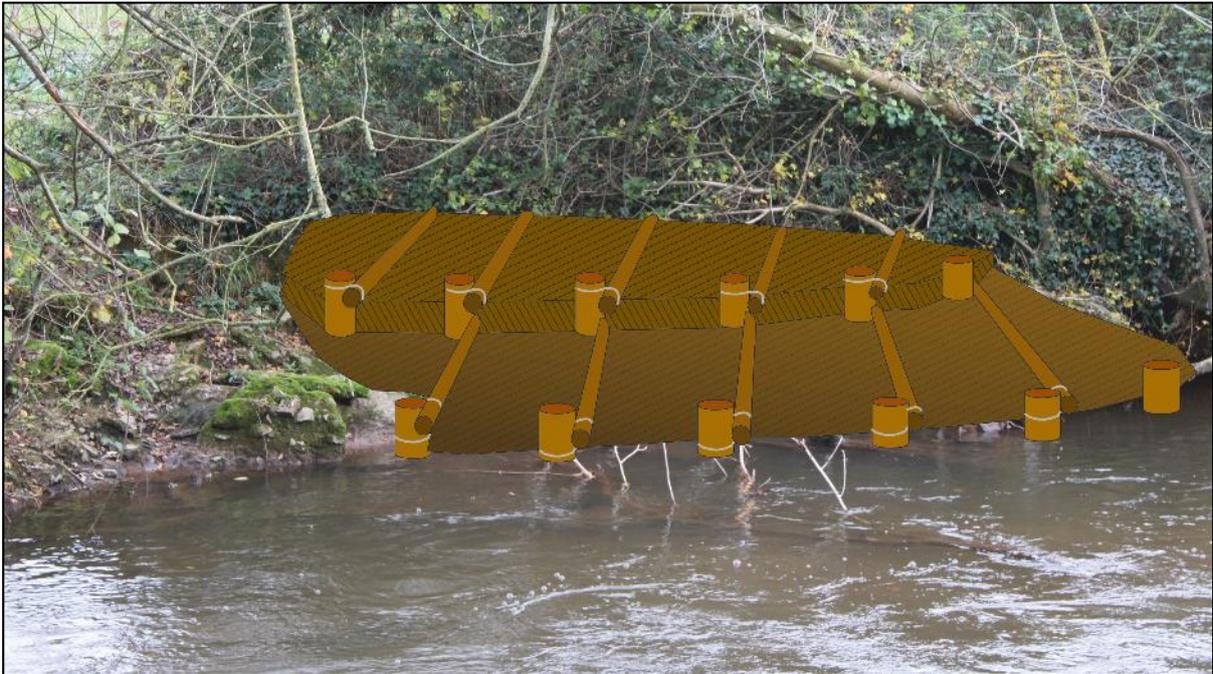
Figure 21: An illustration of how a brushwood mattress repair of the eroded bay would look (pre-vegetation).

2. Repair the eroded bay by installing a brushwood marginal mattress via the following methodology:
 - Drive wooden (ideally sweet chestnut) stakes securely into the bed at approximately 800mm centres to form the outer edge of the mattress.
 - Densely back-fill behind the stakes with the coppiced brushwood to approximately average summer water level.
 - Drive a second row of stakes through the brushwood and into the bed to form an upper terrace at the rear of the structure
 - Back-fill the upper terrace with coppiced brushwood.
 - Lay straight rods of hazel across the structure and secure to the stakes with galvanised fencing wire and staples.
 - Drive the stakes further into the bed to compact and secure the brushwood (Figure 21).

This solution should require no more than one or two days work, should cost no more than £500 - £1000 and will be significantly more sensitive to the river ecosystem than a hard-engineered solution. This type of solution is also likely to be more successful as the brush absorbs and slows flow against the banks, rather than deflecting erosive forces downstream.

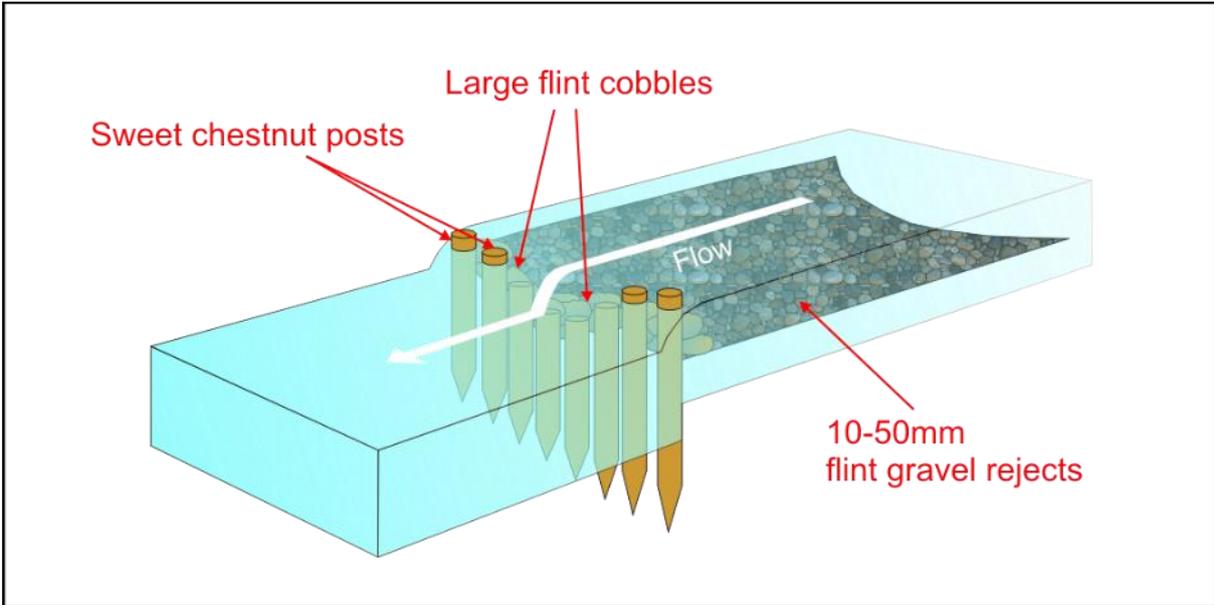
Figure 22: An illustration showing a basic design of a retained riffle fish pass

If the removal or lowering of the weir proves unfeasible in the short term, other options to improve fish passage and habitat connectivity should be explored. For example, a stepped, retained riffle could be installed to replace the weir whilst retaining the water level upstream. This technique has been successfully used on other rivers to improve fish passage by spreading out the head loss of an impoundment (Figures 22 and 23).

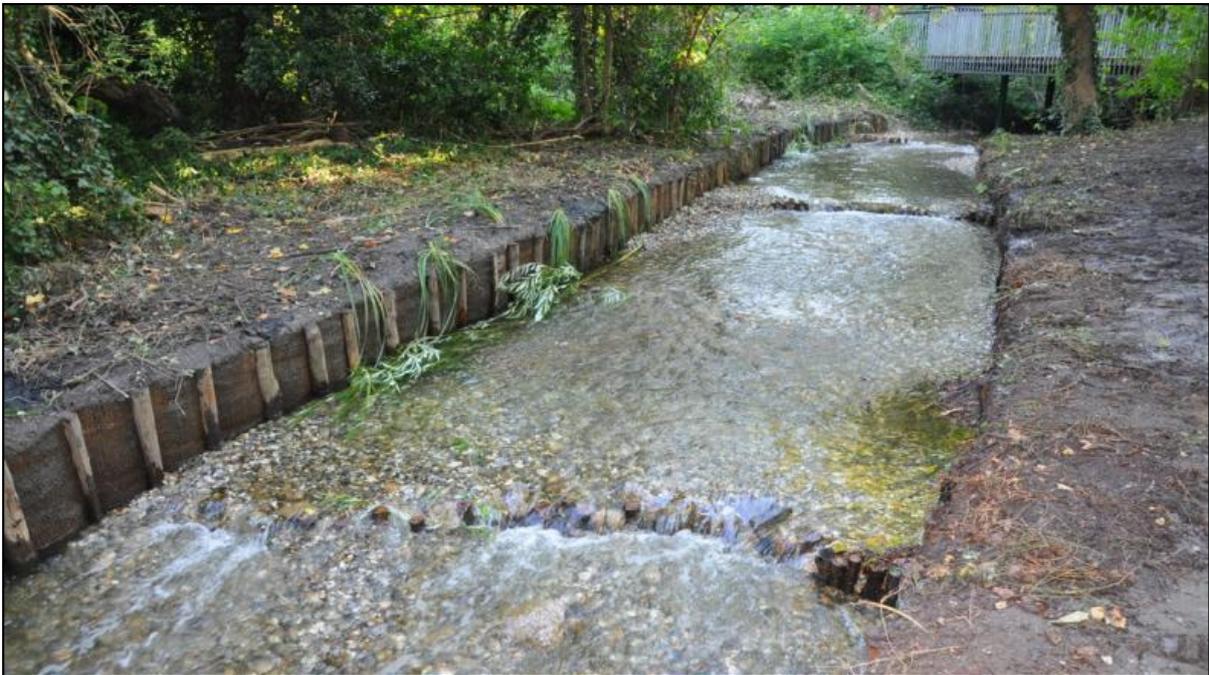
Figure 23: A long gravel riffle passage easement installed to replace a weir in Ravensbury Park on the River Wandle. (Image courtesy of Cain Bio-Engineering Ltd).

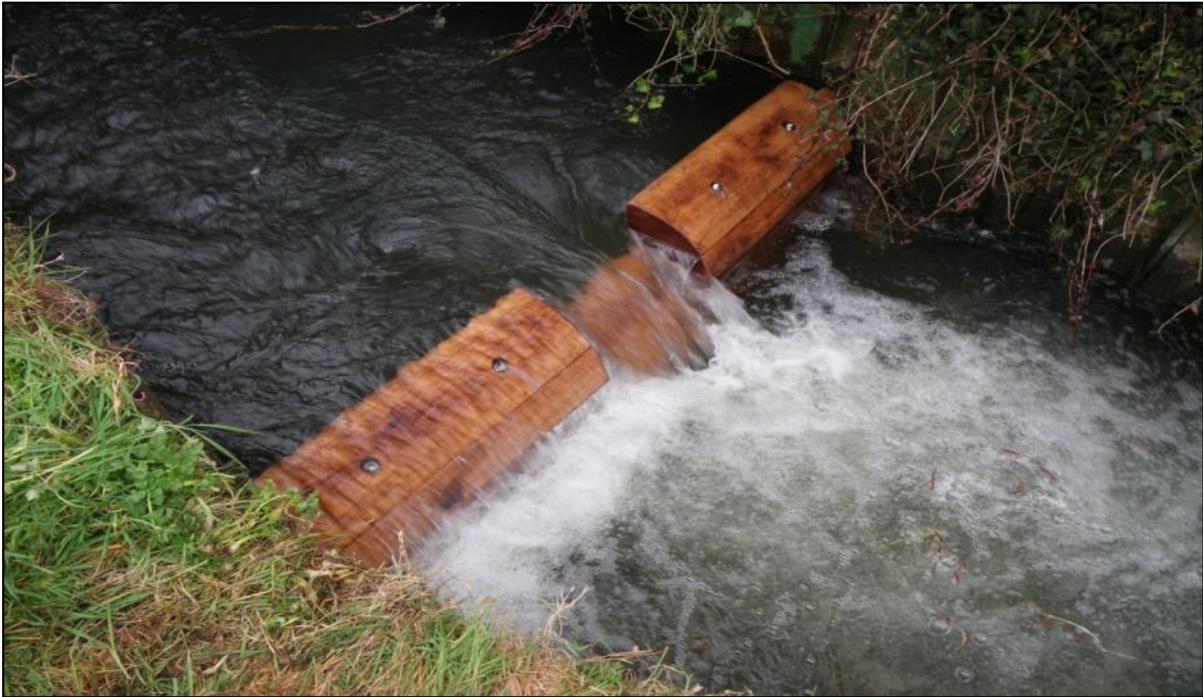
Figure 24: An example of a timber pre-barrage installed to ease fish passage by raising water level immediately below a weir

Another option could be to install a technical fish pass on the weir. A number of engineering firms specialise in bespoke and pre-fabricated fish and eel passes that can be attached to existing structures. As a minimum, fish passage over the weir should be eased by installing timber baulk pre-barrages to create a 'pool and traverse' passage easement (Figure 24).
