Advisory Visit

Harper's Brook, Northamptonshire

January 2018

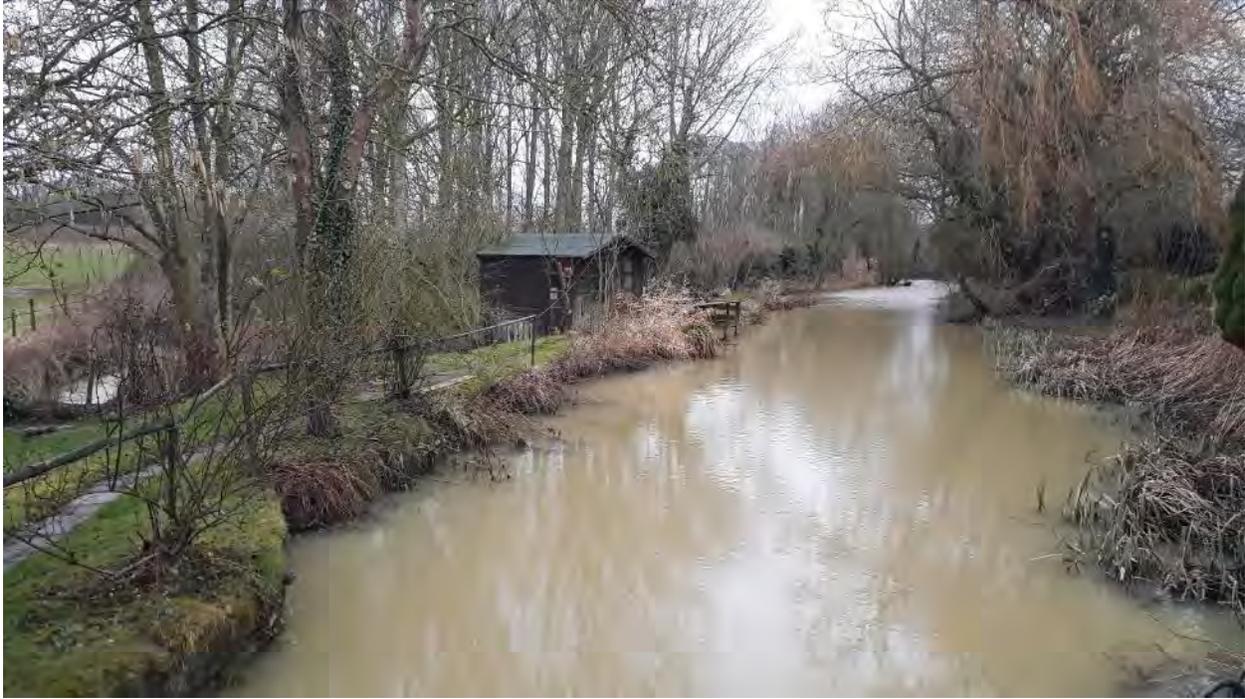
Picture 1 – A view of the mill channel (at the mill pond) looking upstream.

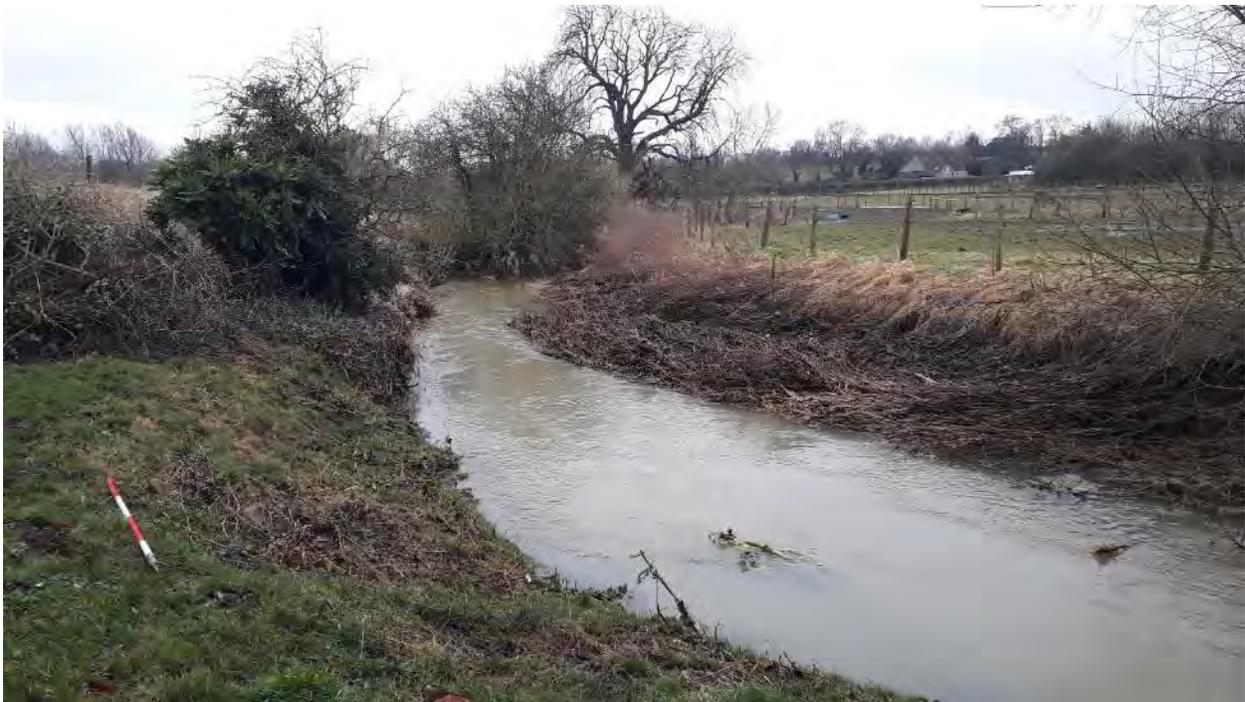
Picture 5 – The harper's Brook downstream of Lowick Mill where it runs in a single channel. The ranging pole marks the height that the recent flood had reached.

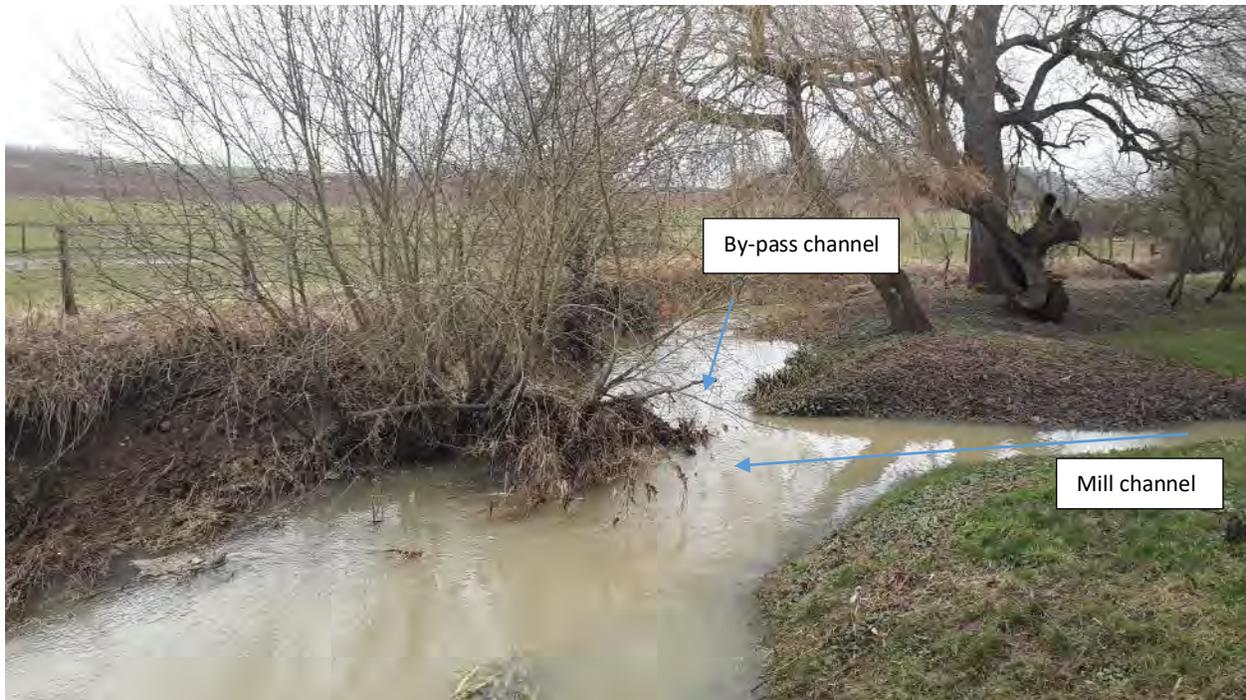
Picture 6 – The view upstream where the mill channel is joined by the by-pass channel. Note the good cover that is provided by the water level willow tree with flood debris.

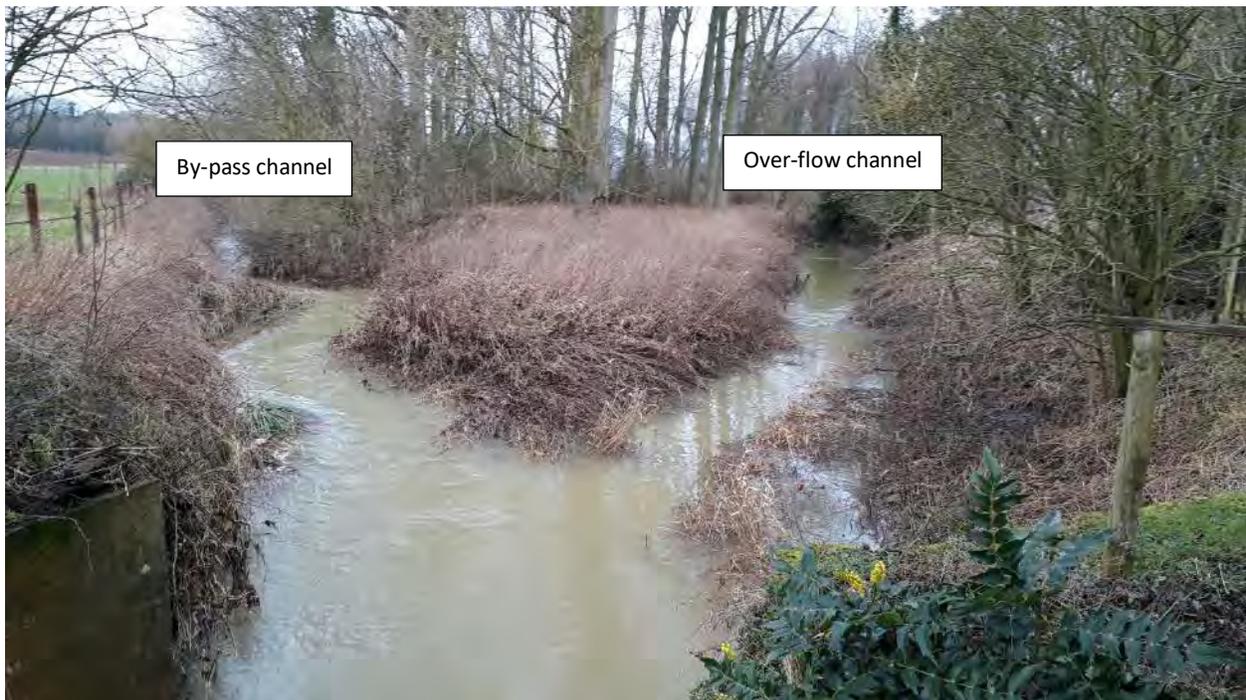
Picture 7 – The view upstream where the by-pass channel is joined by the over-flow channel. Note the sinuous form of the by-pass channel indicating that natural process are creating channel diversity which will increase habitat diversity.

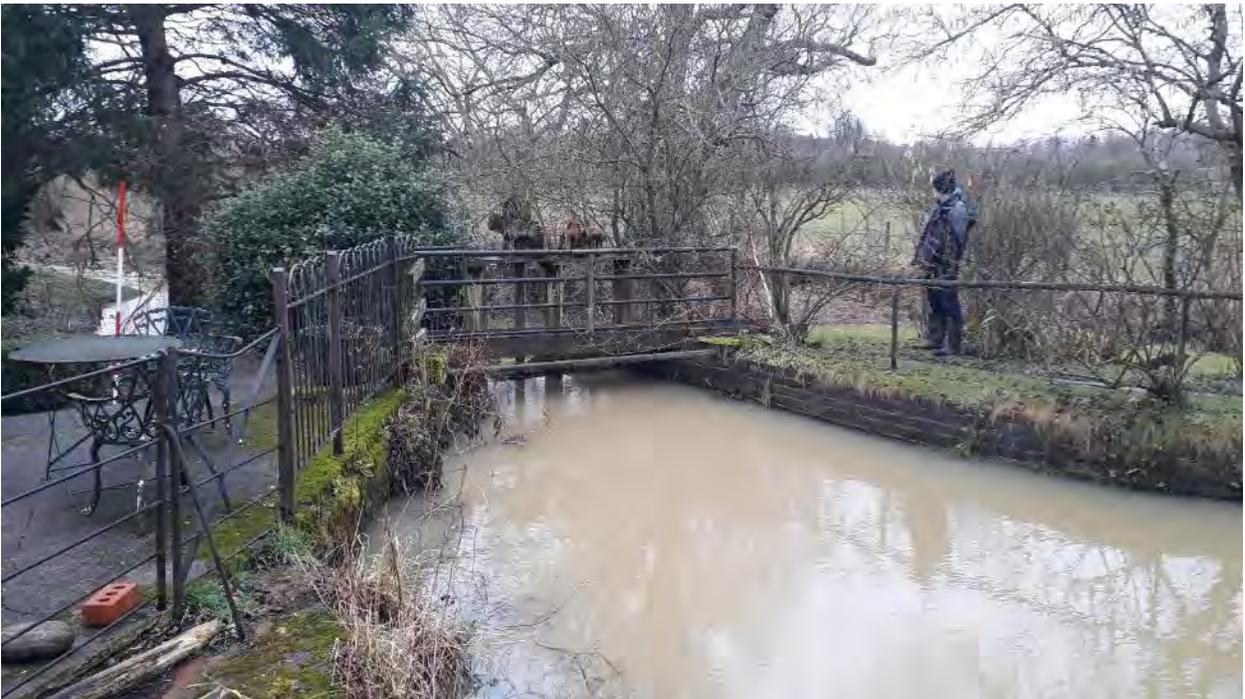
Picture 10 – The sluice gates viewed from upstream.

It is very doubtful that fish would be able to traverse the sluice gates when initially opened due to the velocity of water over the smooth stone plinth, and its lack of cover and roughness to aid fish passage. However, once the mill channel has discharged its stored water and conveys only the river flow, the velocity may be less, thus enabling fish to traverse the sluice gates.

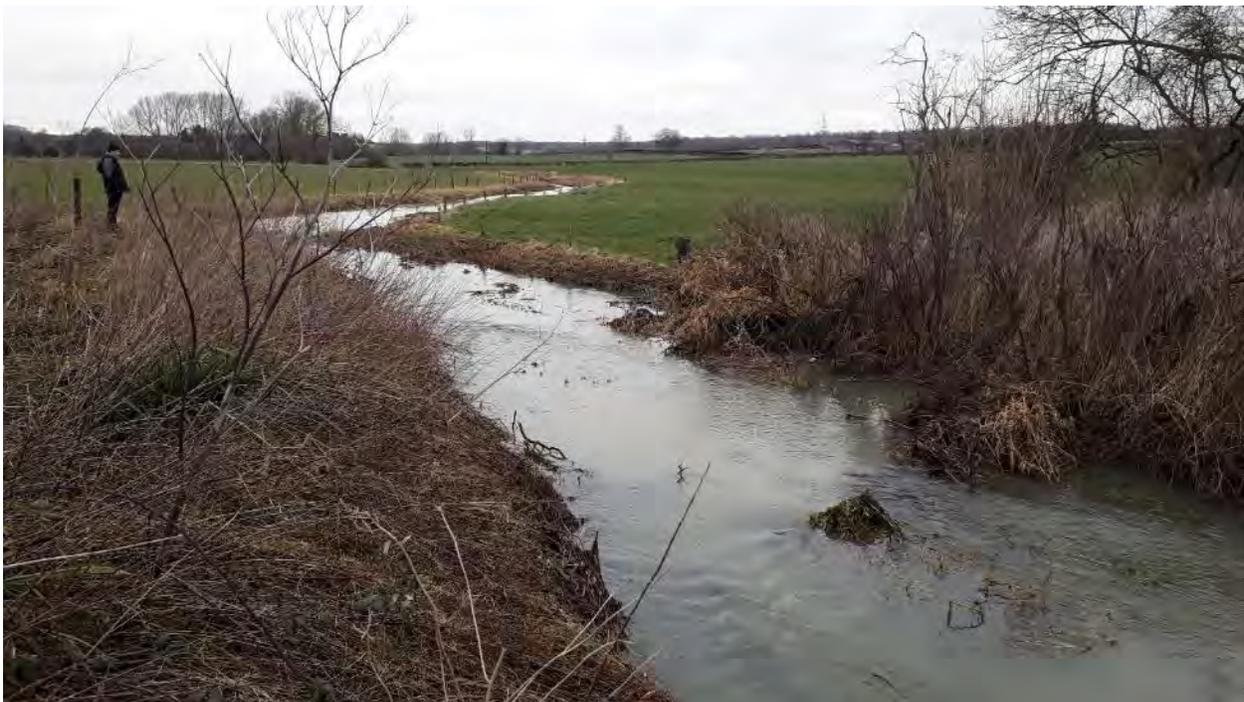
The ingress of common reed into the mill channel suggested a build-up of silt which, if combined with high nutrient loading of the water, will lead to further reed growth across the channel. It did not appear simple to remove the reeds by mechanical means due to limited access. High velocity flow is probably the best means of scouring clean the mill channel of reed and silt.

Picture 14 – The Harper’s Brook at the upper point of the visit where the channel is split to form the by-pass channel and the mill channel. (The mill channel is in the foreground.)

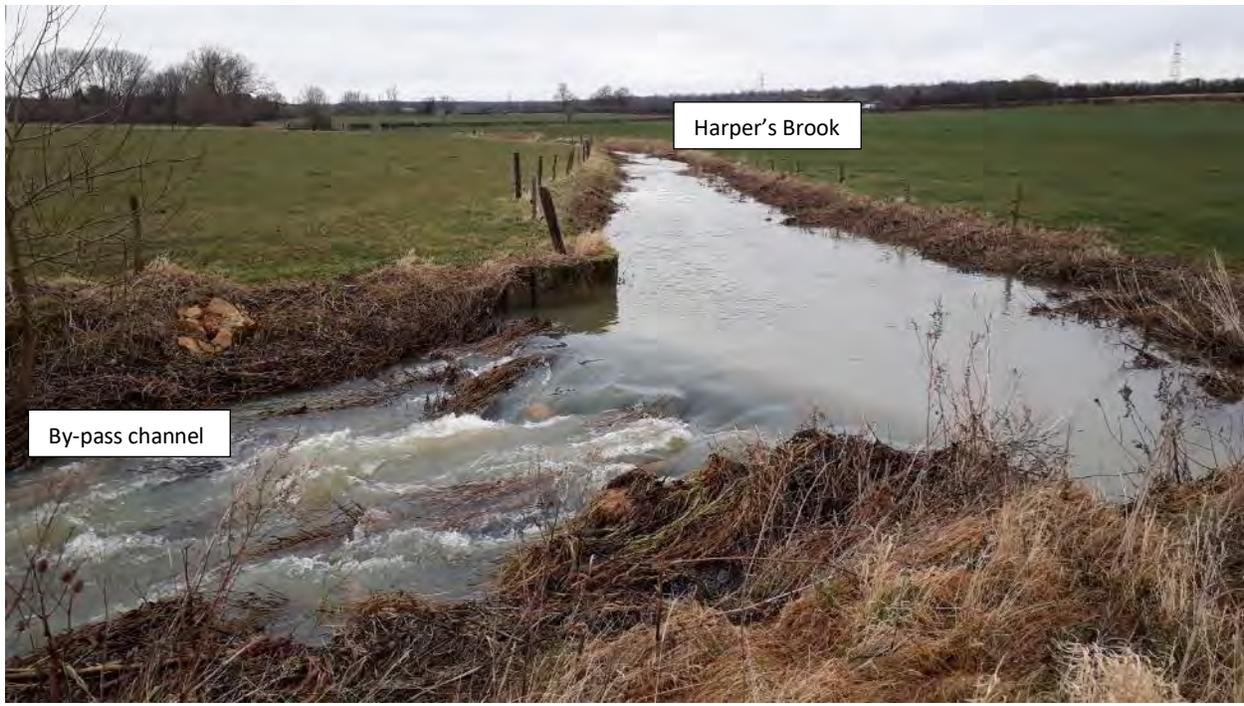
Picture 15 – The stone weir which retains a head of water to the mill channel and allows water to flow down the by-pass channel.

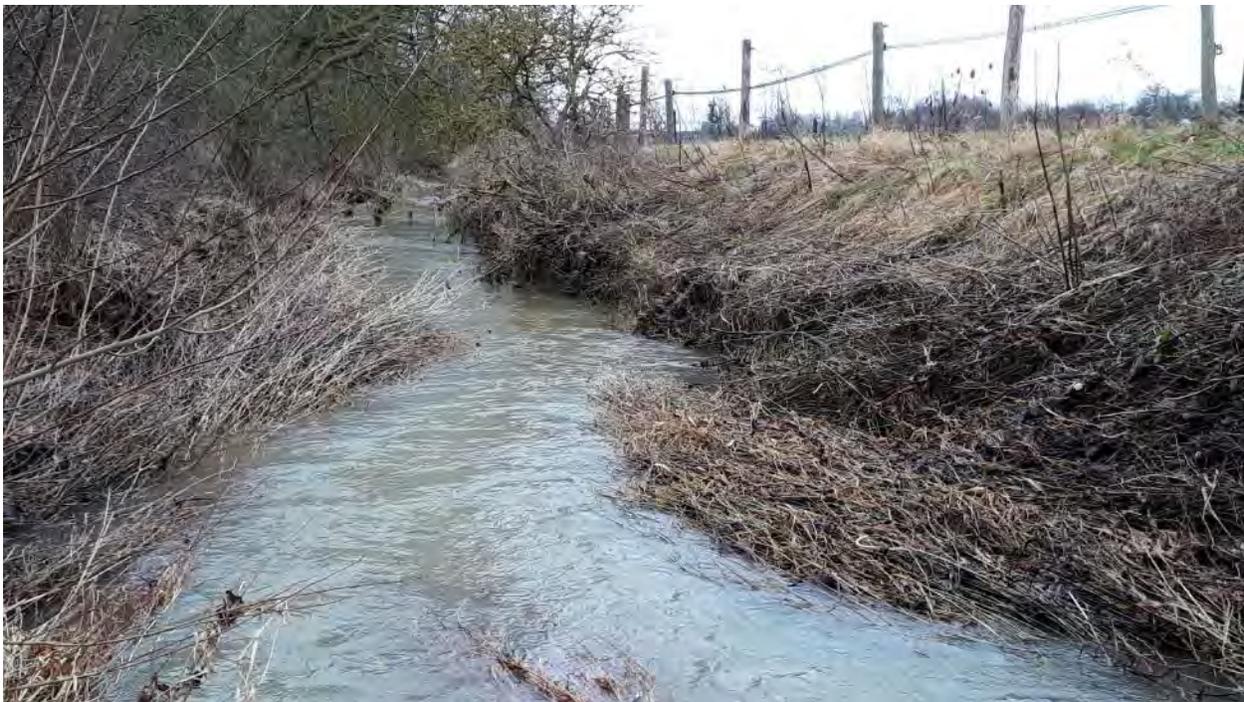
Picture 21 – Good trout habitat was found in the by-pass channel. The presence of low trailing branches is pushing flow across the channel and increases sinuosity which will assist in sediment transport and bedform diversity. Note the vegetated berm on the right of the picture which would provide important cover for trout fry when they emerge in early spring.

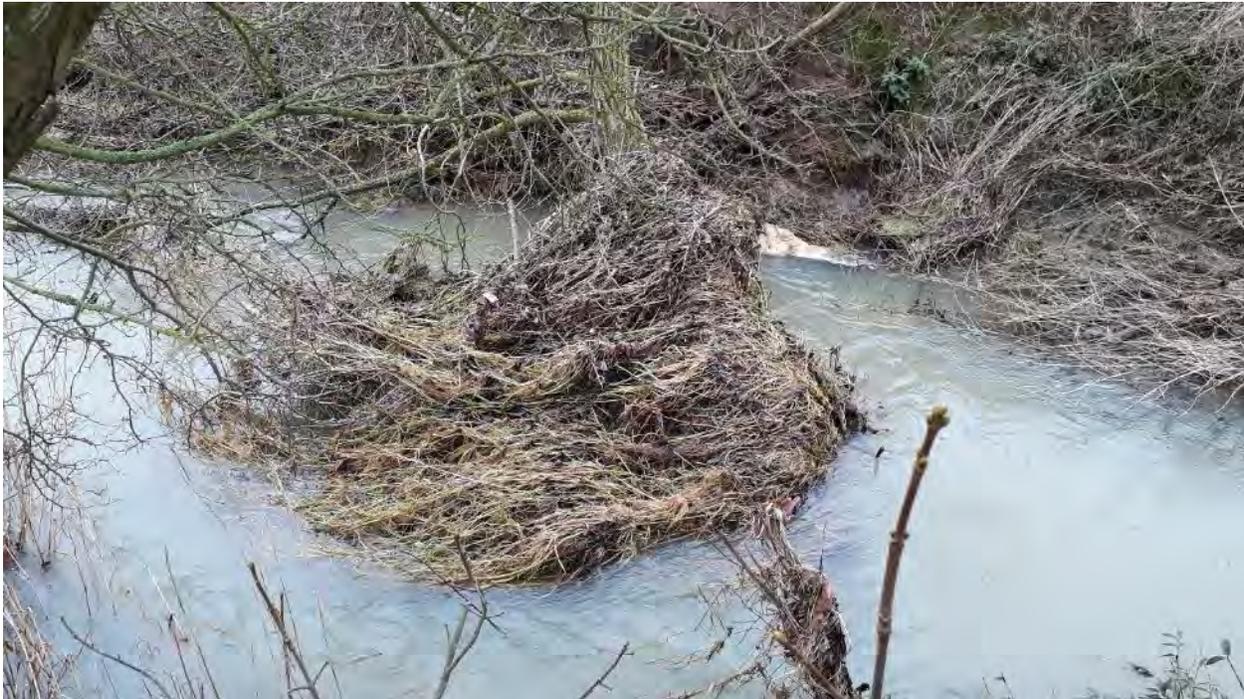
Picture 26 – Large woody material (LWM) caught up on tree branches. Whilst this type of feature may look untidy it is very important habitat for a wide range of invertebrates, and it will be used by juvenile fish as cover in high flow periods and by adult trout for cover in normal flow conditions. This type of mid-channel LWM is also creating flow patterns around it thus increasing lateral scour.

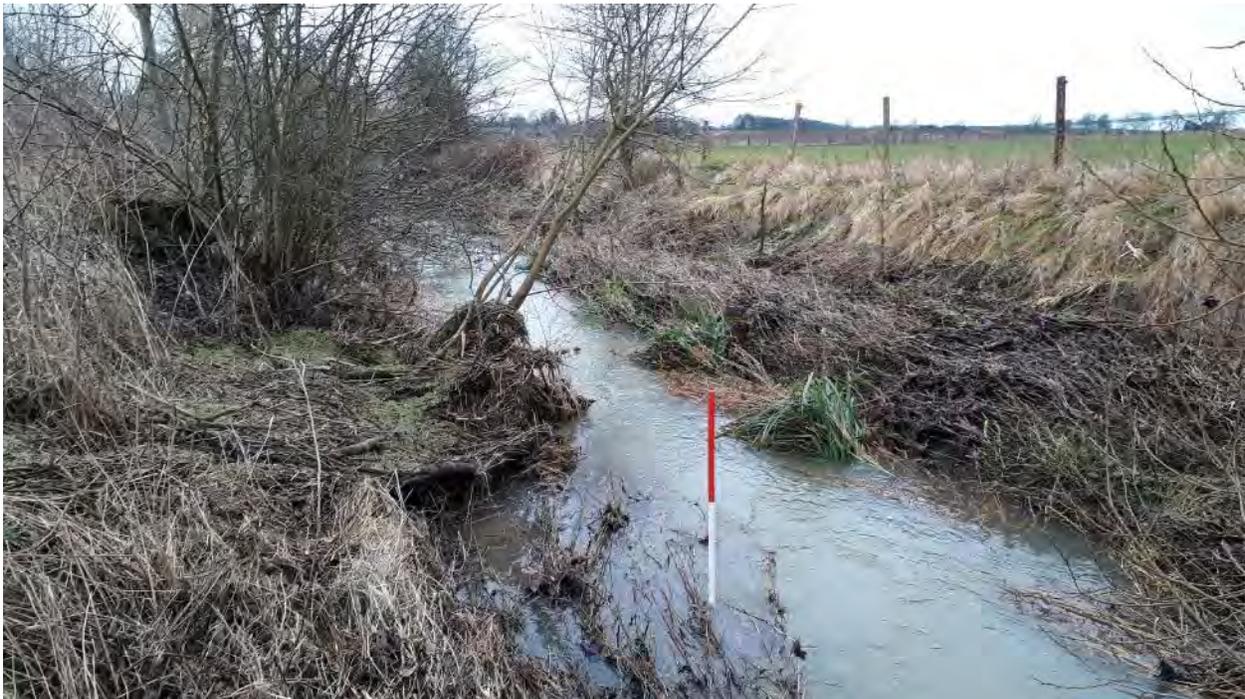
Picture 27 – LWM providing marginal cover and flow diversity.

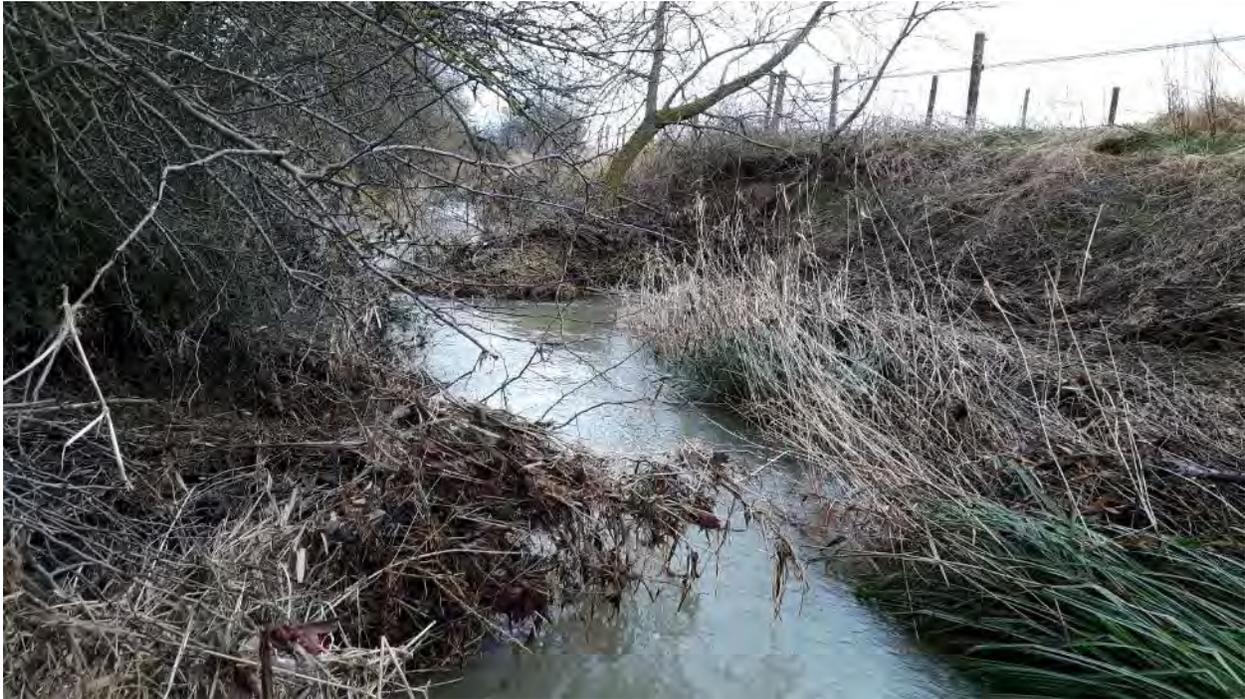
Picture 28 – Good habitat diversity for brown trout is provided by a vegetated berm (right), LWM at water level creating overhead cover (left) and a tree with wrack against it which will create bed scour (middle).

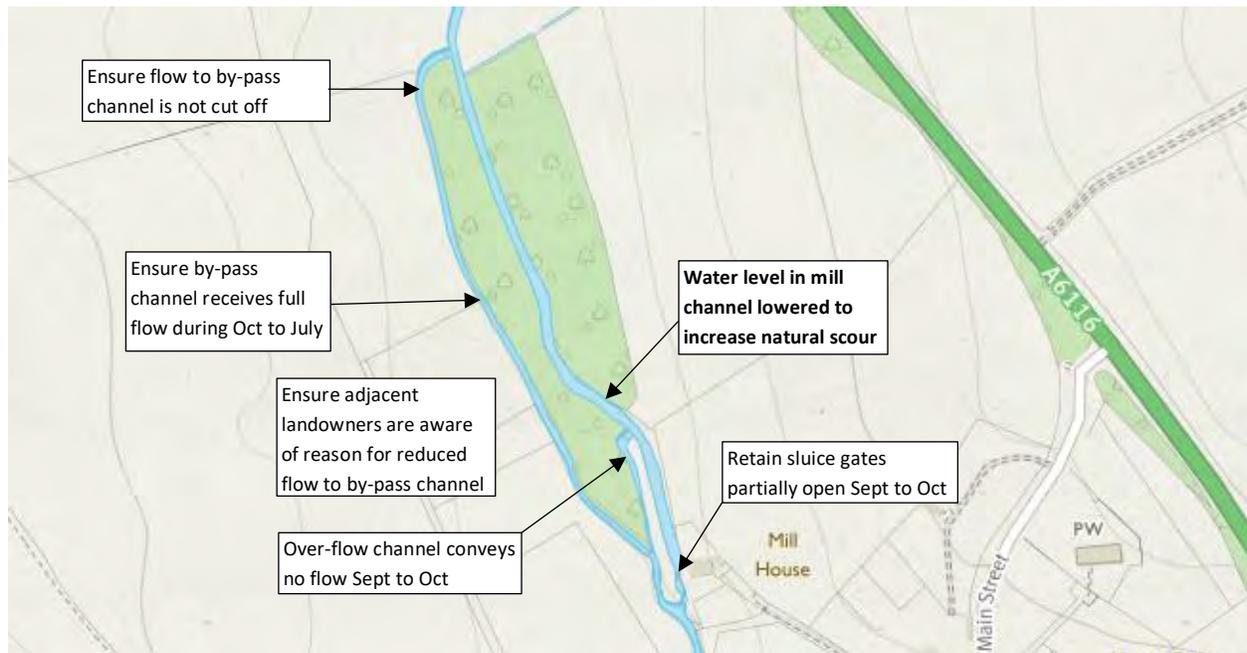
Map 4 – Option 1, using flow to cleanse the mill channel. © Ordnance Survey.

- drain the by-pass channel to the point where fish become stranded and/or exposed to predators,
- upset adjacent landowners who may express concern at the lack of water and may have a legal right to receive the water,
- diminish flow when it is needed for fish spawning and nursery (late October to late July).

This approach is not without risk to the river environment.

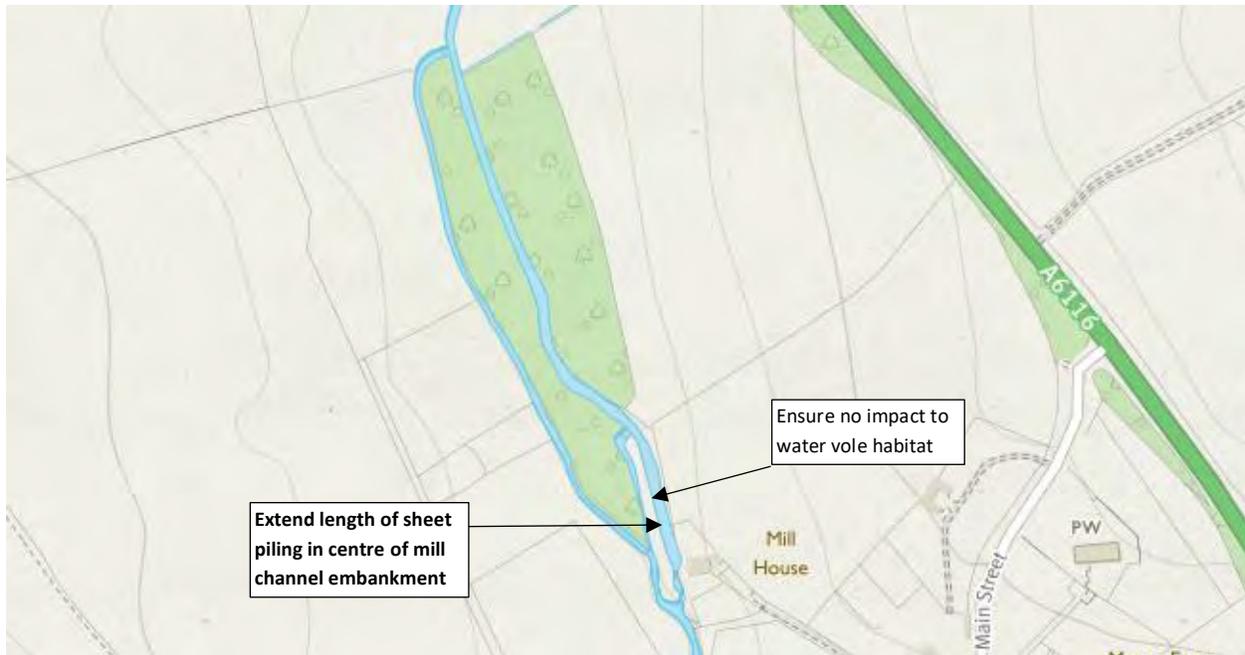
Map 5 – Option 2, repairing the mill embankment. © Ordnance Survey.

The mill channel embankment was repaired in 2004 by the Environment Agency who used sheet steel piling (see pictures 8 & 12), and the work is still considered satisfactory. The landowner reports that the Agency are not in a position to undertake such work. The use of sheet piling to fix the leak points would appear to be the most sensible approach as it would give a durable and watertight finish and piling could be driven into the centre of the embankment (subject to detailed engineering survey) so that the natural frontage of the banks are retained. If sheet piling had to be delivered near **the water's edge** then it would be possible to mitigate its harm through the

use of pre-planted coir rolls and further earth to create a new bank habitat in front of any piling.

In the 'do nothing' scenario leakage through the mill embankment and around the weir structure will continue to worsen. Only reducing the pressure (by lowering the head of water) will ease the situation. The pipeflow points will not repair themselves and it is advised that independent engineering advice is sought as to the best way to make good the situation.

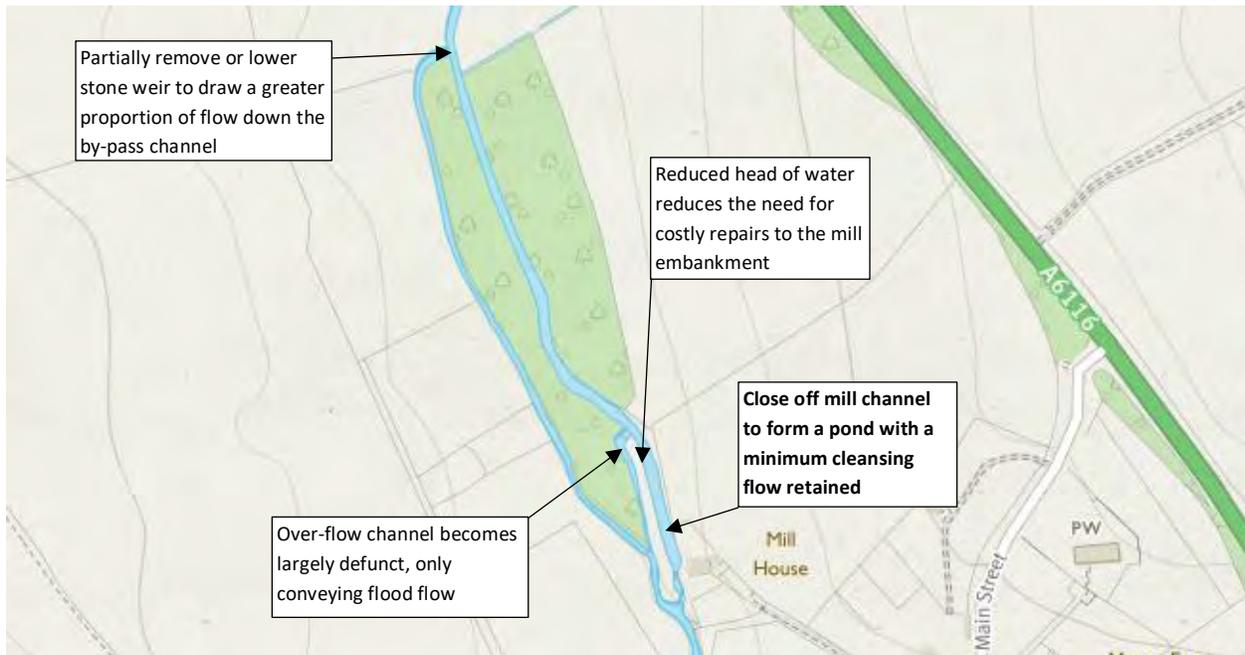
Map 6 – Option 3, closure of the mill channel to form a pond. © Ordnance Survey.

An alternative approach to consider is to close off the mill channel so that it does not receive the silt laden water or the excessive duckweed and organic matter. The point of closure would be downstream of the leak points, however a small cleansing flow could be retained to the mill channel. The mill channel would now more closely resemble a true pond which could be drained and cleaned out, and then filled as required. This approach could lessen the need for repair to the mill embankment as leaks would not affect water retention in the pond area.

The above approach would necessitate the **majority of the brook's flow to** be permanently diverted down the by-pass channel. This would enable a more

natural flow regime and plan form to be established on the brook again; one that is not subject to an impoundment and barriers to sediment transport. This approach would see the over-flow channel become largely defunct, with it only conveying flow in flood periods. Re-establishing the Brook in its natural course should be a high level aspiration.

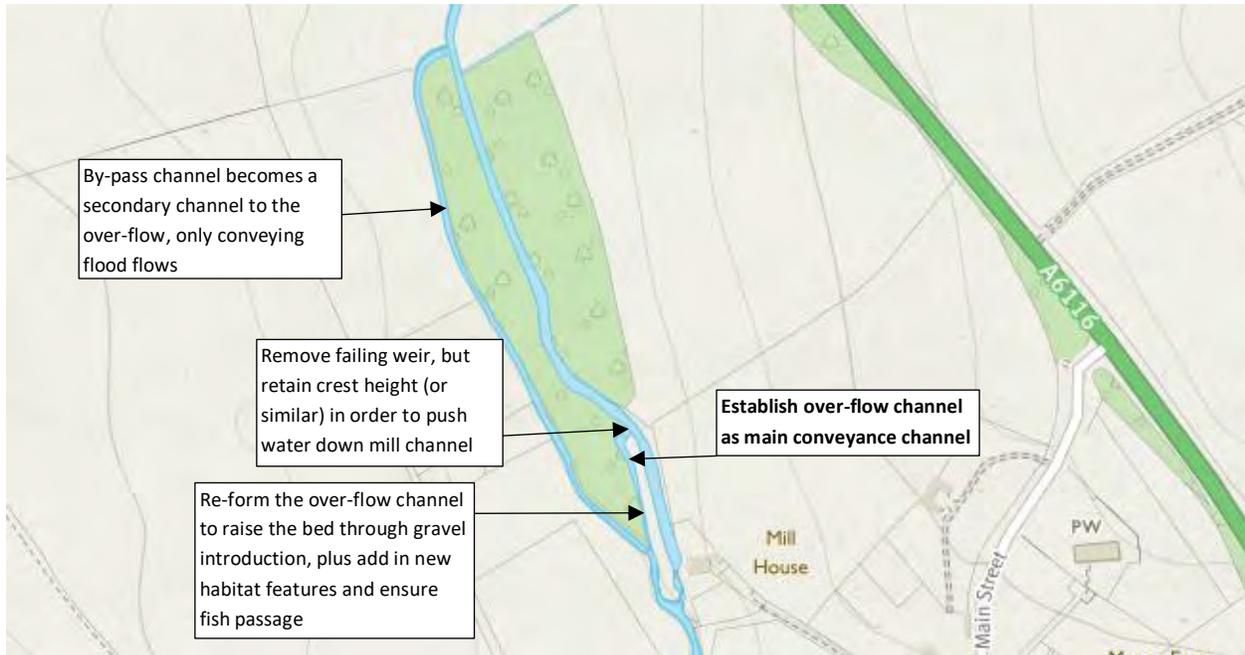
Map 7 – Option 4, closure of the mill channel to form a pond. © Ordnance Survey.

If costly repairs are to be avoided then removal of the weir might be worthy of consideration. With the weir removed the over-flow channel could take the place of the by-pass channel but the fall of ~1.7m at the weir would need to be overcome. That could be addressed by raising the bed level of the over-flow channel to bring it up by ~1.7m over a suitable length (most probably the full ~110m) so that an acceptable gradient is achieved. By

effectively lining the over-flow channel with suitable stone and compacting it, it may be possible to alleviate the need to address water leaks through the mill embankment as the stone might plug the leaks if laid deeply and firmly enough.

The over-flow channel could then become a gravel-lined stream which would provide a spawning and nursery habitat for fish, especially trout.

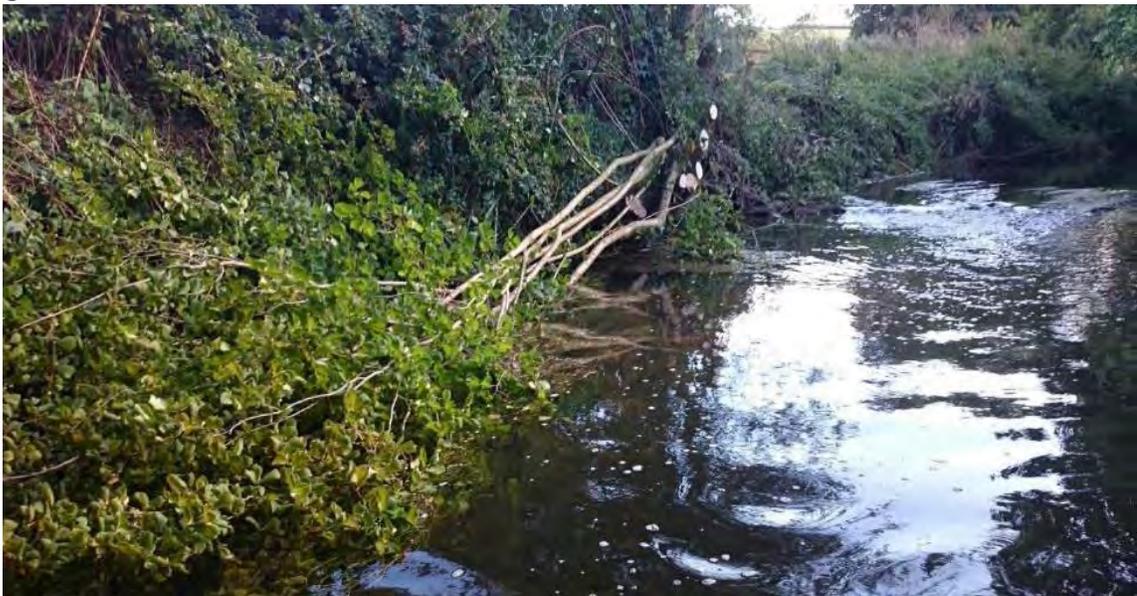
Picture 29 - An example of tree hinging, a simple and effective technique for increasing cover in a river.

- Tree management – in places the canopy of dense trees was preventing good marginal growth from establishing. Canopy management by crown thinning, crown lifting, tree hinging (similar to hedge laying), pollarding or even coppicing would be beneficial in order to create areas of dappled shade. A general rule is to retain some shade over pool habitats and to allow sunlight to riffles and fast glides.

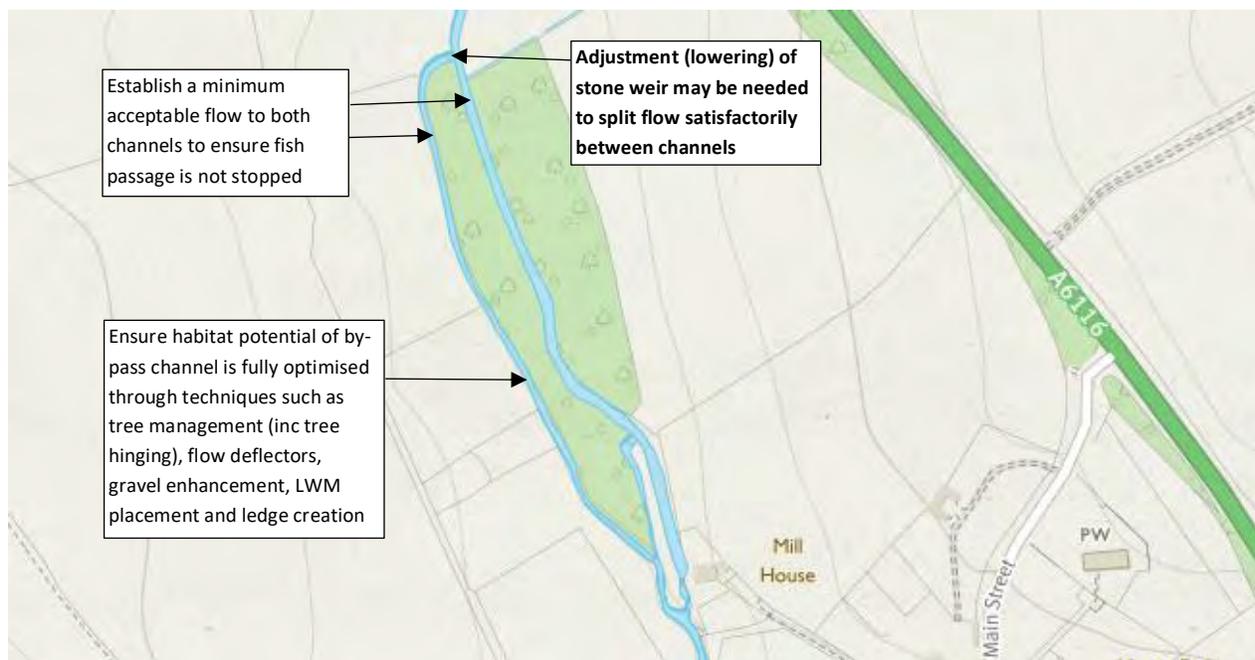
Map 8 – Option 5, adjustment (lowering) of the stone weir to ensure minimum acceptable flow to both channels. © Ordnance Survey.

Low flow conditions could be exacerbated by a dropping water level in the mill channel (created by leaving the sluice open). If that situation occurs, then fish passage should be maintained by establishing a minimum acceptable flow to both channels. This is particularly important if adjusting flow regimes in the autumn as brown trout will be migrating ahead of their spawning season (October to January).

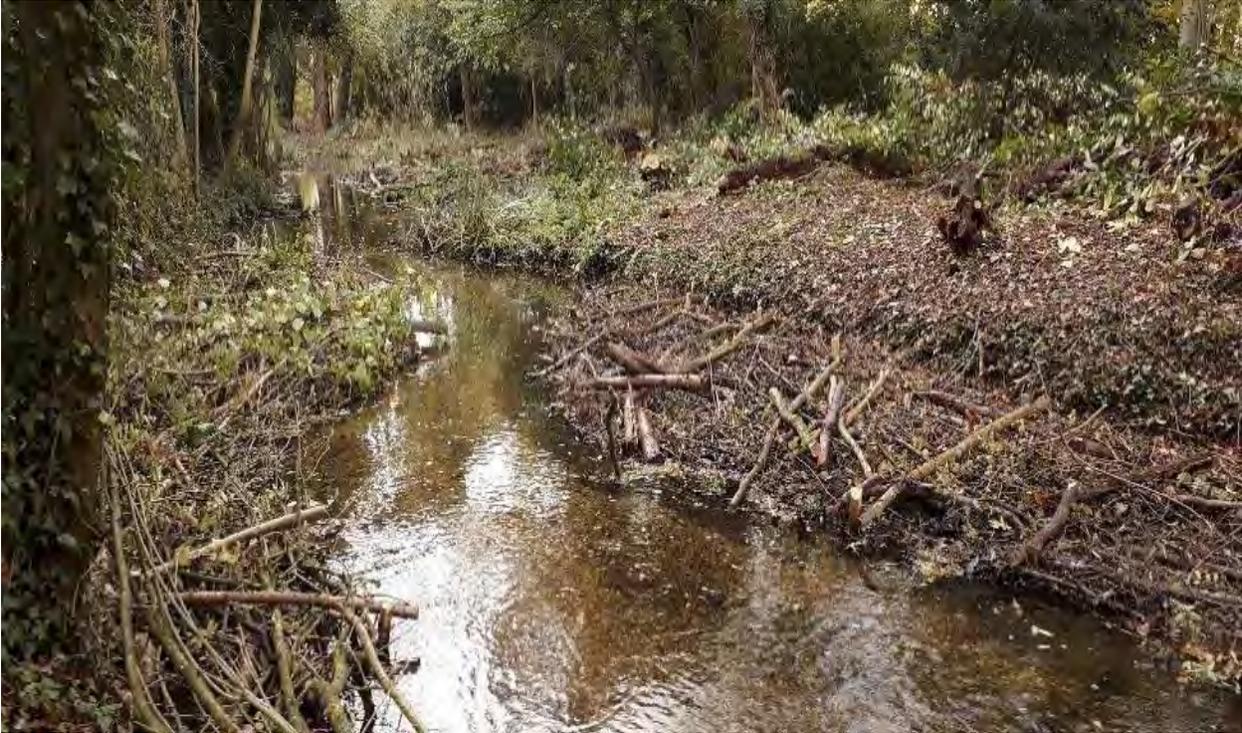
Picture 30 – Examples of low level brushwood berms created on the River Misbourne following tree thinning work. Brushwood berms can be used to protect banks from erosion, to create in-channel sinuosity and to entrain silt and sand.

- Tree planting – the RHB showed very few trees and there is clearly space for some planting. The use of quick growing species such as crack willow would be good for some immediate cover and bank stabilisation. The use of common alder would provide a slower growing species that in time would provide excellent bank stability and marginal cover as its dense root system extends into the channel.
- Brushwood berms – these features can be created following tree works. A brushwood ledge is an excellent means of creating complex cover at water level. The brushwood lattice will provide many niches for invertebrates and small fish and in time will entrain silt. The silt and lattice work then provides a rooting substrate for plants to become

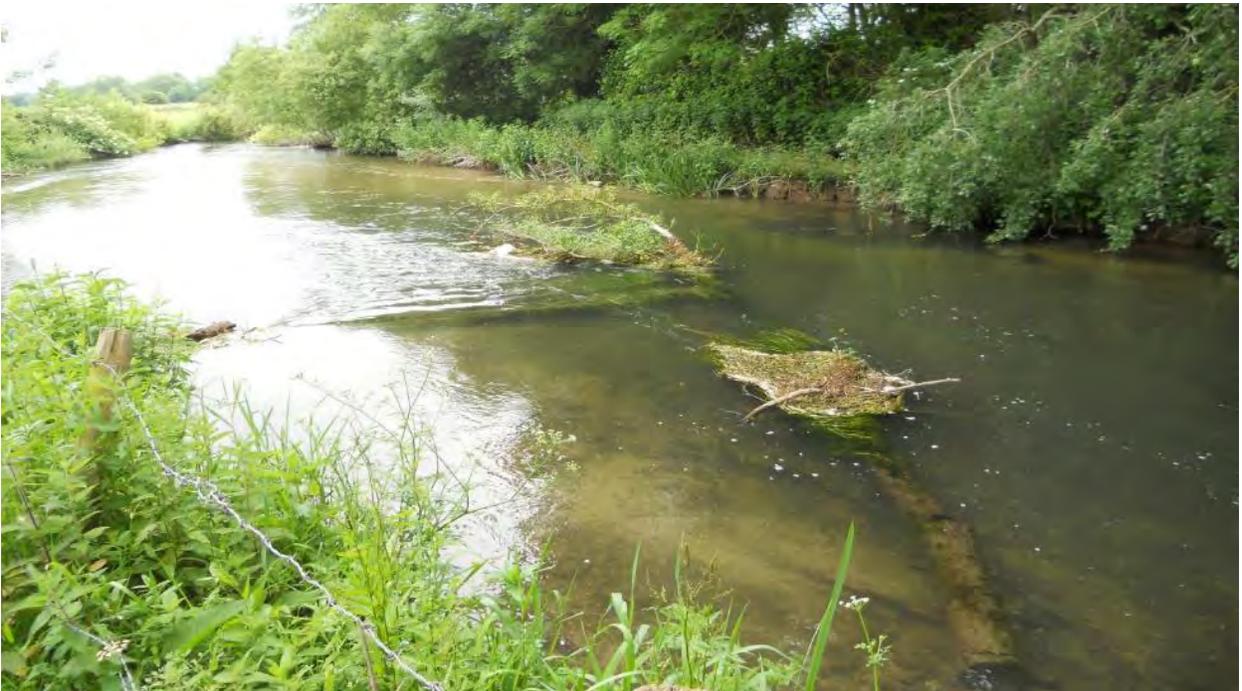
Picture 31 – Examples LWM fixed to the bed on the River Wylfe. The pieces of large timber create both underwater scour to sort sediments and a broken water surface which promote oxygenation and provide cover. The by-pass channel could be further improved for trout by adding such features to it.

- Flow deflectors – these features can be used to increase flow diversity within a channel. They can be simple log deflectors or tethered tree stems. The complex flow that arises from such features aids scour and sediment transport within the channel.

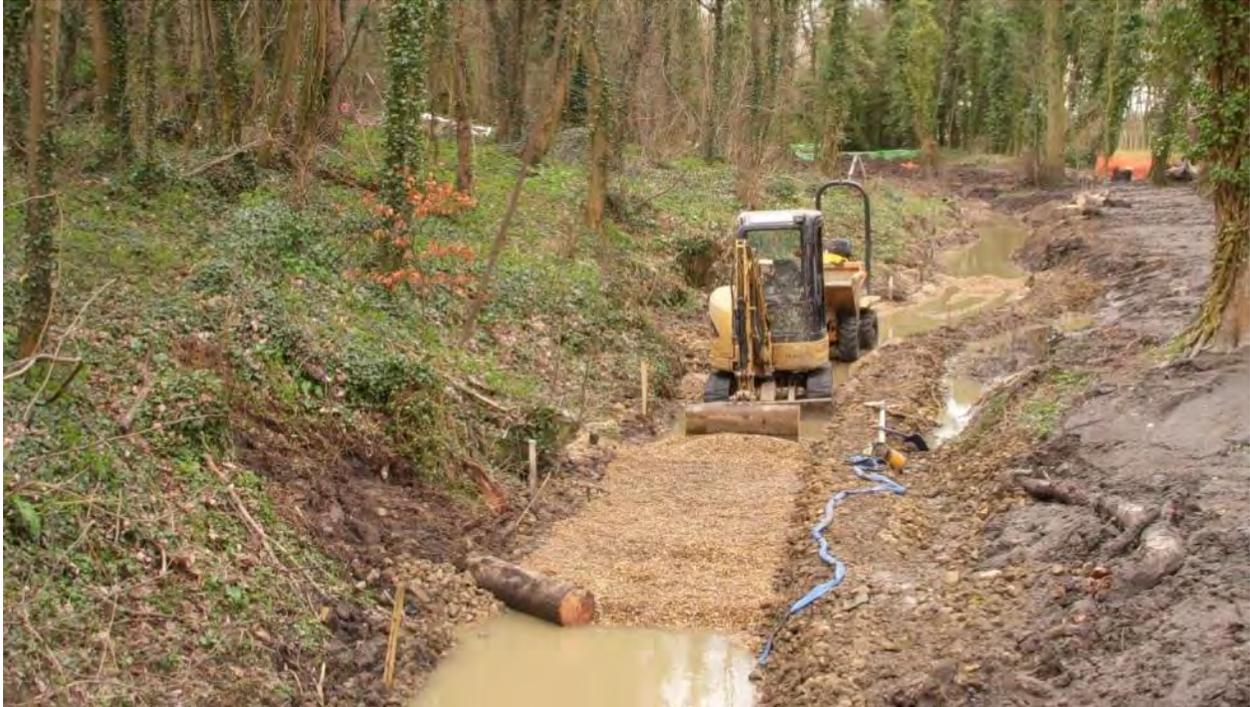
Picture 32 – An example of a former defunct channel (on the River Cam at Byron’s Pool) which was lined with gravel to raise the bed to enable the creation of a new fish by-pass channel. The work has also provided an additional ecologically diverse channel.

- Gravel enhancement – the channel clearly contained deposits of gravel at some locations. Due to the high water level at the time of visit it was not possible to assess the quality of the gravel. If the gravel is considered to be sub-optimal (due to an excessively large particle size, compaction and/or high silt content) it is possible to rectify the matter. This can be through the introduction of new gravel, or through water jetting the existing gravel to loosen compaction and flush out fine sediment from within it. Following such works it would be necessary to **identify the original cause of the gravel's deterioration so as to aim for a sustainable solution.**
