Advisory Visit

Harper's Brook, Sudborough, Northamptonshire

September 2018

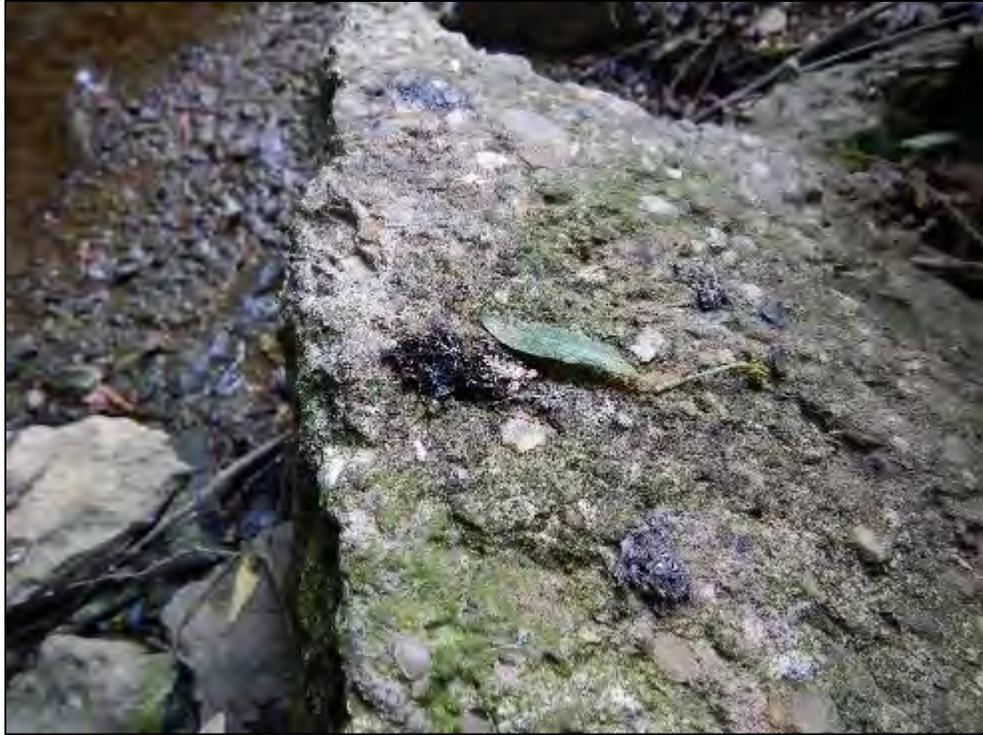
It is doubtful that water voles are present due to the heavily tree-lined and shady nature of the brook at Sudborough suppressing the lush marginal vegetation required by voles for feeding and cover. No specific field signs of water vole were observed during the visit. Water voles and their habitat receive full protection under the Wildlife and Countryside Act 1981 (WCA 1981). Otters are known to be widespread in the region, and it was not surprising to find spraint deposited on riverside stones (pic 1). Otters and their habitat also receive full legal protection under the WCA 1981.

Pic 1 – An otter spraint found alongside the brook.

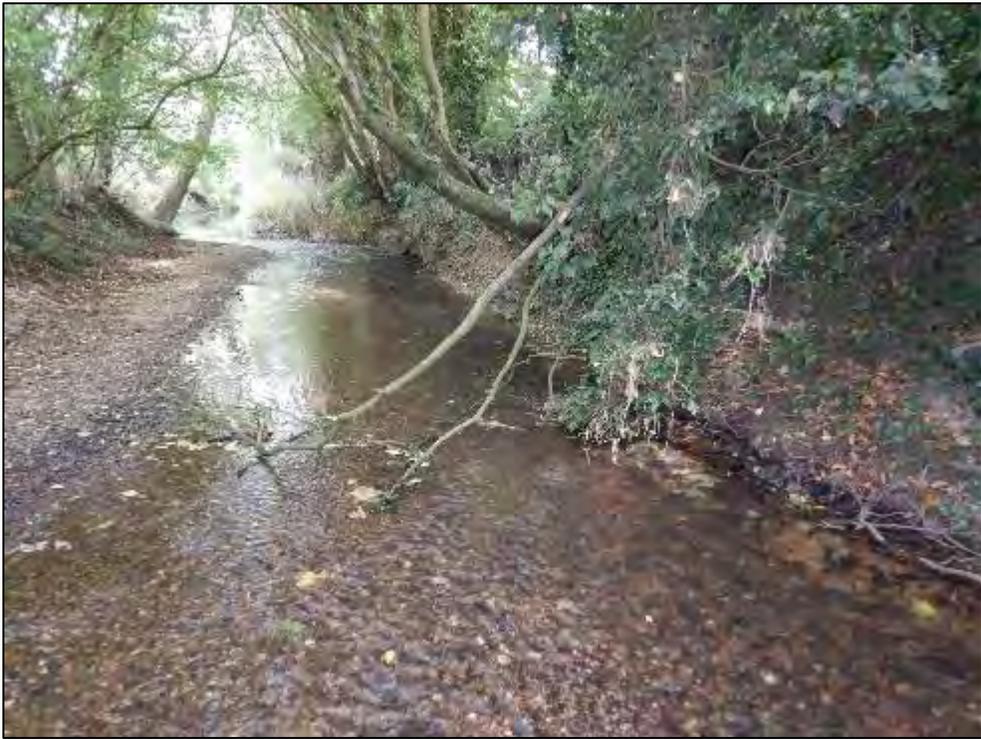
The presence of veteran coppice field maples, is interesting as it is indicative of a tree canopy that has not been broken for many years. This suggests that mechanical maintenance, such as dredging, has not taken place for many decades (if at all). The lack of dredging has allowed coarse sediment (gravel) to accumulate at certain points leading to ecologically important habitats (riffles, glides and exposed gravel bars; pic 12).

Pic 12 – Exposed gravel bars are an important habitat for specialist invertebrates.

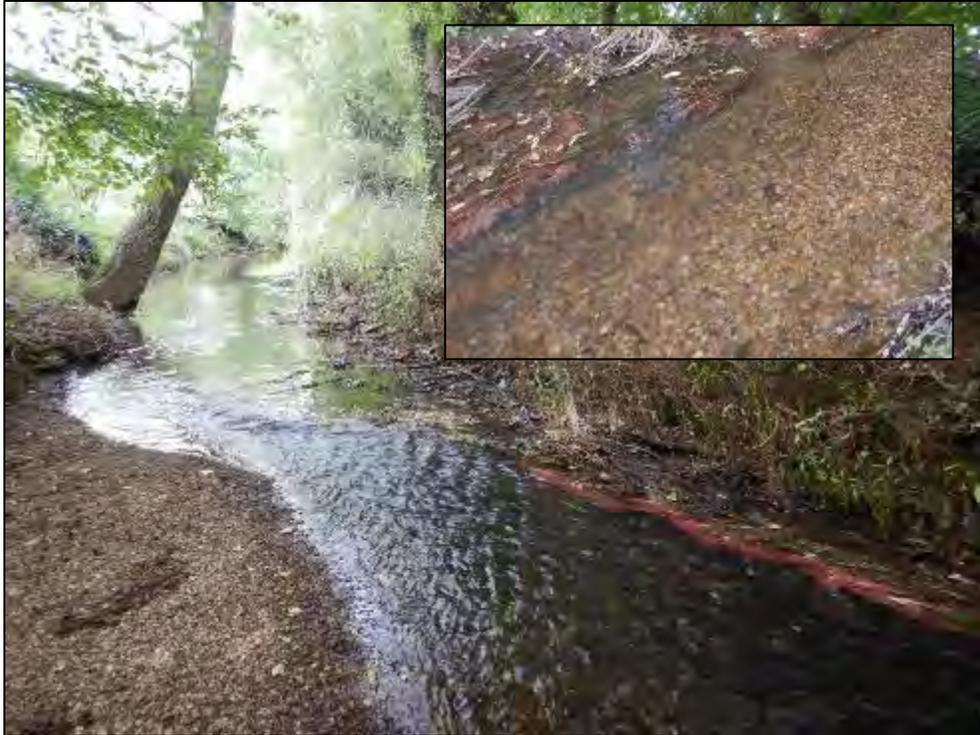
One specific pool and riffle sequence is of particular interest. Under the recent low flow conditions, the channel width has reduced down to ~1m but the water velocity has remained fast, keeping the gravel cleansed of fine sediment and partially mobile as can be seen by its golden colour (pic 17 plus inset). As the flow enters the pool, there is an accumulation of woody debris which in turn is acting as a trap for fine sediment (pic 18).

Pic 17 – The water velocity leading into the pool is enough to keep the gravel cleansed of fine sediment.

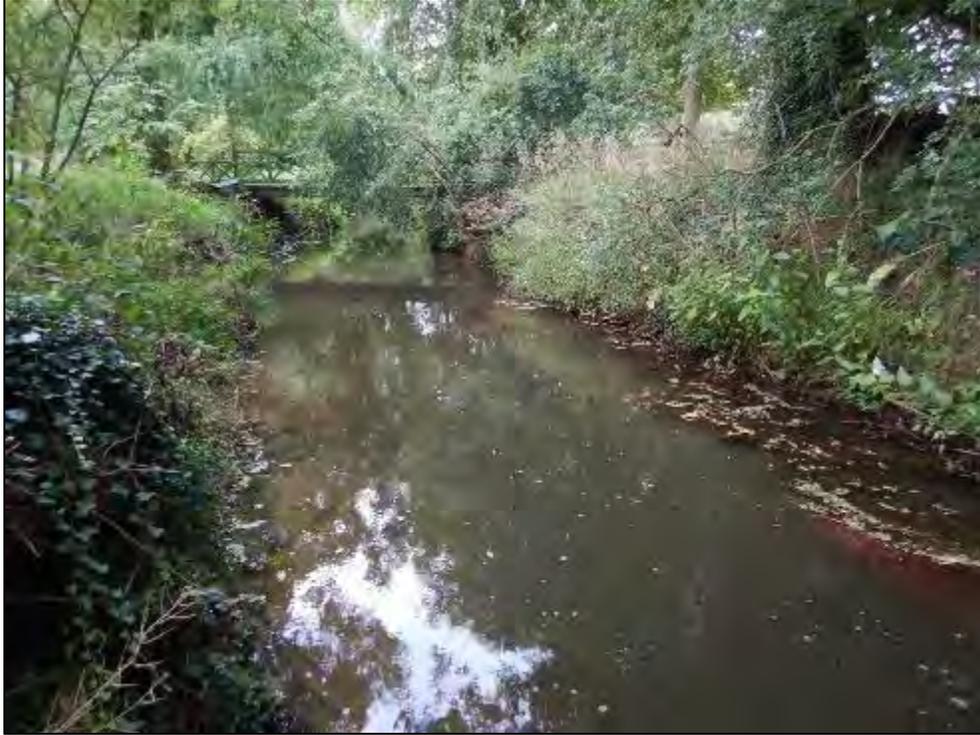
Pic 19 – Fish were observed rising in this pool. The species was unknown.

The depth cover offered by the pool will be utilised by adult brown trout. Wild brown trout require habitat diversity, food, spawning and nursery areas and good water quality. Trout (as well as chub, dace and minnows) will spawn on well-sorted gravels (particularly in the range 15mm to 40mm) that are relatively stable within a river. A pool and riffle sequence is important in river systems as it naturally diversifies the flow and provides habitat for juvenile trout (within the shallow riffles) which keeps them from competing with (or from being eaten by) adult trout. Appendix 1 contains a diagram illustrating **the brown trout's life cycle**.

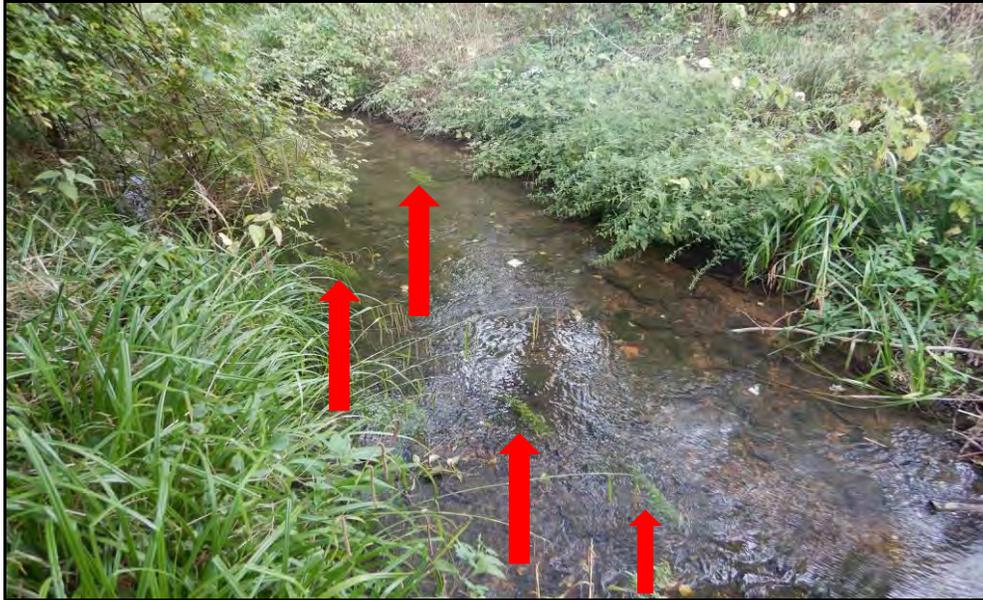
As the brook was followed downstream to the limit of the Old Rectory, it became more open. The number of pendulous sedge plants increased but the diversity of marginal plants remained low. Starwort grew from the river bed and at one location, a number of branched bur reed plants were observed; other than this the aquatic plant diversity was low.

Pic 24 – Where light is able to reach the channel there was a greater number of marginal plants and starwort was present (red arrows).

The brook is over-shaded for much of its length, restricting the growth of marginal plants. Careful tree-thinning to achieve a shade/light balance along the lines of 60: 40 should be considered. Tree management should have regard
