## Holly Wood Local Nature Reserve Brook

### Advisory Visit

**Wild Trout Trust Report – Following a Site Visit on 28/11/2017**

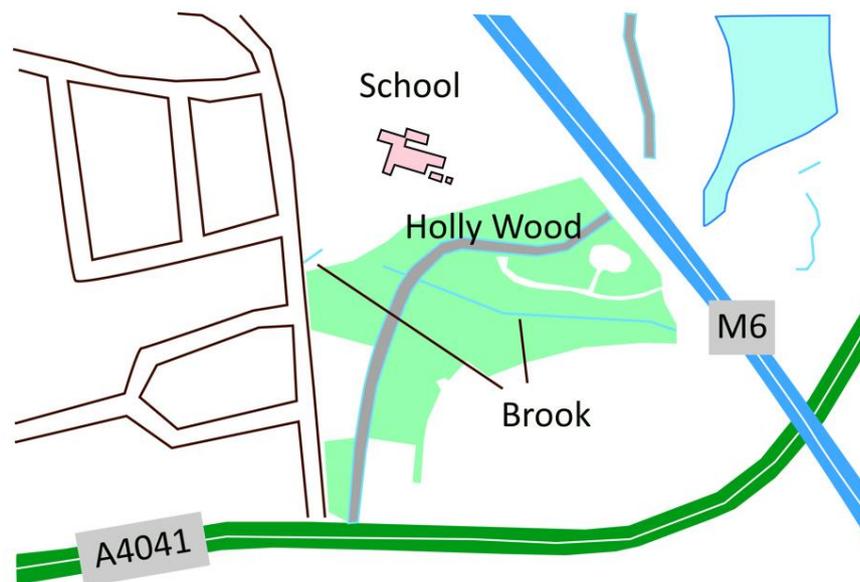
The upstream and downstream limits of the brook that were visited within the Local Nature Reserve at Holly Wood were at National Grid References SP05115 94521 and SP0549294454 respectively. These limits are noted on Figure 5 as well as the context of the surrounding transport network infrastructure.

**Figure 5: Upstream (far left of marked "Brook") and downstream (far right of marked "Brook") limits of the inspected reach. The watercourse is a very small, straight woodland stream with a relatively steep longitudinal gradient.**

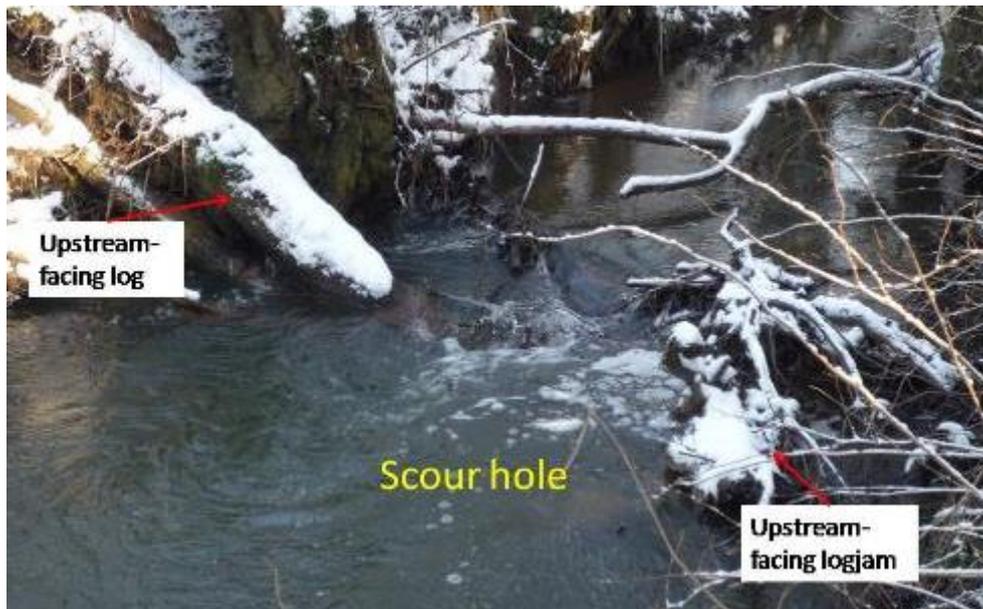
**Figure 16: Securely pinned/staked woody material producing localised bed scour during higher flows. Using this technique with material arising from tree management – or even repositioning existing in-channel material - would create better habitat.**

Introduction and secure anchoring of woody material within the channel could focus spate flows to create localised scour and deposition. In turn, this would result in a greater range of physical conditions that could make a broader range of habitat niche conditions available for colonisation.

- Use materials arising from any routine tree-management activities within the park to securely fix limbs, stems and branches from trees to encourage localised bed and (where safe to do so) bank scour (e.g. Fig. 17).
- Explore the potential to control/remove dominant stands of Rhododendron growth
- Planting areas that have been cleared of Rhododendron bushes with “plug” plants of appropriate native understory species may be beneficial (e.g. Fig. 18). There appears to be little supporting evidence for the theory that Rhododendrons “poison the soil” for other plants – rather than simply dominating the space and the nutrients as well as producing poor leaf litter

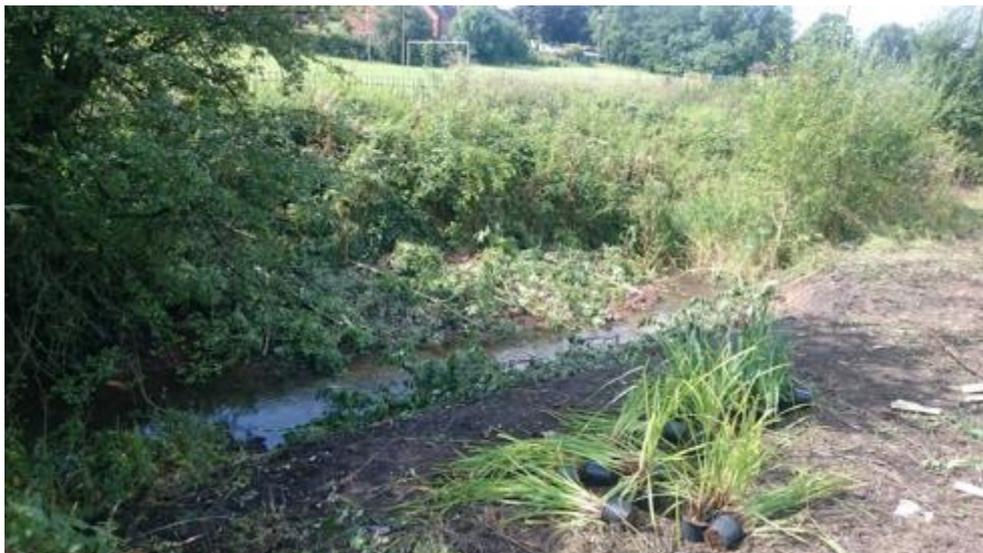
**Figure 17: Plug plants ready to be planted to augment the in-channel features on the near bank and opposite bank created using brush (also pictured here) within an urban park on the Lyme Brook in Staffordshire.**
