Advisory Visit

River Leven

Hutton Rudby Fly Fishing Club

25/03/2019

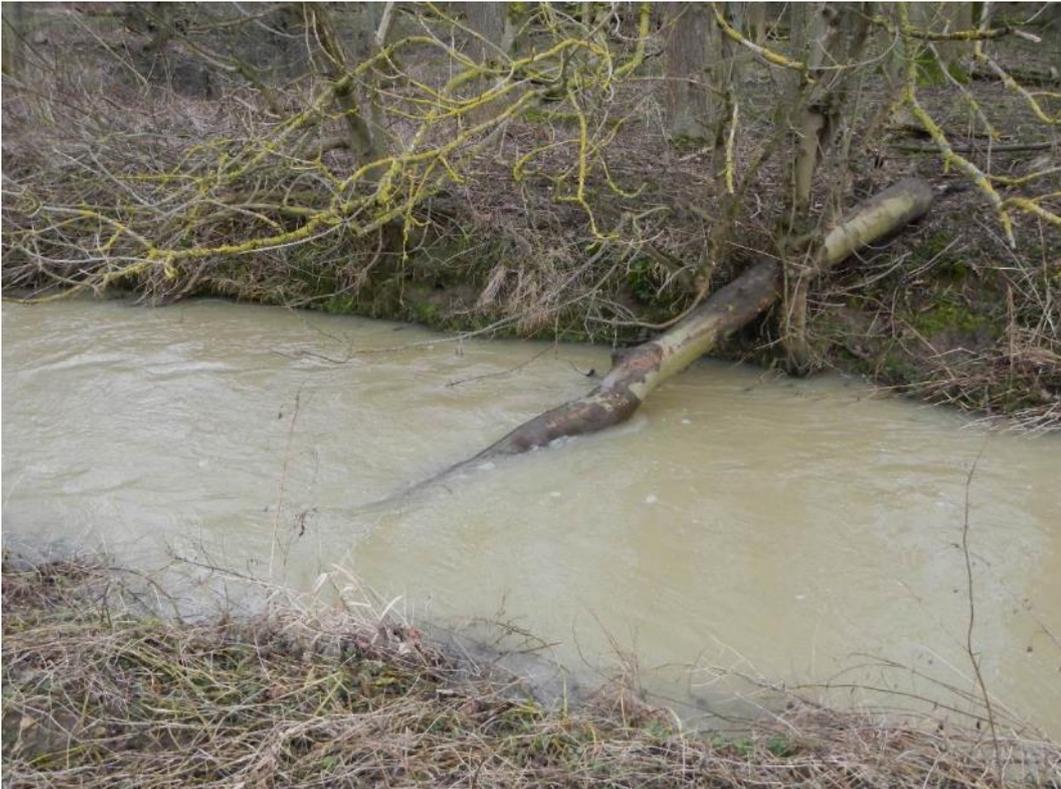
Figure 25. A lodged flow deflector – the technique can be used with a single pole (primarily to increase scour) or a branched limb (to create greater flow dissipation). The elevated butt end (bank end) reduces the potential detrimental bank scour usually associated with d/s deflectors as a through-flow is maintained along the bank.

As highlighted in Fig. 24, there are multiple stems of alder from which one could be cut (with no significant detriment to the overall canopy or other habitats) and lodged between two or more the remaining stems, closely mimicking the natural occurrence in Fig. 17. The technique is also shown in Fig. 25.

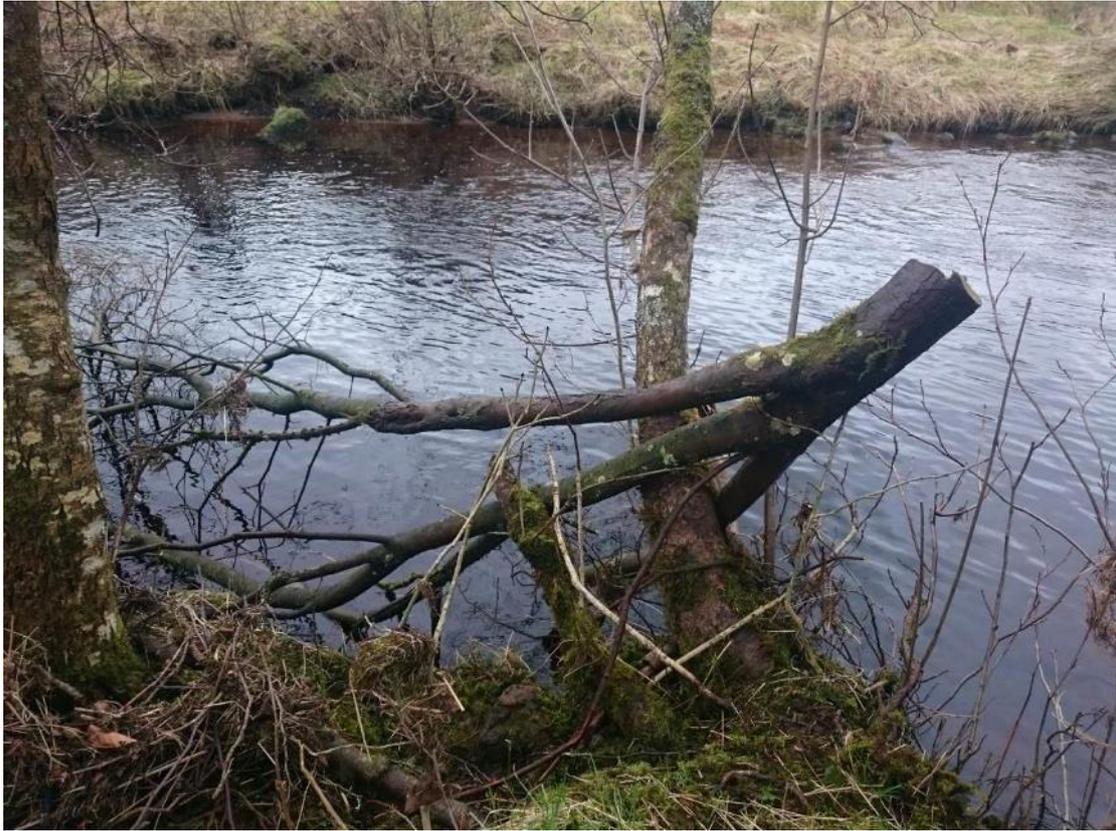
Figure 26. A medium-sized piece of lodged woody material which is securely anchored in place against an upright tree.

An alternative, nature-like lodged flow deflector method is equally simple but relies upon a deflector with multiple branches. It simply involves hooking one of the branches around an upright tree (Fig. 26). The example uses a medium-sized branch, but any size of branch or tree can be employed providing the anchor tree is stable and of sufficient size.
