**Advisory Visit**

**River Isla**

**October 2014**

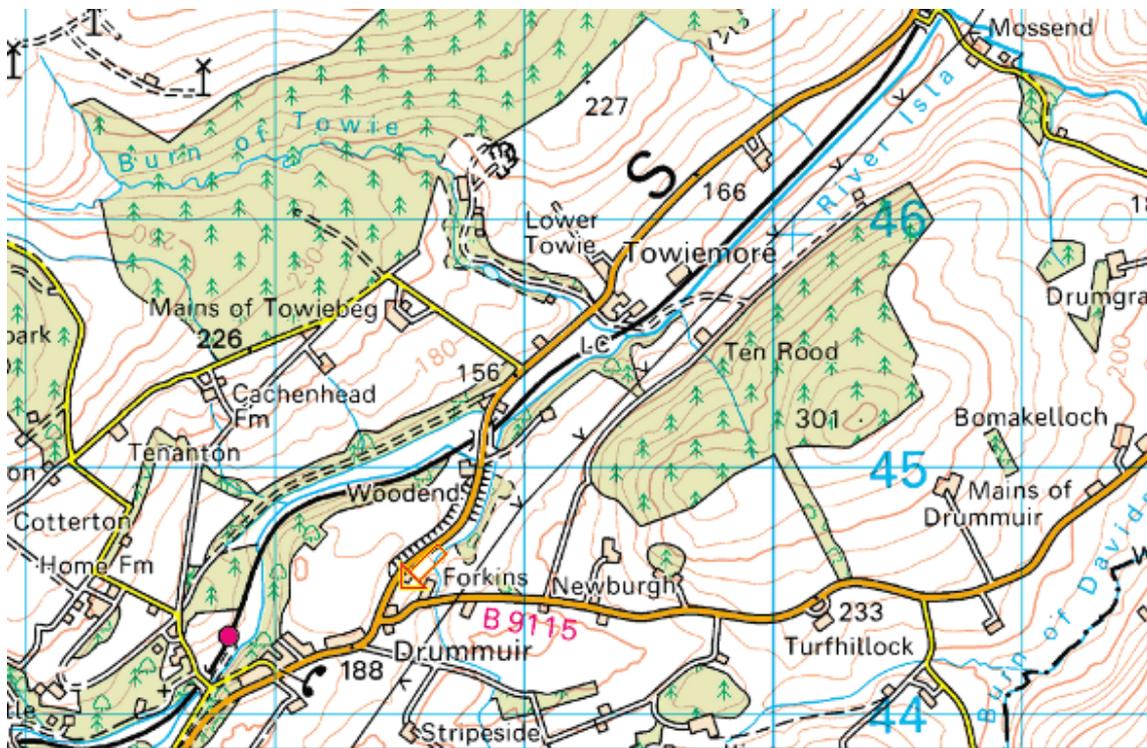
Figure 1 Upstream section of walkover survey, showing Drummuir station (bottom left) and the confluence of the Burn of Towie and the River Isla (centre). (River flowing towards the north east).

The river channel here has been straightened at some point in the past, possibly when the railway line was constructed (Figure 1). The river has a uniform width and depth profile and is predominantly shallow (Photo 1). There is no pool-and-riffle sequence, the in-stream habitat being largely shallow glide with an un-sorted riverbed substrate (Photo 2). The banks are stable, with mature trees present along both banks.

The section of the Isla downstream of the Towie Burn has obviously been straightened, possibly when the adjacent railway line was constructed (Figure 1) along the left bank. The river here has a moderate gradient (apparently steeper than the upstream Drummuir section) and tree-lined banks which promote bank stability; these factors have combined to produce reasonably good in-stream habitat despite the very straight channel (Photos 3, 4).

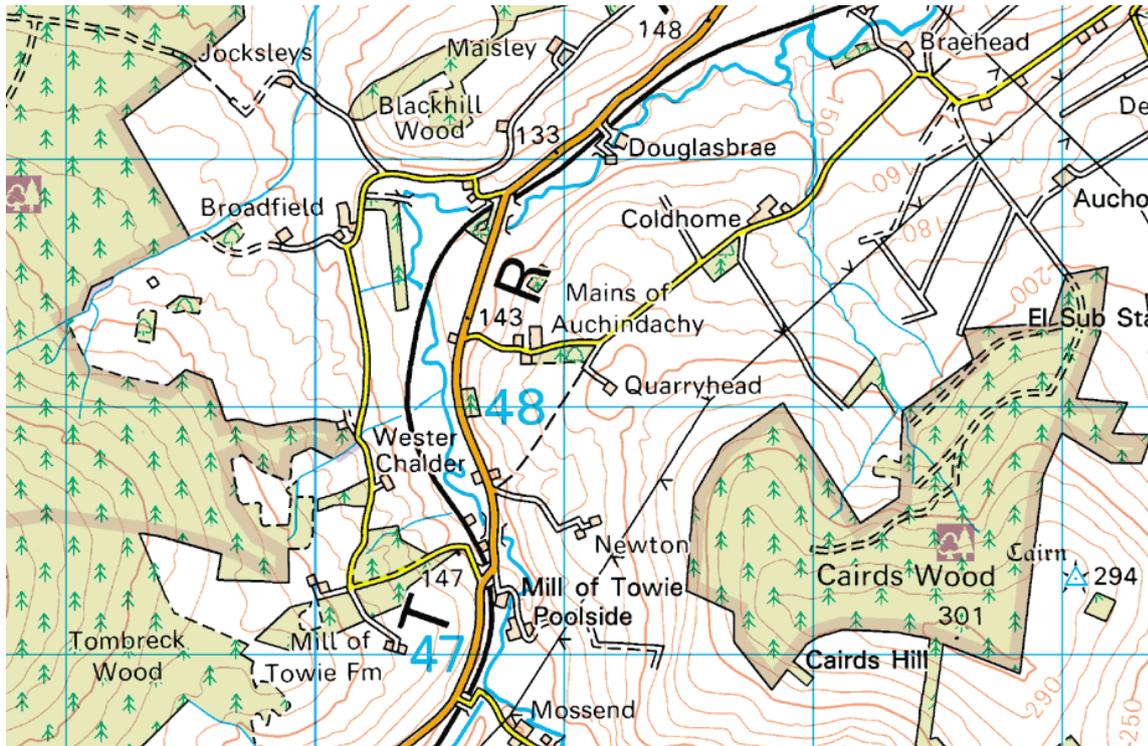
Figure 2 Middle section of walkover survey

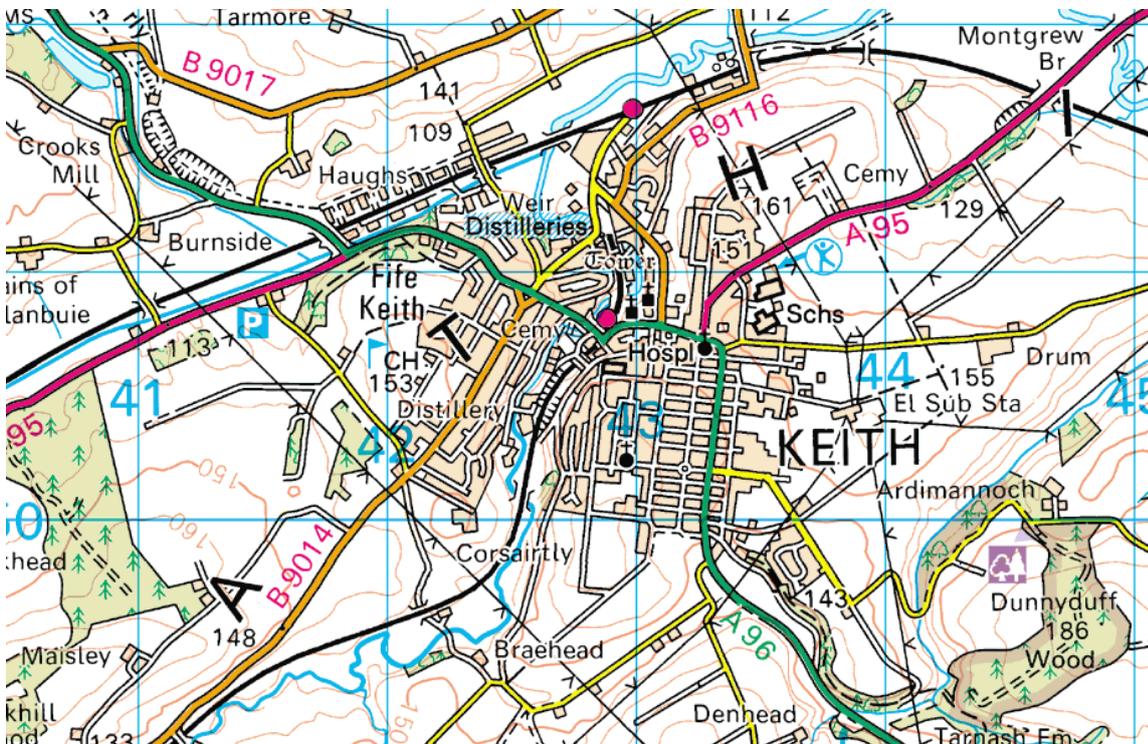
Figure 3 Downstream section of walkover survey

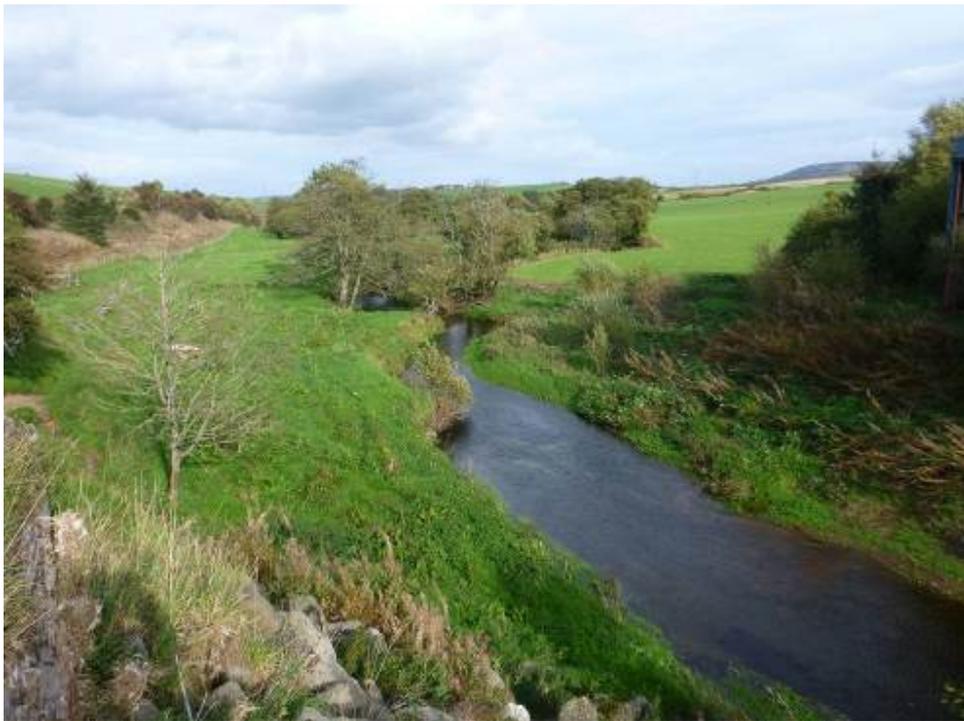
Downstream of the Bridge of Maisley, land use alongside the river appears to be predominantly grassland, with the occasional arable field. The river has a meandering plan form and the banks have moderate tree cover, with some lengths fenced off from livestock (Photos 35, 37). No areas of severely accelerated bank erosion were observed, although there are some areas suitable for brushwood revetment and fencing, such as Photo 34 (these would be a lower priority than on the section upstream of Bridge of Maisley). In-stream habitat is good, with a pool-riffle sequence, although low and submerged cover is lacking in some areas (Photo 36).

**Photo 35 View downstream from Douglasbrae (NJ4116249059)**

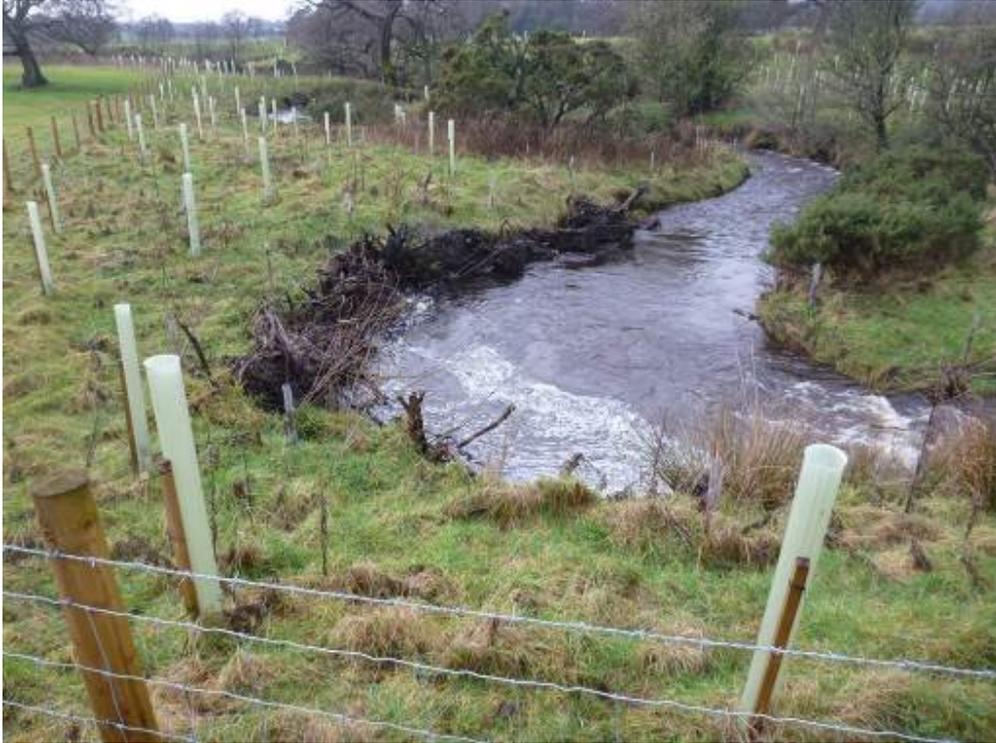
**Photo 39 Woody bank revetment (in this case with root wads), fencing and tree planting provide good habitat and a long-term solution to accelerated bank erosion.**

- Reduce accelerated rates of erosion by the use of a combination of brushwood revetment and creation of a fenced buffer strip planted with native, deciduous trees (Photos 39, 40). The buffer strip should be as wide as possible (a minimum of 5 m, preferably 10 m). Brushwood revetment is a much quicker technique than willow spiling, allowing longer lengths of bank to be treated. The use of live willow is possible with this technique, but consideration should be given to future maintenance requirements. Low growing sallow species are recommended over crack or white willow. Dead brushwood will trap silt, vegetate and consolidate the bank very effectively as long as livestock are excluded.

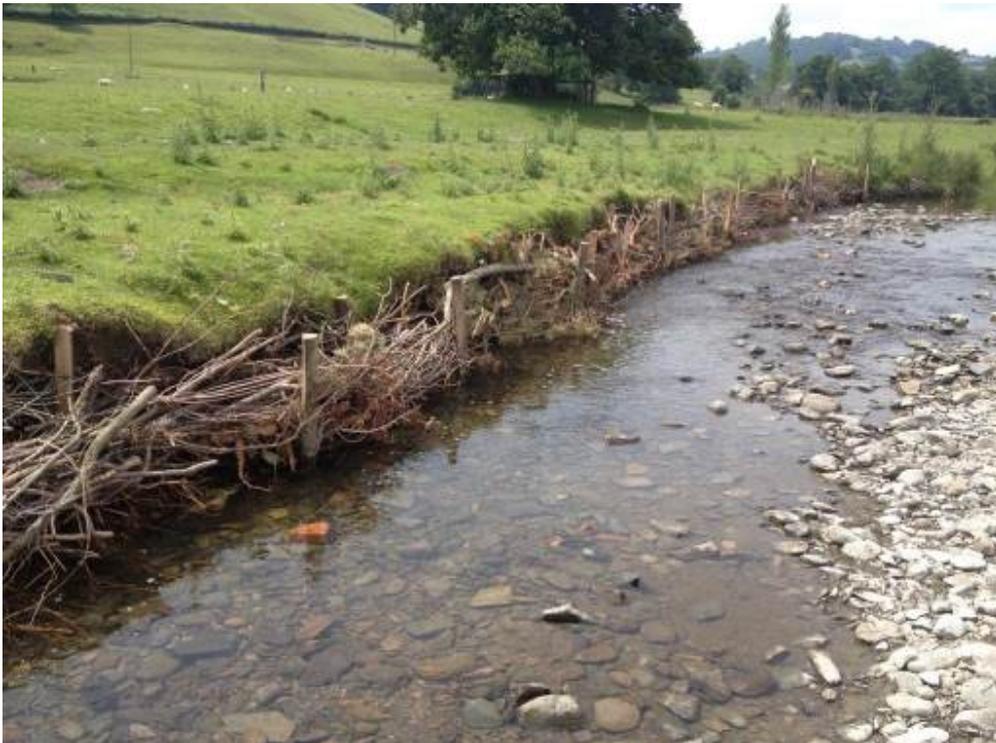
**Photo 40 An example of brushwood revetment, prior to livestock exclusion.**

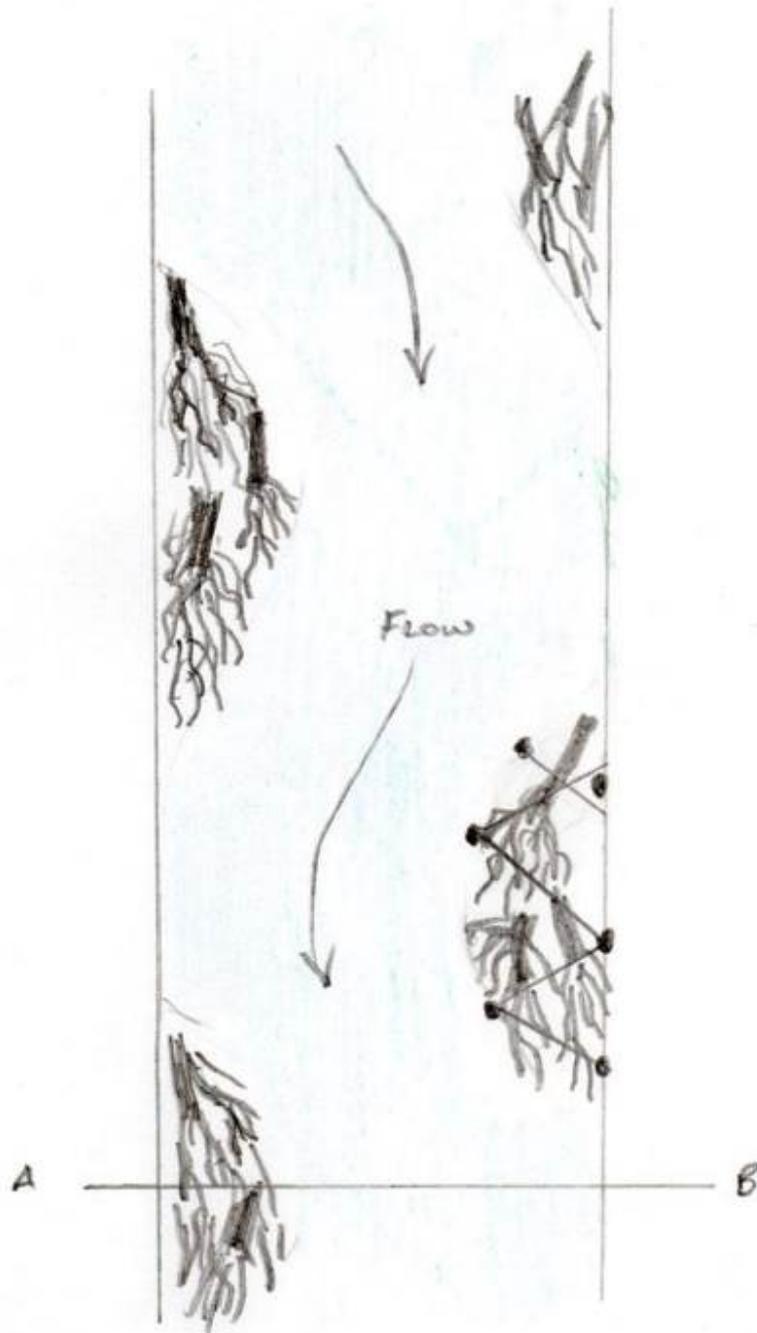
Figure 4 Schematic of structures on alternate banks

- Consider the use of in-stream structures on the Drummuir station section to increase habitat variation. The gradient here appears quite low and a longer length than covered on this visit should be inspected (e.g. to check there are no downstream impoundments). If the area seen reflects the natural gradient, then structures like log flow deflectors and K-dams are not appropriate and the approach should be to introduce sinuosity within the existing channel with D-shaped groynes on alternate banks (Figure 4). The simplest way to do this would be to use tree kickers or hinged trees on alternate banks (Photos 41, 42).

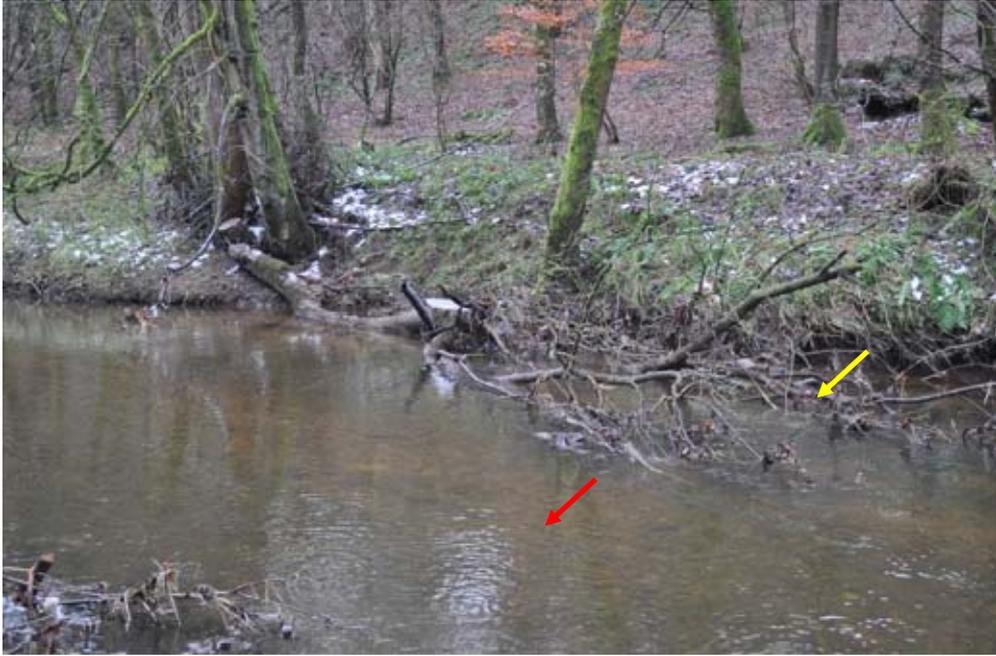
**Photo 41** A “tree kicker” installed in the River Petteril, Cumbria, securely cabled to a tree stump. This provides cover and changes the depth profile by promoting deposition (shallowing, yellow arrow) amongst the branches and scour (deepening, red arrow) of the open channel

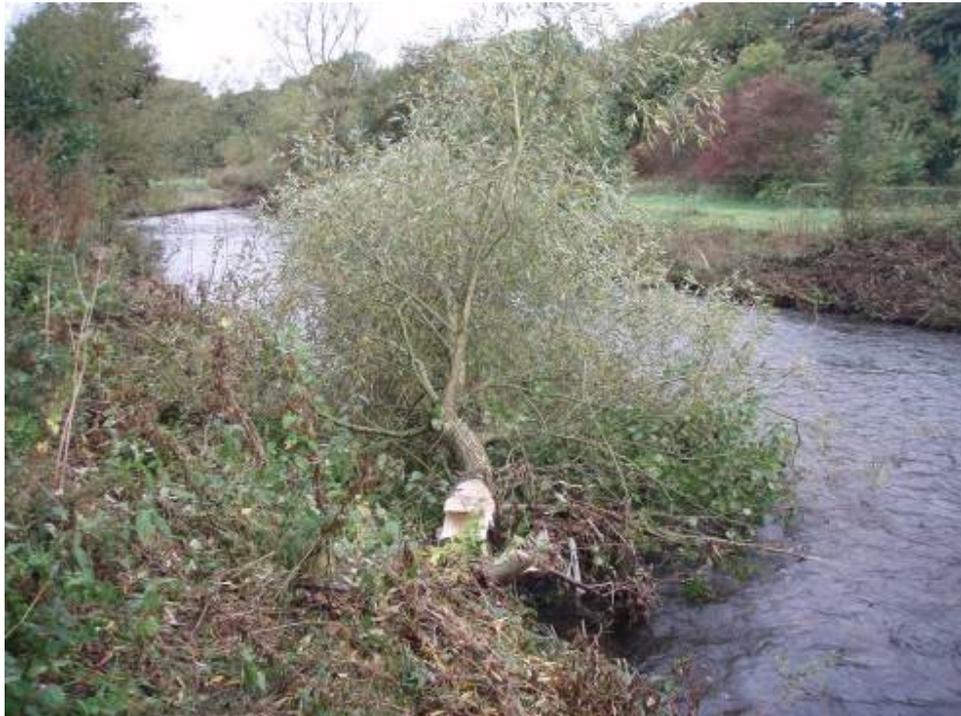
**Photo 42** Partially cut and laid tree. Young trees such as alder, willow and hawthorn up to about 15cm trunk diameter are most suitable

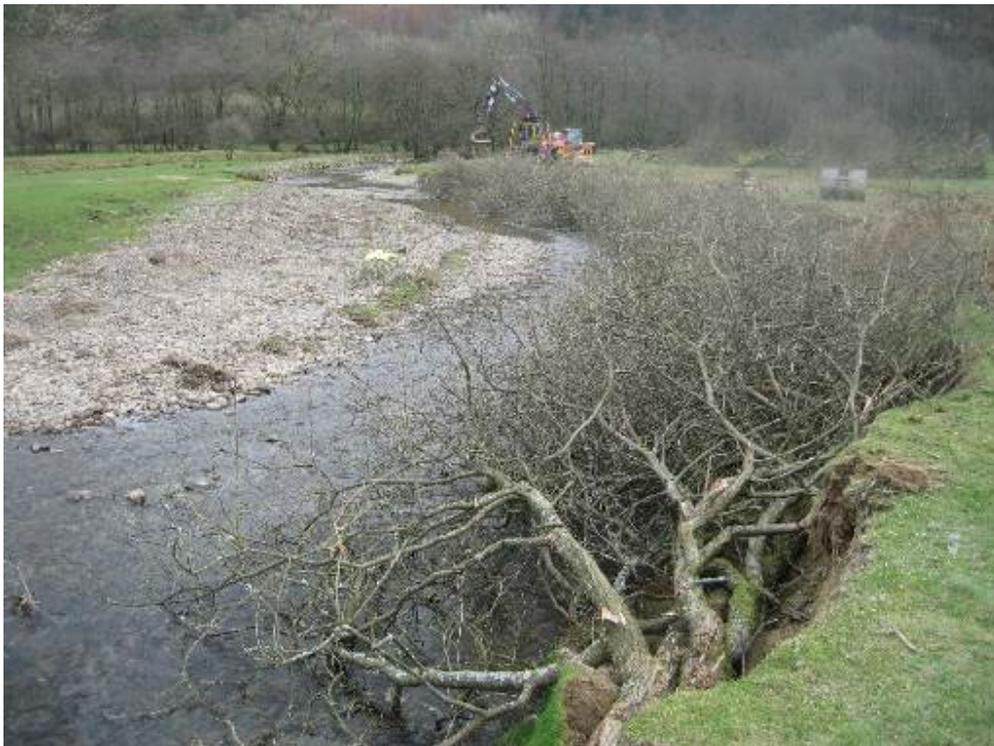
**Photo 43** Large scale brushwood project at a site which subsequently showed a large increase in salmonid fry and parr numbers (courtesy of Wye & Usk Foundation).

- In addition to brushwood structures providing erosion control, they have also been shown to dramatically increase the numbers of juvenile salmonids in areas where cover was previously lacking. The Wye & Usk Foundation (WUF) in Wales have demonstrated this effect and have carried out large scale brushwood projects, along with the laying of coppice re-growth into the river margins. Straightened, shallow sections of the Isla would benefit from something similar.

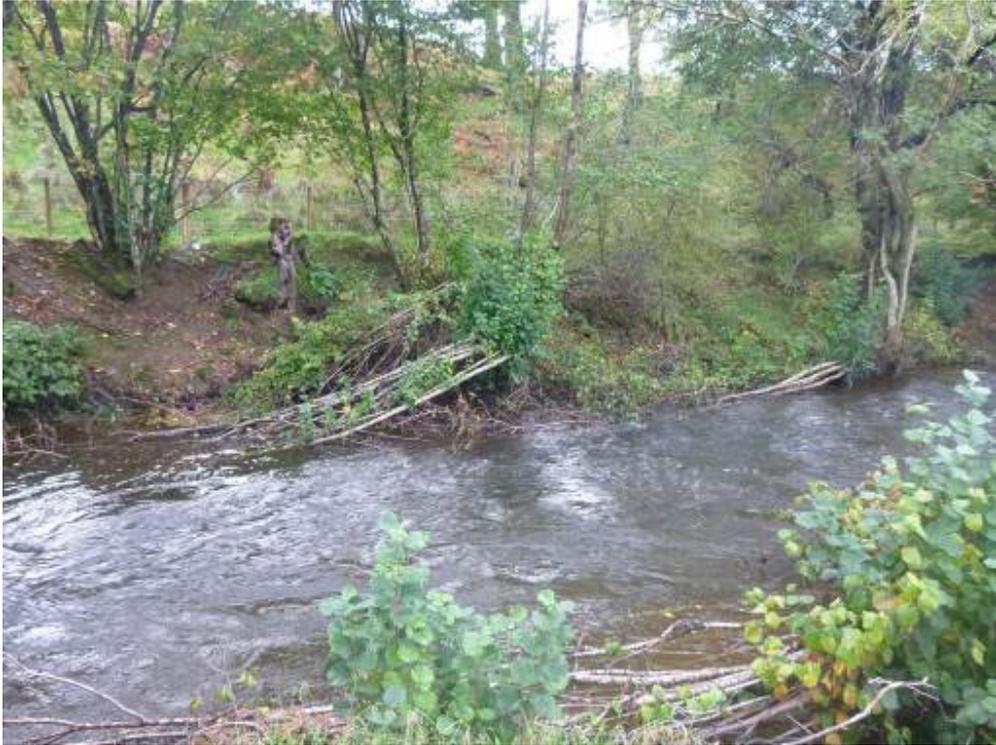
**Photo 44 Coppice re-growth laid into the margins creates excellent cover very quickly**
