Advisory Visit

R. Wharfe, Kilnsey Angling Club

19/02/2018

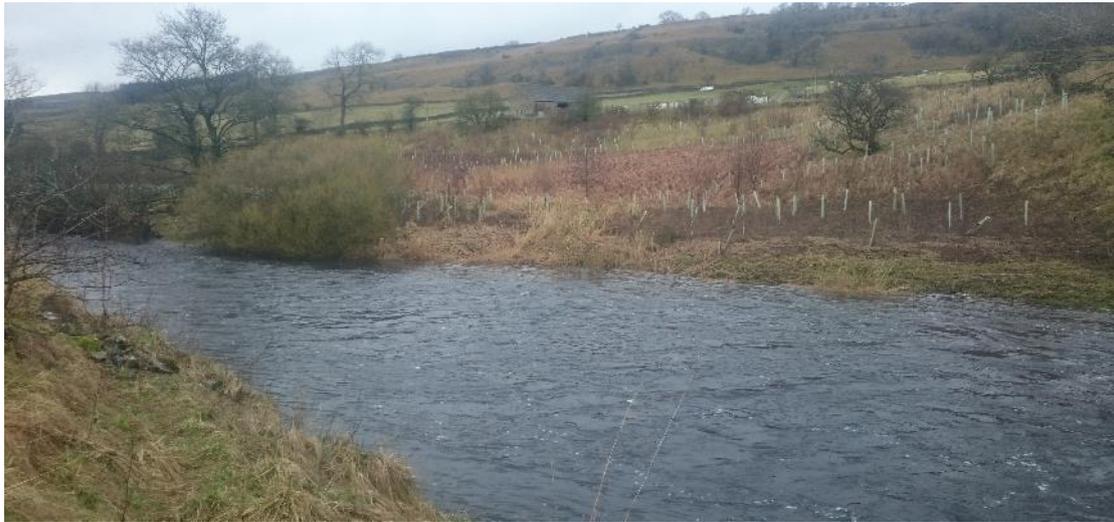
Fig 14. More evidence of recent tree planting on the LB behind some goat willow, presumably as part of the Throstle Nest holdings.

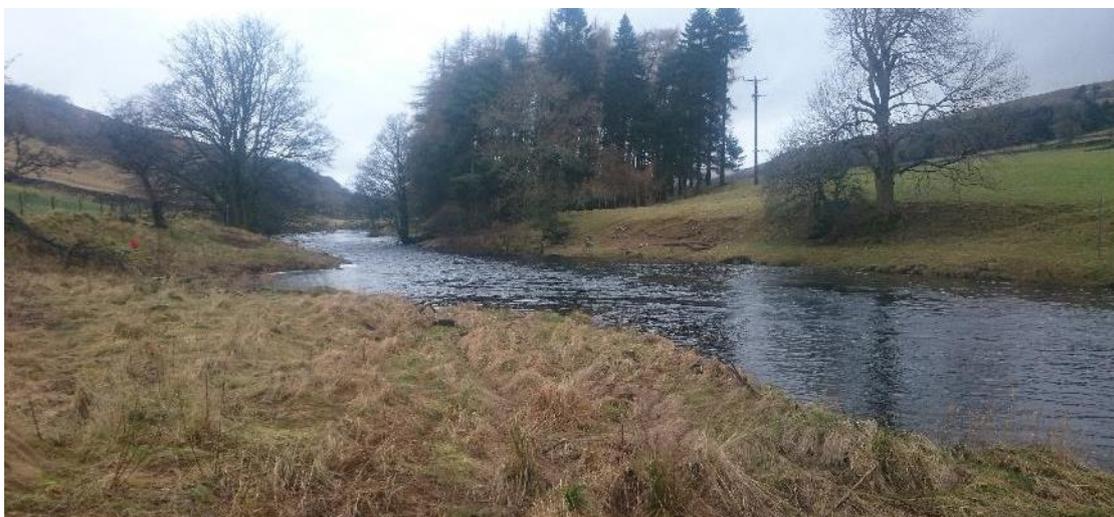
Fig 16. Mile House Dub is formed from a natural pinch in the valley (note the slope on each side of the river) which has constrained the channel width at this point.

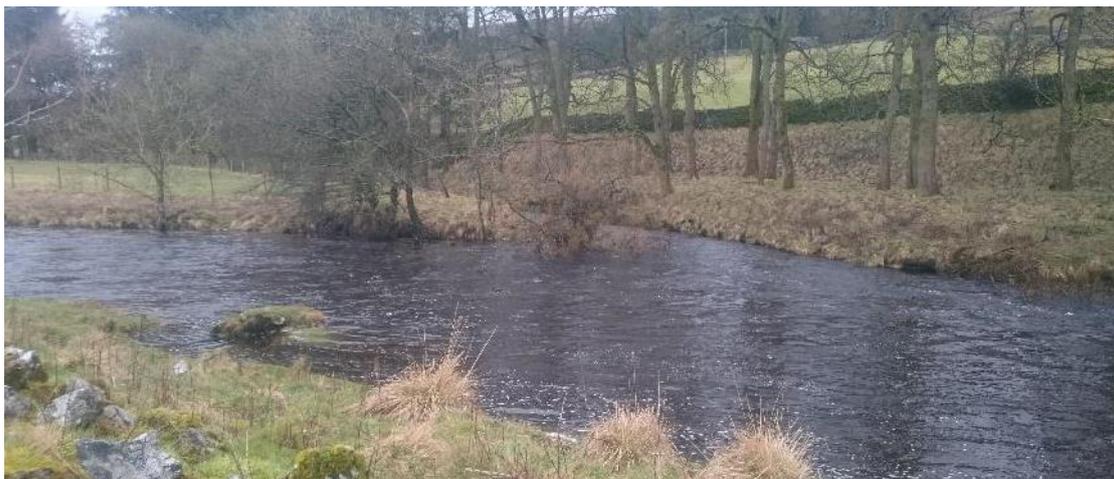
The confluence of Black Keld with the Wharfe was clear and appeared to offer easy access to fish (Fig 18); see Section 3.4.

Fig 18. The confluence of Black Keld, entering the Wharfe from the LB. Access appears good, as does riparian buffer fencing along this potentially important spawning tributary. See Becks section.

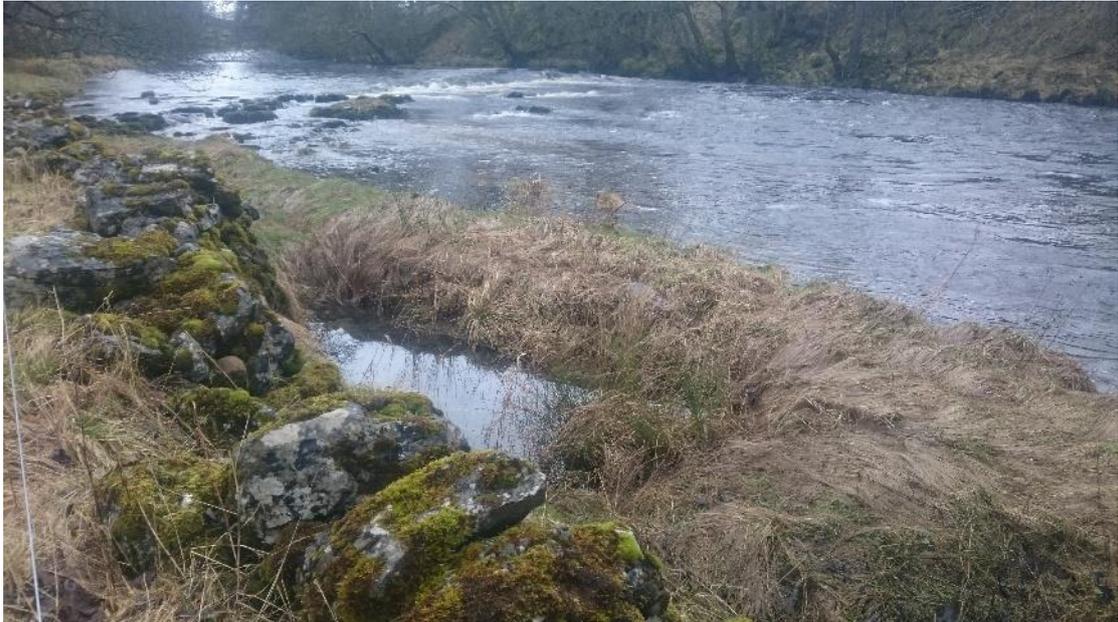
Fig 20. Natural bedrock outcrops have allowed this deposition bar to form d/s, which has been stabilised by colonising plants. Such overgrown pockets of water are useful nursery holding areas for weaker swimming fry.

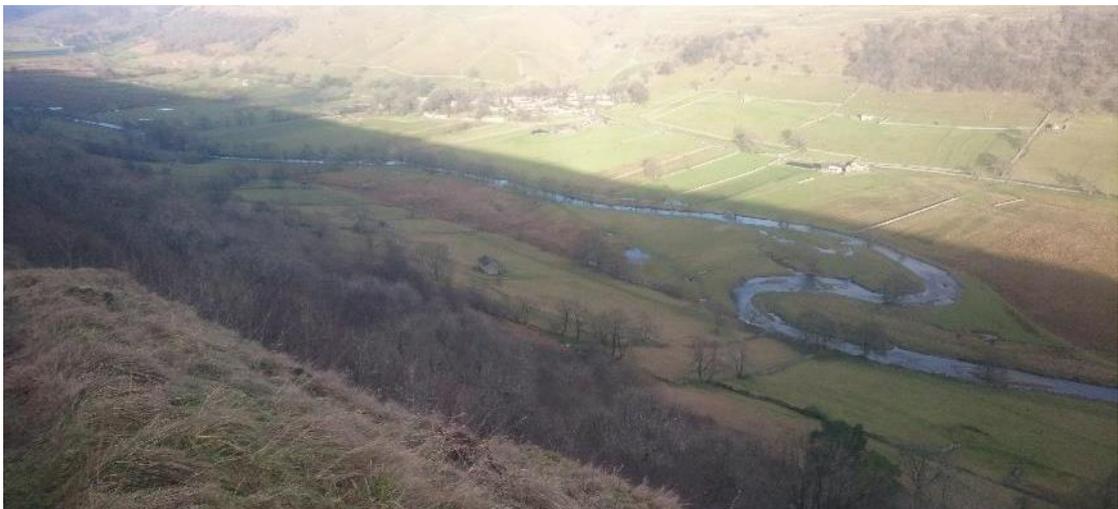
The Wharfe between Kettlewell and Starbotton exhibits two magnificent meanders which demonstrate what the river should be doing within its floodplain (Fig 21). In stark contrast to this sinuosity, examination of the area using Google Earth or maps highlights the straightened sections and the 90-degree bends that are forced upon the channel elsewhere. Consider how many kilometres of channel length have been shaved off the river by all the engineering, and how much longer it would take a flood peak to reach Otley, Wetherby or Tadcaster if the natural sinuosity was to be reinstated.

Fig 21. Looking down from Moor End Fell at what the Wharfe should be doing in its floodplain. Imagine how many more miles of fishing Kilnsey Angling Club might control, and how diverse the habitat would be if there were more meanders like this.

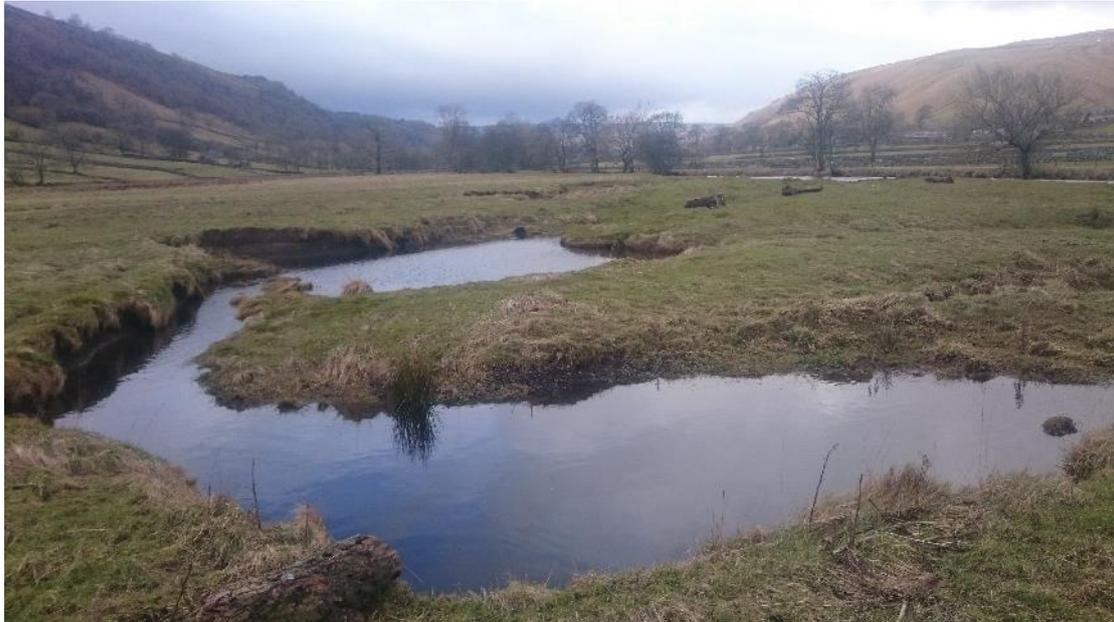
Palaeo-channels are evident across the floodplain (Fig 23), indicating how dynamic the river has been when unconstrained (and hence why farmers have tried to shackle it). This entirely natural movement by lateral erosion supplies the river with a lifeblood of substrate which should be transported and deposited downstream. Straightened channels are starved of supply, but will transport lighter substrate more effectively, leaving an unsorted (more uniform) bed of larger boulder and cobble.

Fig 23. Palaeo-channels are evident within the floodplain. Where they retain water, they provide important habitat for flora and fauna better suited to slower flows or still waters. They will also act as temporary refugia for fish during spate flows.

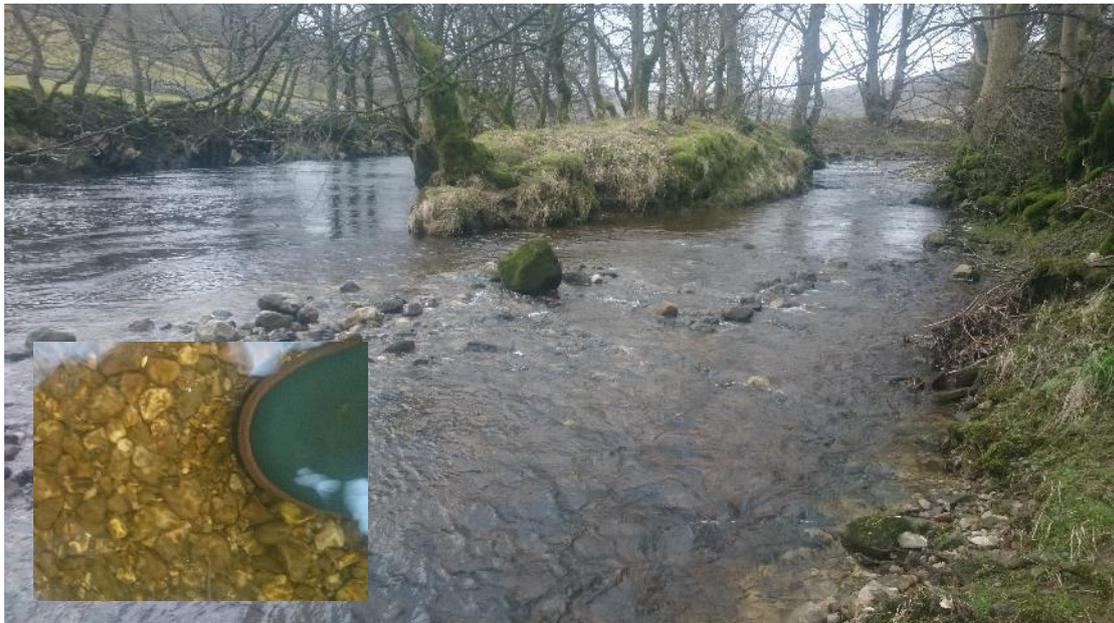
Within a small copse at Starbotton, Cam Gill Beck joins the Wharfe on the LB (Fig 27). Access was good and the gravel bar at the mouth comprised appropriately sized gravels for trout spawning (15-40mm).

Fig 27. Access to Cam Gill Beck is good and the tributary has an abundant supply of gravel of appropriate sizes for trout spawning (inset). See Becks section.

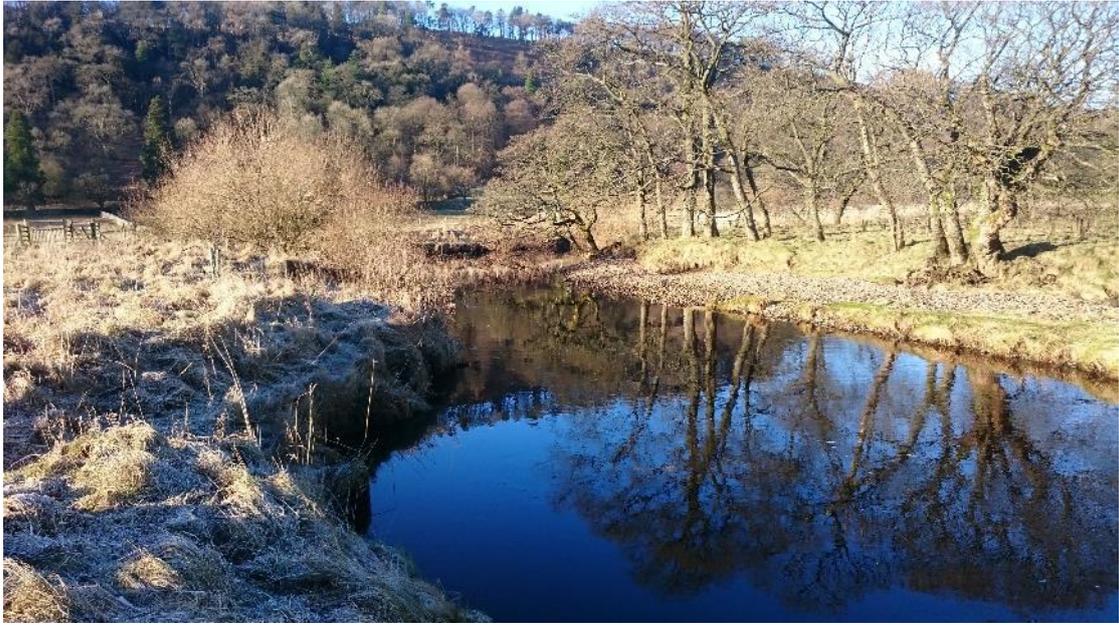
Fig 33. The mid-section of Buckden Down where the river crosses the valley floor has some natural pool-riffle-glide sequences. Riparian cover is being augmented by planting from YDRT.

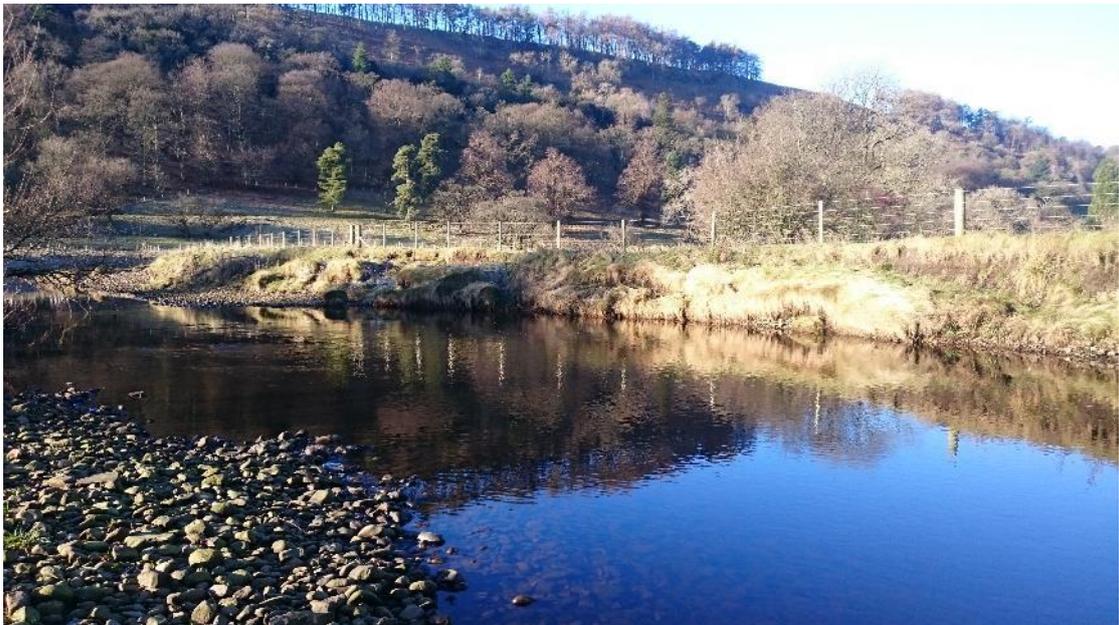
Fig 34. Buffer fencing is present right through Buckden Down and there is typically good quality, 'shaggy' vegetation at the toe of both banks.

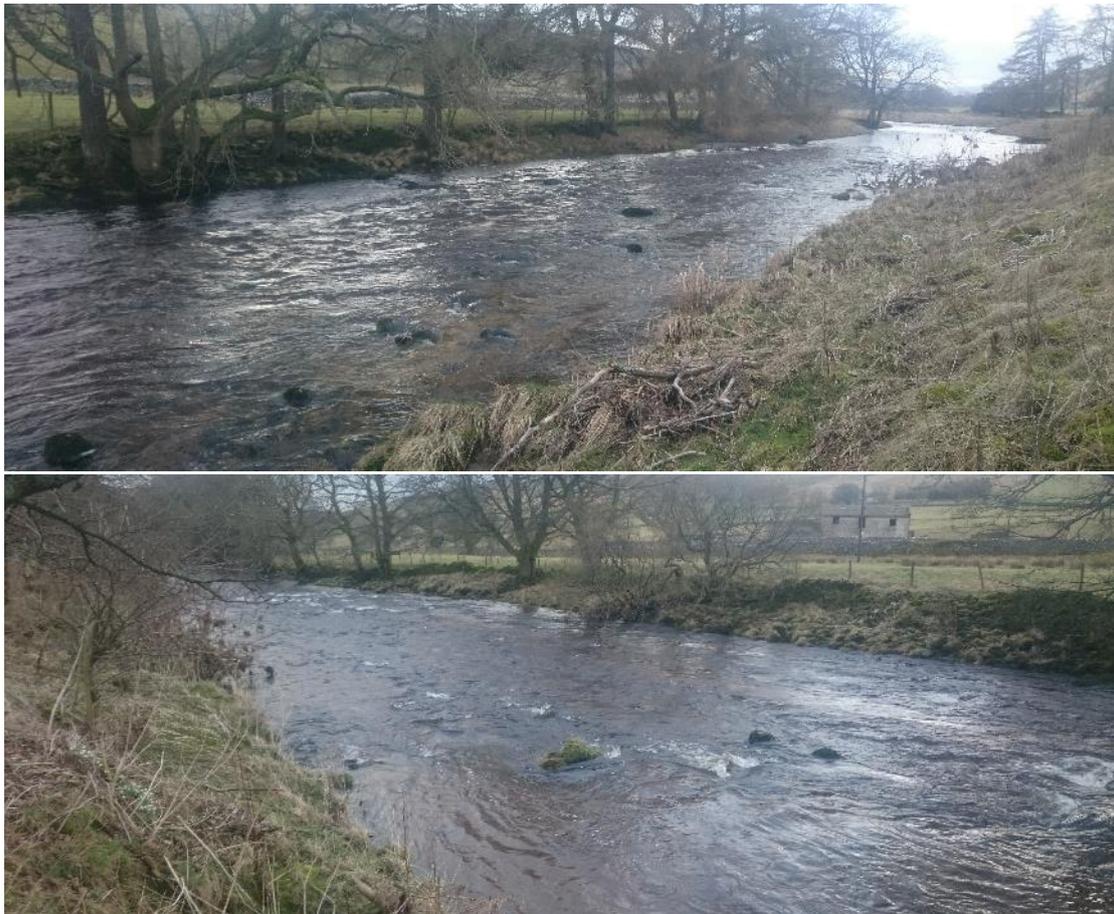
energy tends to be dispersed over a greater area and the bed substrate and cross-section profile become more uniform; a shallow trapezoid. The presence of large boulders can introduce some habitat heterogeneity (limited 'pocket water') and makes for reasonable juvenile / parr habitat (Fig 38) but offers less holding potential than deeper pools would for larger individual fish.

Fig 38. Up & downstream views of the Skirfare just above Hawkswick demonstrating similar proportions and straightened character as in Fig 37 but with better riparian tree coverage and buffer fencing.

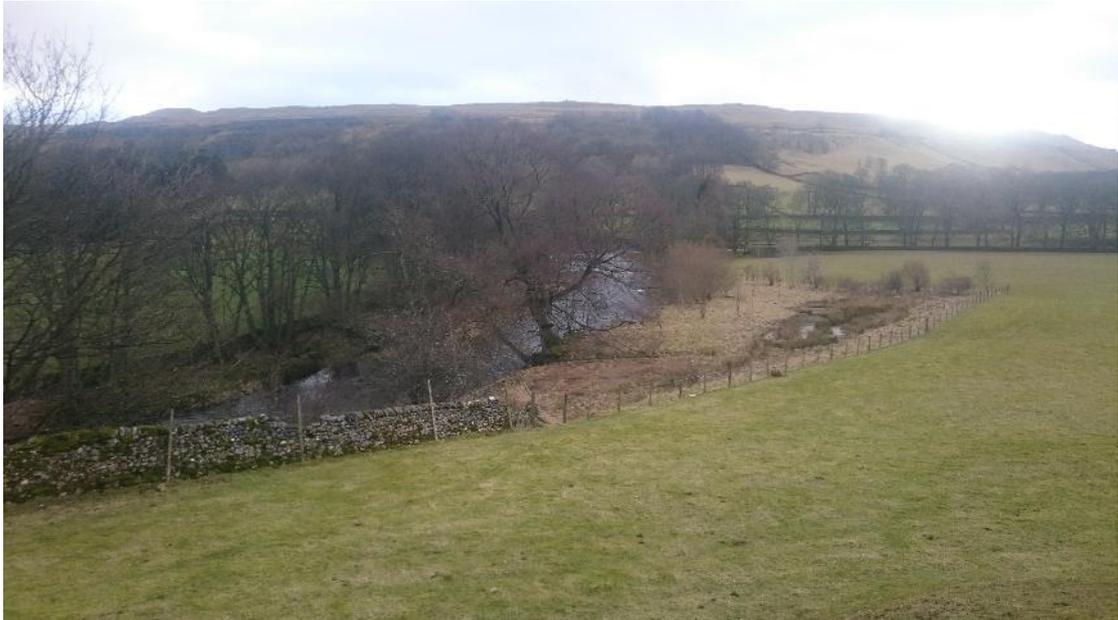
There are a number of reaches where it appears that livestock are effectively excluded by fencing or walling from one bank or the other, but which still lack trees. This may be due to stock crossing the shallow channel during summer flows, or deer browsing. Tree planting should be considered in those reaches. An example of what can be achieved with adequate stock exclusion is shown in Fig 40, on a more natural bend in the river just above the Kilnsey limit.

Fig 40. A small area of good quality, diverse habitat containing palaeo-channels where the Skirfare traverses from one side of the valley to the other. Note the buffer fencing.

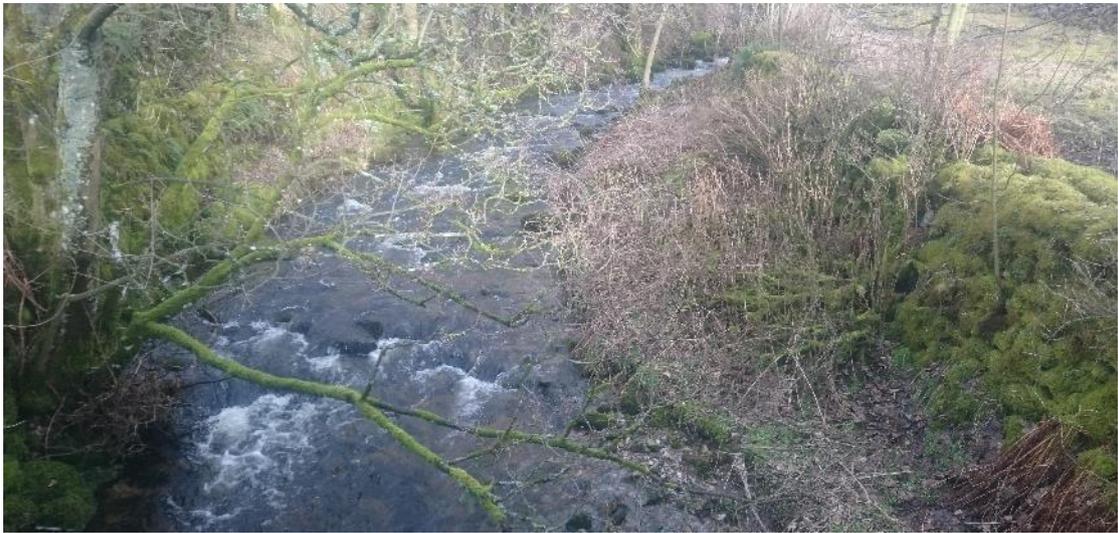
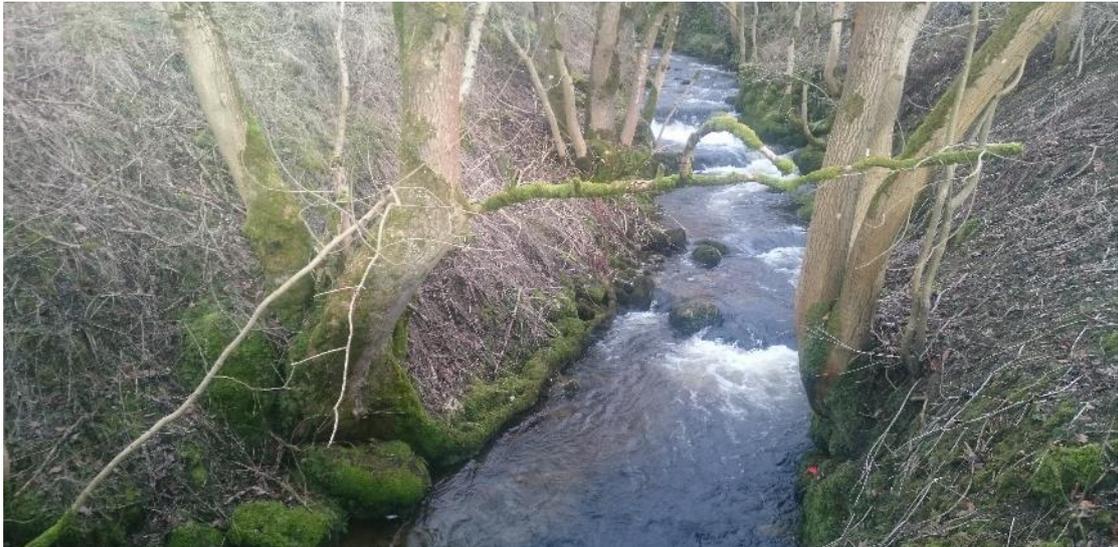
Fig 46. Two views of Cam Gill Beck as it wends its way behind the village of Starbotton. Naturally steep banks are covered by a diverse, natural flora.
