Walkover Assessment

Lumley Park Burn – Source to Herrington Burn

River Wear, Co Durham

Date – 18/02/15

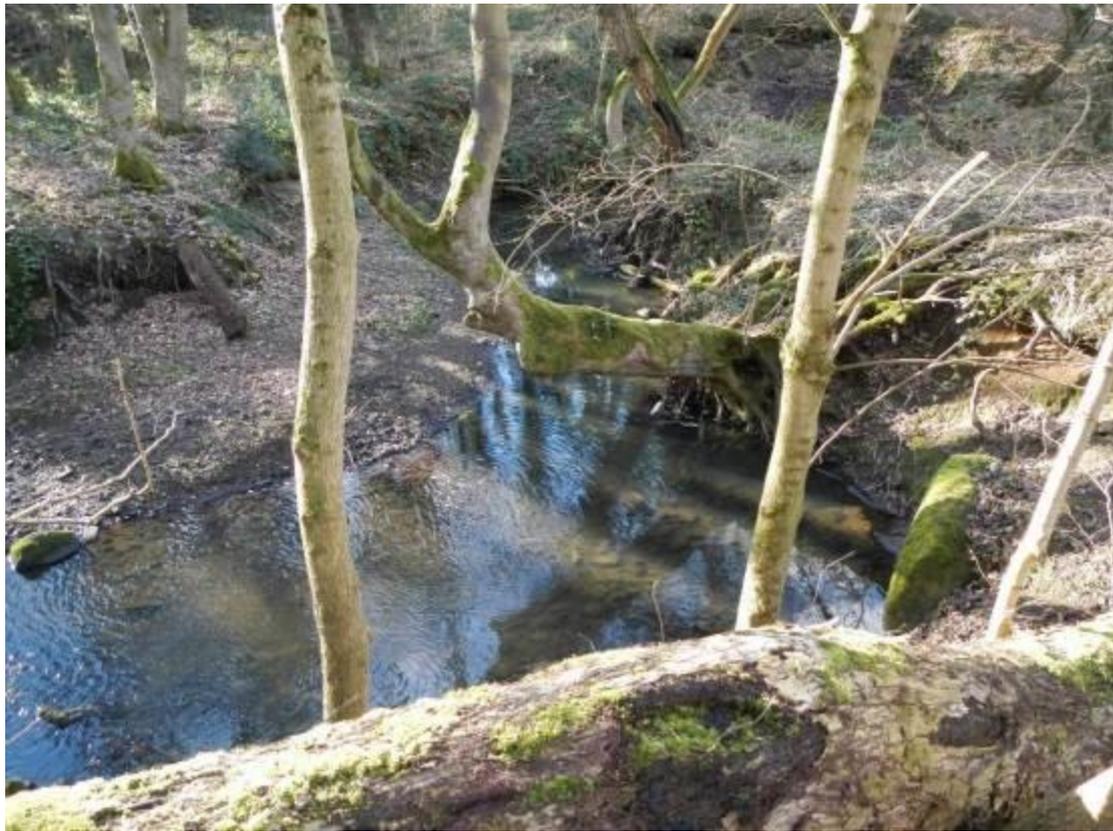
Within the wood, the channel gradient reduces slightly and the habitat improves, particularly where the Burn is more sinuous, facilitating more significant scour and deposition features. Overhanging, mature trees and undercut roots, along with LWD all provide valuable habitat features (Photo. 8). Areas of inset berms are also evident, where deposited fine sediment has become vegetated (Photo. 9).

Photograph 8. Overhanging trees and undercut banks provide good fish cover and shelter.

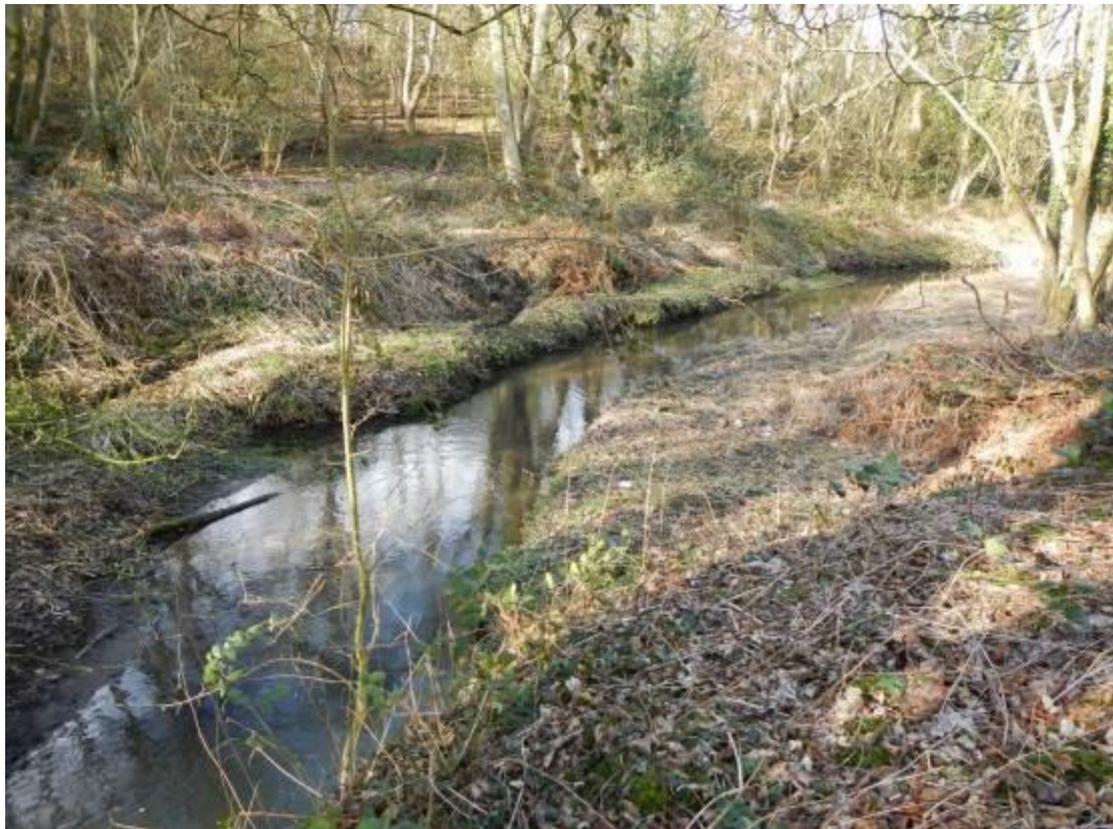
Photograph 9. Vegetated berms alongside the channel.

Planting is recommended throughout the burn wherever there is a lack of low cover (Photos. 9, 18, 36, 37, 38 & 39) and also in the heavily grazed areas (Photos. 29-34), if fenced. It will be of particular use if trees are planted in clusters along straight channel sections and trained into the channel to redirect flows. As such it would be beneficial to plant alternately along each bank, with gaps between. Willow whip planting would also be ideal to help reduce areas of bank erosion (Photos. 21 & 5). Subsequent maintenance of planted trees may be required in sensitive areas.

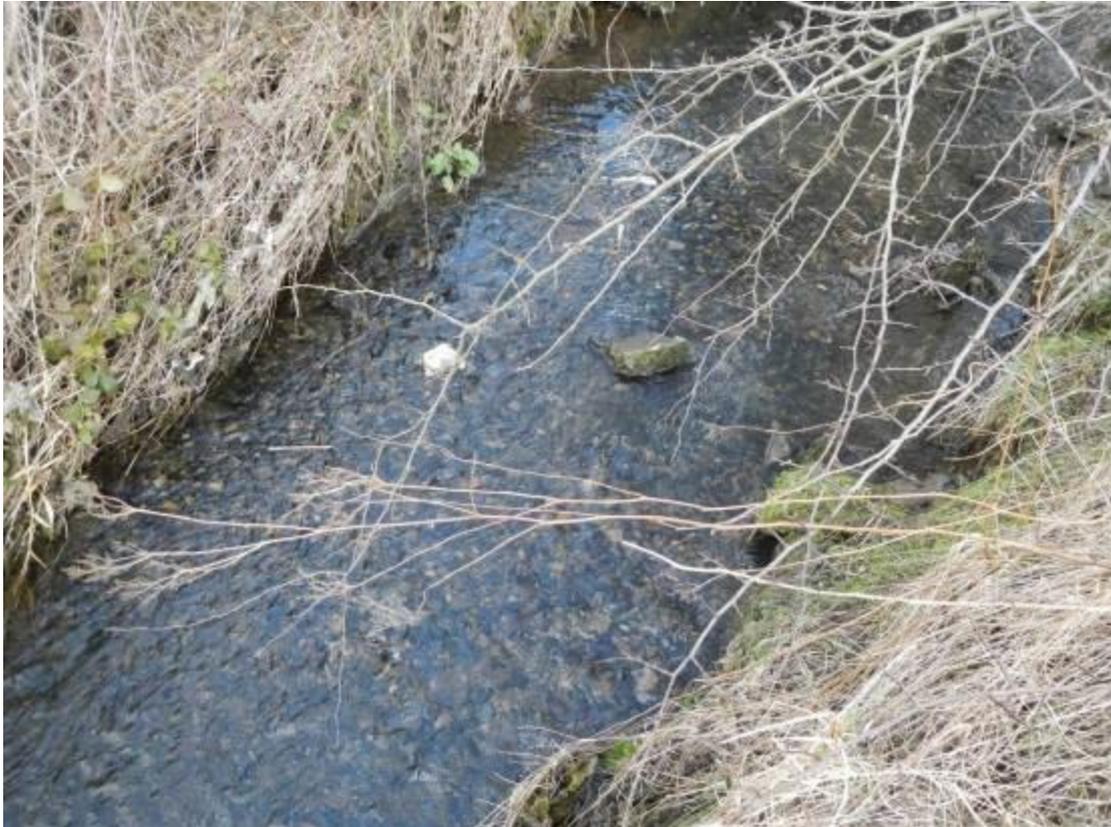
Although straightened, the channel in this section does support some areas of spawning gravel, supplied, at least in part, by the bank erosion and reworking of material depicted in Photo. 15, upstream.

Photograph 16. Substrate suitable for salmonid spawning.

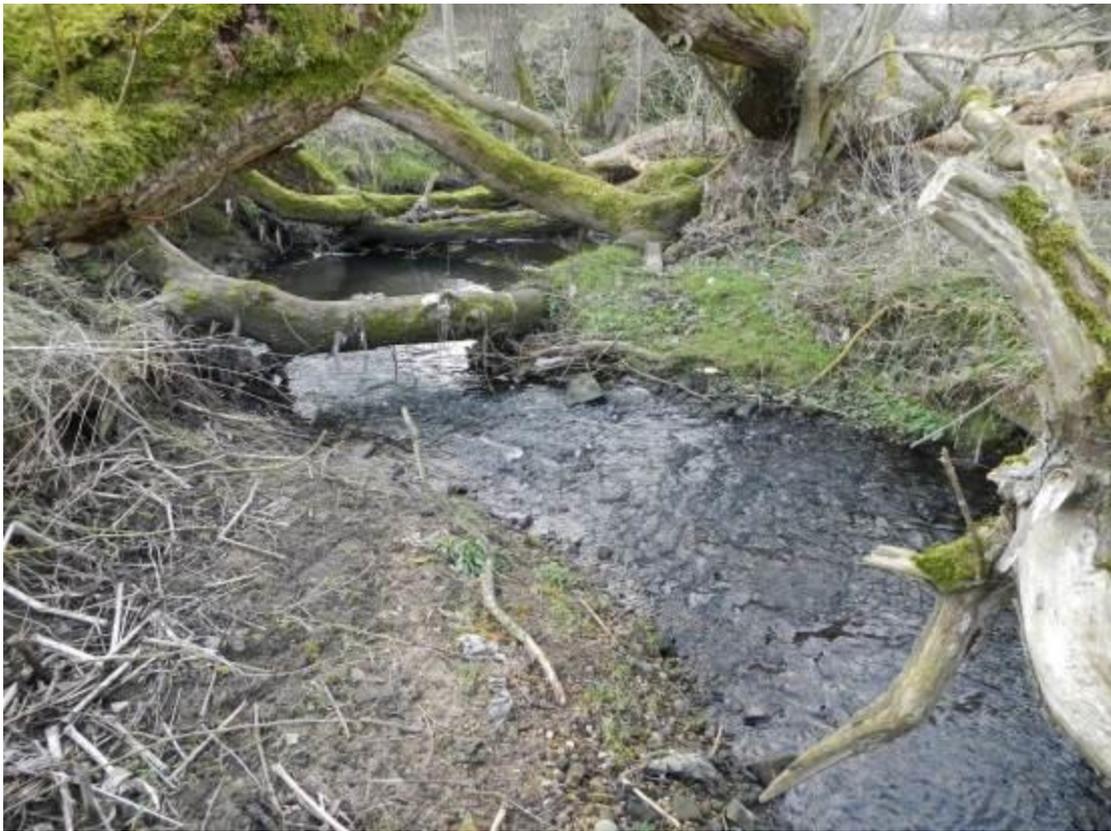
At the downstream end of the field, the Burn enters another short wooded section along Hetton Houses Wood. Here again, the habitat improves in the absence of grazing and channel modification. Bankside trees natural LWD and a sinuous channel provide cover and assist erosion and depositional features, cleaning and sorting the gravel substrate (Photo. 17).

Photograph 17. Improved habitat where trees and LWD are present.

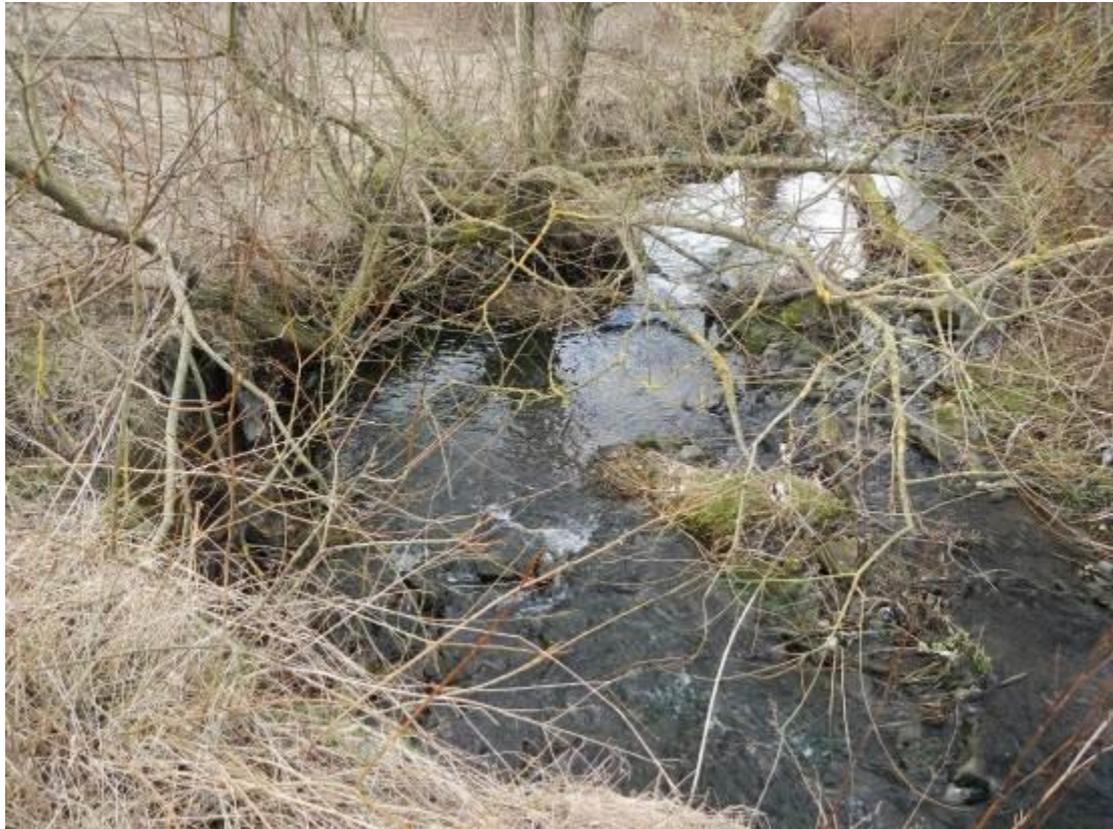
Occasional bends provide scour and deeper pool habitat, particularly where tree roots protect the bank and divert erosional forces into the bed (Photo. 19). The canopy of the trees also provides valuable low-level cover.

Photograph 19. High quality, covered pool habitat.

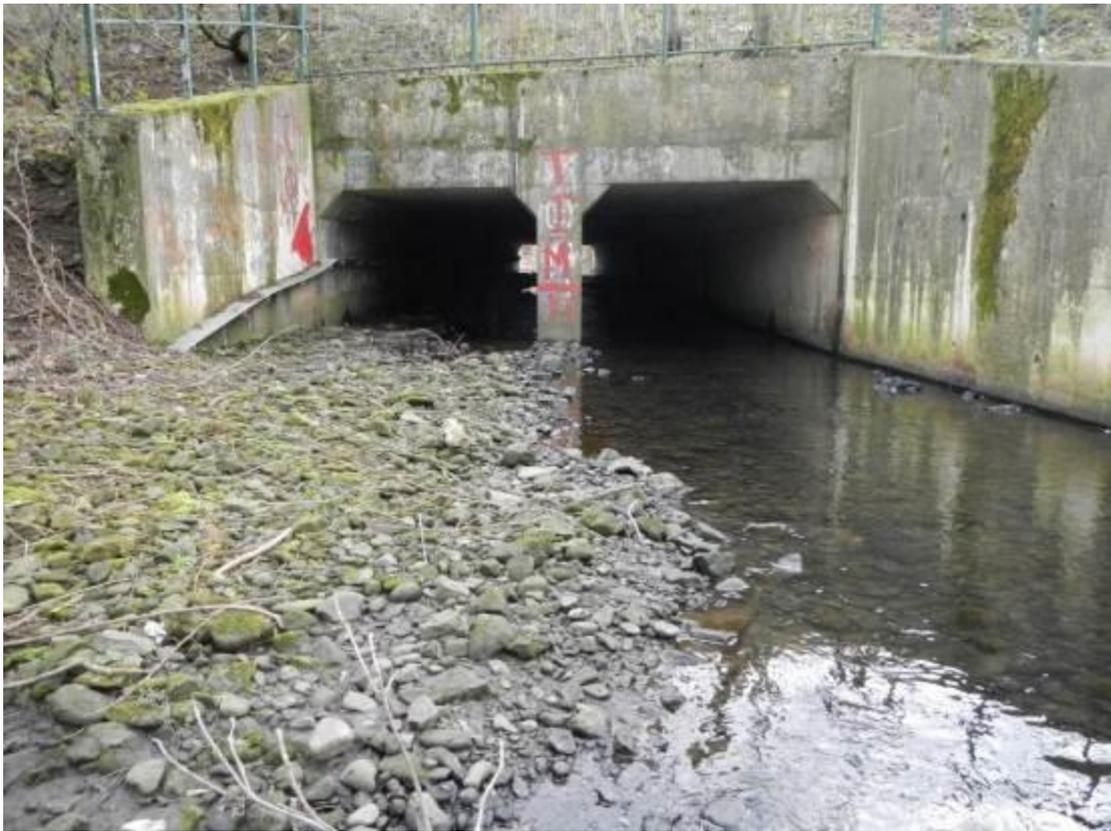
The Burn emerges on the D/S side of the A690 from a large double culvert (Photo. 25). Brief inspection revealed it to be set below the bed level, now supporting a natural substrate throughout its length, relatively day-lit and hopefully posing no significant issue to fish passage.

Photograph 25. A690 Road Bridge culvert – no apparent significant obstacle to fish passage.

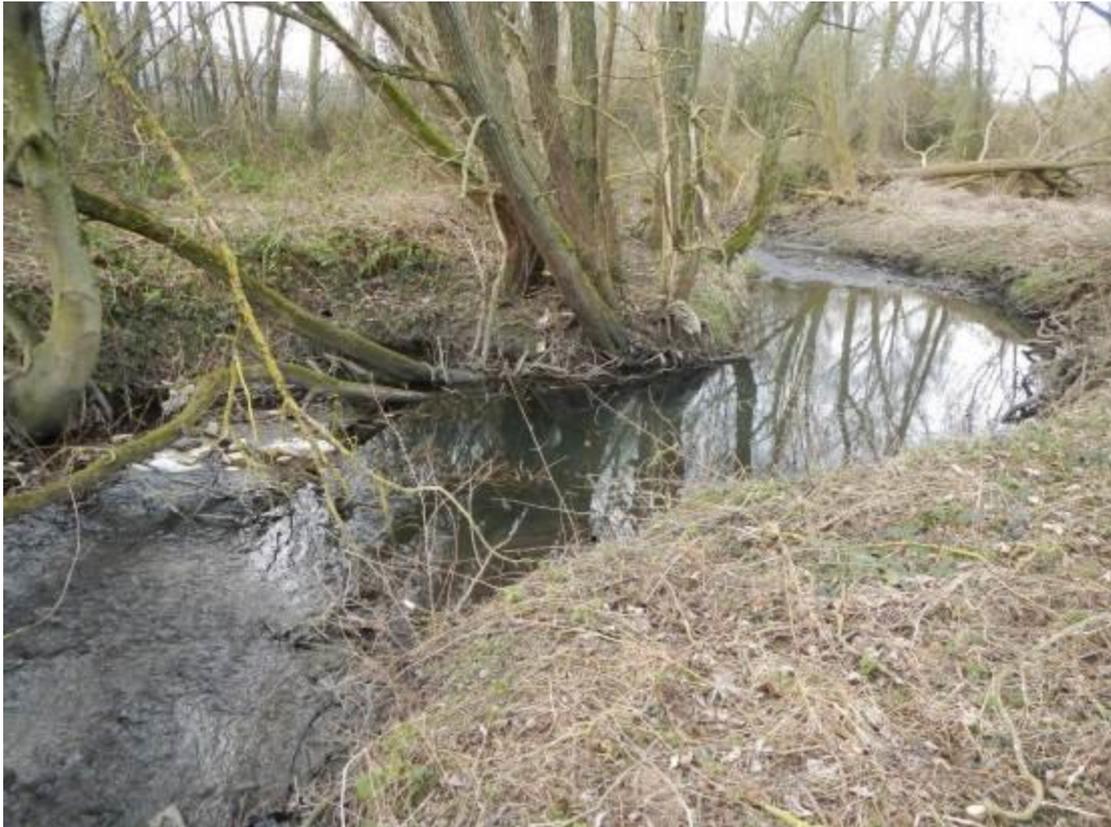
Where trees have been left unmanaged they provide valuable bank and in-channel structure, with deep pools and undercut banks – ideal trout habitat (Photo. 27). Leaning and collapsed branches enhance these features, along with depositional bars (Photos. 27 & 28). Such features could be promoted through willow planting and hinging/laying in other areas to further improve habitat and reinstate features lost through historic channel maintenance. Very selective coppicing could also be employed to reinstate low-level regrowth and increase cover.

Photograph 27. High quality, deep pool habitat with leaning branch and undercut root cover. Encouraging low-level foliage would further improve habitat quality.

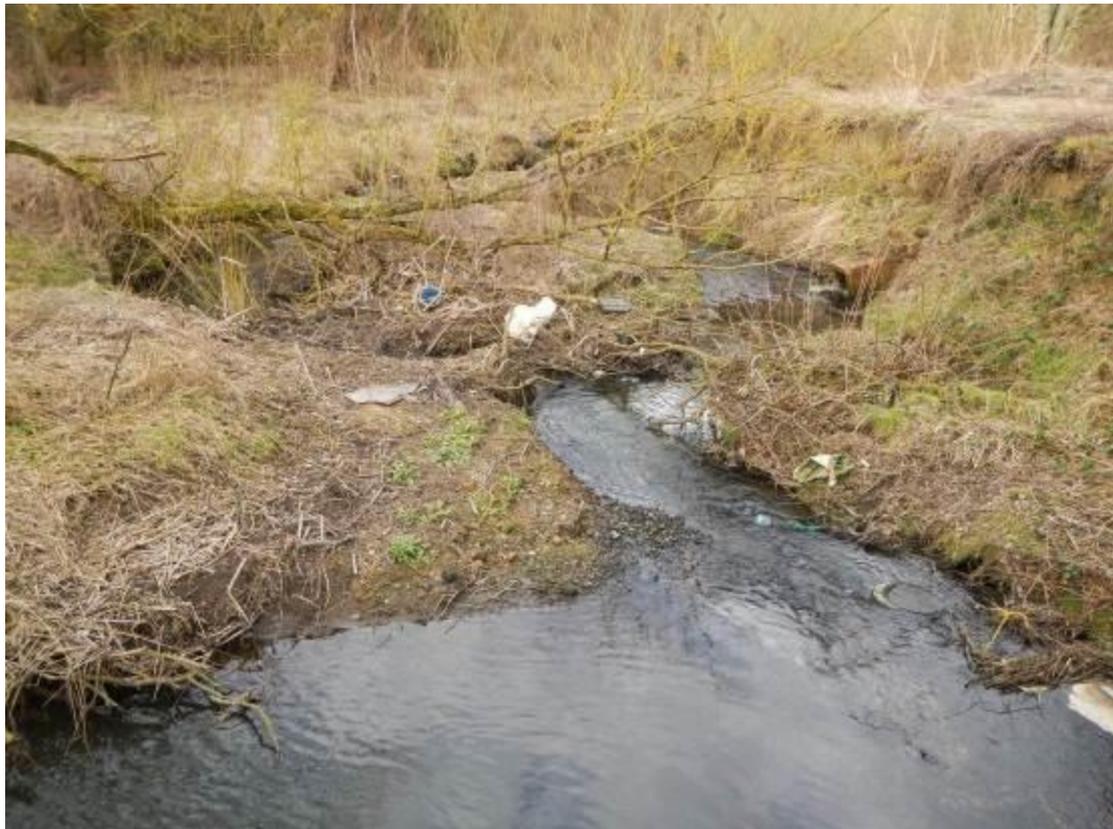
Photograph 28. Fallen willow limb facilitating beneficial sediment deposition and encouraging channel sinuosity/complexity.

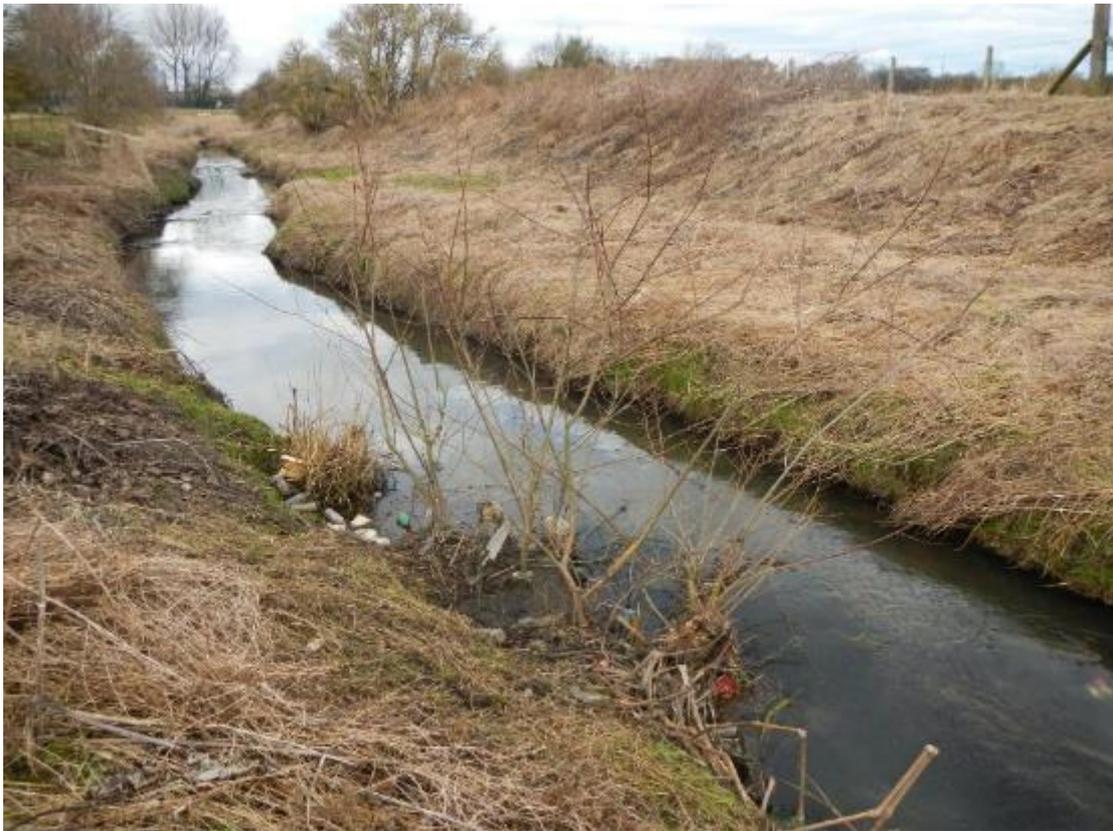
Photograph 38. Natural willow regeneration providing cover and structure in a degraded, channel. This type of feature could be easily replicated to enhance the habitat in other areas.

The prescription of tree planting and laying branches applies for the remainder of the waterbody as a measure to replicate the valuable natural habitat already forming in the area (Photo. 38). In the farthest downstream area (D/S Sedgeleth Road - NZ3250550761) there is the additional consideration that unconsented horse grazing again becomes an issue (Photo. 39). This is something that is unlikely to be prevented, but the impact can be minimised by confining planting and live willow work to the opposite bank.

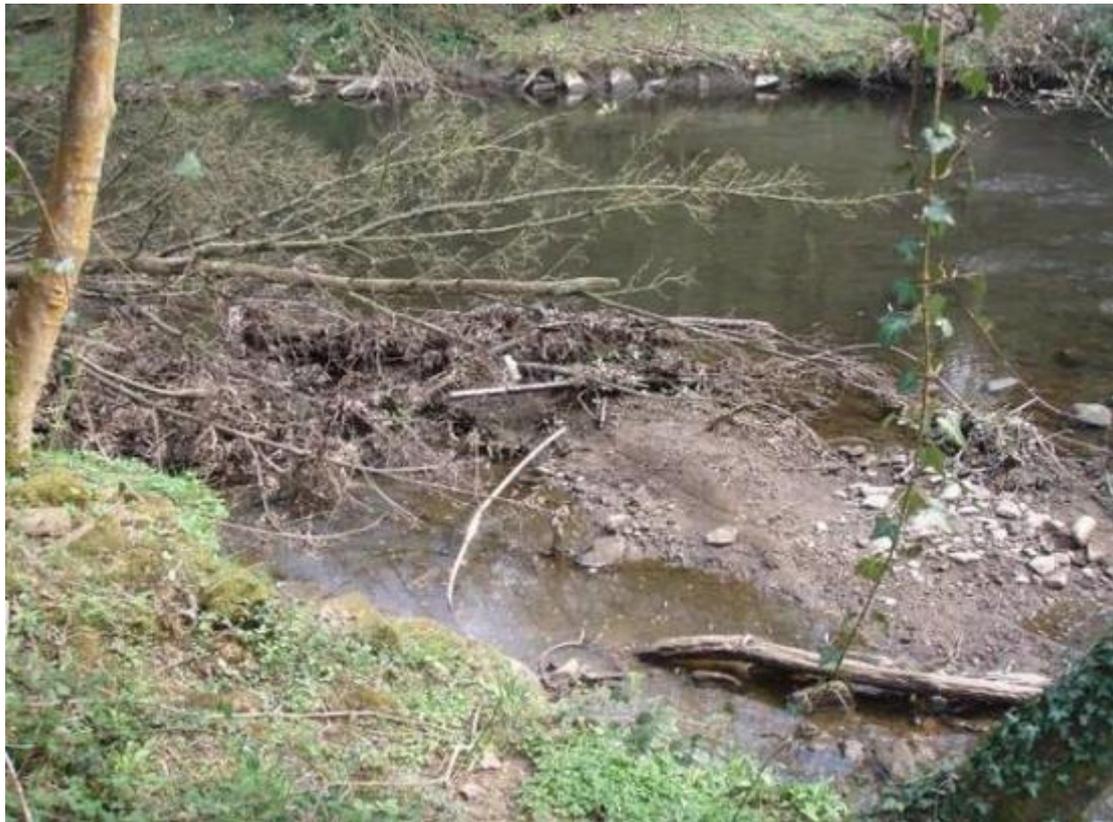
Photograph 42. Note the narrowing effect through significant sediment accumulation (centre and right of shot) in the sheltered area downstream of the tree kicker.

In the shorter-term, and in areas where the channel cannot be re-meandered, assisting the natural channel recovery which is already underway would be greatly beneficial and would help counteract a history of unsympathetic channel maintenance and realignment. To encourage new areas of scour and deposition, in-channel structure and increased bankside vegetation will be key. Introducing LWD and structures like tree kickers (live and dead) will concentrate flows in certain areas of the channel (usually towards the centre), and scour deeper pool habitat, while also creating slacker areas within the margins where deposition will increase (Photo. 42, and also naturally occurring in Photo. 37).

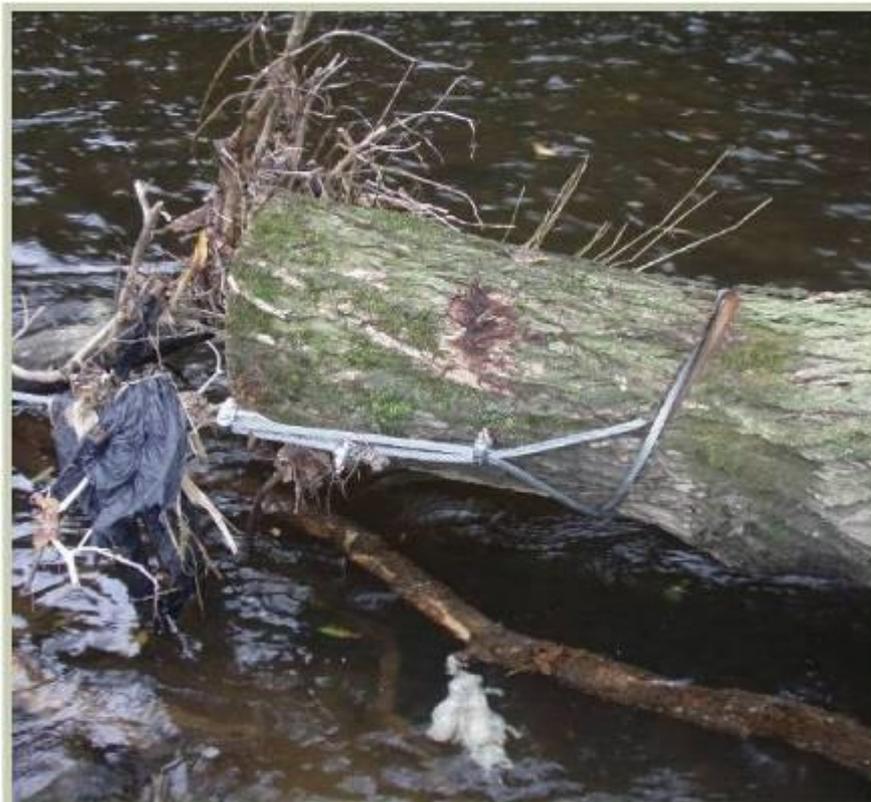
Photograph 43. Cabling for a tree kicker.

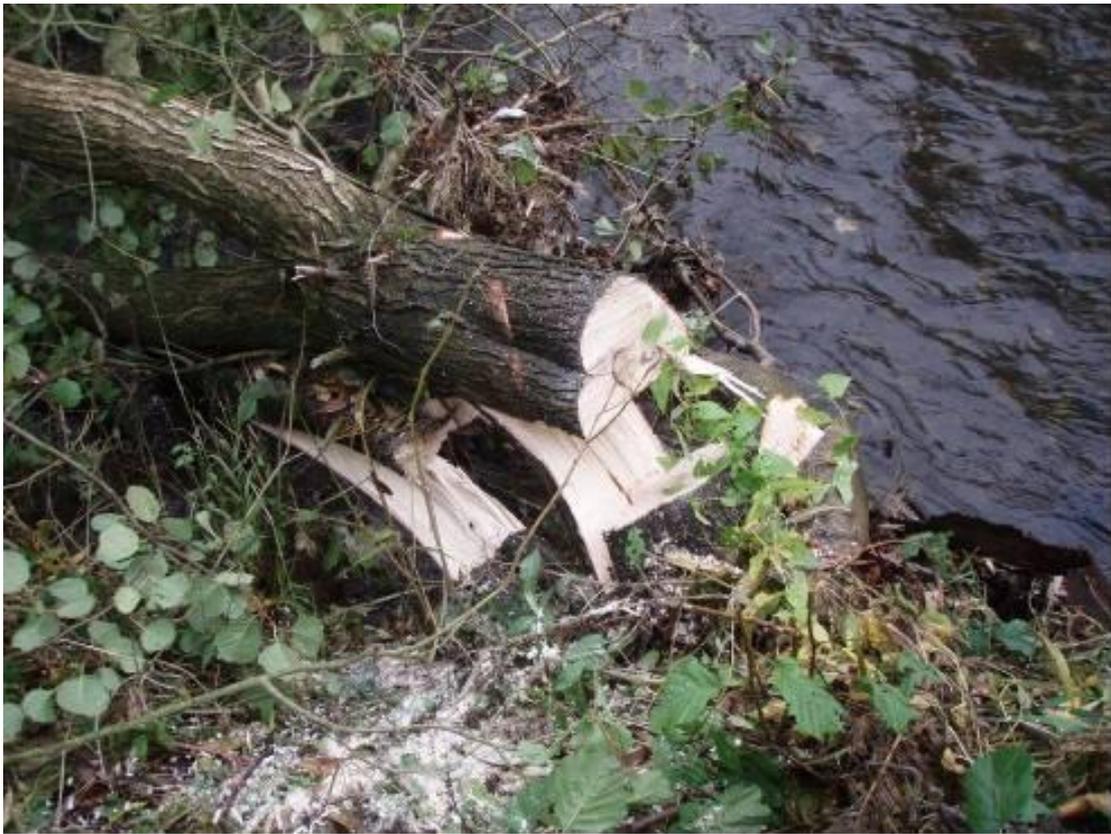
Photograph 43. Hinged willow.

The process involves cutting part way through the stem/trunk (a bit at a time) until it can be forced over into the channel (Figures 43 & 44). The depth of the cut should be limited to that which is required to bend the limb over, to retain maximum strength and health.

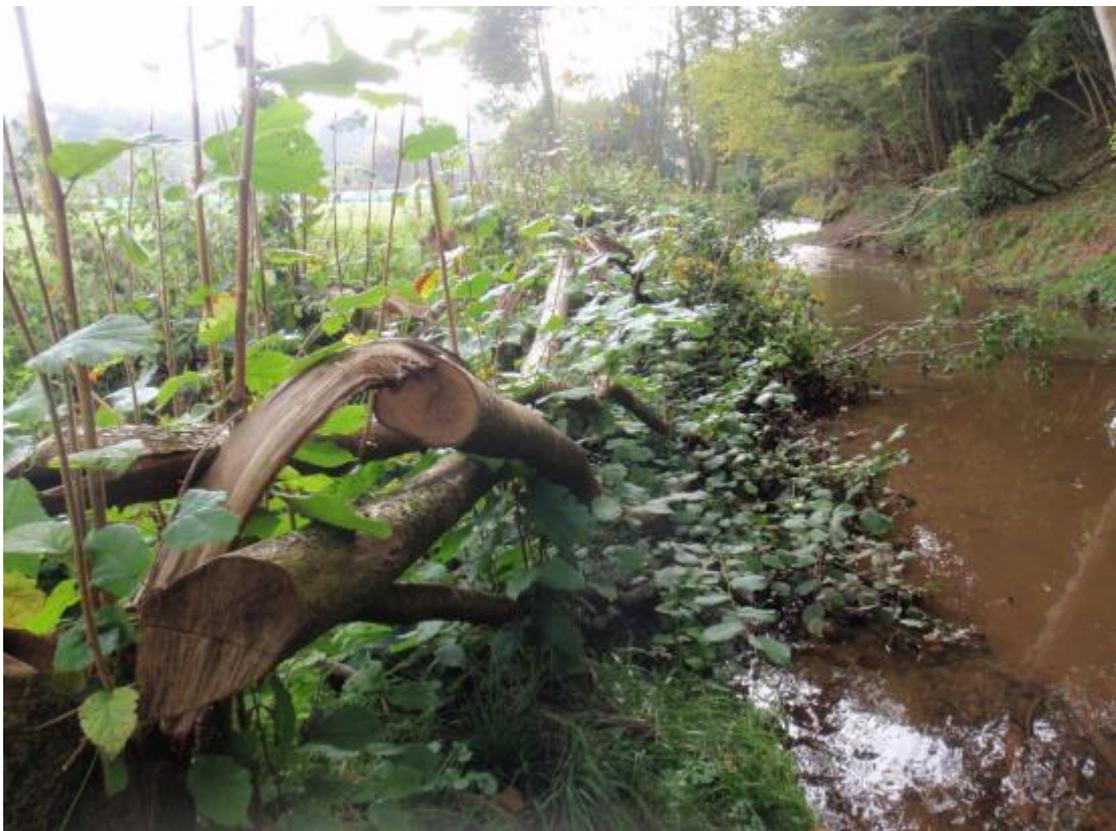
Photograph 44. Hinged hazel.
