Advisory Visit

River Lagan, Dromore, Co. Down

July 2011

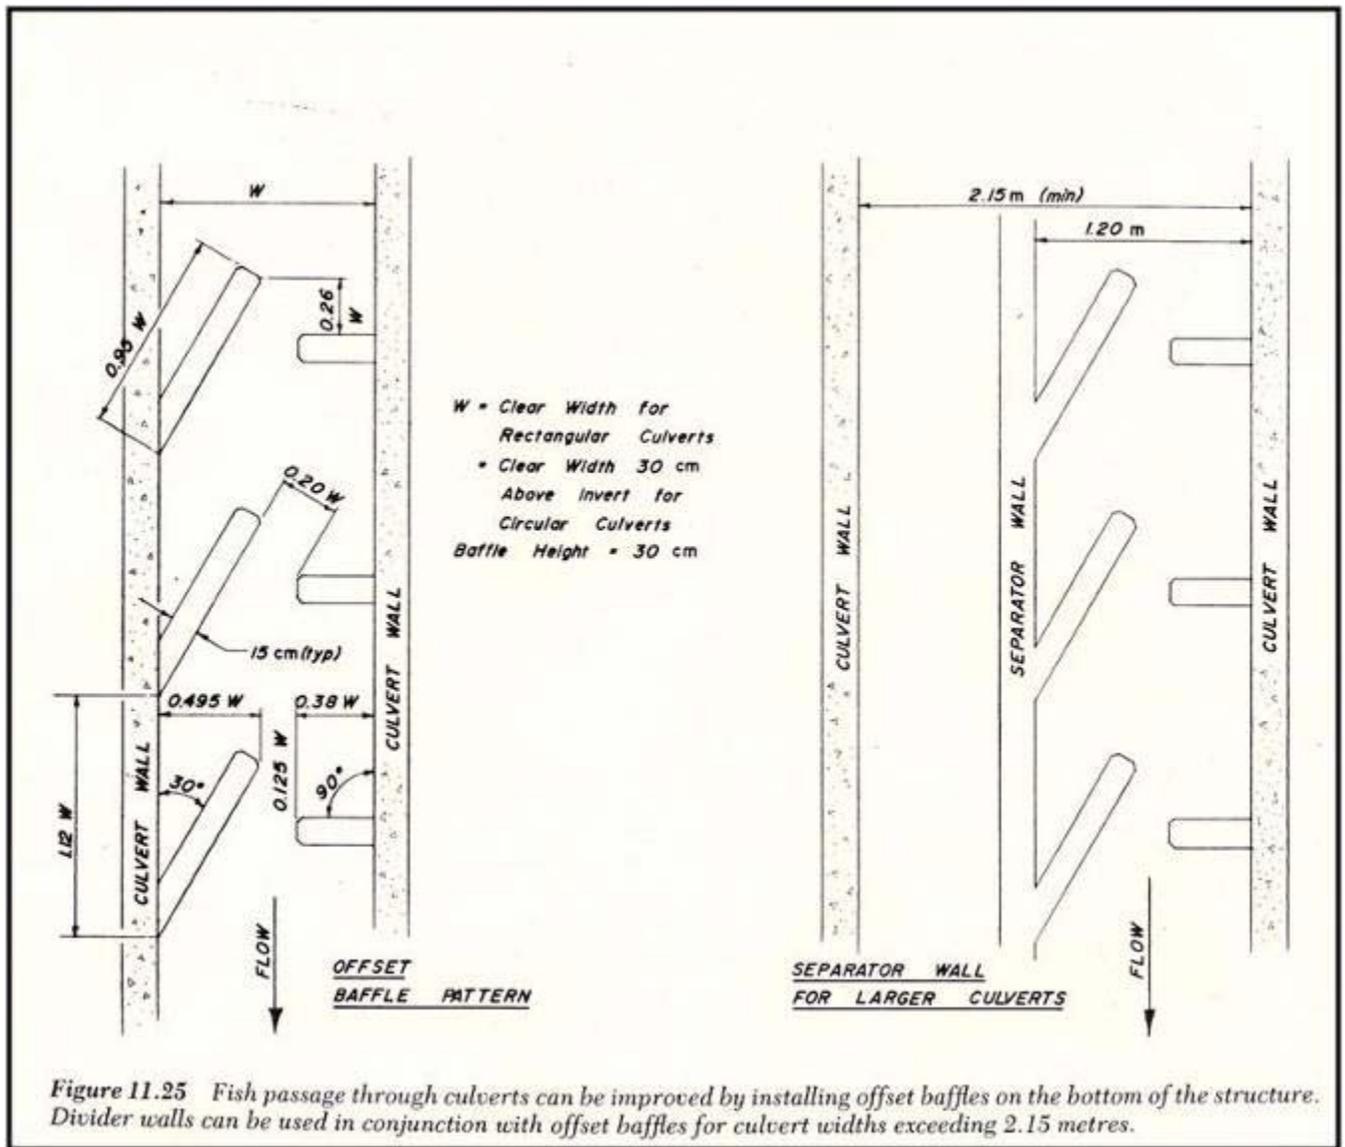
Figure 1 (From Stream Enhancement Guide, (1980). Province of British Columbia, Ministry of Environment, Vancouver, Canada).

illustrates the concept; Figure 1 gives an example of a design for baffle arrangement;

The aim should be to concentrate low to medium flows through one arch of the bridge by constructing a low fillet across the entrance to the other arch; this would overtop in flood flows. The fillet could be wedge-shaped (pointing upstream) to allow trash to wash over the top in high water. Photo 24

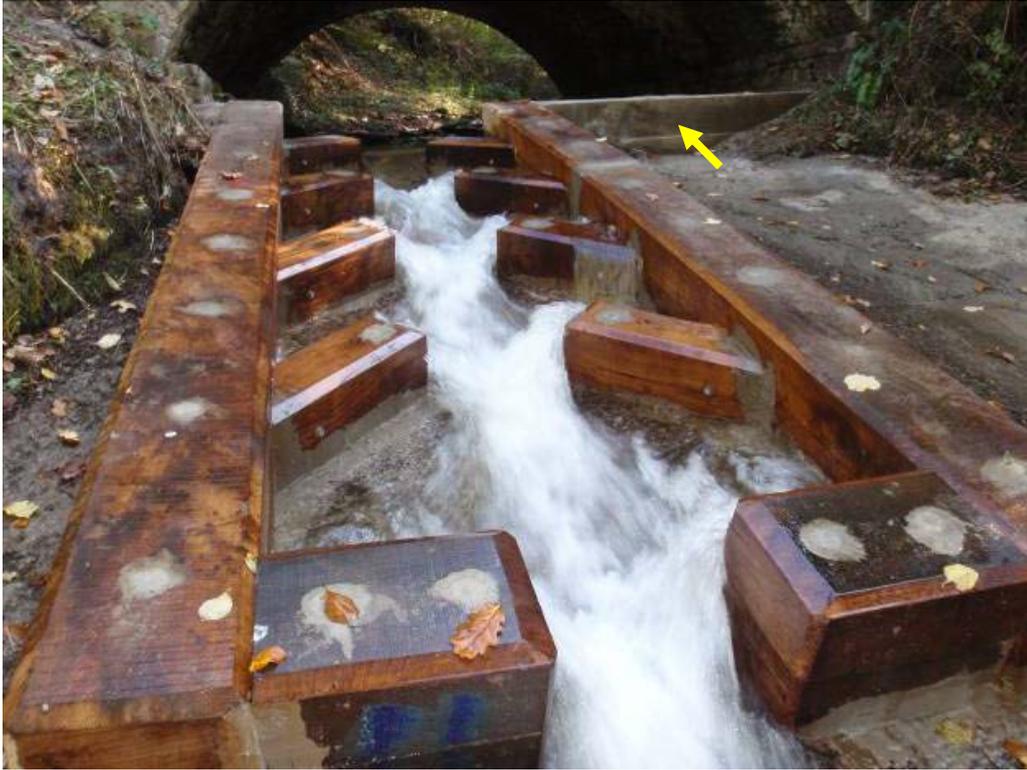
Photo 25 Example of wooden baffles and flow deflector (arrow) fitted to a bridge culvert in Wales.

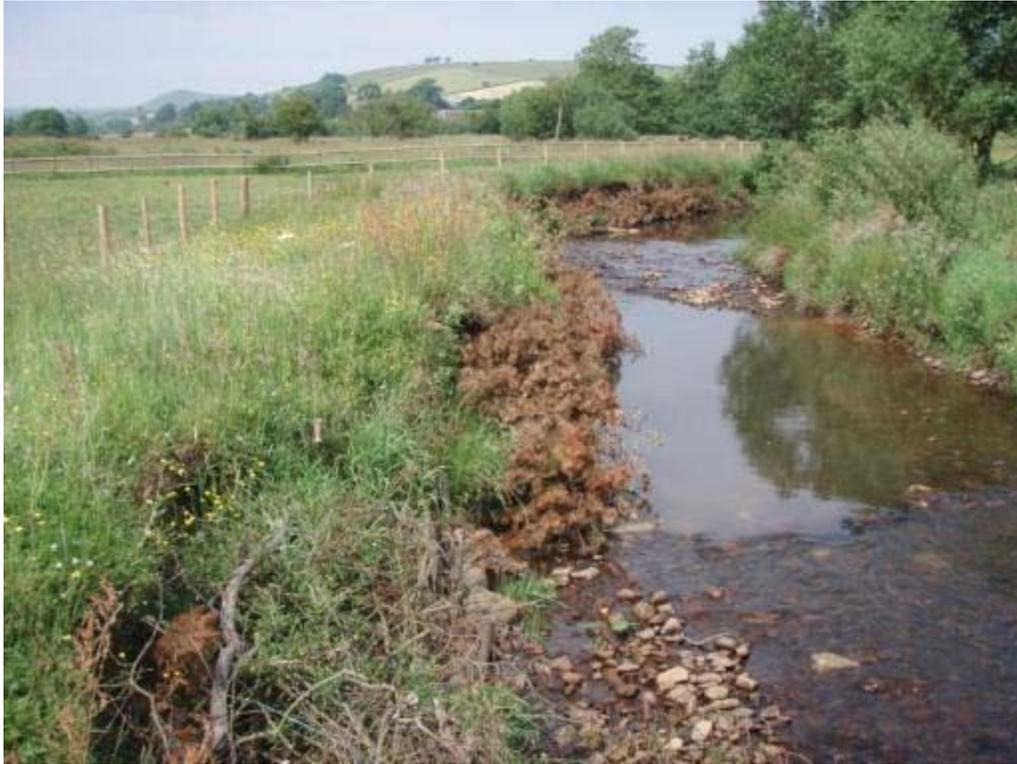
Photo 27 Brushwood revetment along a formerly rapidly eroding bank on the River Manifold, Staffordshire. This technique (combined with fencing) has greatly slowed the rate of erosion, provided excellent in-stream cover for trout and locally increased the diversity and abundance of fly life.

A number of areas along the river have structures made of block stone, including low weirs (Photo 14), flow deflectors (Photo 21) and bank re-inforcement (Photo 26). Whilst stone is the right choice in some circumstances, the use of softer materials such as brushwood, Christmas trees and root wads can achieve similar aims and also provide much better in-stream habitat. The WTT's Upland Rivers Habitat Manual provides detailed guidance on these techniques and can be downloaded from the publications section at www.wildtrout.org.
