**Advisory Visit**

**Lea Brook, Derbyshire**

**July 2017**

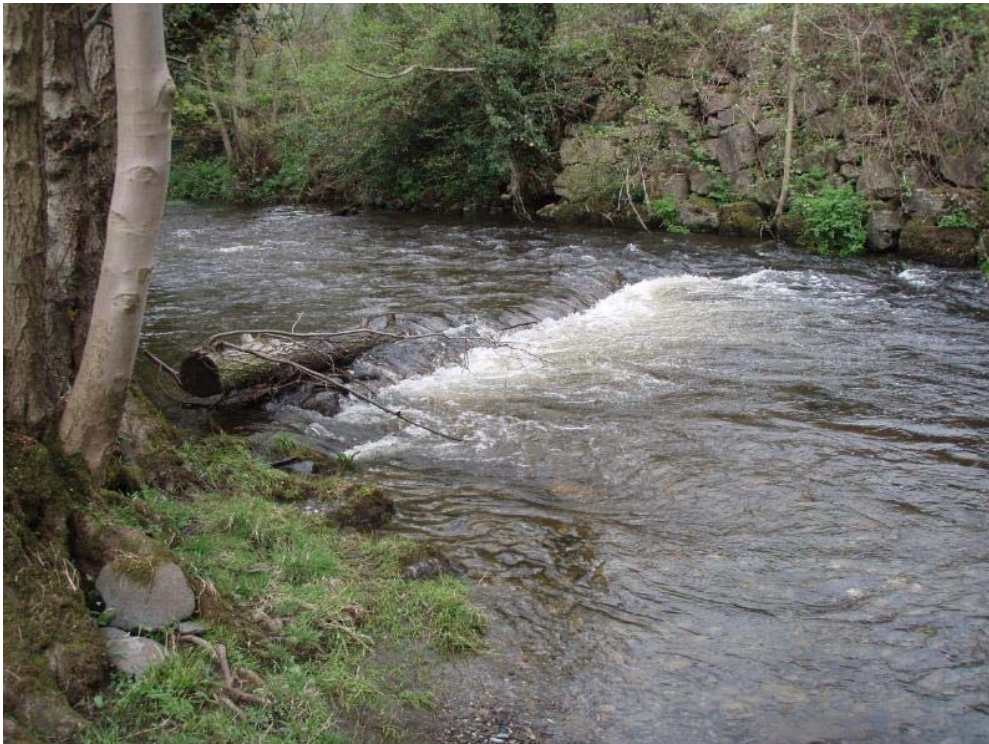
**Photo 20 Large woody material pinned to the river bed to promote localised bed scour and depth variation.**

- Place and secure large woody structures in straighter shallow sections downstream of the road to encourage pool formation (Photo 20)
- Label surface water drains for pollution prevention.

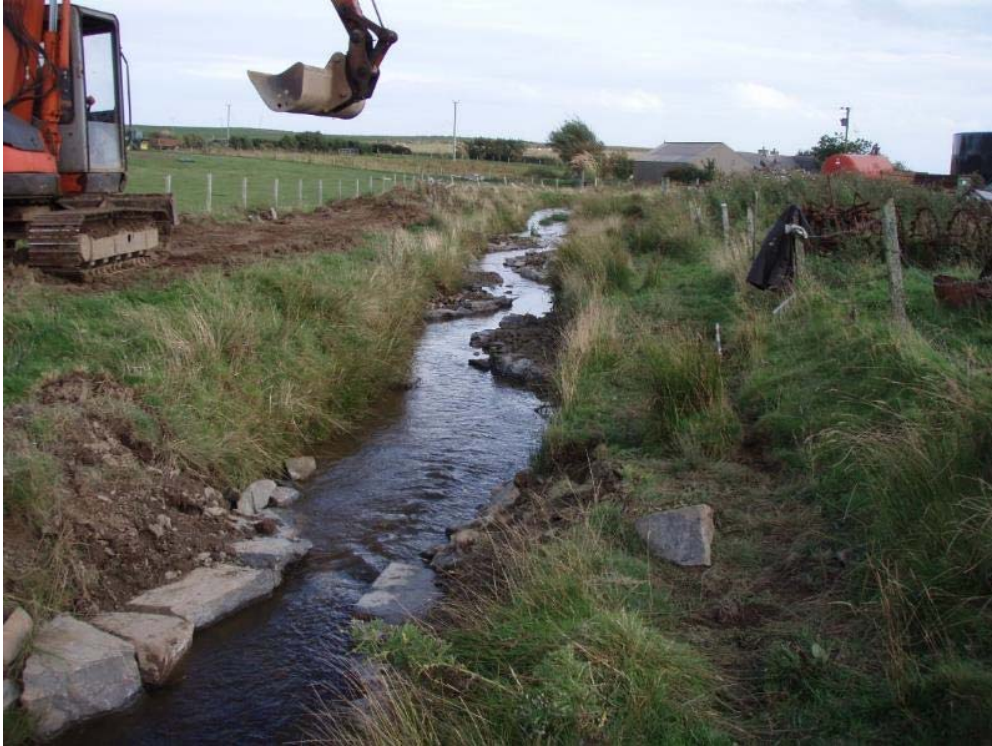
**Photo 21 Stone structures built to improve depth variation without causing flow impoundment on a small burn on Orkney.**

- Create some deeper pool areas in the reach immediately downstream of the factory (Photo 11) by placing boulders or building structures designed to scour the river bed (Photos 21 and 22).

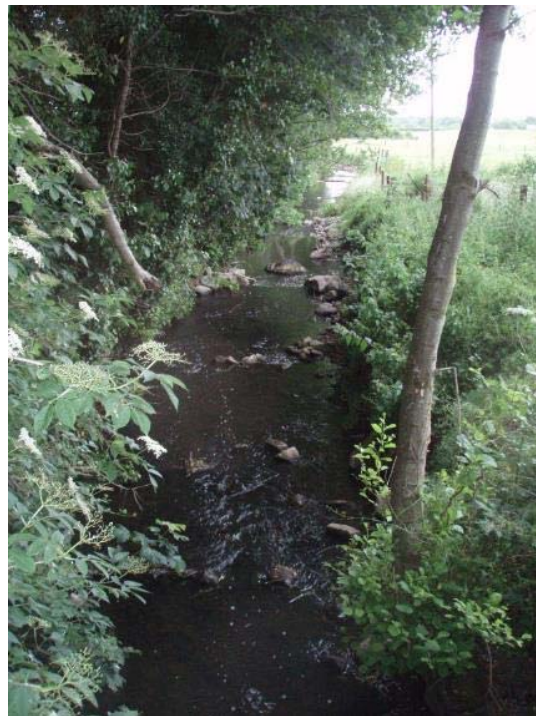
**Photo 22 Selective boulder placement to improve the diversity of flow and depth.**
