Advisory Visit

River Lymn, Lincolnshire

December 2015

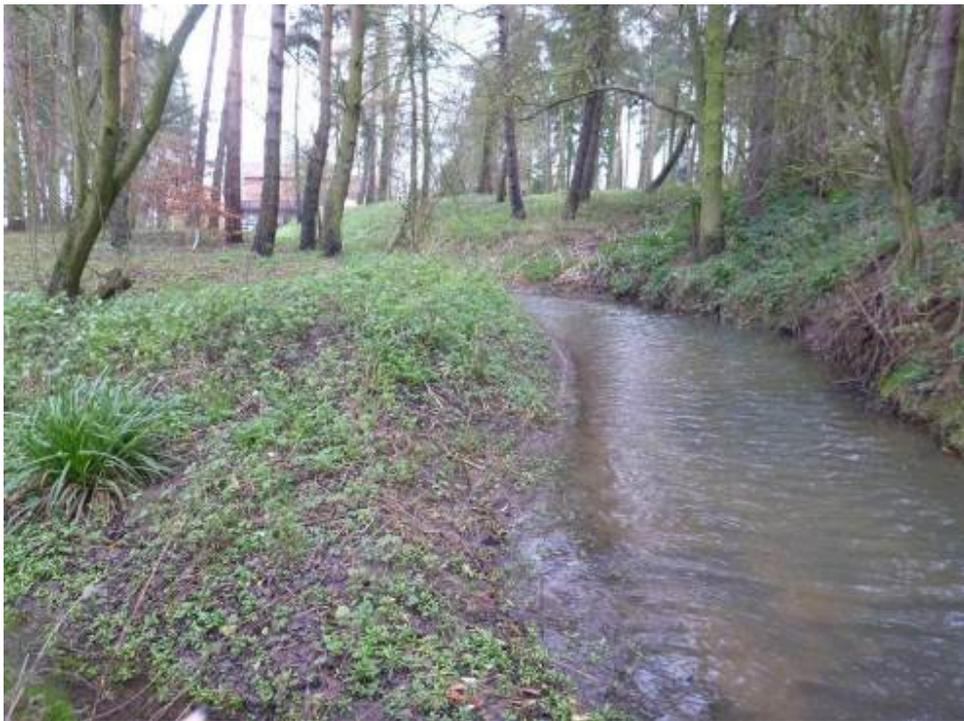
Downstream of the mill impoundment, the river channel is free-flowing and varies in wetted width depending upon the degree of shading and resulting abundance of marginal vegetation (Photos 4 and 5). Two ditches join the river from the RHB, one of which (TF 37471 68907) is probably the remnant channel of the original river course. Land use is arable on both banks, with wide grass margins alongside the river, and two areas of tree planting in field corners (TF 37518 68866 and TF 37846 68730). At least one section of the RHB is in Higher Level Stewardship.

Photo 4 Free-flowing river downstream of the mill (upstream view).

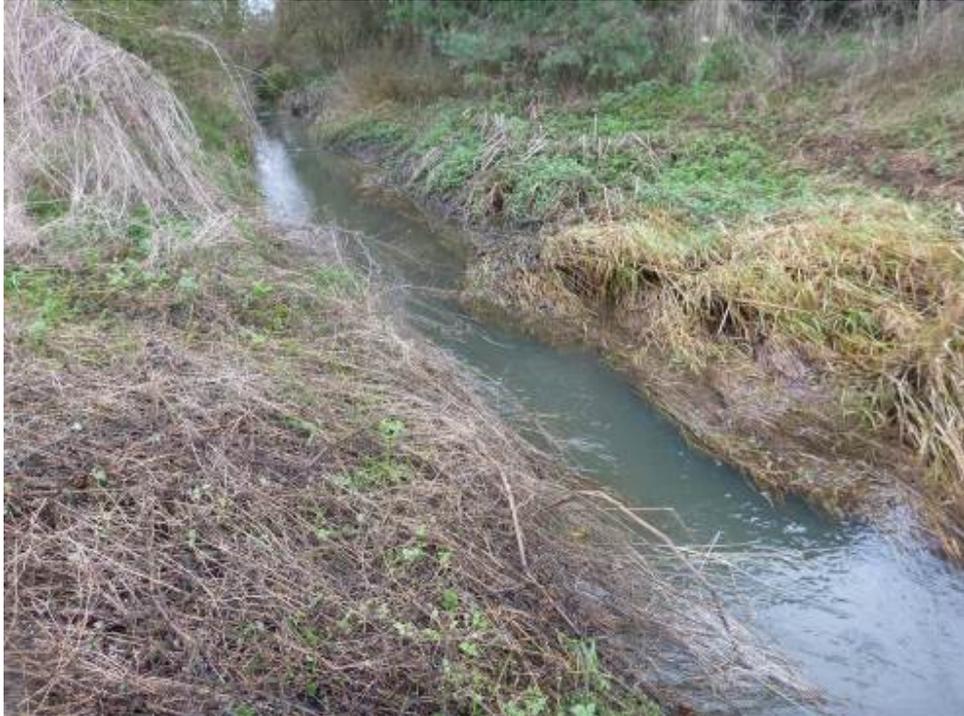
Photo 5 Narrow, deeper channel formed by consolidation of marginal vegetation into berms.

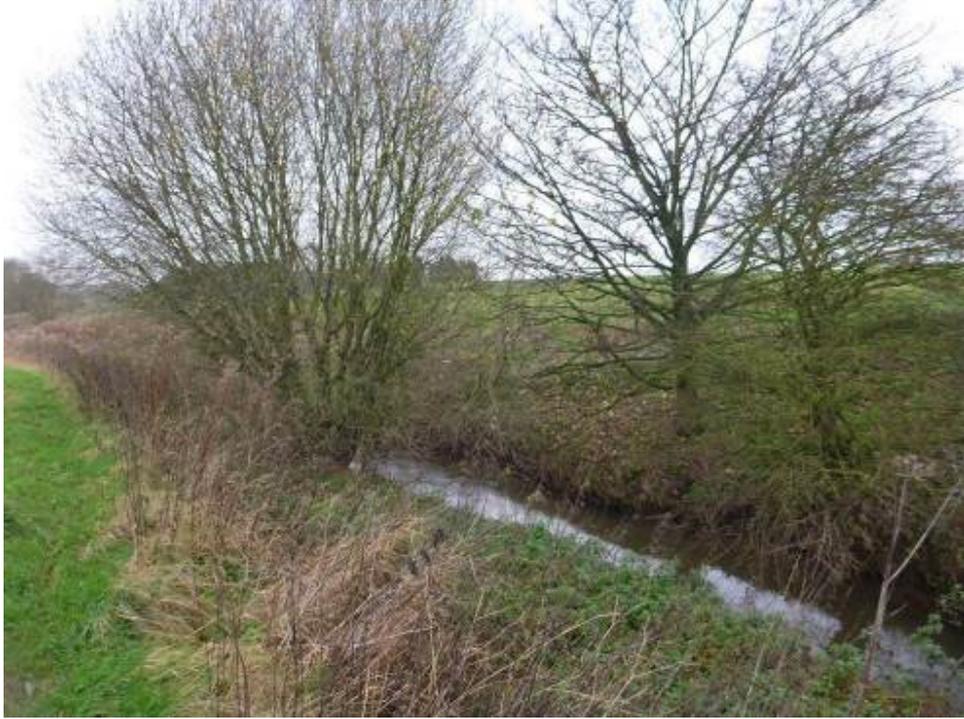
Bankside vegetation is mainly tall, scrubby plants such as willow-herb and nettle; trees and bushes are rare. A small patch of sallow, alder and hawthorn occurs at TF 37738 68826 and it is noticeable that the channel is wider here because in-stream vegetation is inhibited by the shading of the trees (Photo 7). Elsewhere, beds of emergent vegetation (such as reedmace) are common.

Photo 7 Sallow, alder and hawthorn provide some shade, restricting in-stream plant growth.

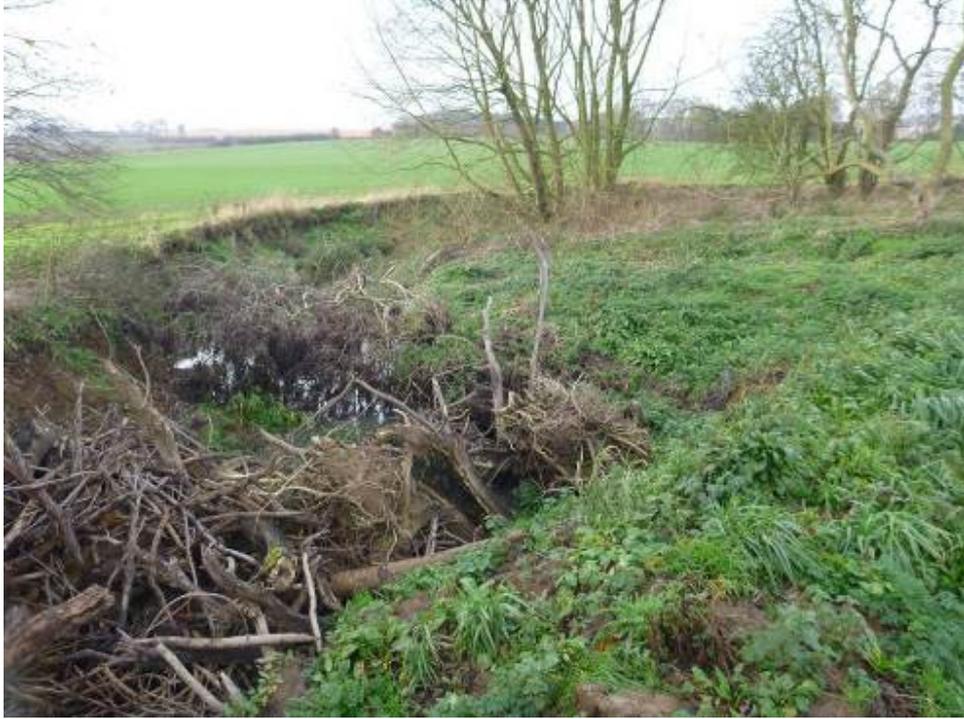
Photo 11 Former meander (upstream view)

Downstream of the bridge, recent engineering of the river channel has been carried out. The channel has been widened, bankside trees and vegetation removed and the channel has been straightened, cutting off a meander loop on the RHB (Photos 10 – 12). These works have severely damaged in-stream habitat, leaving a uniformly shallow river, devoid of any cover for fish. The overwide channel promotes the deposition of fine sediment which tends to smother the areas of gravel that have started to appear (probably supplied from the tributary stream). The removal of meanders is very damaging to river habitat, because it removes lateral scour pools which form on the outside of bends (as in Photo 8); this removes vital deeper areas (which hold adult fish) and prevents them from re-establishing.

- Re-connecting and restoring the flow to the meanders cut off by the recent works
- Narrowing the low-flow channel by introducing low berms. These should be positioned on the inside of bends, or where the river is straight on alternate banks (Photo 52).

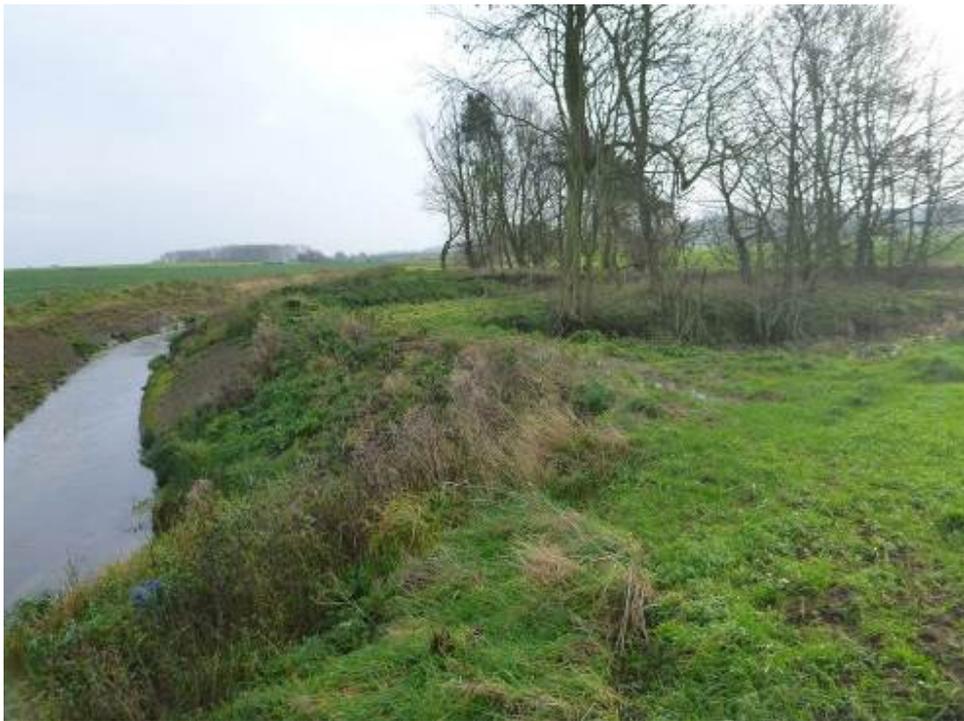
Photo 12 Former meander (right) and new channel (left), downstream view.

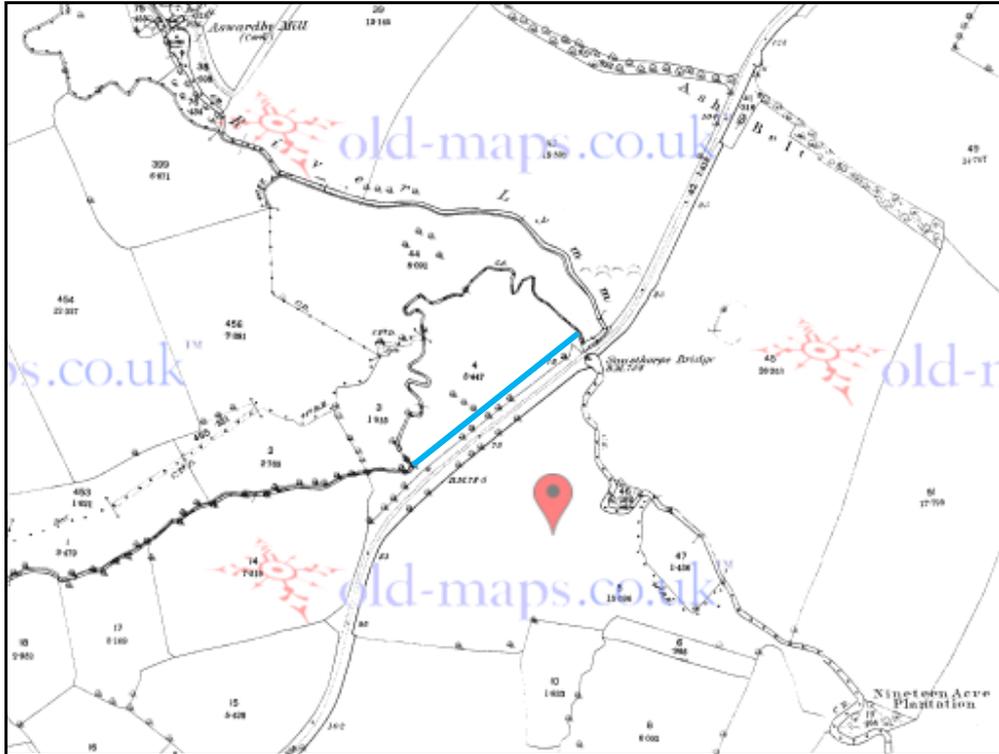
Inspection of old maps (www.old-maps.co.uk) indicates the channel was moved to its present course from a longer, sinuous course sometime between 1956 and 1971 (Figure 2).

Figure 2 1:2500 OS County Series map dated 1888, showing former sinuous course of River Lymn tributary. Blue line indicates present course. The course changes between maps dated 1956 and 1971 (Source: www.old-maps.co.uk).

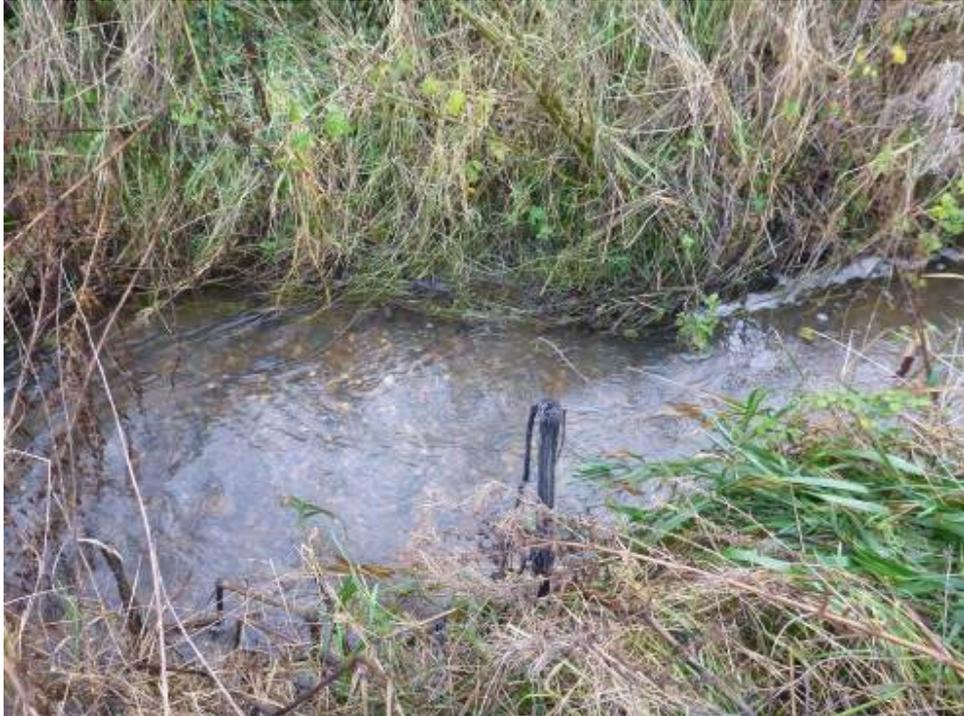
There is hardly any depth variation in this straight section, although the occasional tree root or piece of coarse woody debris is causing localised bed scour. This indicates that log flow deflectors could be used through this section to create some deeper areas which would provide holding water for adult trout and assist migration upstream from the main river. A single redd (trout spawning activity) was observed here (Photo 14). Flow deflectors would also benefit spawning by providing areas of well-sorted gravel.

Photo 14 Recently made trout redd (spawning area) indicated by the clean gravel. Approximate location TF3771668613.

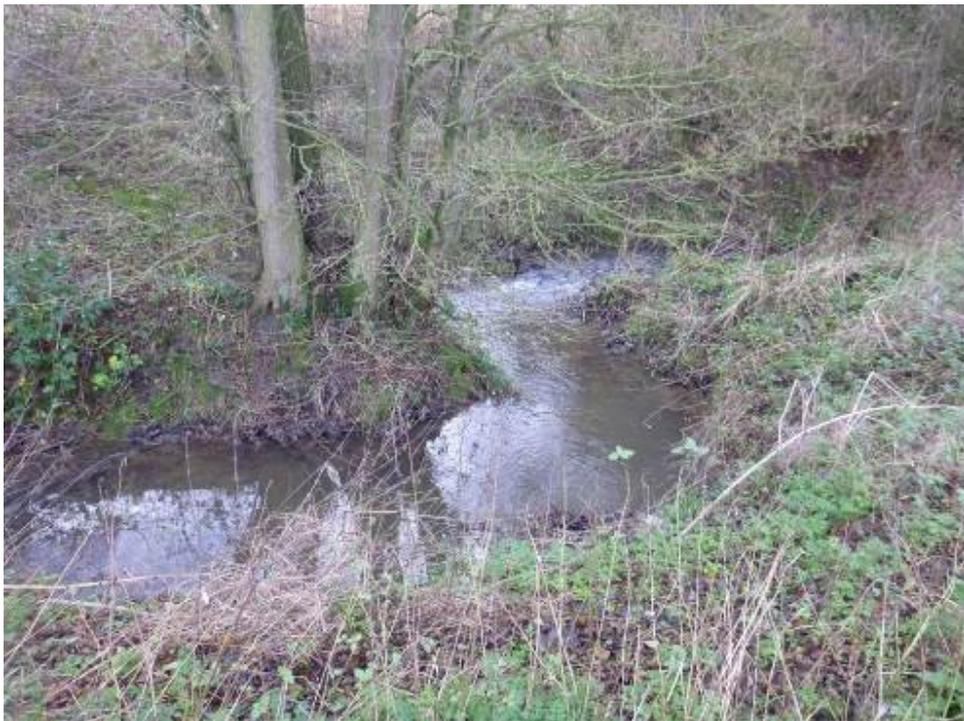
Photo 15 Better in-stream habitat with increasing channel sinuosity.

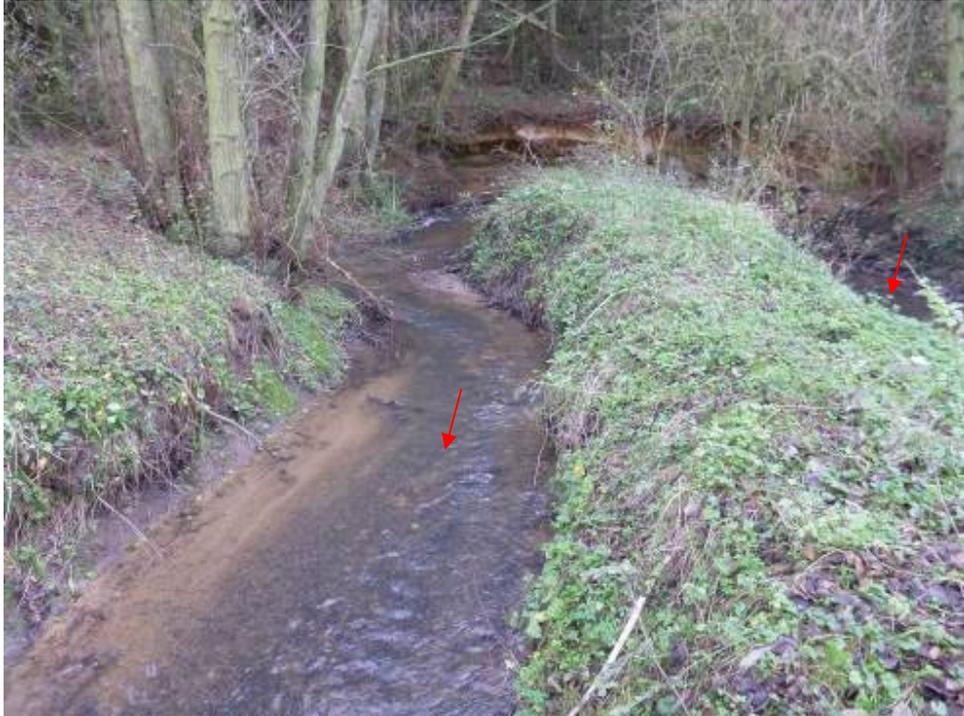
Photo 16 “Horseshoe” bend at TF3722468423 with a deep lateral scour pool (not visible, beyond headland) and two riffles, each with trout redds (locations indicated by arrows).

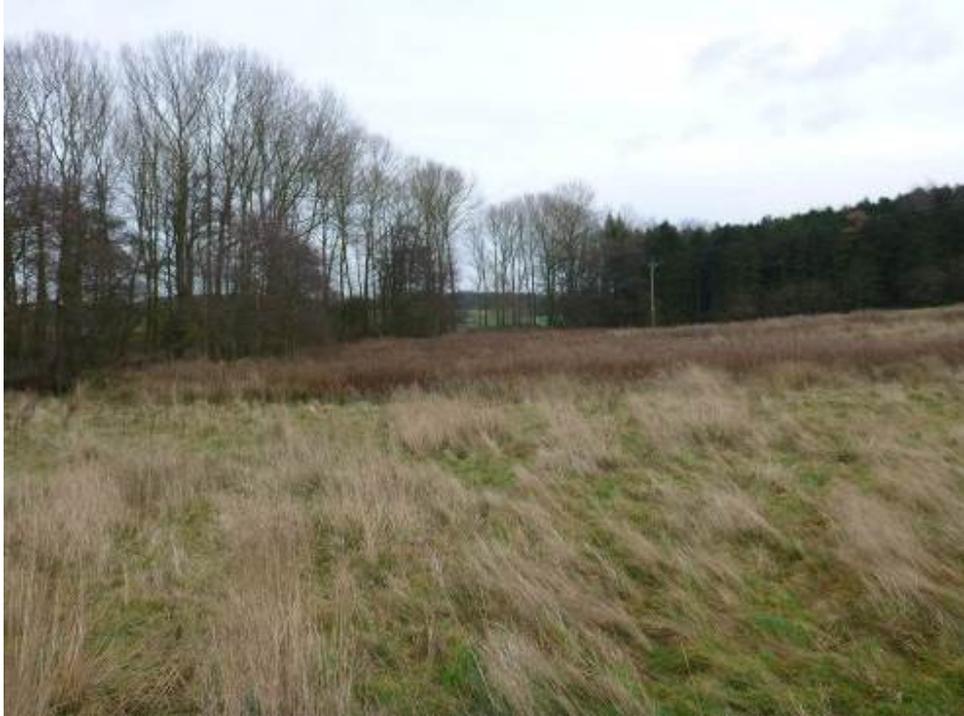
Photo 18 Low intensity conservation grazing and a wet flush, RHB, TF3713568397.

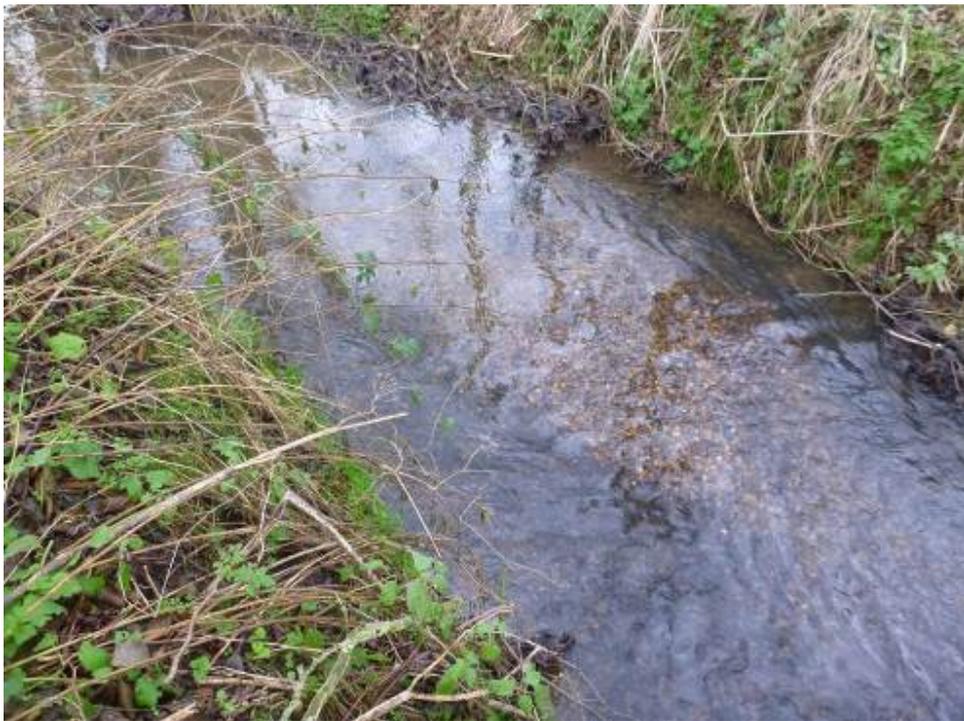
Photo 19 Trout spawning activity TF3696168422.

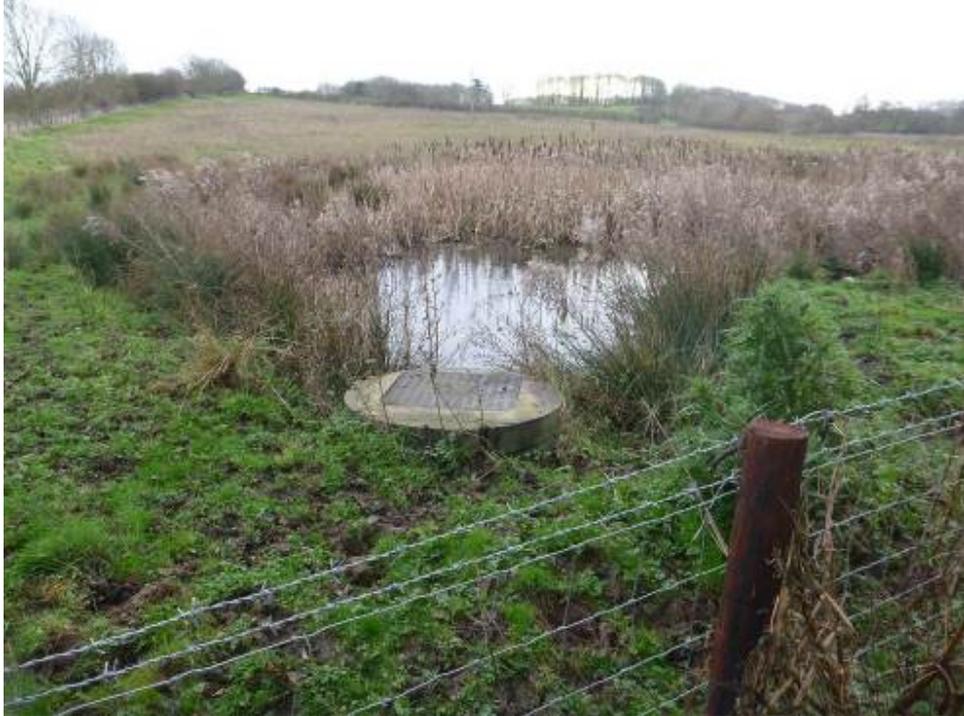
Photo 20 Low intensity land use, RHB upstream of Raithby Bridge.

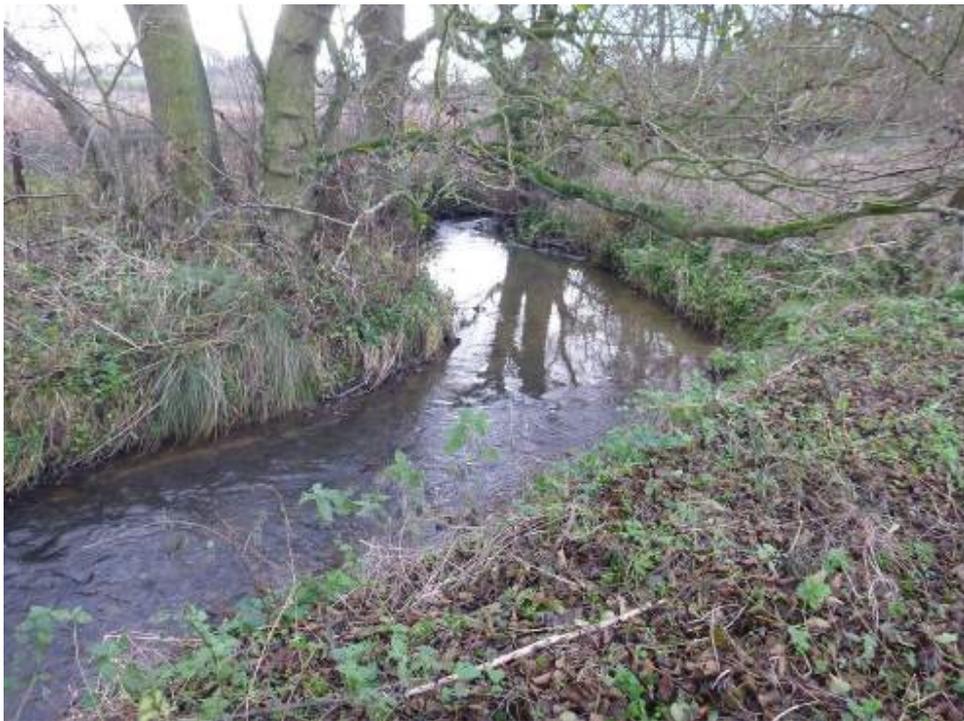
Photo 21 Good habitat upstream of Raithby Bridge – pool-riffle sequence and excellent riparian habitat – but some historic straightening has occurred (Photo 25).

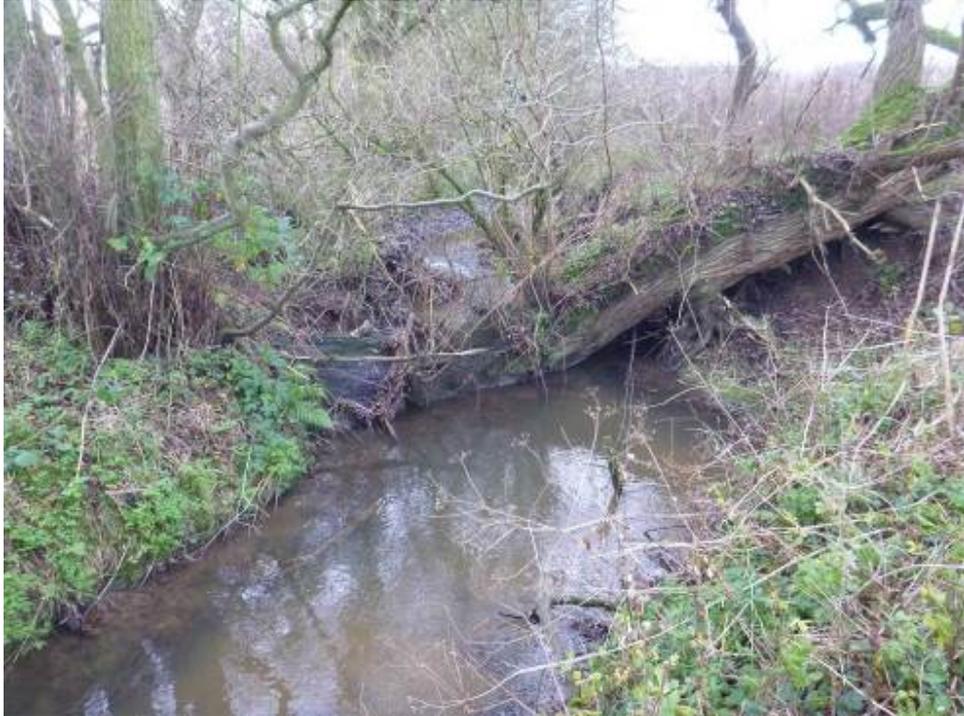
Photo 22 Large woody debris (upstream of Raithby Bridge), providing a superb habitat feature – cover and a deep scour pool.

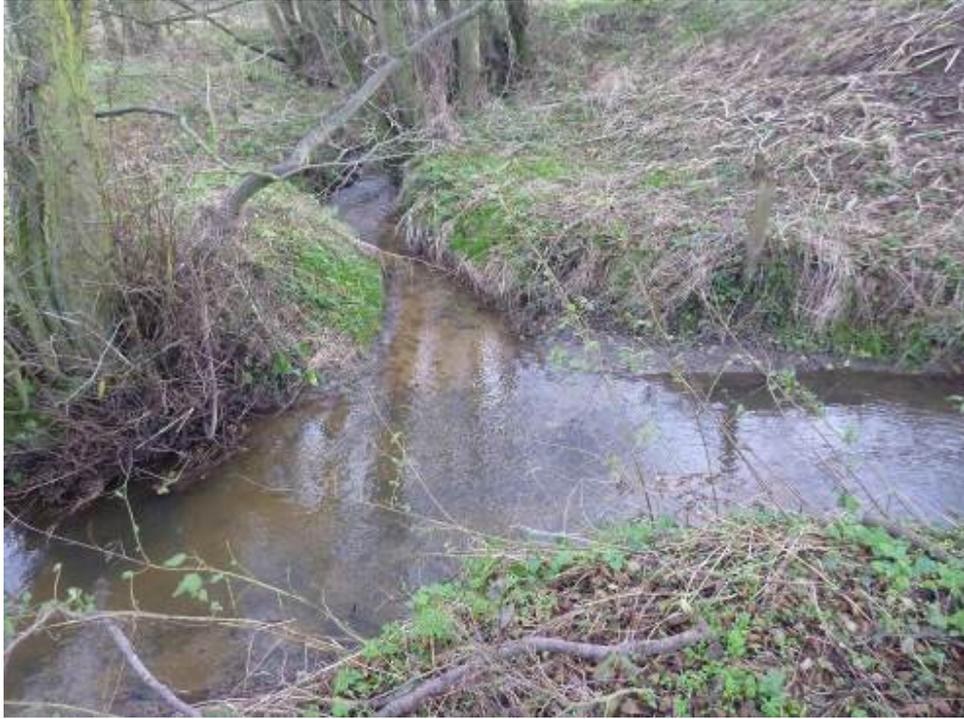
Photo 24 A tributary stream entering at TF3648568139.

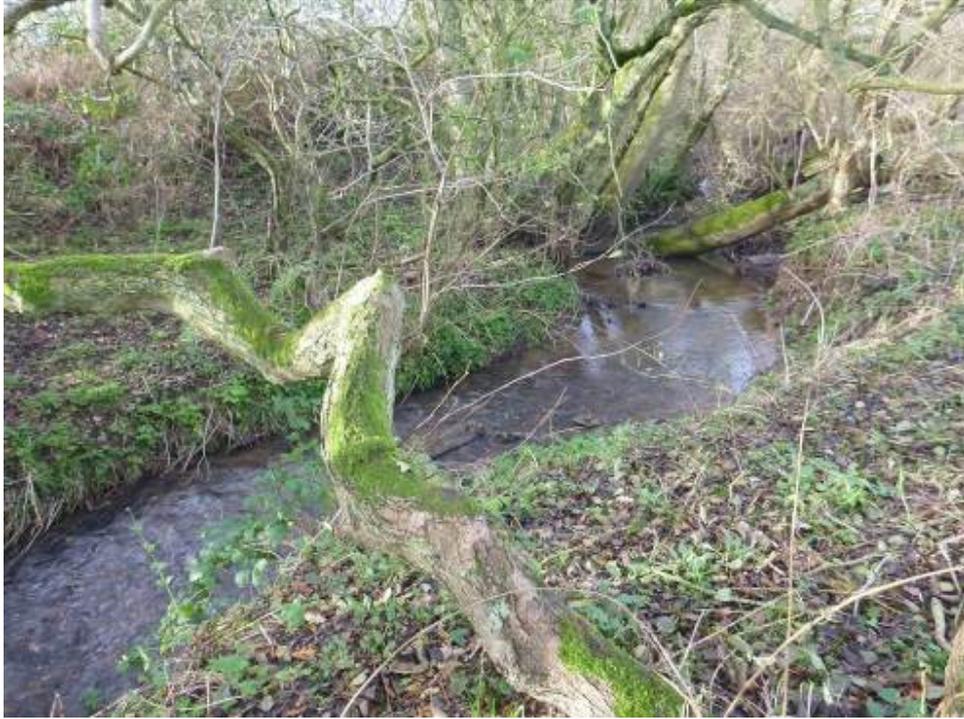
Photo 26 Excellent habitat on the section midway between Raithby Bridge and the ford at Hagworthingham (TF3564768512), including a sinuous channel, pool-riffle sequence and in-channel woody debris.

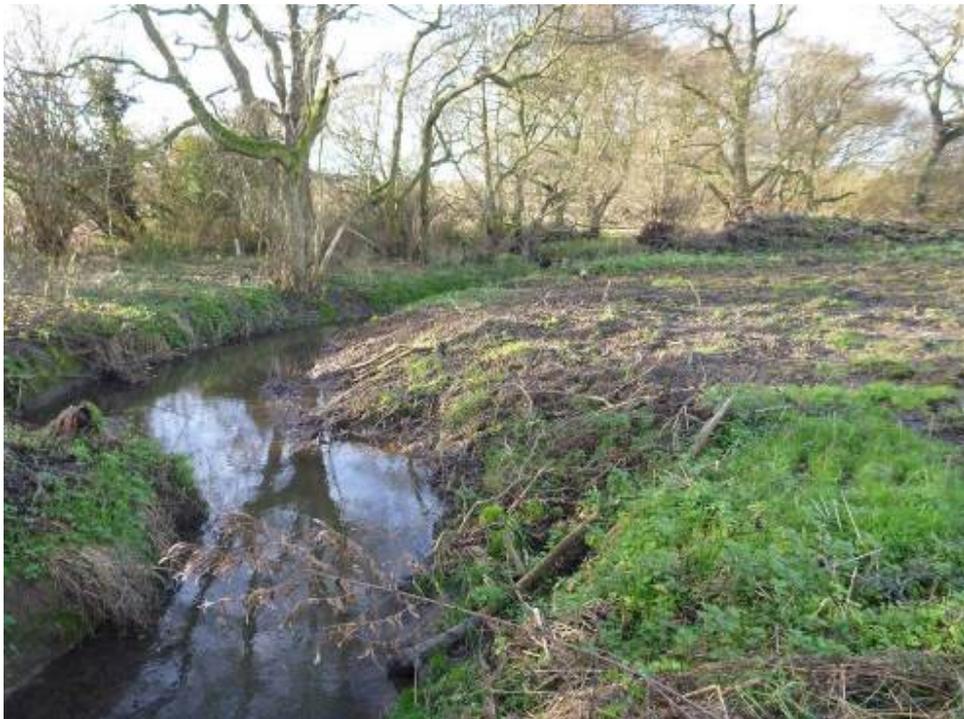
Photo 29 A recently cleared area of the LHB (adjacent to the area in Photo 28) where a new field drain has been installed.

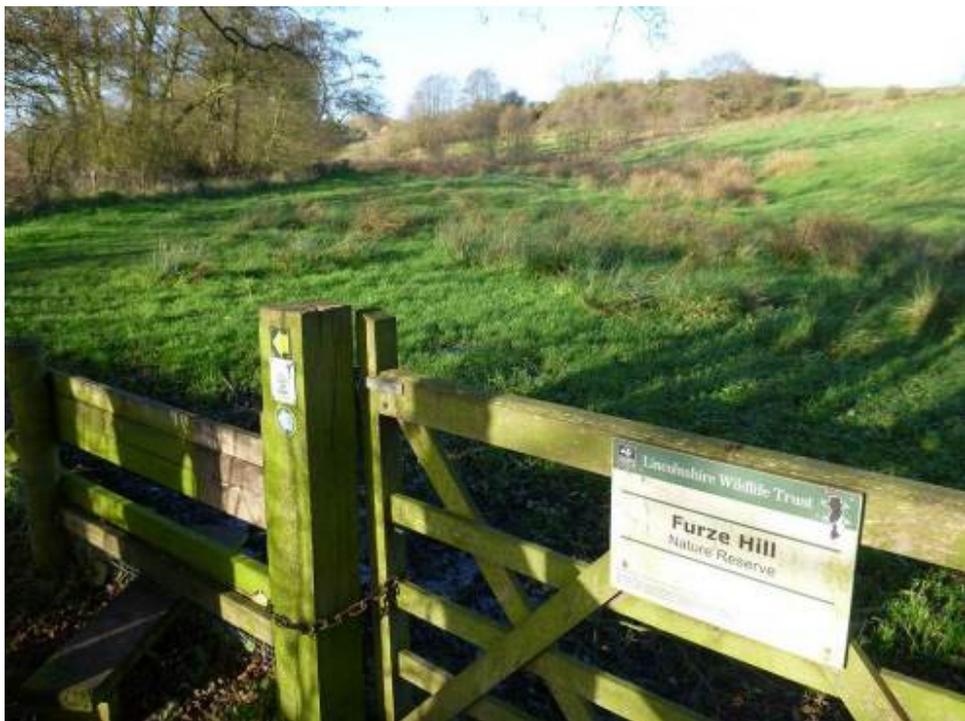
Photo 31 Low intensity grazing on LHB at Furze Hill Nature Reserve.

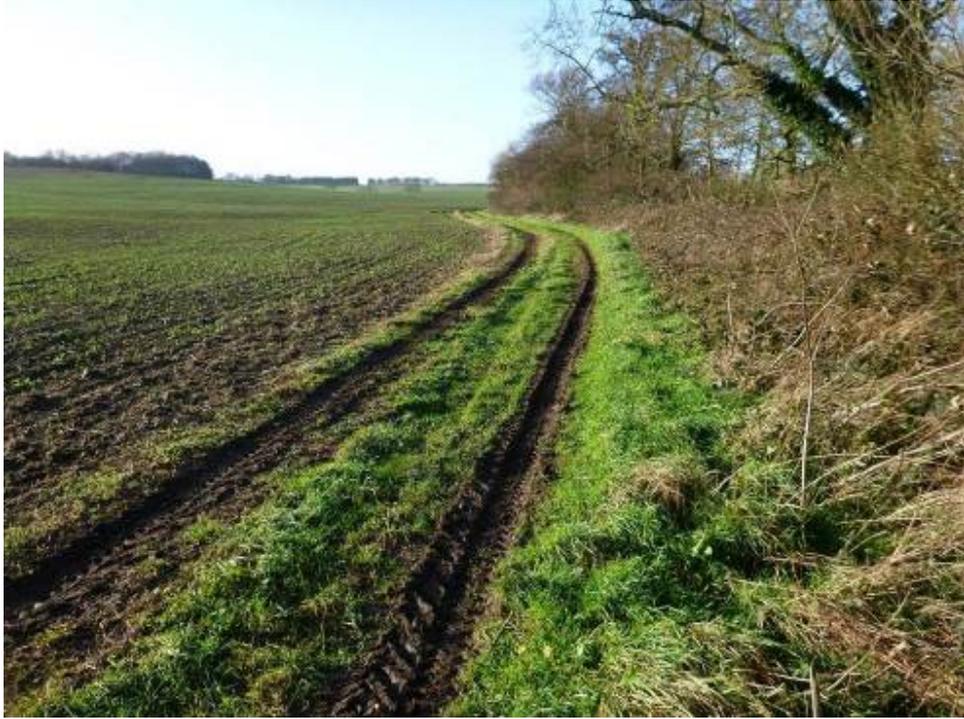
Photo 32 Arable farming on RHB with a grass margin.

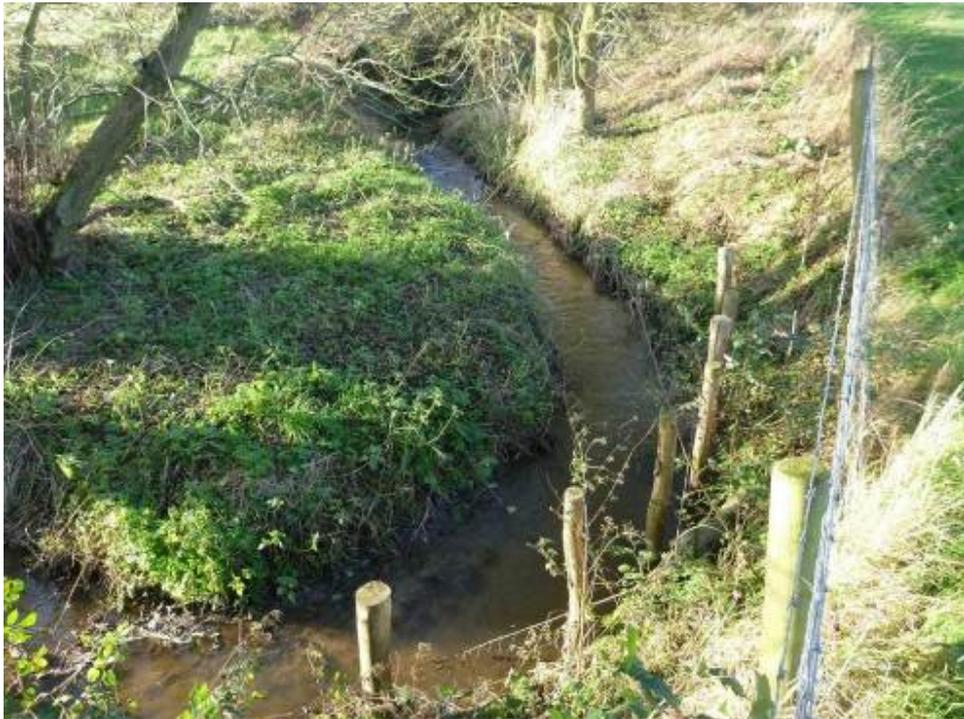
Photo 33 Reasonably good in-stream habitat alongside Furze Hill, although the channel is straighter and lacking pools compared with sections downstream (e.g. Photo 26). Some brushwood bank protection has been installed here.

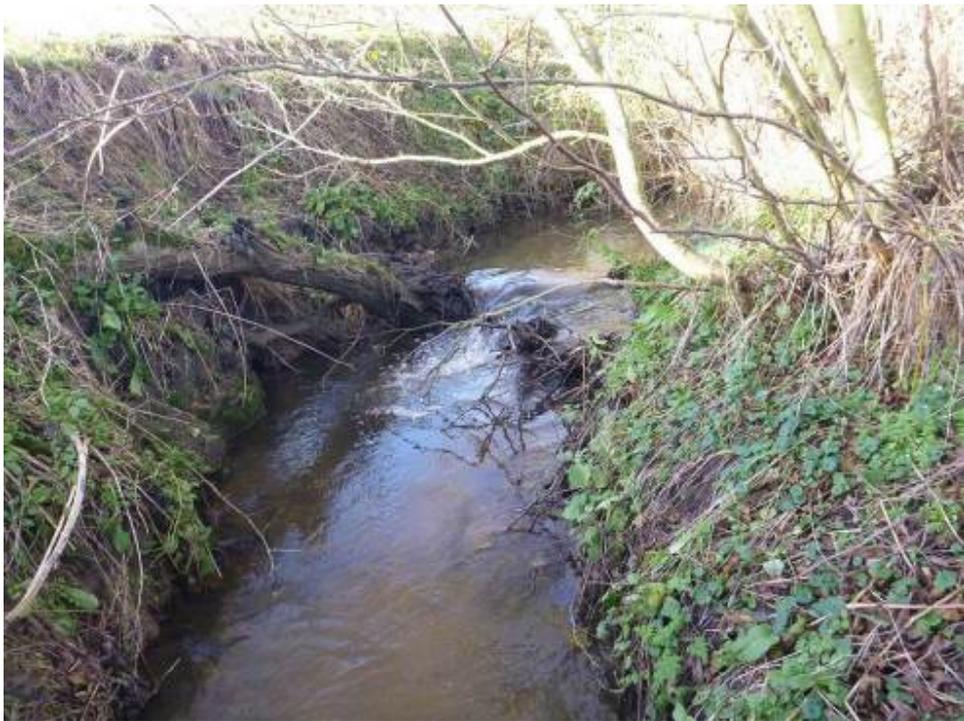
Photo 35 Woody debris creates some excellent habitat features, providing scour and depth variation.

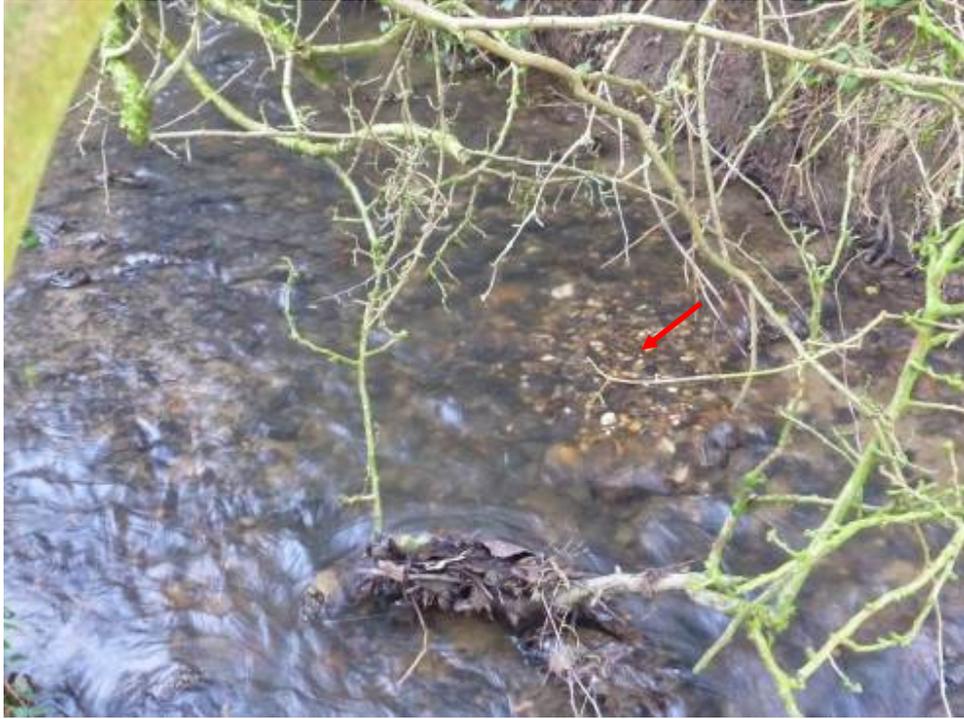
Photo 36 Trout redd made in a patch of gravel where nearby trailing branches have squeezed the flow and scoured away fine sediment from the river bed.

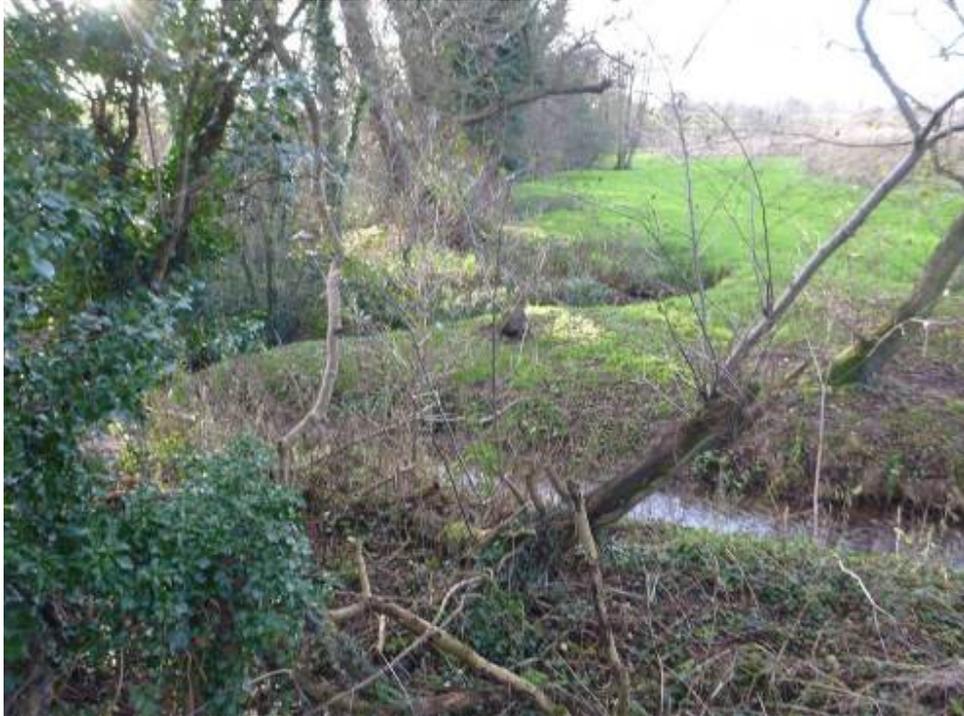
Upstream of the ford, the brook is bordered by a footpath and wooded bank on the RHB and a grassed area with recently planted blocks of trees on the LHB (Photo 38). In contrast to the RHB, there are few mature trees on the LHB immediately alongside the brook. The channel has a meandering planform, but the lack of trees on the LHB is reducing bank stability and leading to increased rates of erosion, which is in turn preventing deeper pool habitat from establishing (Photos 39, 40). Installing brushwood bank protection on the outside of LHB bends in this area, along with the planting of individual or small blocks of trees, would greatly improve the quality of the in-stream habitat.

Photo 38 Upstream of the ford, the brook has a nice, sinuous course. There is woodland on the true RHB (left of picture) and on the LHB, a grass strip with recently planted blocks of trees set back from the brook. Note the lack of trees adjacent to the brook on the LHB.

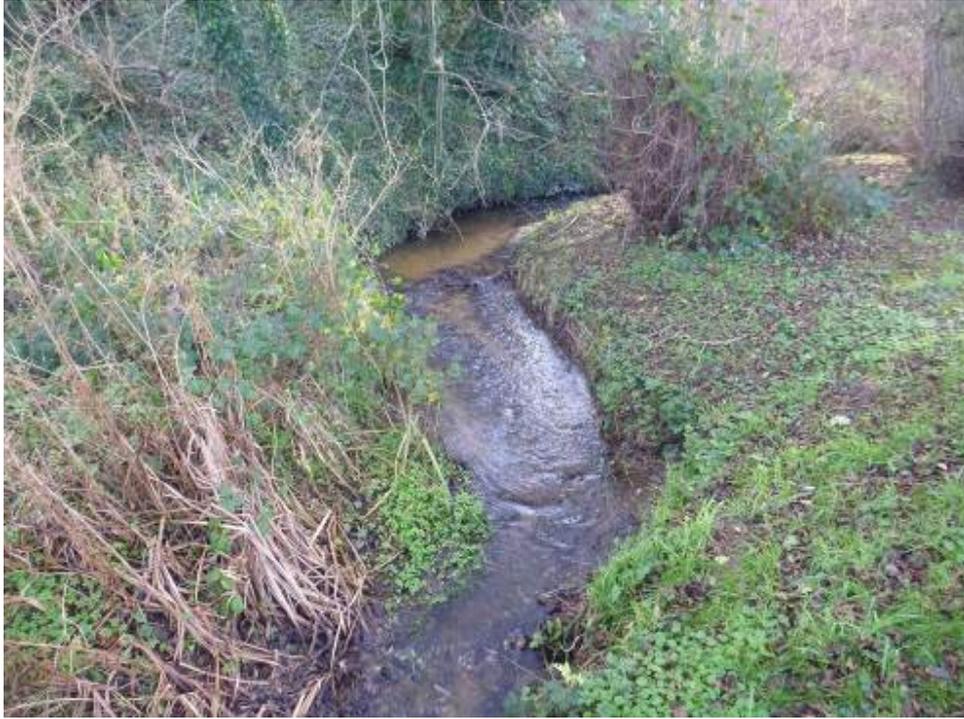
Photo 40 In contrast to Photo 39, outside bends against the more stable RHB have better developed lateral scour pools, providing good adult trout habitat.

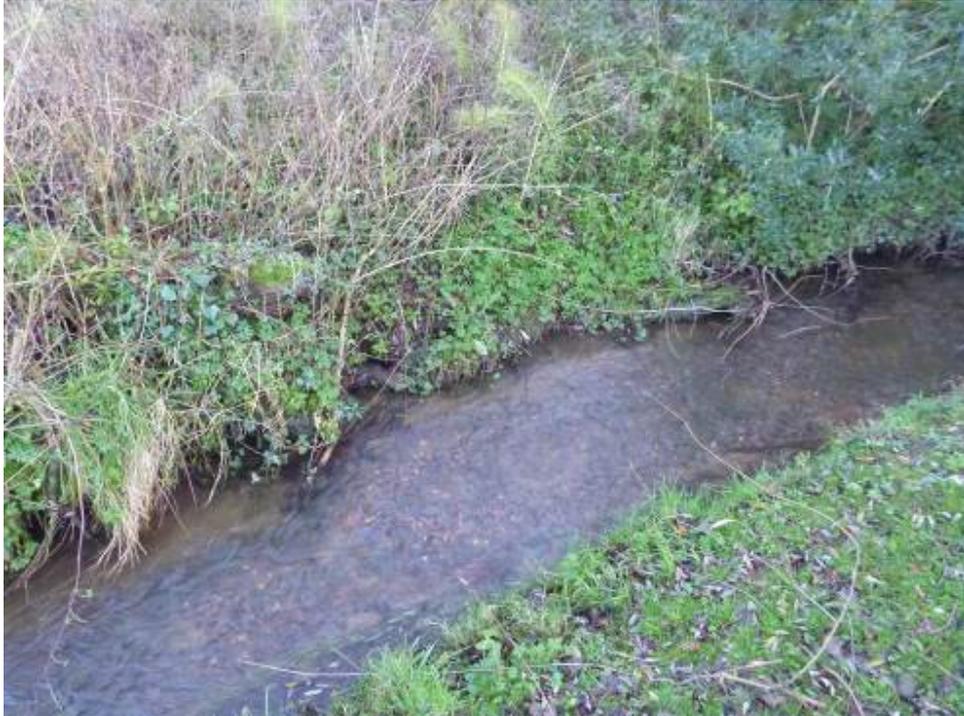
Photo 42 Recent trout spawning activity on an area of gravel immediately downstream of a fallen tree, where undershot scour has sorted the river bed sediments.

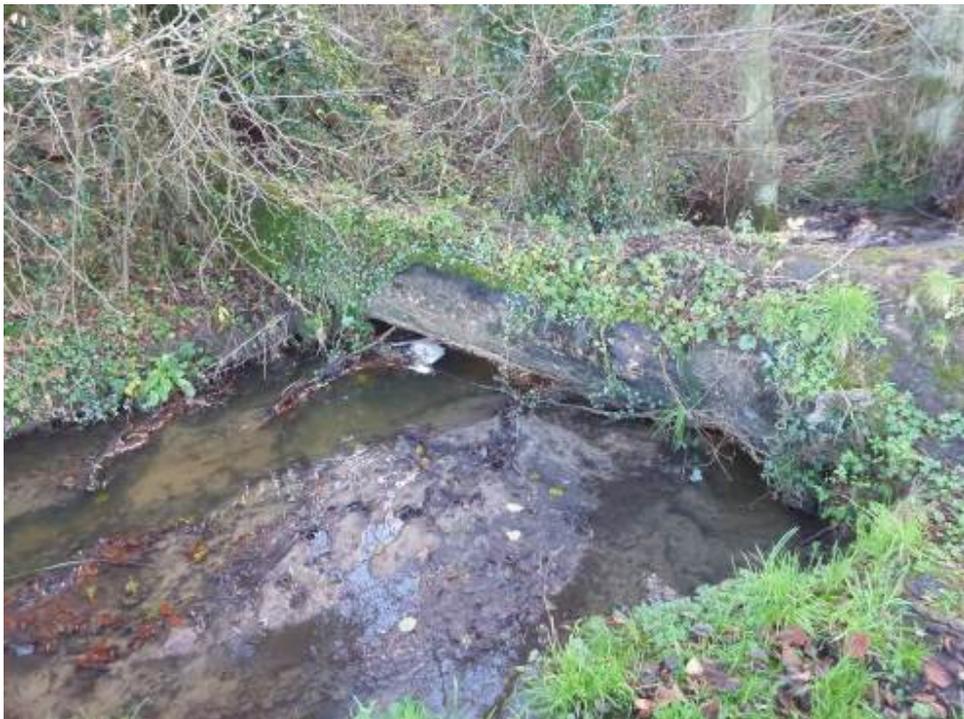
Large quantities of fine sediment are still evident in this section of the brook (Photo 41), although the sinuous plan-form and presence of in-channel woody debris promotes better sorting of the river bed substrate. Trout spawning activity was observed on areas of gravel, mainly associated with localised scour caused by woody debris (Photo 42). Undershot scour caused by water forced underneath fallen trunks spanning the channel seems particularly effective at creating depth and sorting sediments (Photo 43). Mimicking this effect in other areas with introduced structures is recommended.

Photo 43 A large fallen tree creates localised scour and depth variation, as well as a wildlife “bridge” (this is another example, not the one associated with Photo 42).

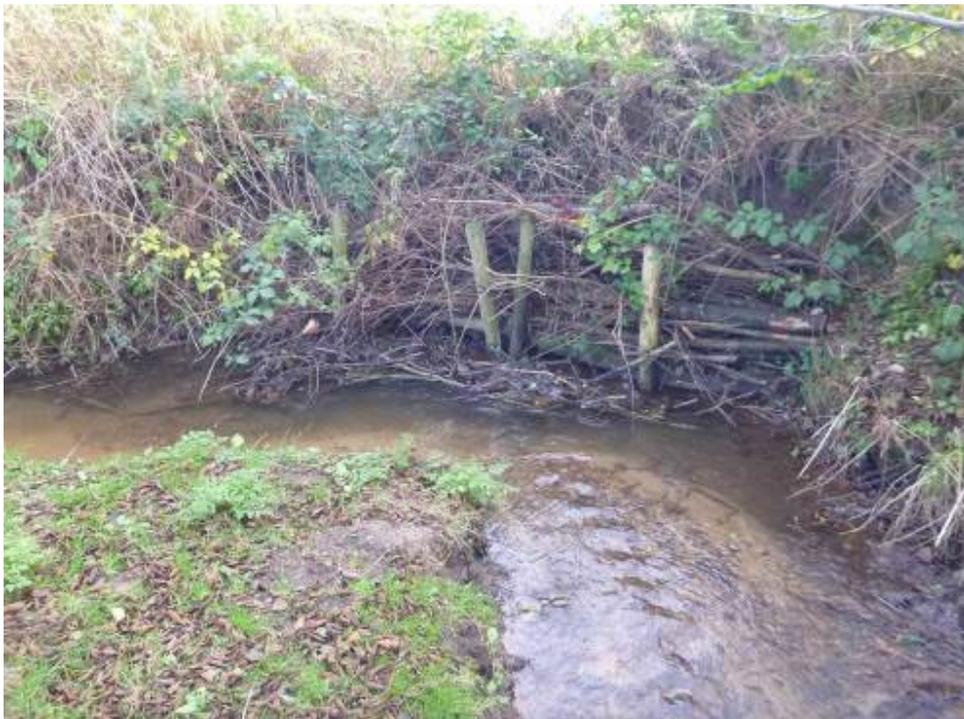
With progress upstream, some sections of the upper course of the brook are straighter and embanked, suggesting past channel engineering. These sections have relatively poor habitat, lacking depth variation and sorting of the bed sediments. A number of significant differences in bed level on either side of the root balls of trees were observed; it is not clear whether these are natural features or indicative of deliberate lowering of the river bed in the past, the areas adjacent to trees being inaccessible for engineering (Photos 44-46). The straighter sections of the channel could easily be improved by introducing woody debris features (see recommendations). Some areas of the RHB have been protected with brushwood revetment, which is also providing some valuable in-stream cover for fish (Photo 47).

Photo 47 Some brushwood bank protection has been carried out on the RHB.

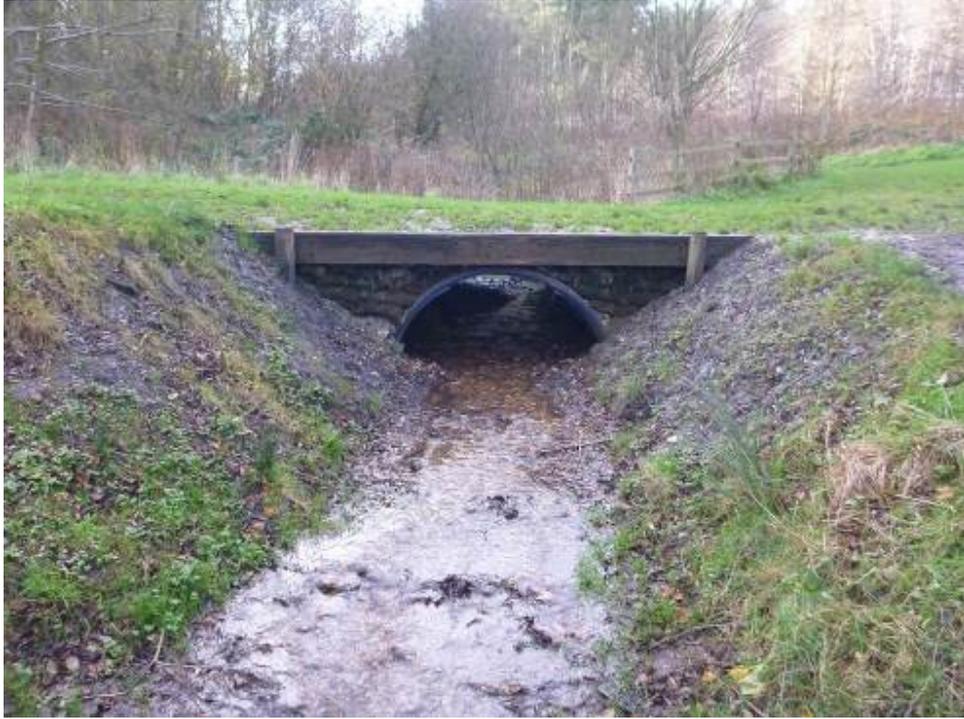
A tributary stream joins from the RHB at Snipe Dales Country Park (TF3385168670); this appears to be an important source of gravel for the brook. The bridge just upstream from the confluence is well-designed, allowing natural sediment transport processes to continue and not impeding fish passage (Photo 48). Upstream from the confluence, the brook is small and quite straight with only very occasional pools capable of supporting trout

Photo 48 Culvert bridge over a tributary stream on Snipe Dales Country Park. This is an example of good practice with the pipe (or possibly arch) well sunk into the stream bed, allowing natural sediment transport and free fish passage.

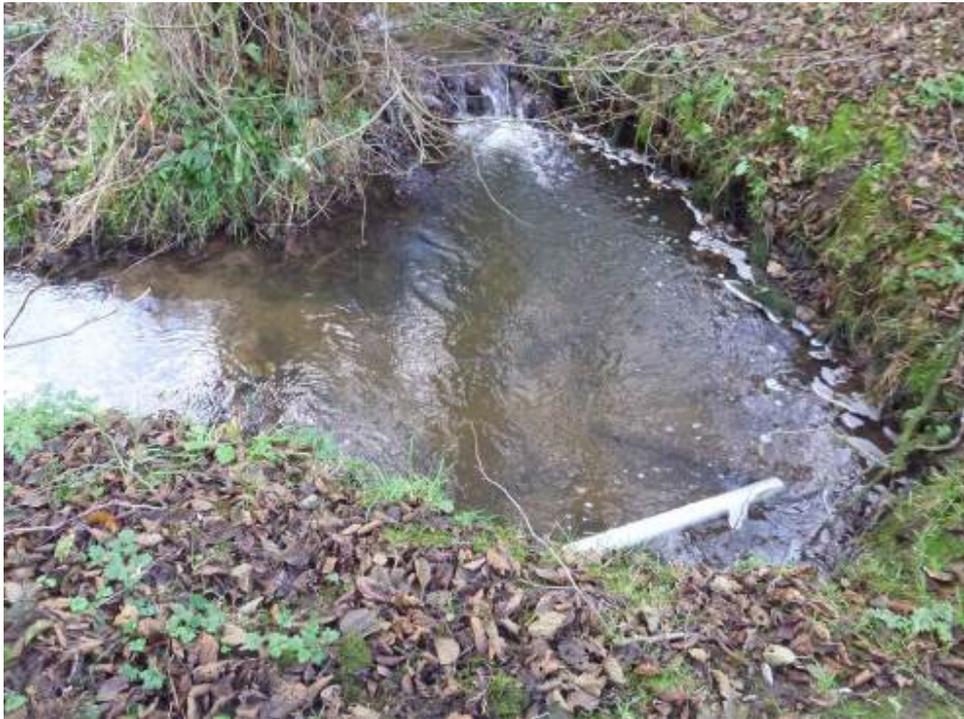
(Photos 49, 50). Woody debris structures to promote bed scour and the development of a more sinuous course would be beneficial in this area.

Photo 49 A rare pool on the upper section of the brook within Snipe Dales. Features like this are essential for holding trout.
